Preliminary Arboricultural Report

Tweed Valley Hospital Project

17 October 2018

Preliminary Arboricultural Report relating to four (4) individual trees and 150+ hedgerow trees located at 771 Cudgen Road Kingscliff NSW

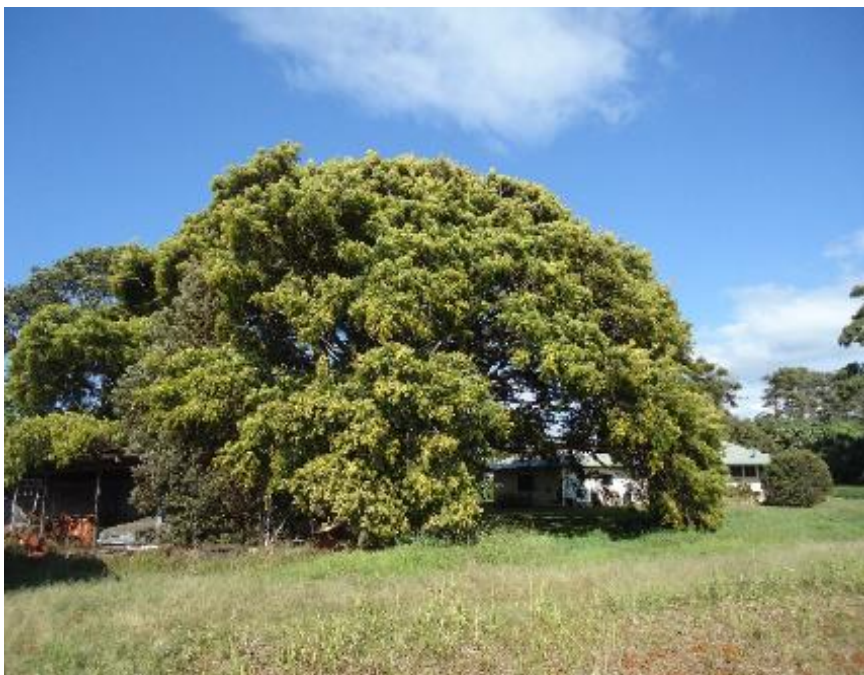
- 5.2.3 Tree 4 was a *Ficus benjamina* (Weeping Fig). The tree was located adjacent to Cudgen road, immediately east of the existing house structure. The tree was large and well established for its species and formed a significant feature within the landscape (see Figure 6).
- 5.2.4 Tree 4 was of good health and fair structure and had an estimated life expectancy of greater than 25 years (25–50 years). The lower trunk structure was a mass of competing stems typical of the species (see Figure 7).
- 5.2.5 The TPZ for Tree 4 is 15m, and the SRZ is 3.9m, measured at a radial distance from the centre of the trunk.

Figure 6. View to south of Tree 4 *Ficus benjamina* (Weeping Fig) in its growing environment. Source: Andrew Clark, 20 July 2018

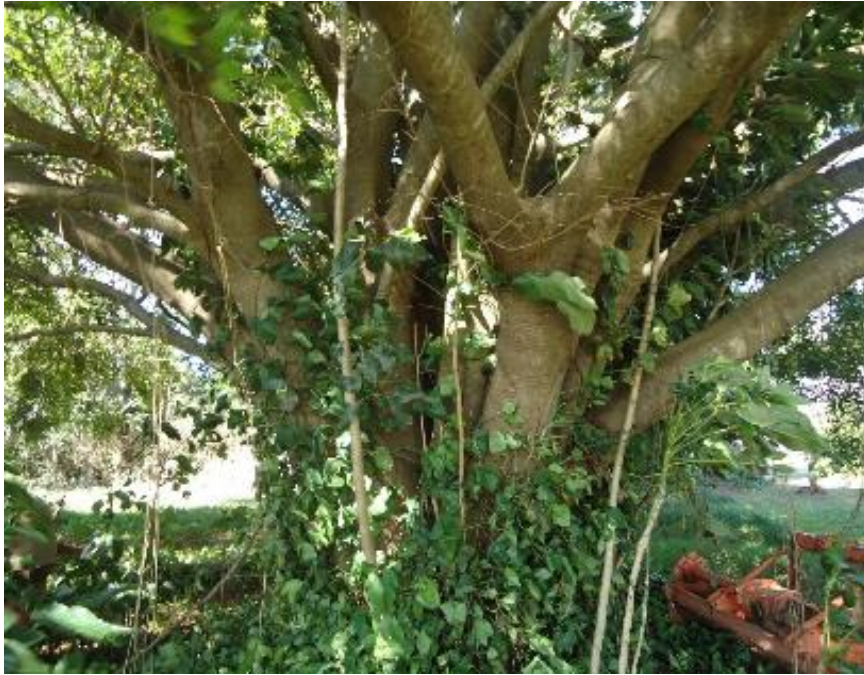
Figure 7. View of the lower trunk structure of Tree 4 *Ficus benjamina* (Weeping Fig). Source: Andrew Clark, 20 July 2018

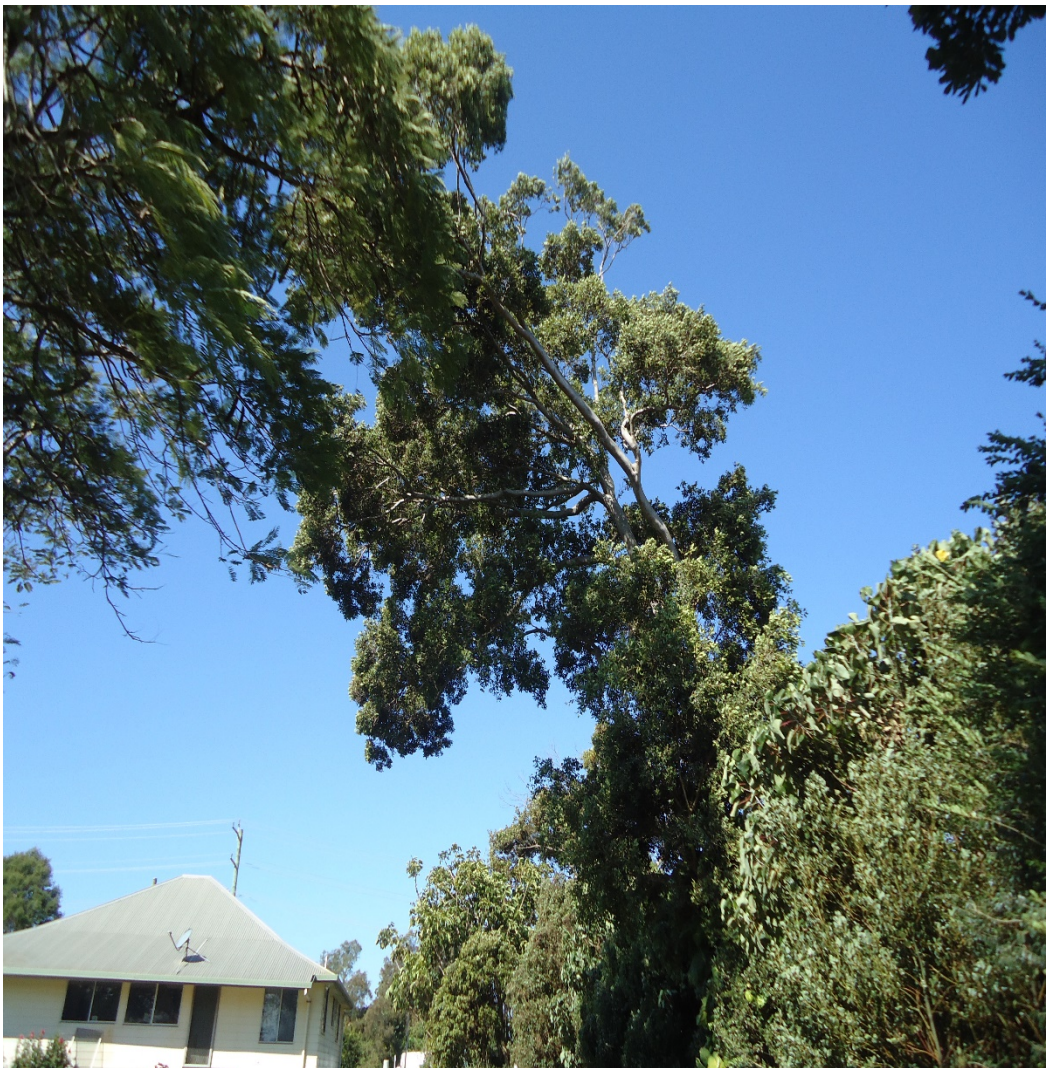
- 5.3.3 Tree 1 was a *Ficus obliqua* (Small Leafed Fig). The tree was considered to be in good health with a fair structure. The tree canopy had a significantly crown bias to the east, attributed to suppression from an adjacent, previously removed tree, which detracted from its overall visual / aesthetic appearance (see Figure 9).
- 5.3.4 The tree had established over and around a decaying stump, from the previously removed tree, causing cavities and uneven growth with the basal area and structural roots. Overall structural stability was not considered to be compromised, at the time of inspection, and root growth of this kind was considered typical of the species. A large European bees' nest was observed within the basal hollows of the tree.
- 5.3.5 The TPZ for Tree 1 is 12m, and the SRZ is 4.4m, measured at a radial distance from the centre of the trunk.

Figure 9. View to south of Tree 1 *Ficus obliqua* (Small Leafed Fig) in its growing environment. Source: Andrew Clark, 20 July 2018

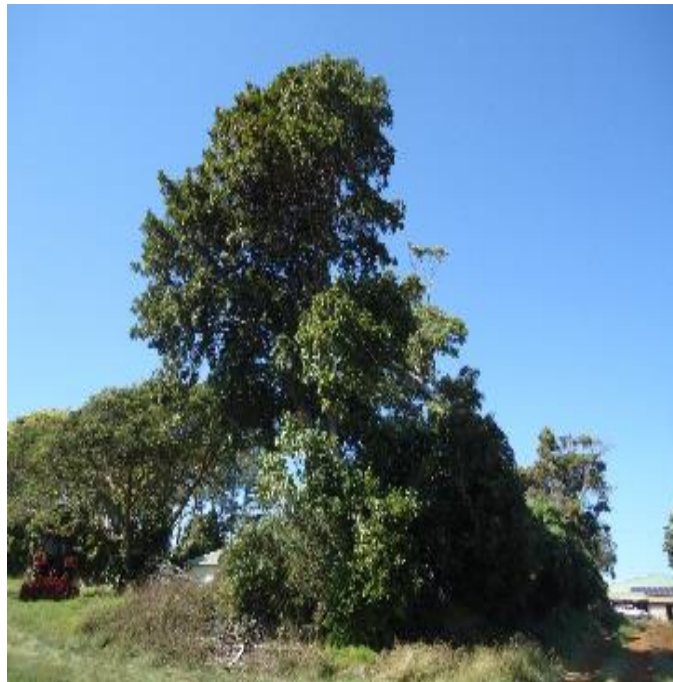
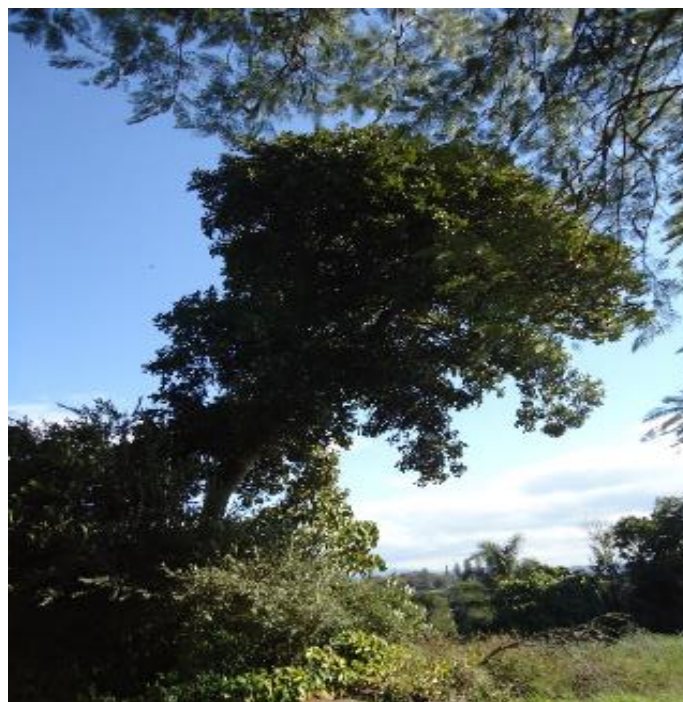
- 5.3.6 Tree 2 was a *Cupaniopsis anacardioides* (Tuckeroo). The tree was of a large size for the species and considered in good health with a fair structure. The tree canopy had a significantly crown bias to the north east, attributed to suppression from an adjacent previously removed tree, which detracted from its overall visual / aesthetic appearance (see Figures 10 and 11). Several wounds from previous lateral branch failures were observed within the crown.
- 5.3.7 The TPZ for Tree 2 is 7.2m, and the SRZ is 2.8m, measured at a radial distance from the centre of the trunk.

Figure 10. View to south of Tree 2 *Cupaniopsis anacardioides* (Tuckeroo) in its growing environment. Source: Andrew Clark, 20 July 2018

Figure 11. View to west of Tree 2 *Cupaniopsis anacardioides* (Tuckeroo) in its growing environment. Source: Andrew Clark, 20 July 2018

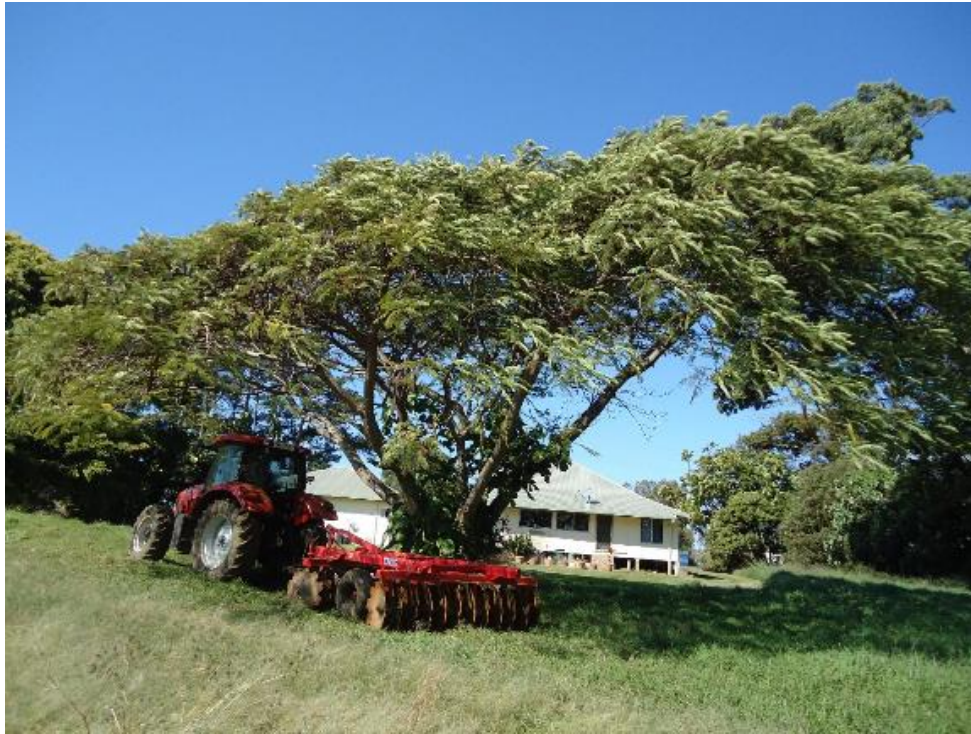
- 5.3.8 Tree 3 was a *Delonix regia* (Poinciana). The tree was of a moderate height for the species and was in good health with a fair structure. Several included unions between co-dominant stems were observed. Although these unions were considered stable at the time of assessment they could detract from the tree's long-term structural stability.
- 5.3.9 The TPZ for Tree 3 is 9.4m, and the SRZ is 3.4m, measured at a radial distance from the centre of the trunk.

Figure 12. View to west of Tree 3, *Delonix regia* (Poinciana) in its growing environment. Source: Andrew Clark, 20 July 2018

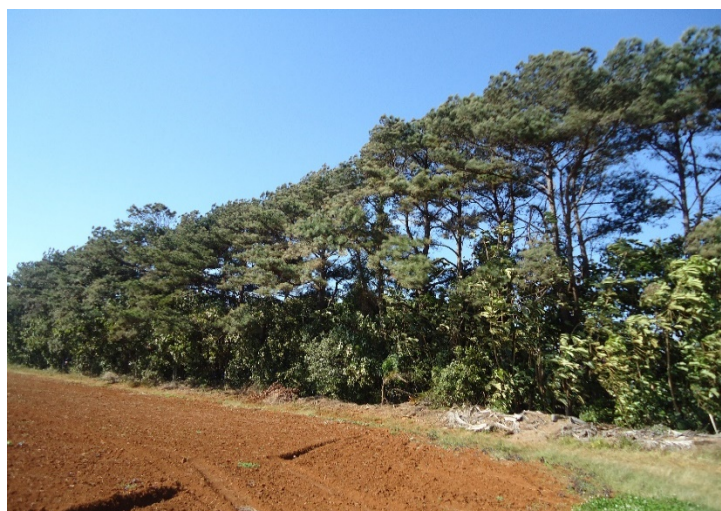
- 5.4.3 The line of wind break trees on the boundary of Cudgen Road were identified as *Pinus elliottii* (Slash Pine), of which there were over 150 individual trees (estimated), planted at 3-4m spacings. The DBH of the larger trees was observed to be approximately 40cm (at 1.4m above ground level) with estimated heights of between 15–20m.
- 5.4.4 *Pinus elliottii* (Slash Pine) is regarded as an environmental weed in Queensland and New South Wales (BCC website – 2018) with a variety of control recommendations.
- 5.4.5 The trees provide some screen value between the site and neighbouring properties, however ease of growth (possible weedy tendencies), limited ULE and species type resulted in a classification of Low Retention Value.
- 5.4.6 The average TPZ for the *Pinus elliottii* (Slash Pine) was 4.8m, measured at a radial distance from the centre trunk.

Figure 14. View to the east of the line of *Pinus elliottii* (Slash Pine), and the regenerating trees under the canopy. Source: Andrew Clark, 20 July 2018

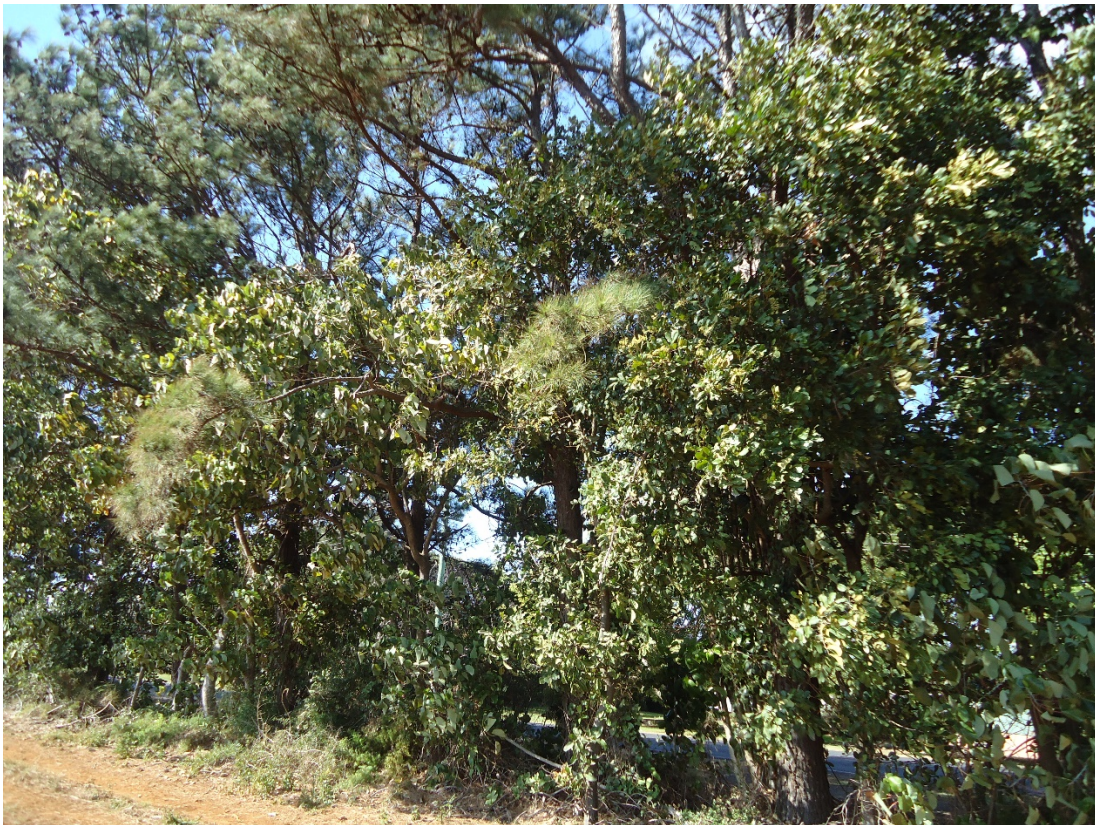
- 5.4.7 The naturally regenerating understory trees consisted mainly of three native species, namely *Cupaniopsis anacardioides* (Tuckeroo), *Macaranga tanarius* (Macaranga) and *Schefflera actinophylla* (Umbrella Tree). The trees were typically suppressed, semi-mature specimens, with a DBH in the range of 10–20cm and tree heights of between 5–10m.

- 5.4.11 The trees provided some screen value between the site and neighbouring properties, however age, size, health and structure, ease of growth and species type resulted in a Low Retention Value.

Figure 15. A closer view of the line of regenerating trees growing under the *Pinus elliottii* (Slash Pine). Source: Andrew Clark, 20 July 2018
