# CONTAMINATED SITE VALIDATION REPORT

**Lots 14 and 15 Section L DP 8993**  
**No. 7 James Street**  
**Argenton**

for  
**Alesco Senior College**

Ref: 2020233.02 – VAL  
24 June 2020

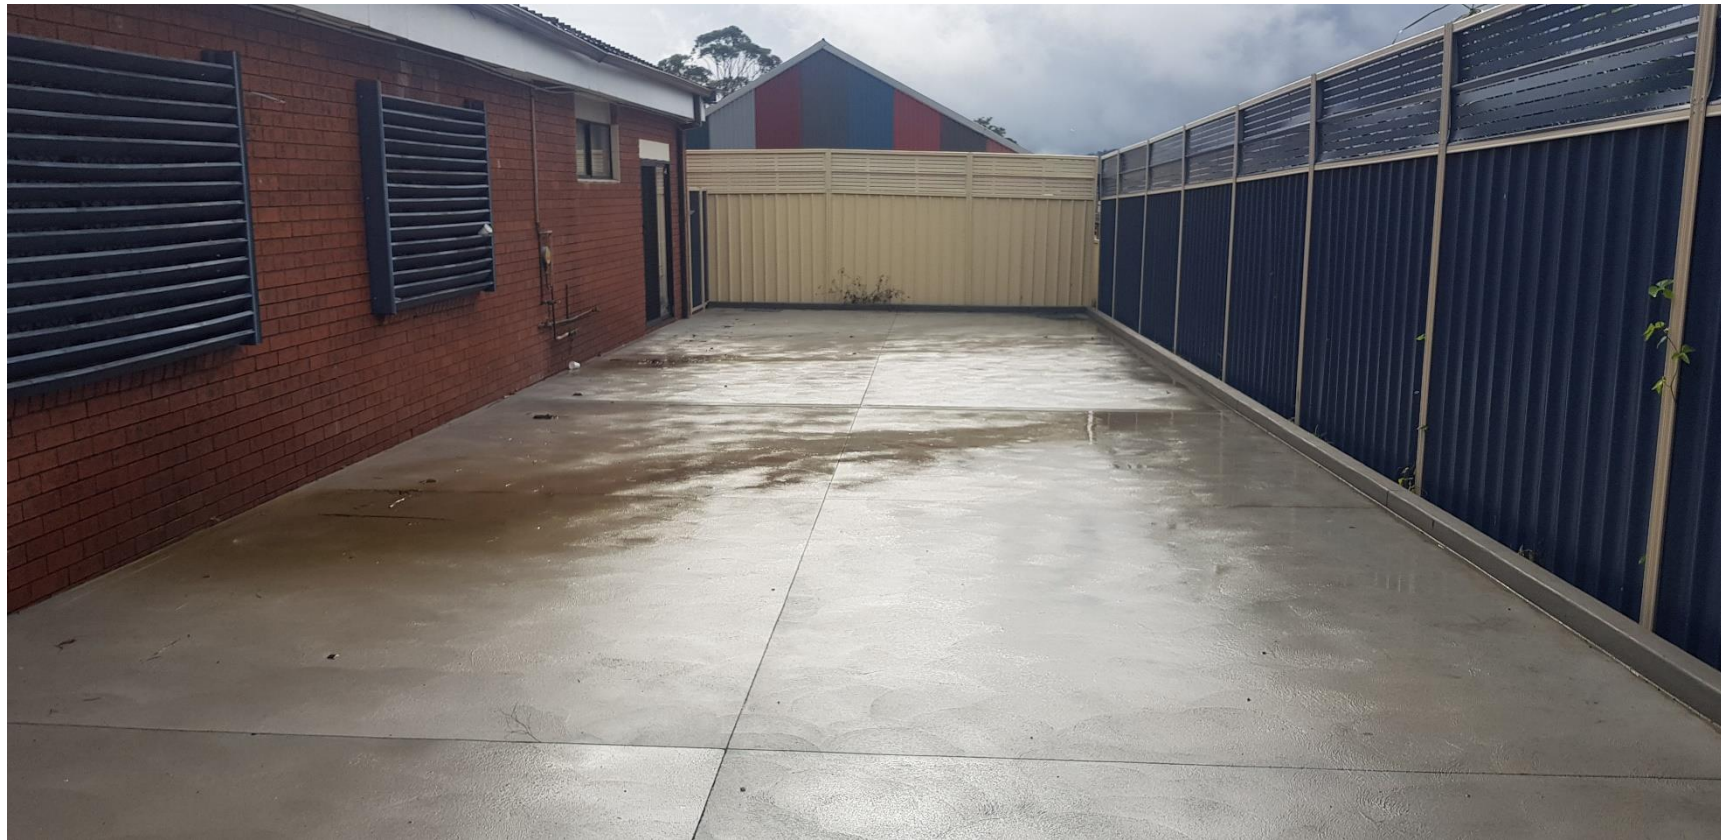
**Photograph 1** – Looking north across the area of concrete capping.

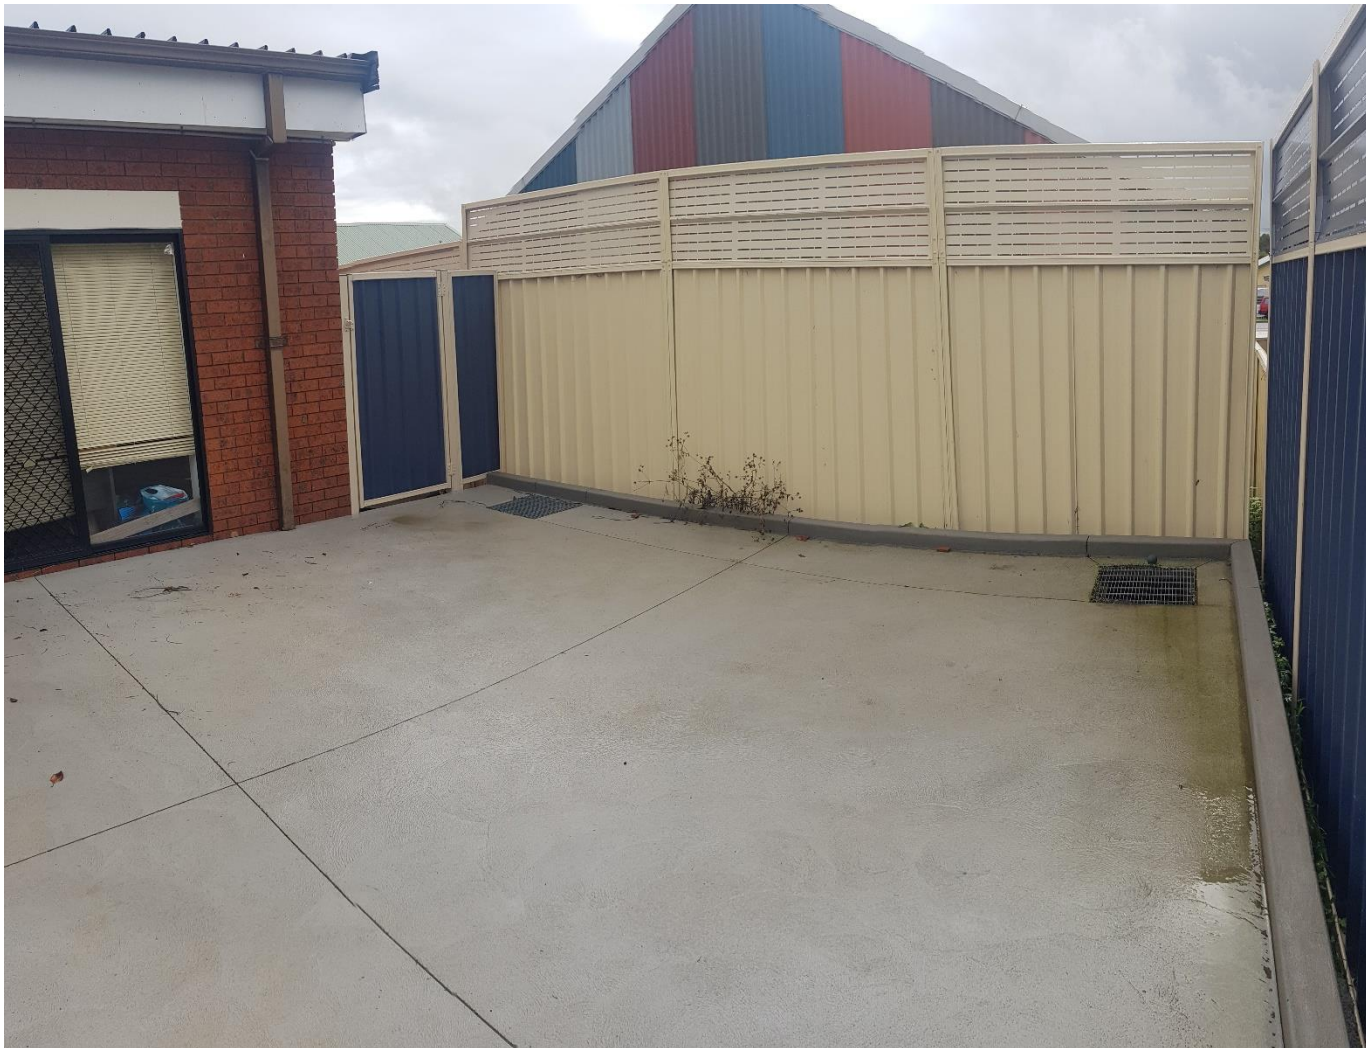
**Photograph 2** – Looking north-west at the rear site boundary. Note drainage grates

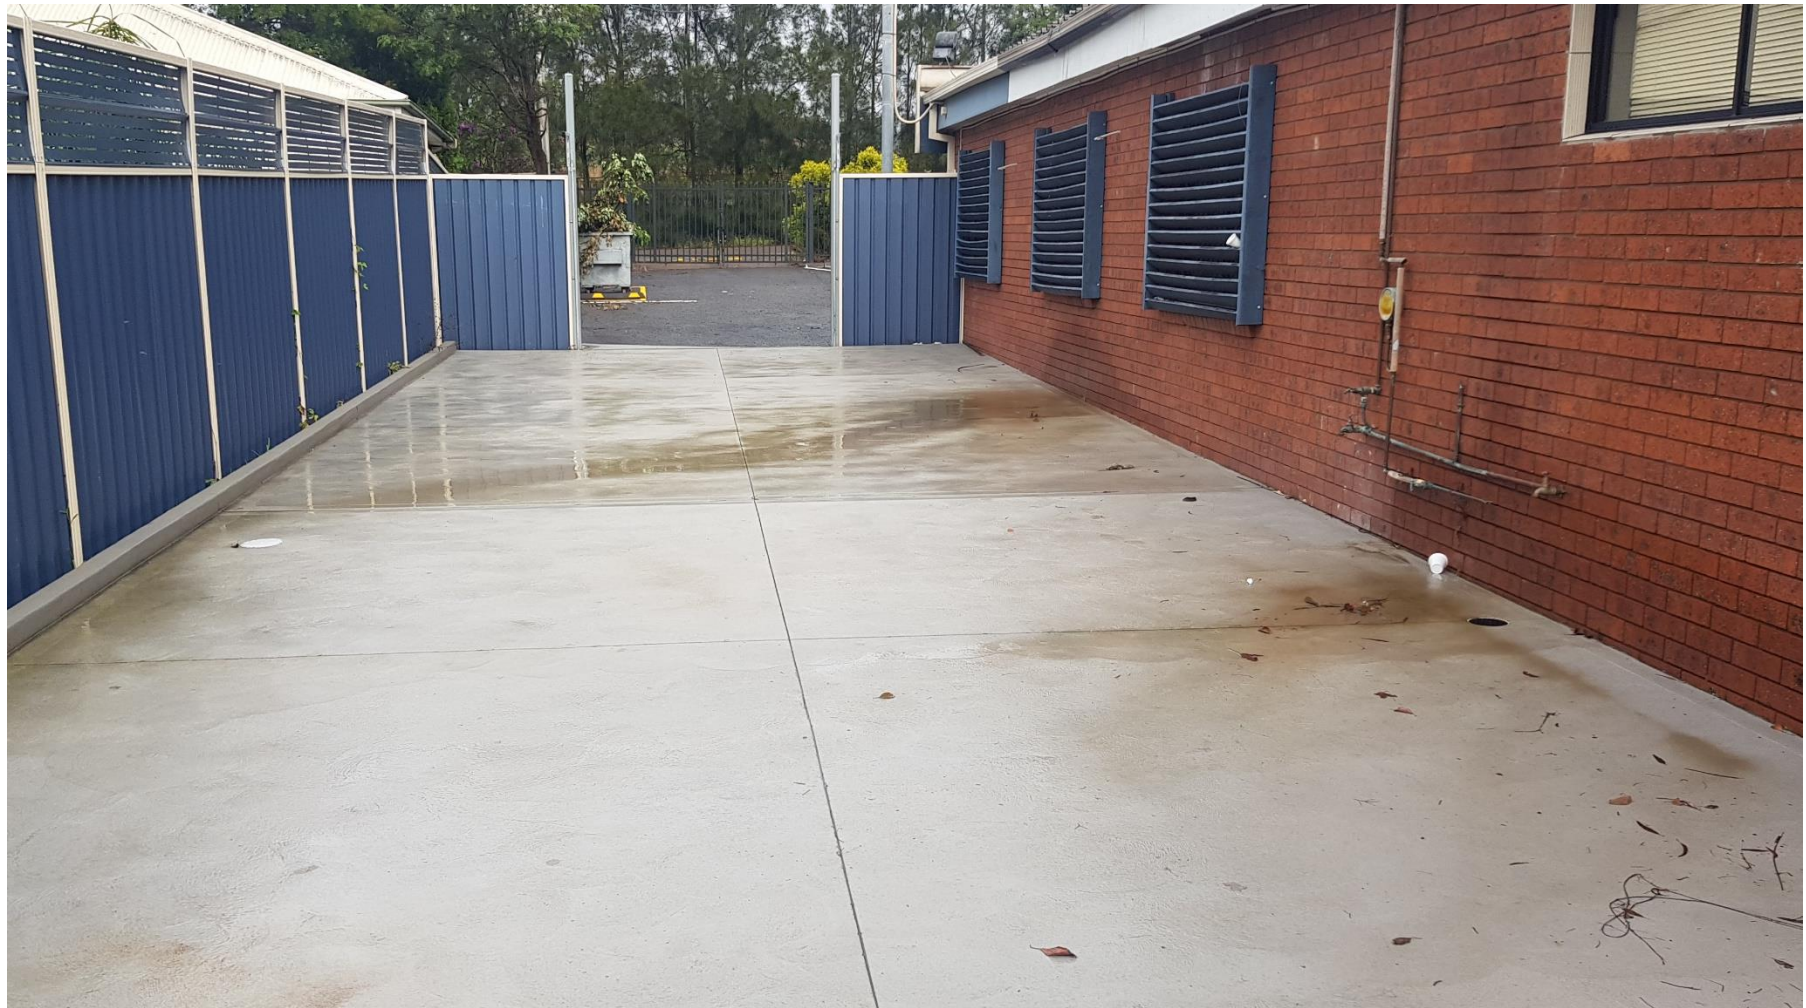
**Photograph 3** – Looking south across the area of capping.
