# Royal Hall of Industries

## Window Glazing Investigation

Inspected Friday 22<sup>nd</sup> March, 2019

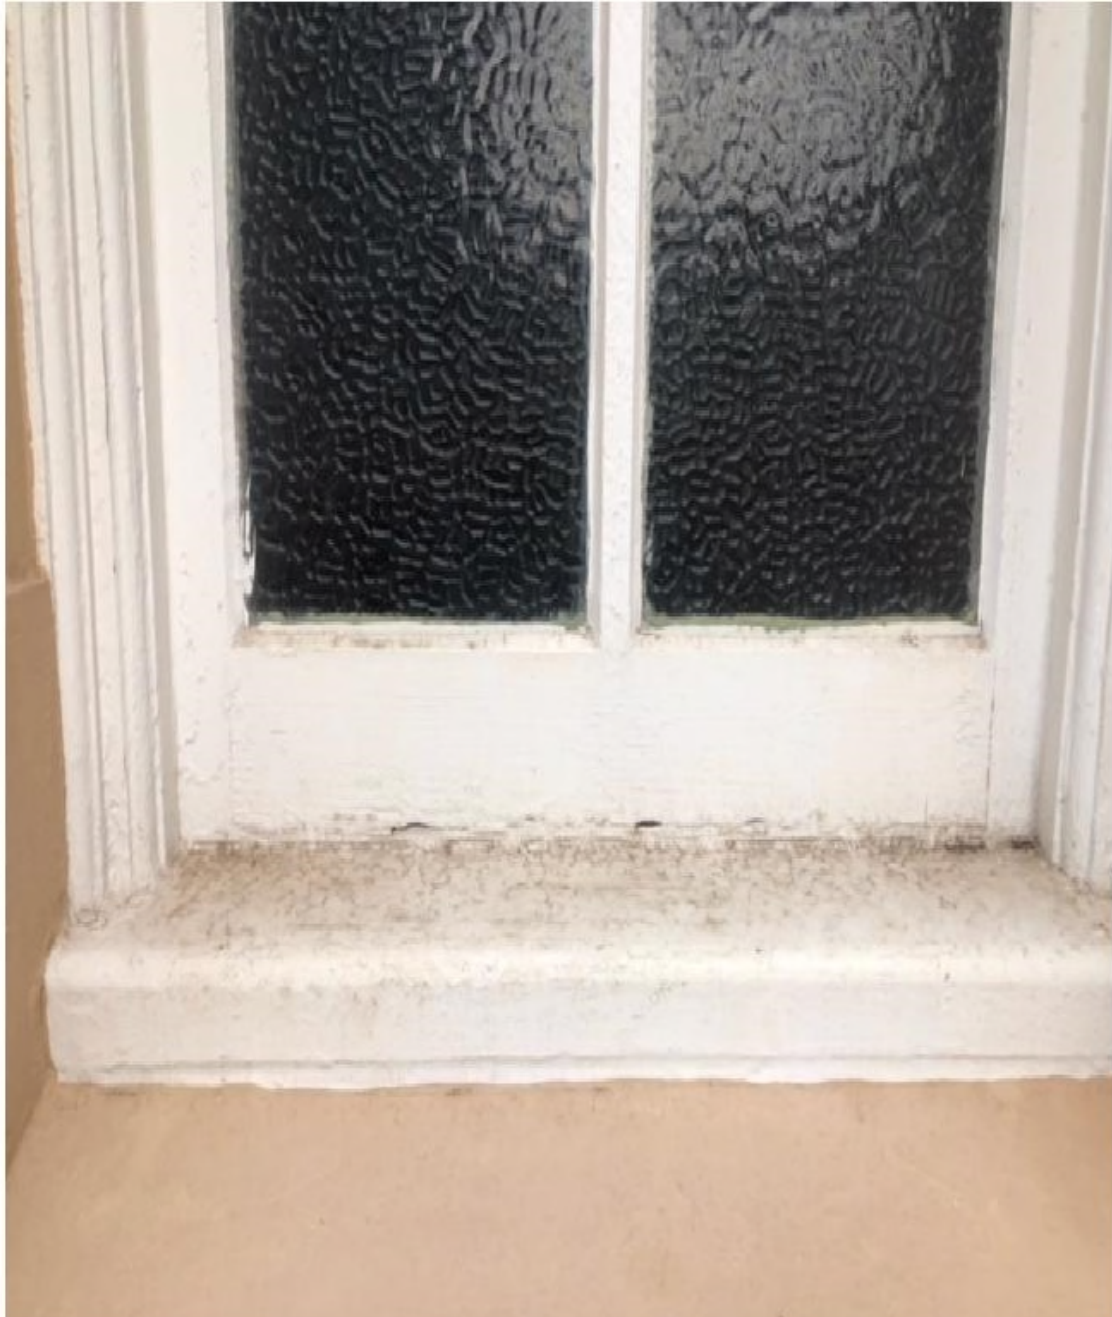
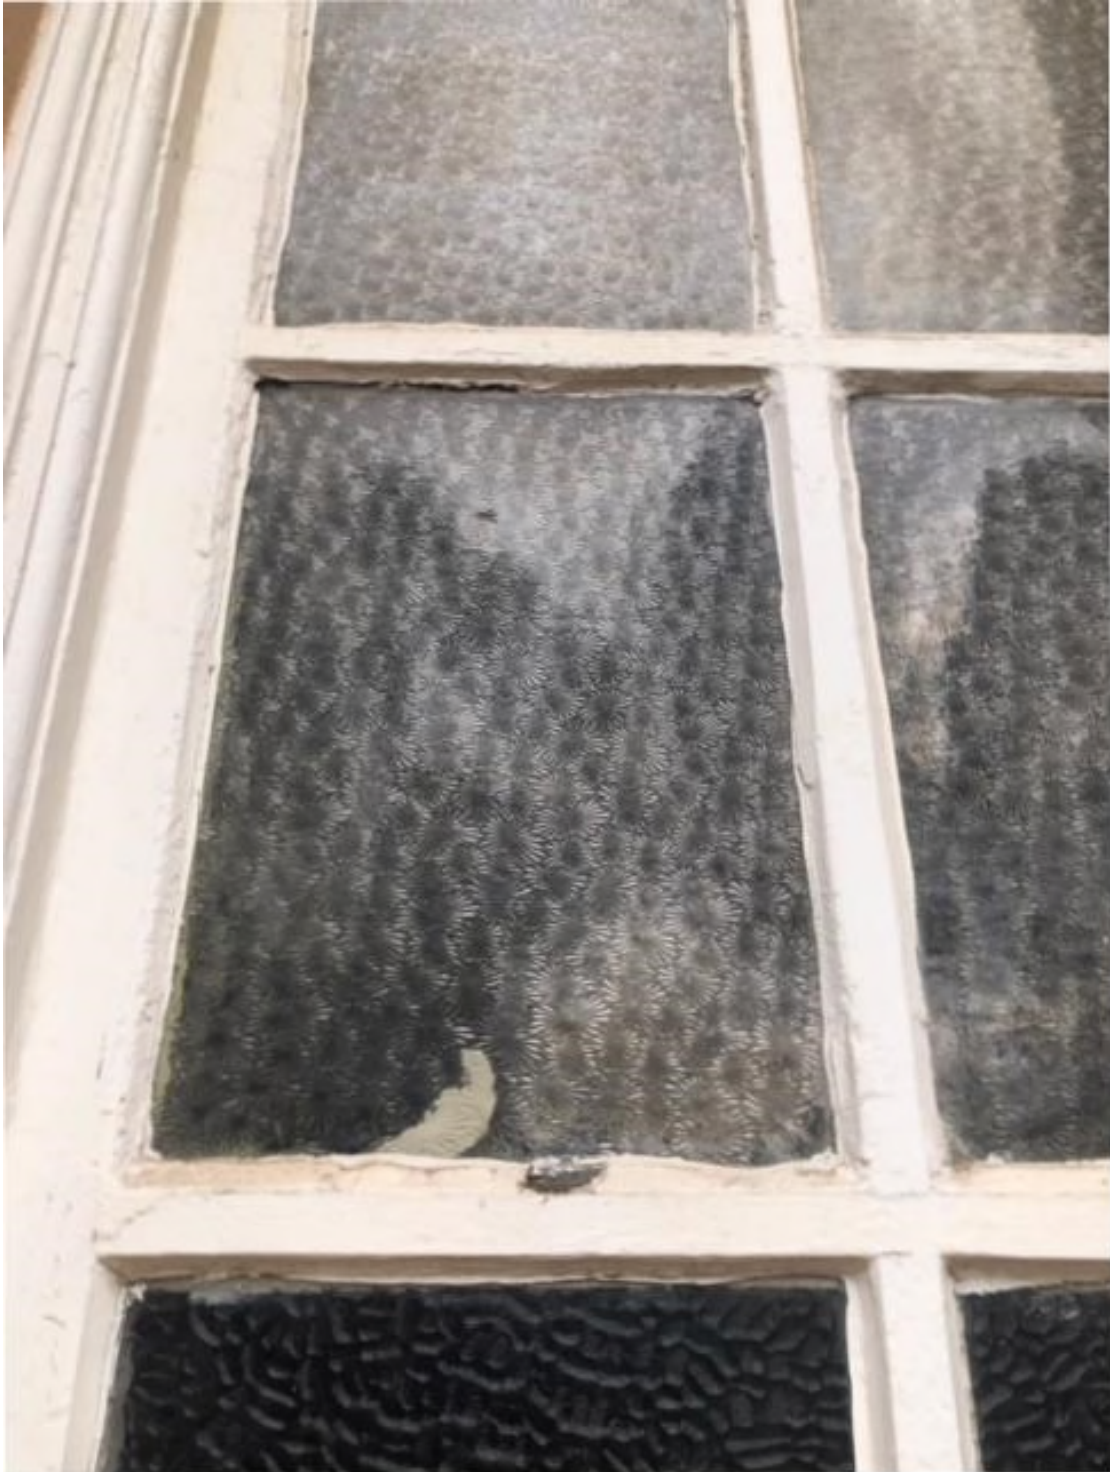
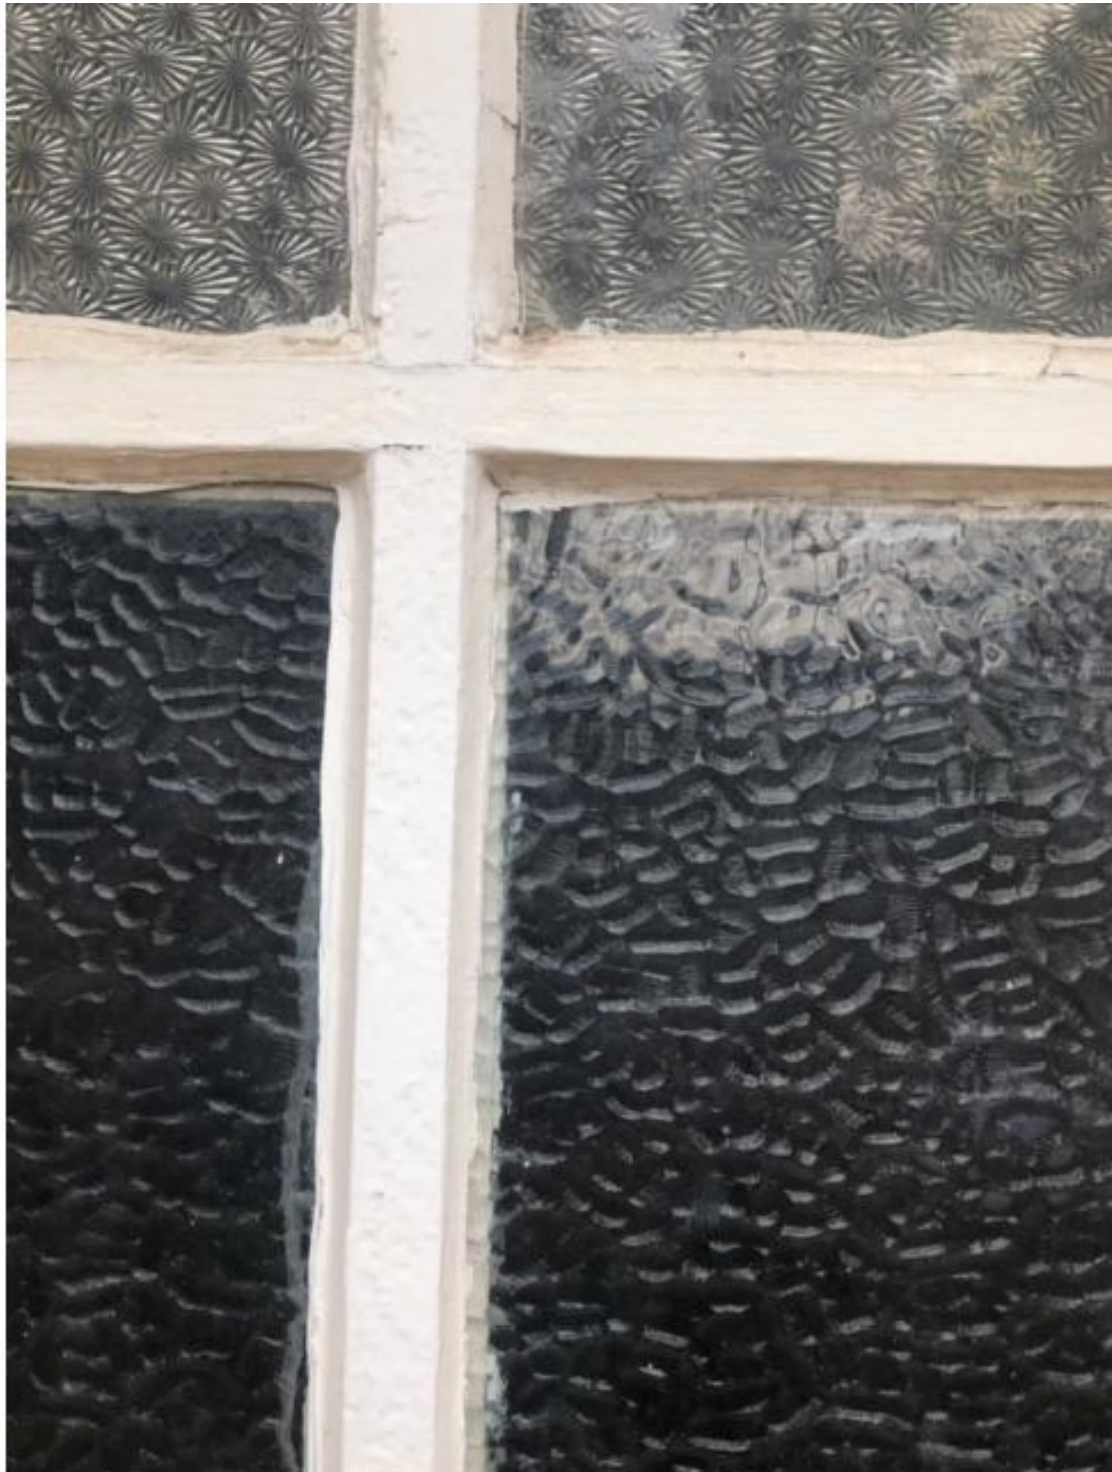
## 1.5 – East Photographs [limited access for photographs]

- **Visual Inspection** carried out to the nominated window on Populous sketch and some surrounding windows.
- Glazing is suspected to be non original and has been replaced at a later stage with what appears to be 3-4mm frosted float glass.
- Frosted glass pattern is non consistent.
- Putty although mostly intact has become very brittle, Cracks in the putty are evident.
- Possibility of glazing falling out due to deteriorating putty.
- The window structure itself seems to be in relatively good condition. Some minor epoxy repair to the bottom rail and sill may be required.

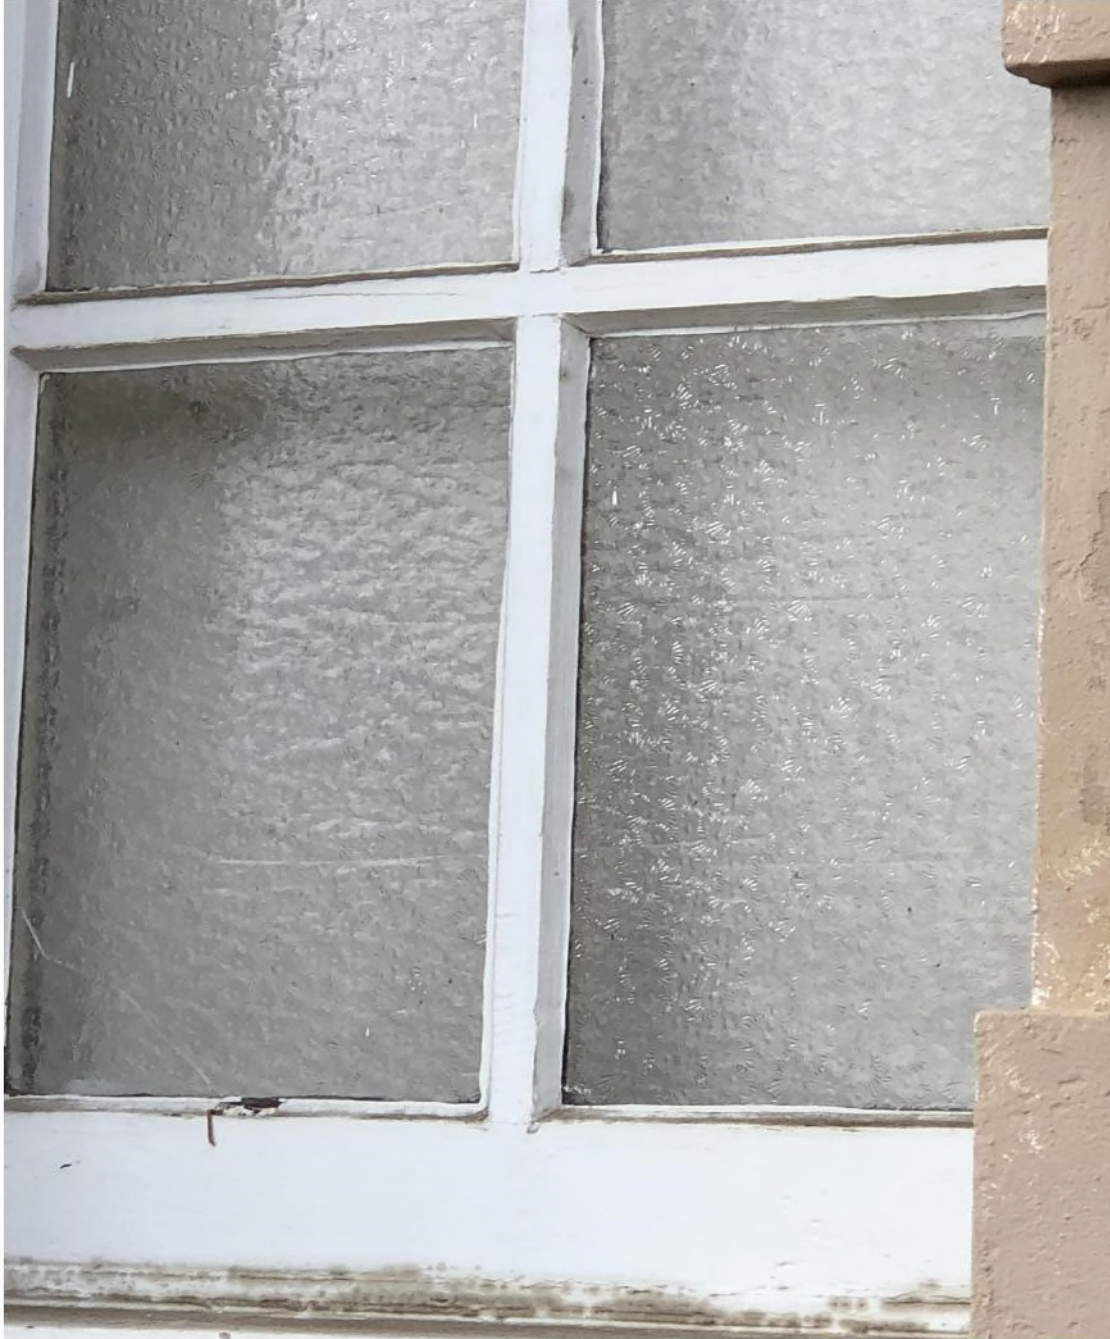
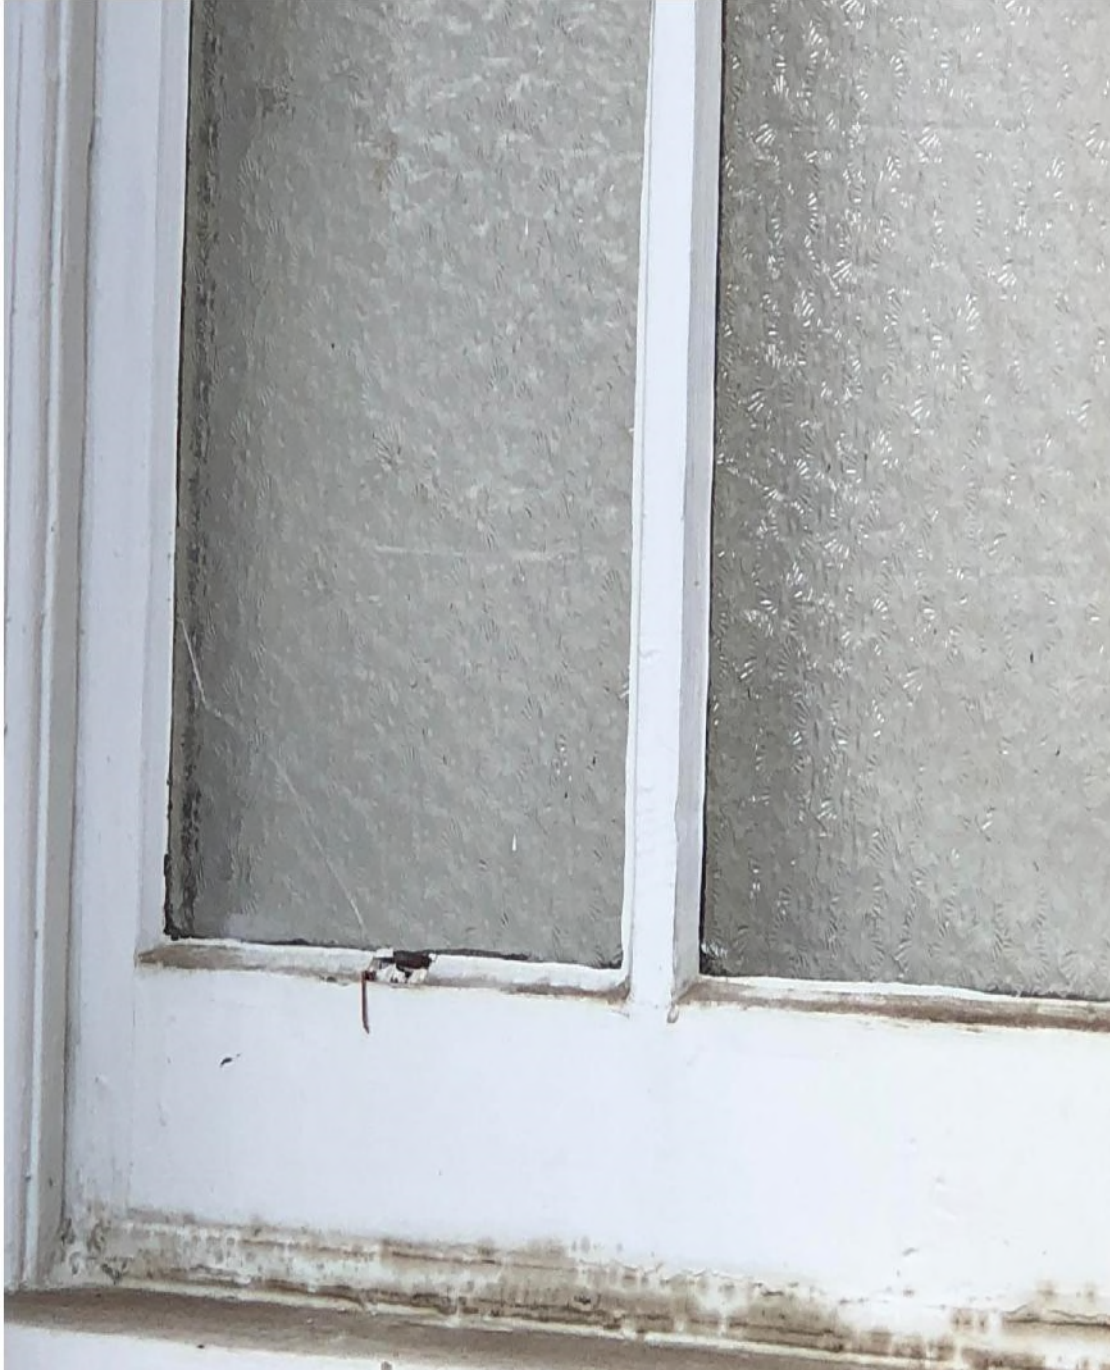
## 1.6 - West Photographs [limited access for photographs]

- **Visual Inspection** carried out to the nominated window on Populous sketch and some surrounding windows.
- Glazing is suspected to be non original and has been replaced at a later stage with what appears to be 3-4mm frosted float glass.
- Frosted glass pattern is non consistent.
- Putty although mostly intact has become very brittle. Cracks in the putty are evident.
- Possibility of glazing falling out due to deteriorating putty.
- The window structure itself seems to be in relatively good condition. Some minor epoxy repair to the sill may be required.

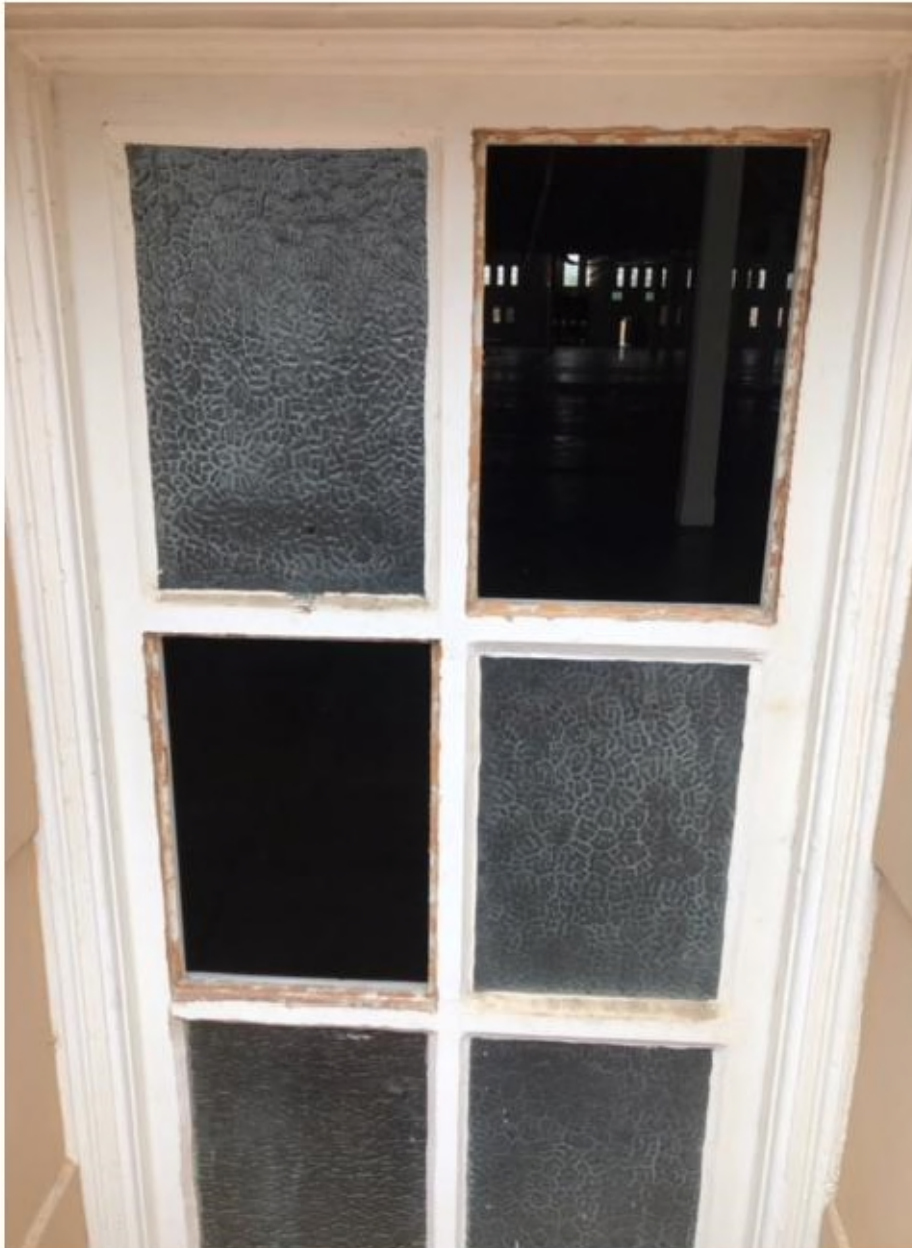
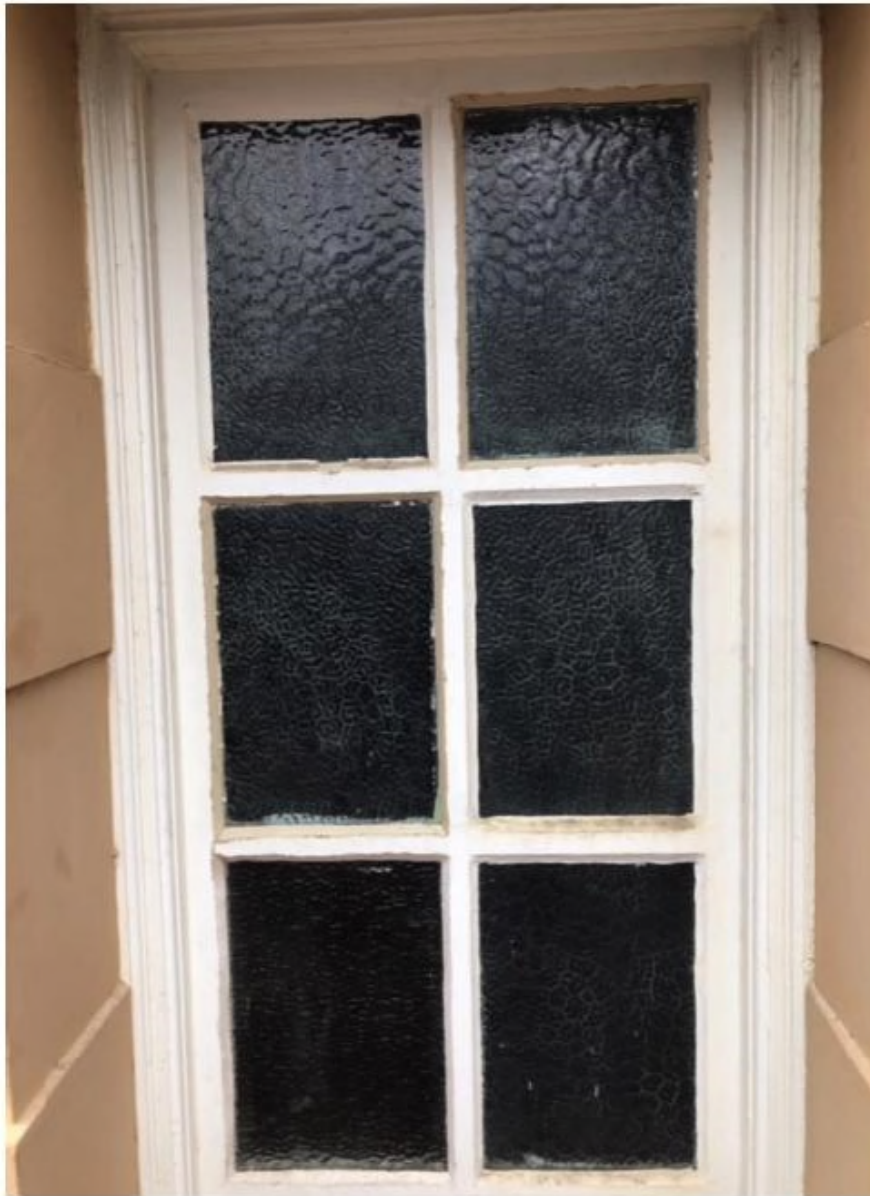
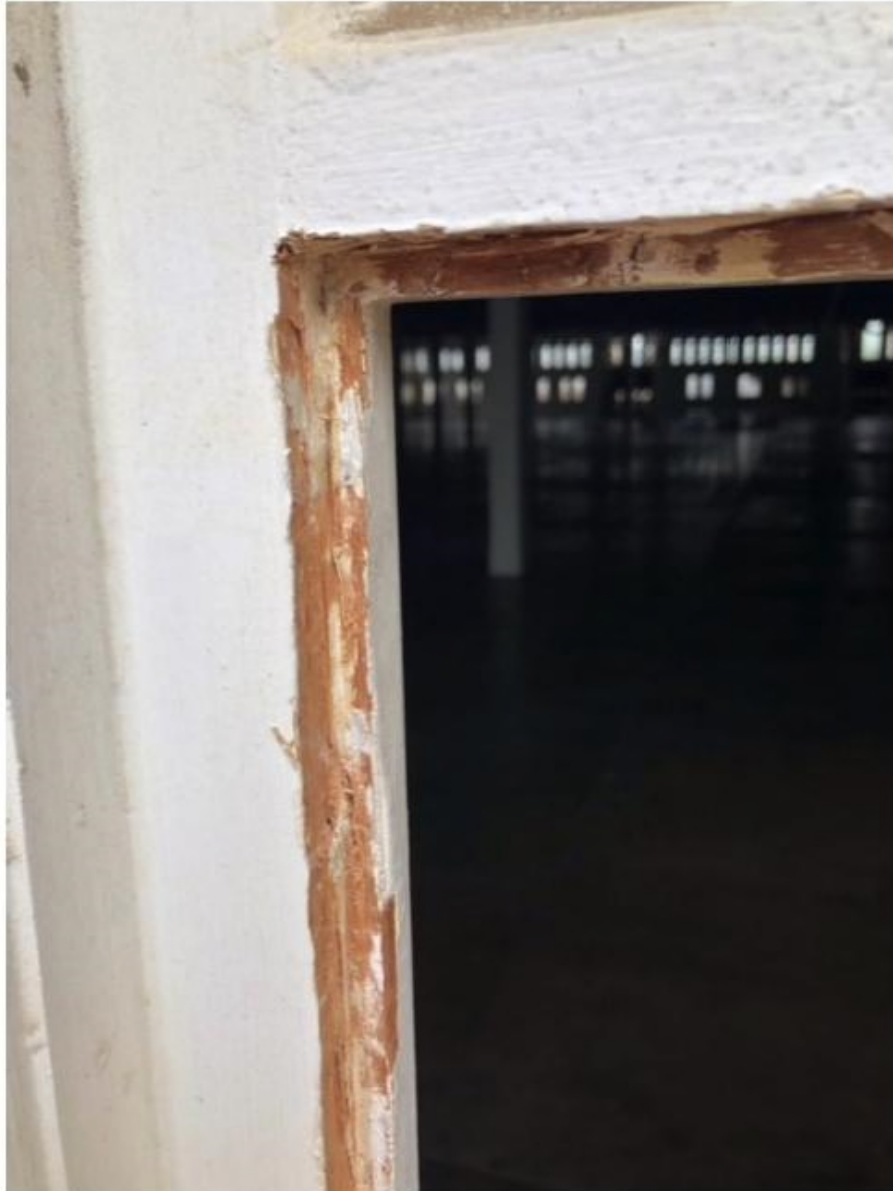
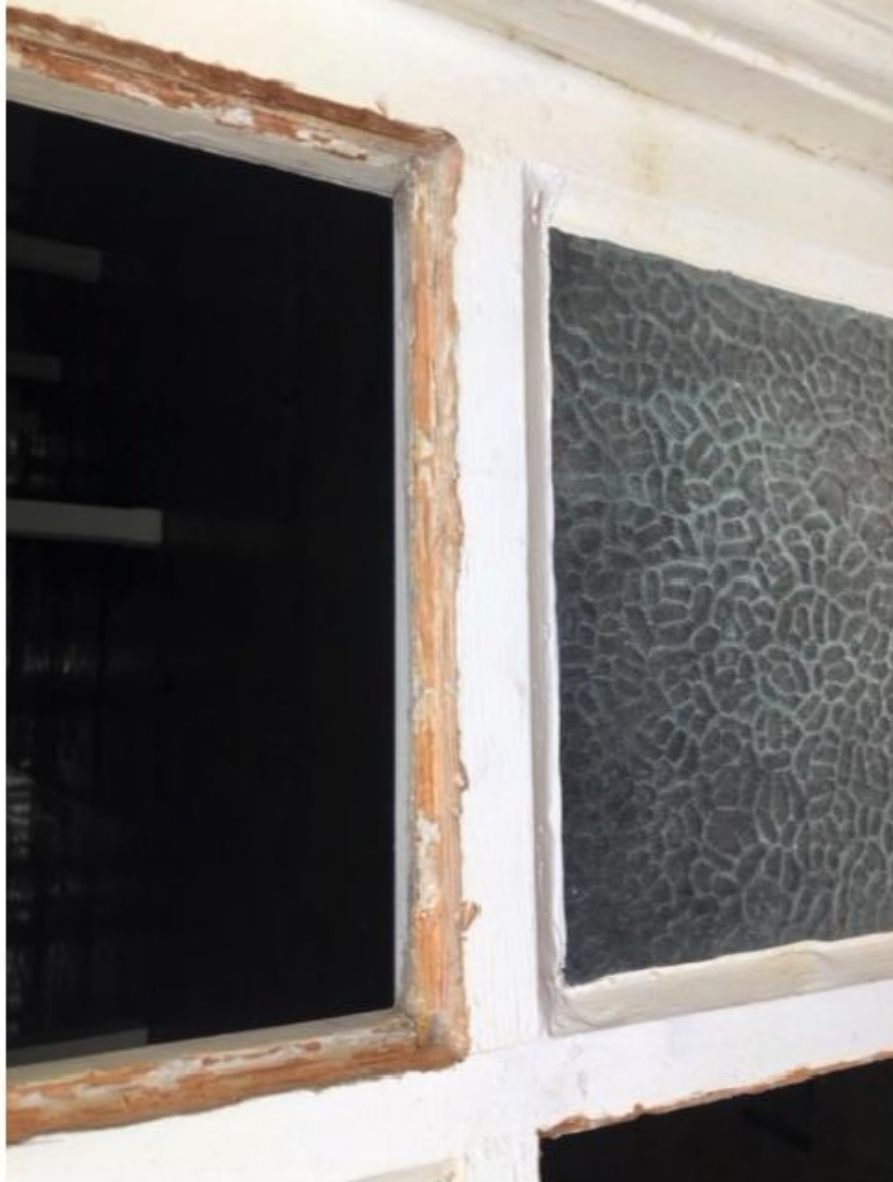
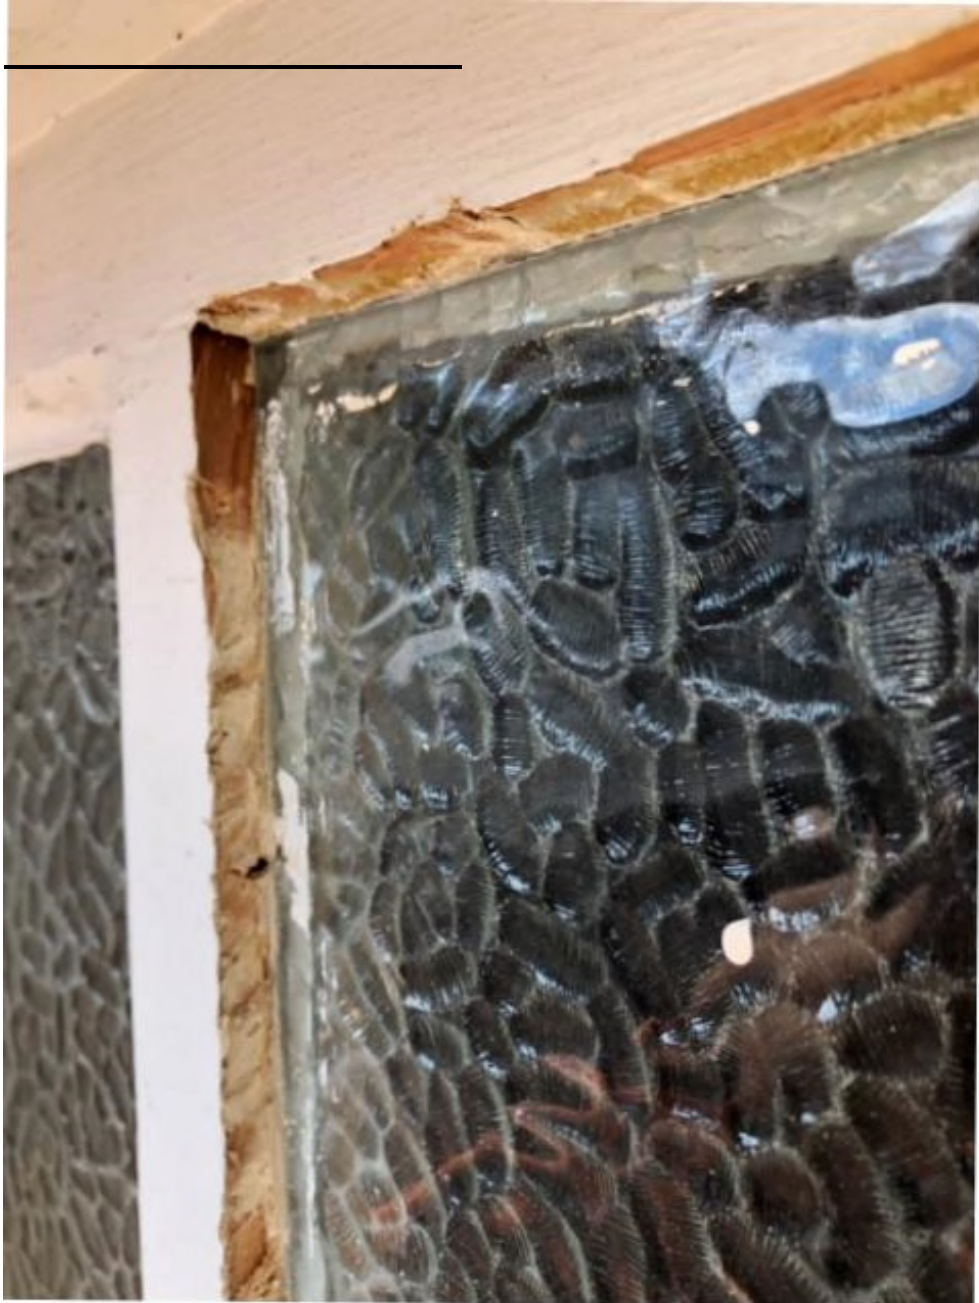
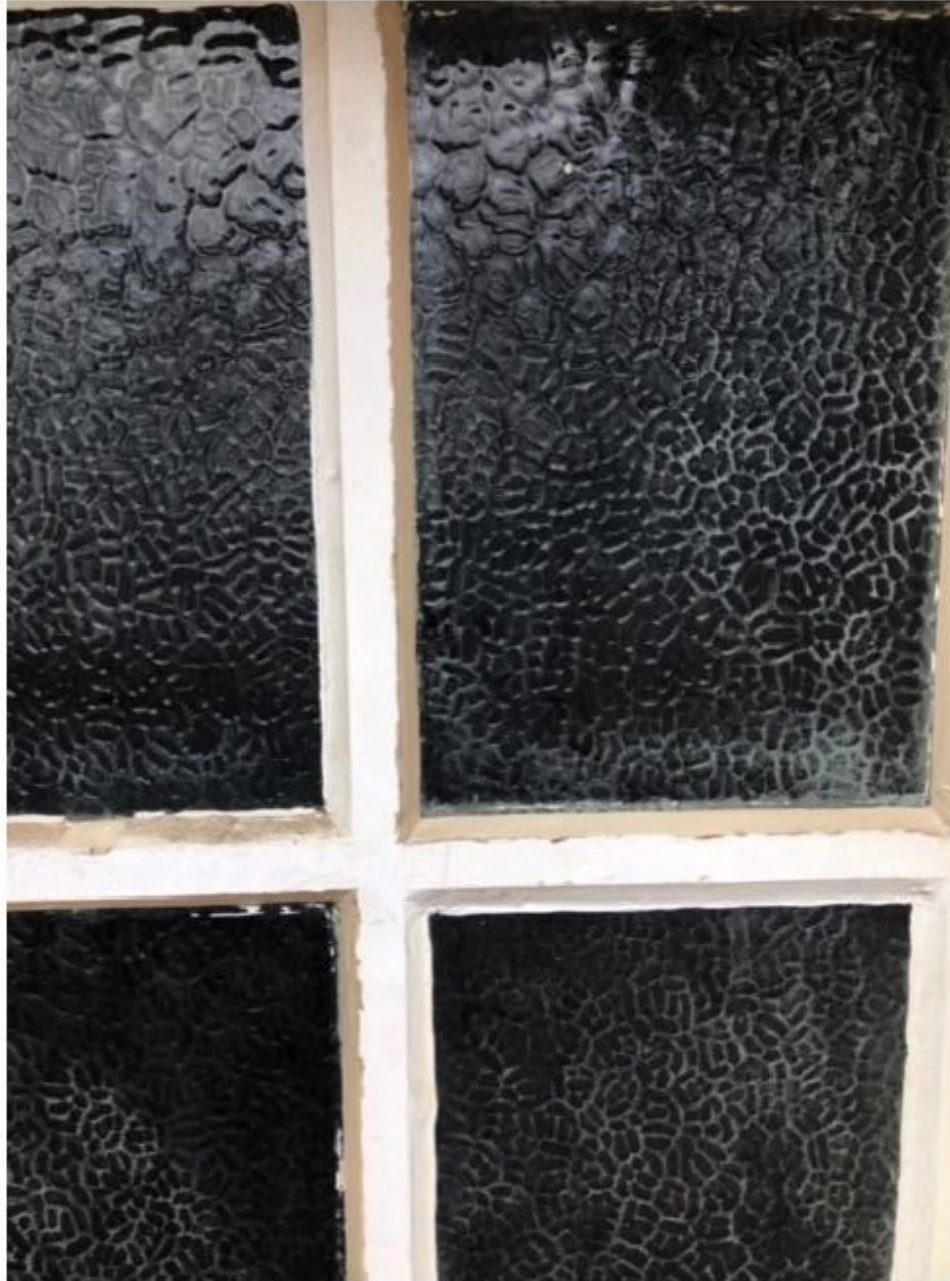
## 1.7 – North Photographs

- Once the glazing was removed, the glazing bars were inspected for signs of rot or deterioration. Glazing bars appear to be in good condition and of sound integrity.
- Some signs of water ingress are evident on the glazing bars from the failing putty [black spots]
- Glazing is suspected to be non original and has been replaced at a later stage with what appears to be 3-4mm frosted float glass.
- Frosted glass pattern is non consistent.
- Putty was brittle and not hard to remove.
- Putty appeared to have “shrunk” allowing the glazing panel to become loose within the frame.
- Window structure itself seems to be in relatively good condition. Some minor repair to the bottom rail and sill may be required.

Two panes of glass were removed as per instruction. Glazing was removed by hacking away the existing putty on the exterior, removing the 4 setting pins and by gently prying the pane away from the putty bed applied to the seat of the glazing bar.

All existing putty was removed from the glazing bar and cleaned. New back putty was then applied, existing pane refitted, setting pins installed and finally new face putty applied.
