# Royal Hall of Industries

## Window Glazing Investigation

Inspected Friday 22<sup>nd</sup> March, 2019

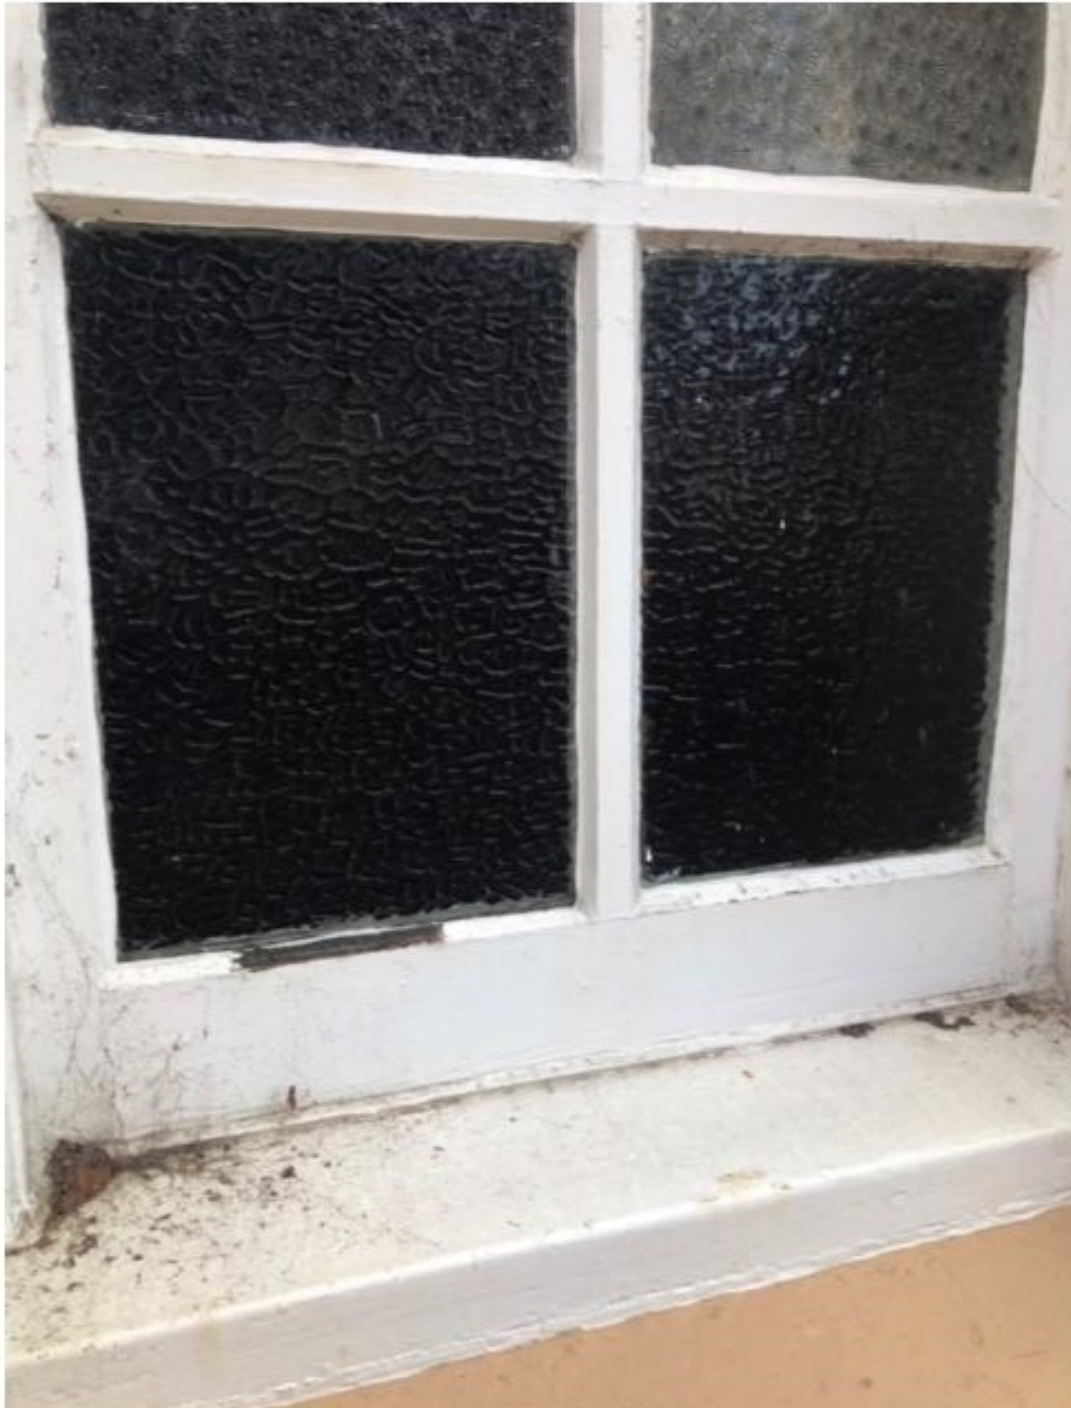
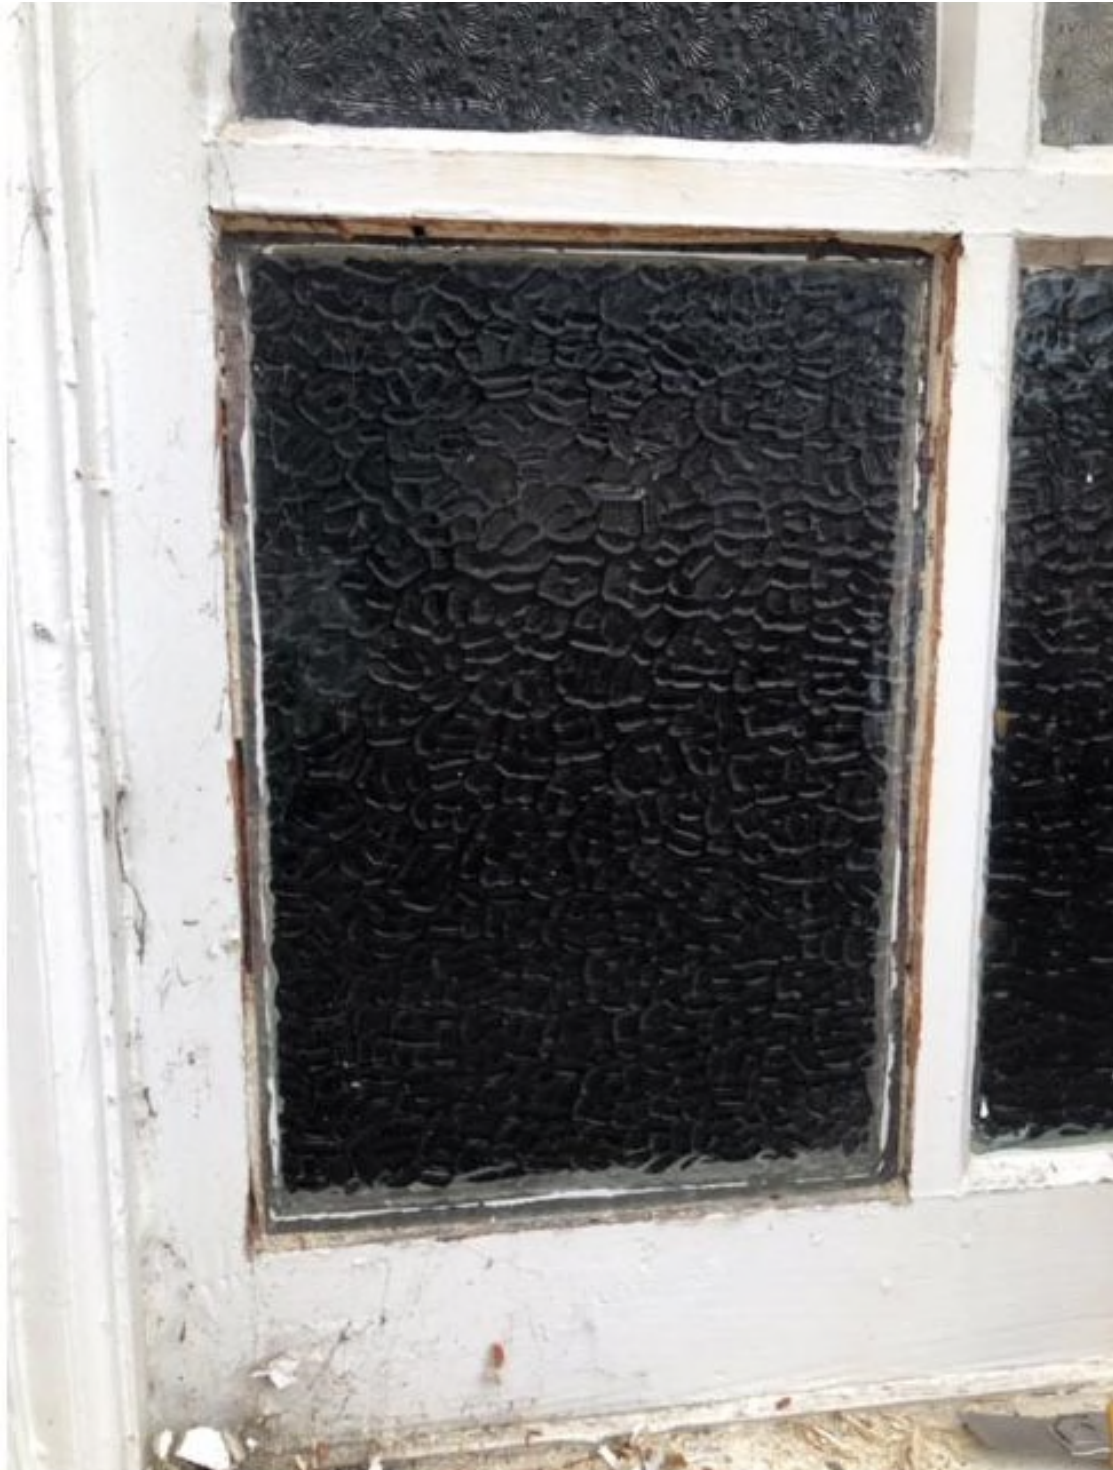
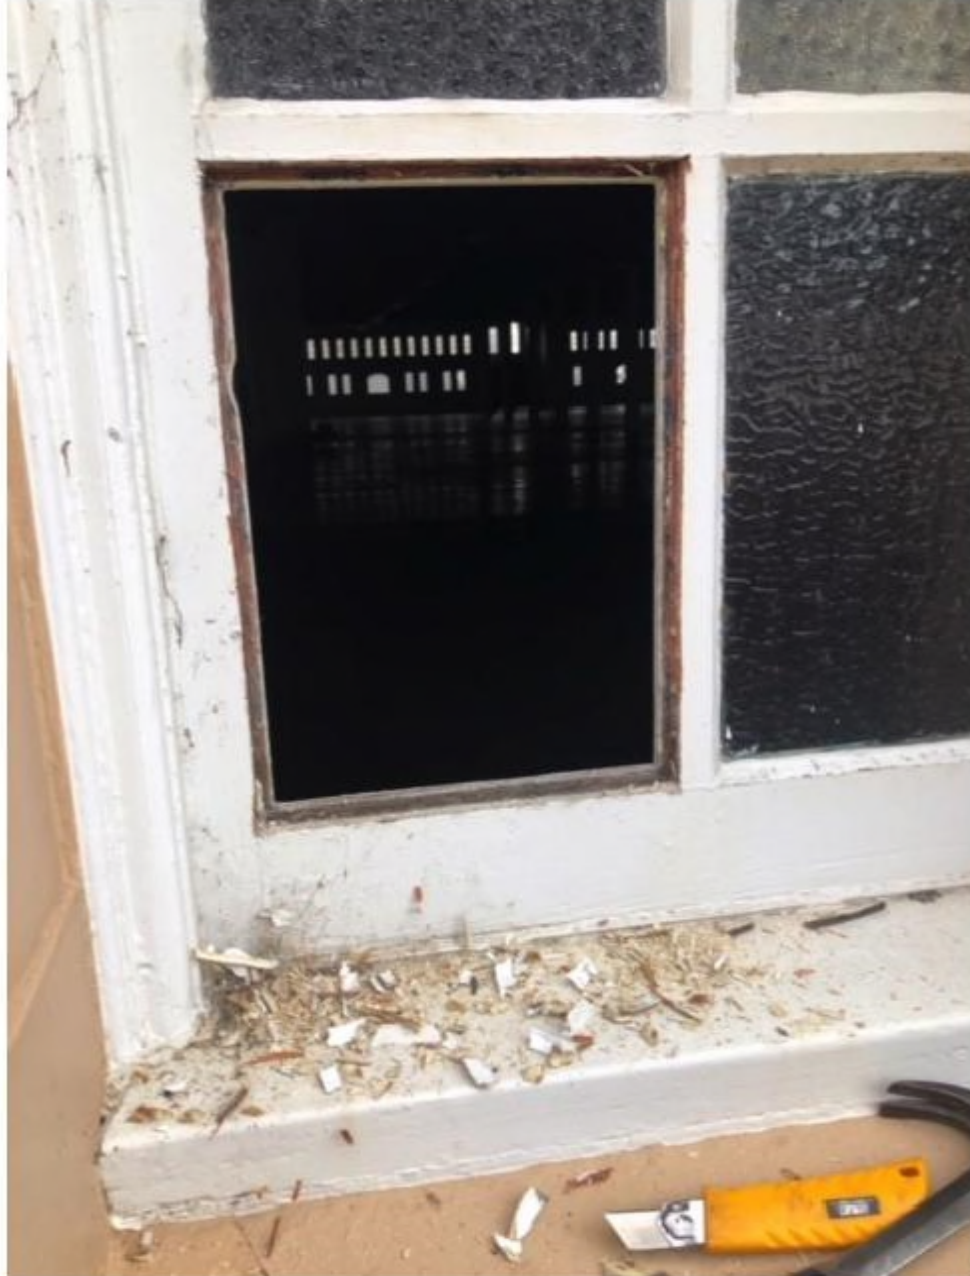
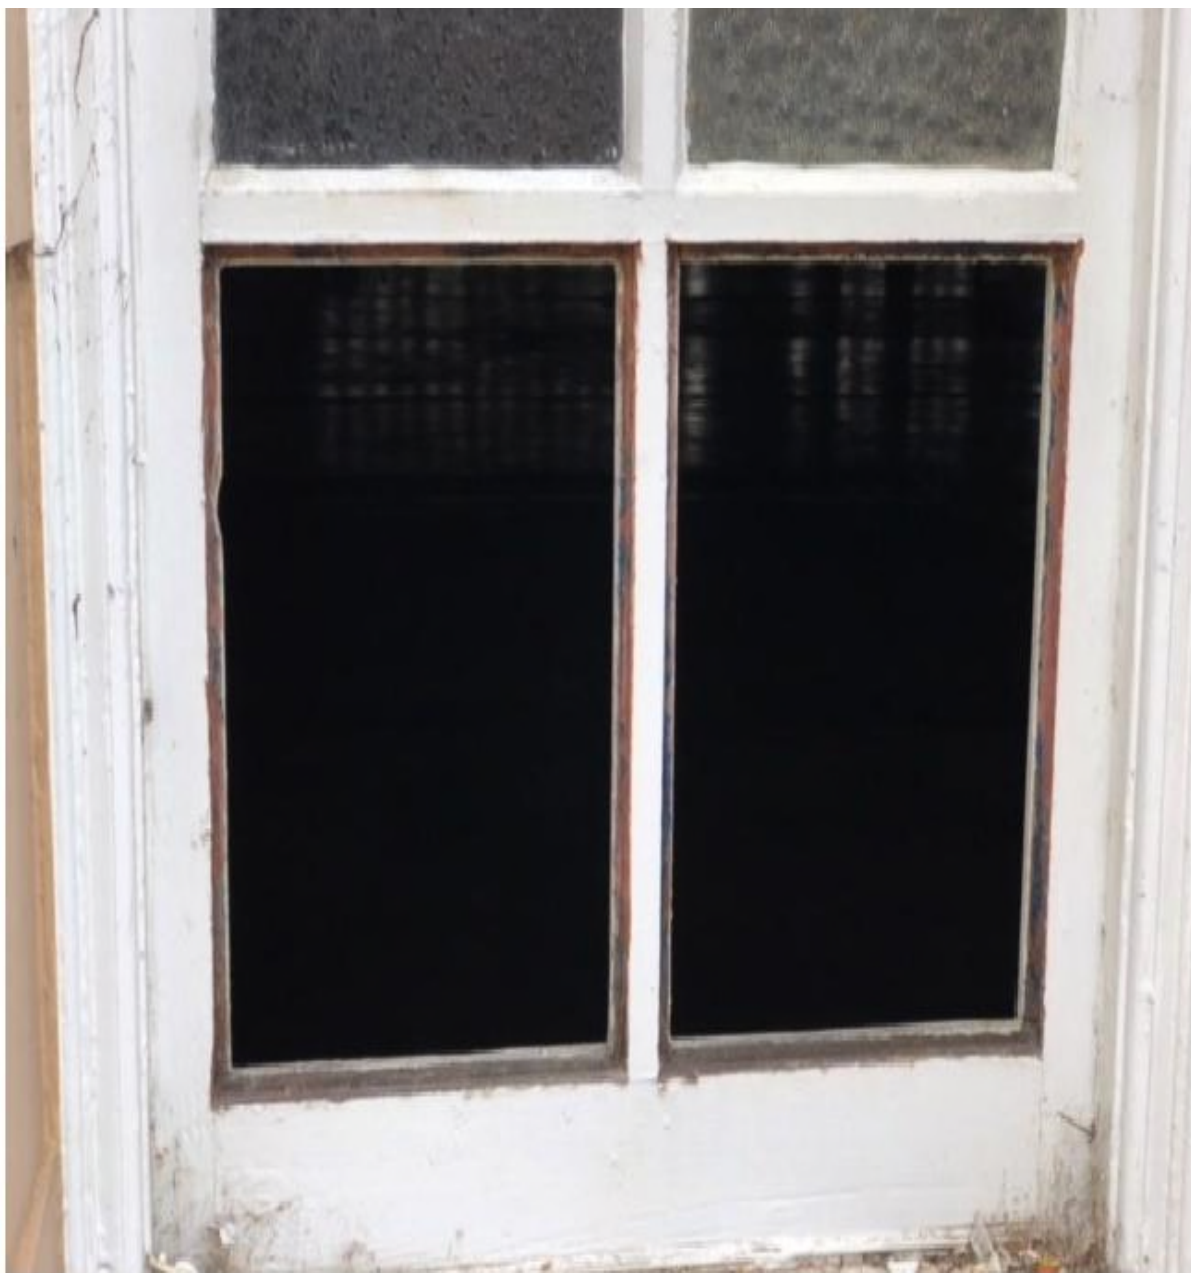
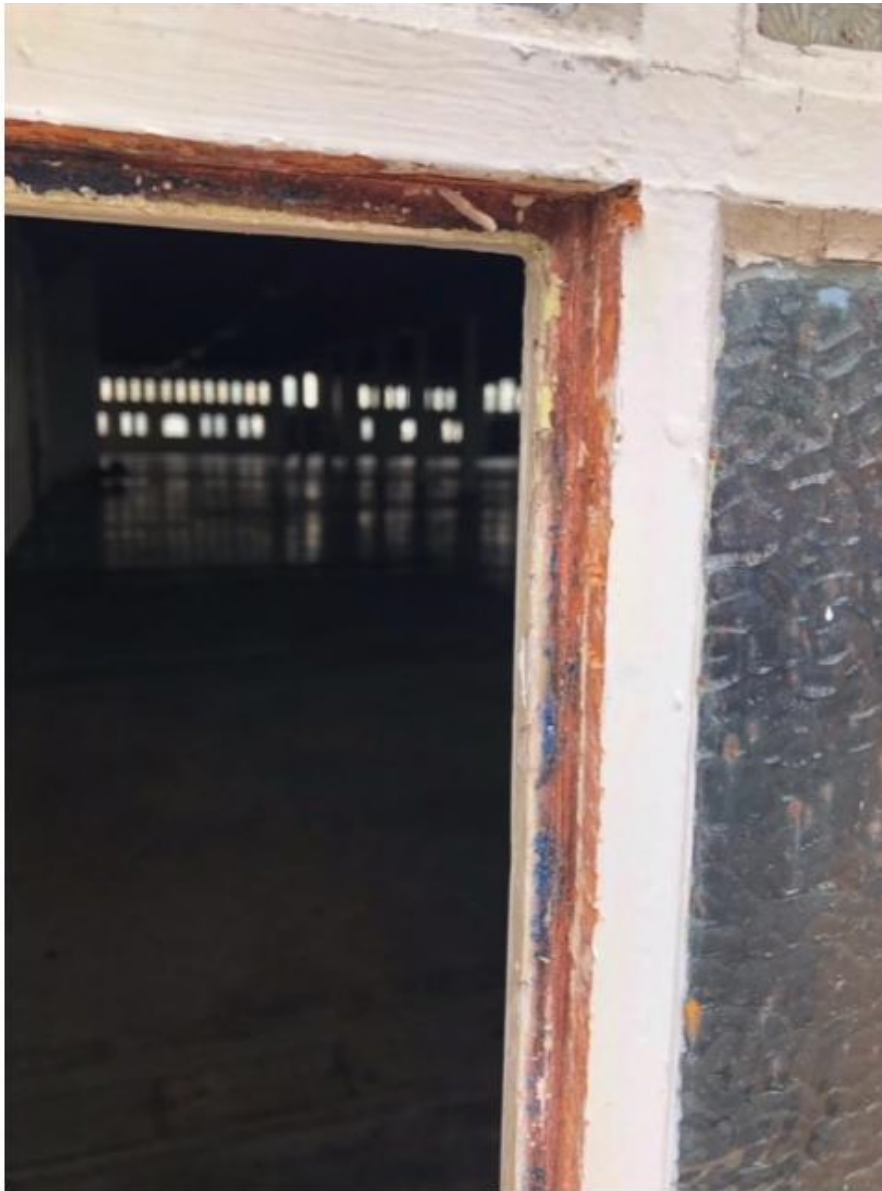
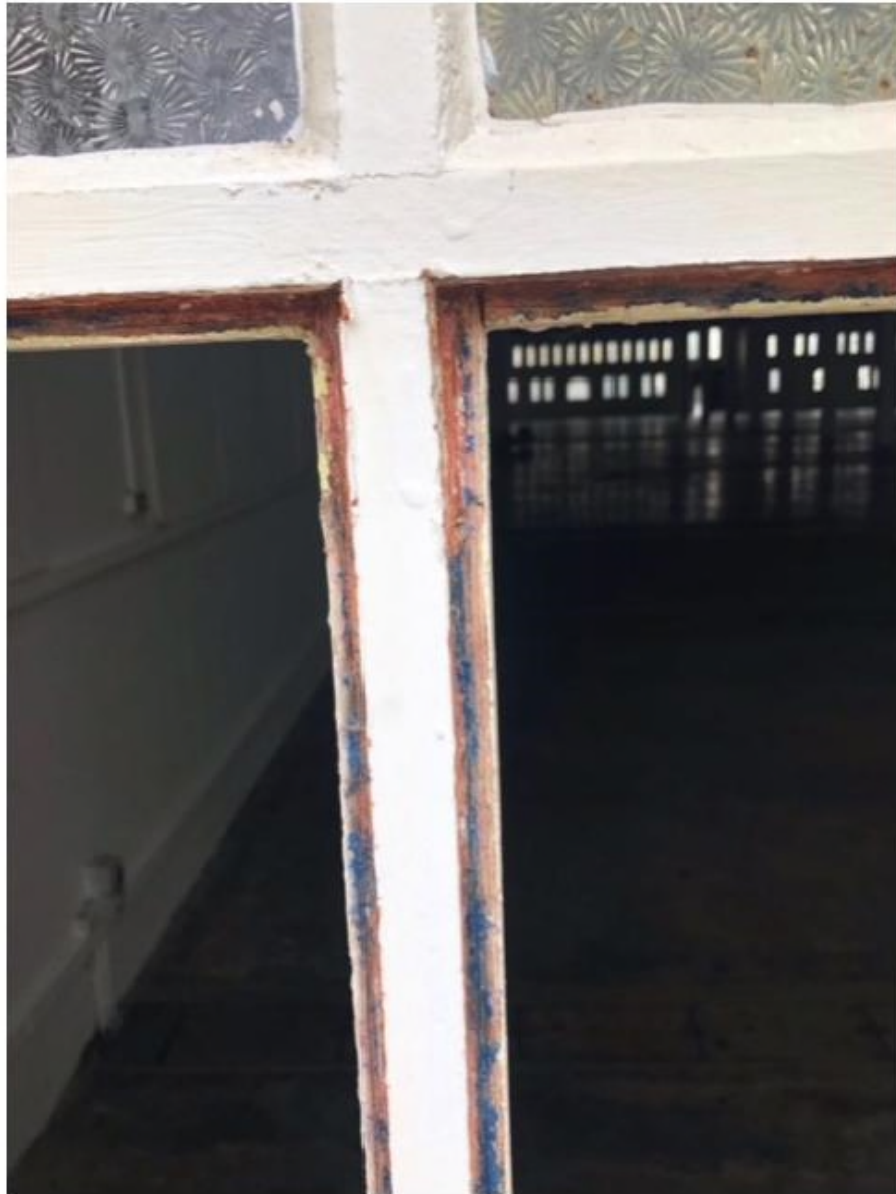
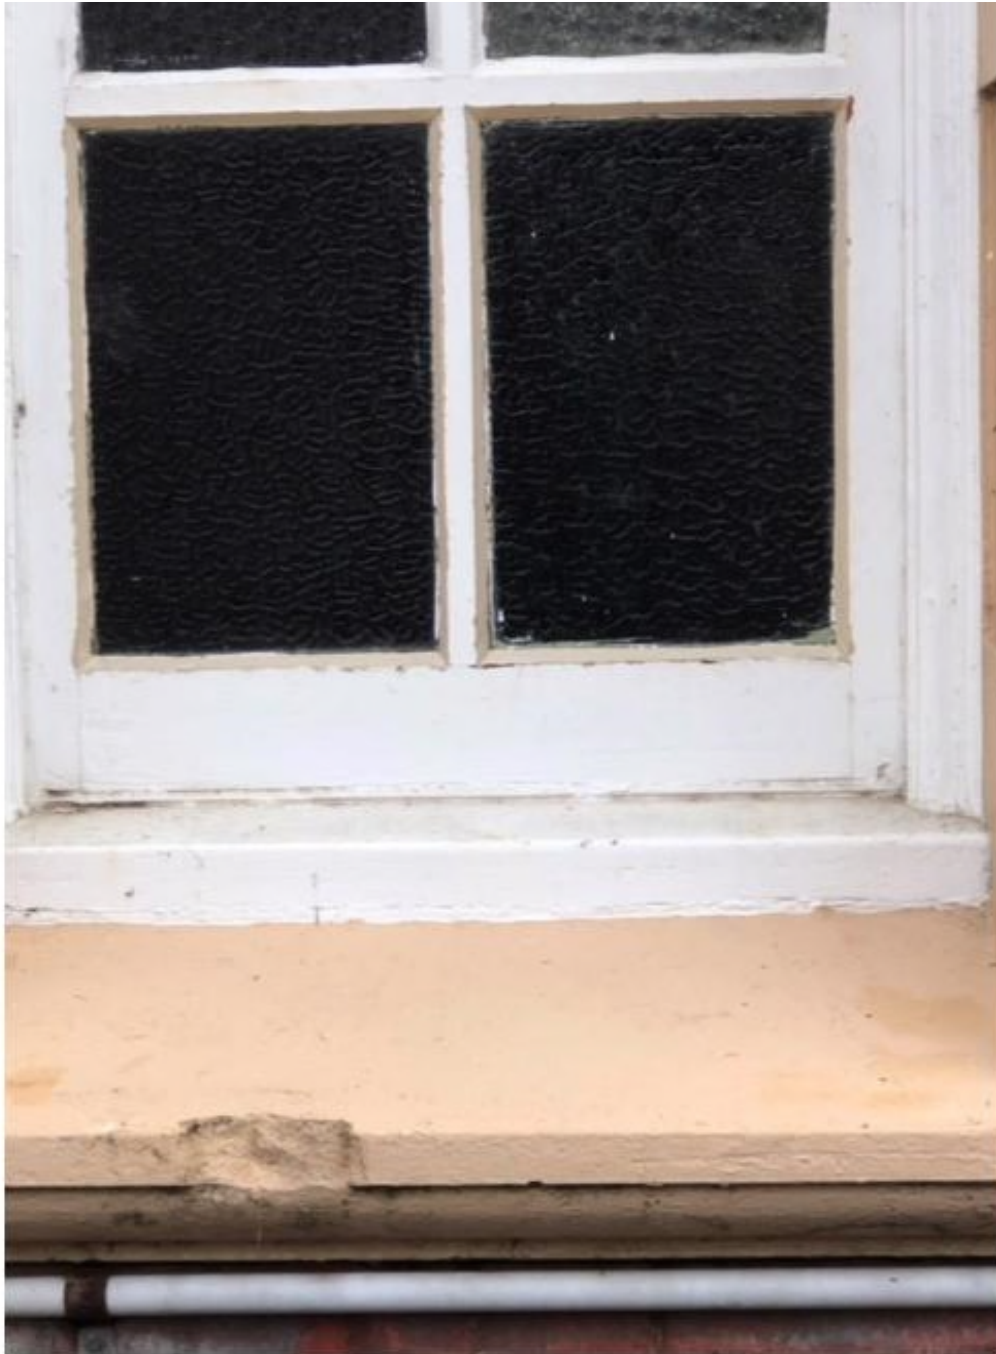
## 1.8 – South Photographs

- Once the glazing was removed, the glazing bars were inspected for signs of rot or deterioration. Glazing bars appear to be in good condition and of sound integrity.
- Some signs of water ingress are evident on the glazing bars from the failing putty [black spots]
- Glazing is suspected to be non original and has been replaced at a later stage with what appears to be 3-4mm frosted float glass.
- Frosted glass pattern is non consistent.
- Putty was brittle and not hard to remove.
- Window structure itself seems to be in relatively good condition. Some minor repair to the bottom rail and sill may be required.

Two panes of glass were removed as per instruction. Glazing was removed by hacking away the existing putty on the exterior, removing the 4 setting pins and by gently prying the pane away from the putty bed applied to the seat of the glazing bar.

All existing putty was removed from the glazing bar and cleaned. New back putty was then applied, existing pane refitted, setting pins installed and finally new face putty applied.

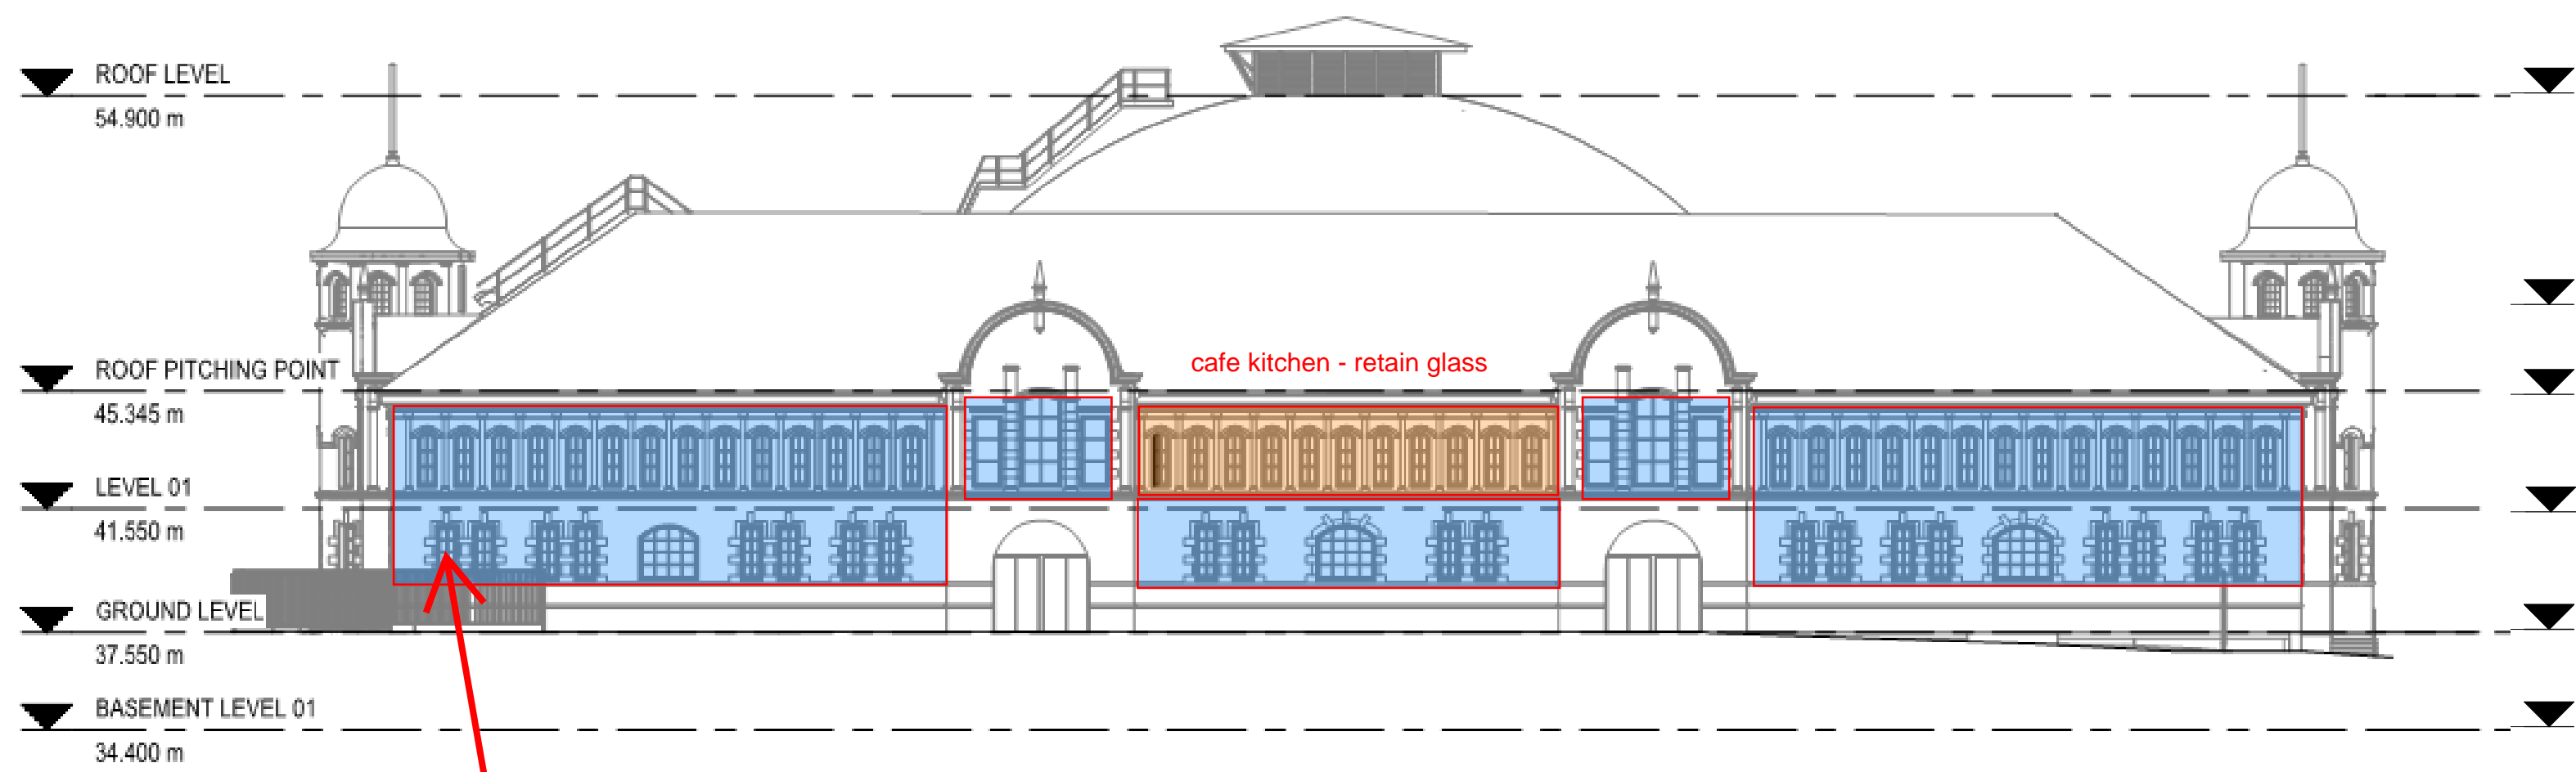
4 SOUTH ELEVATION  
1 : 200

This window was tested for hazardous materials

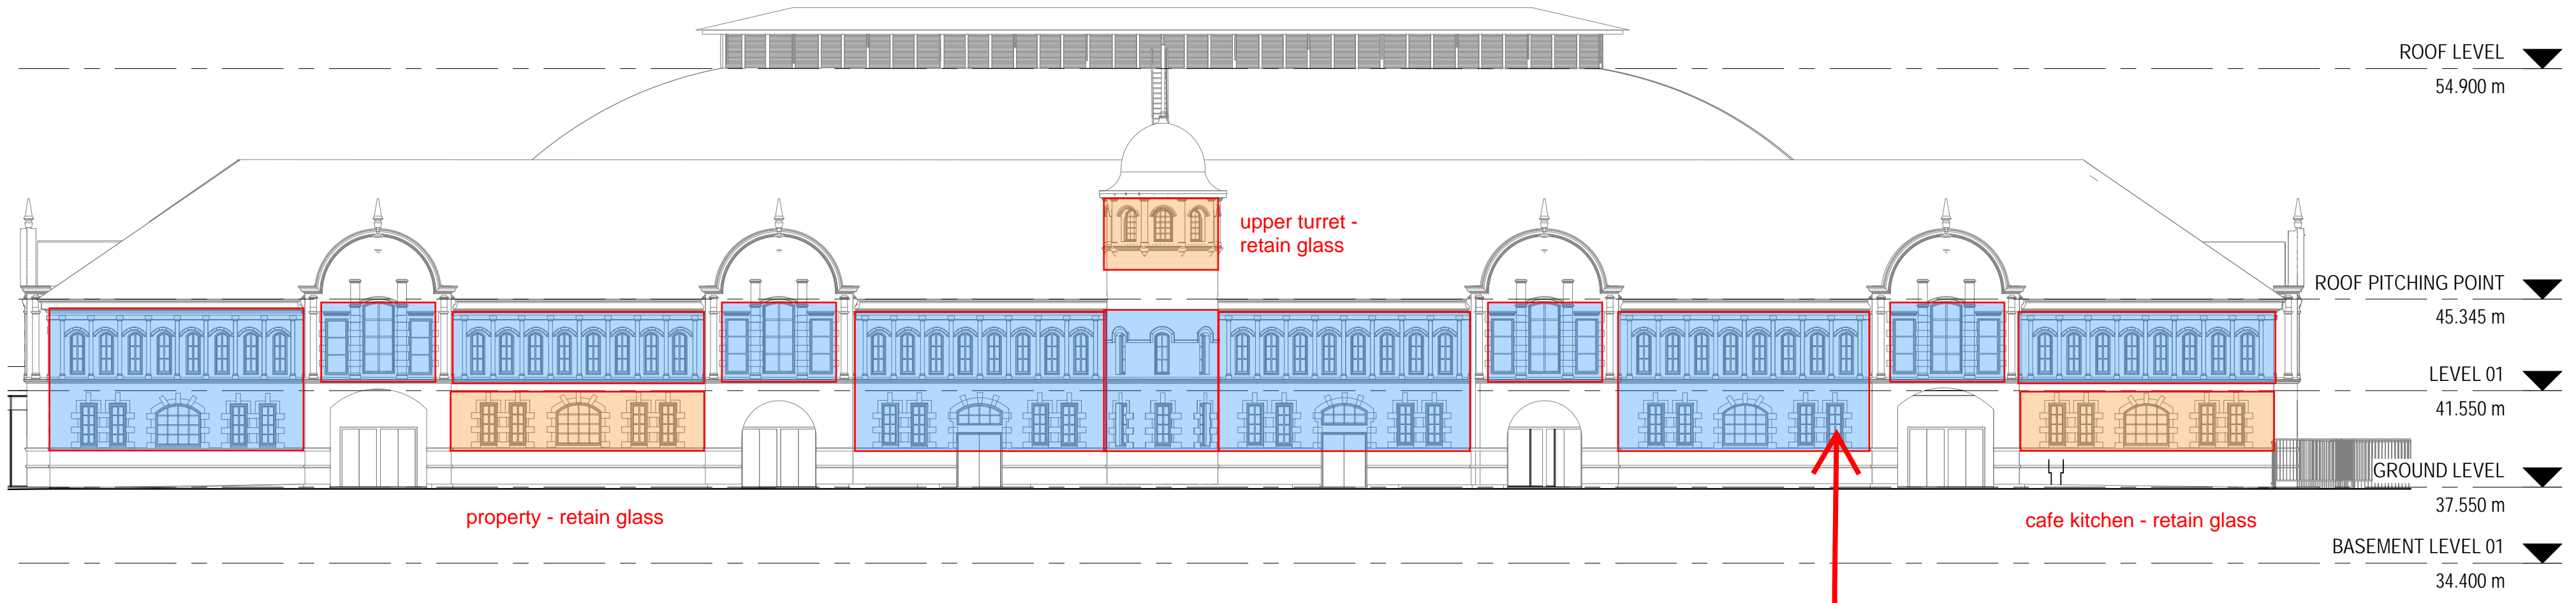
1 EAST ELEVATION  
1 : 200

This window was tested for hazardous materials

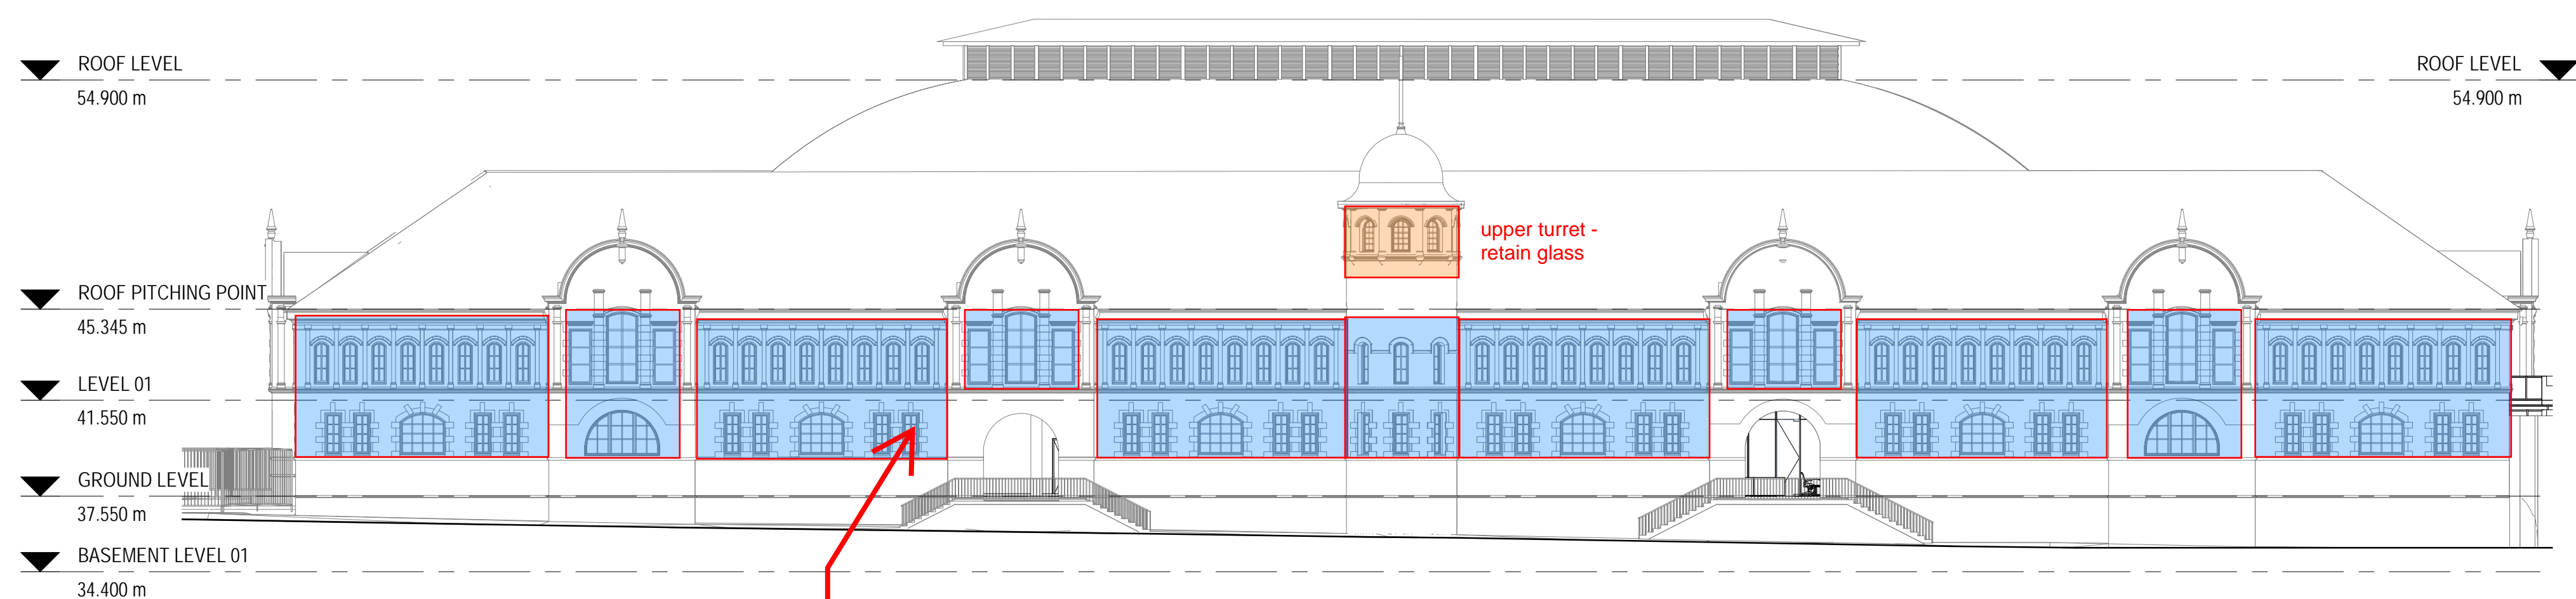
2 WEST ELEVATION  
1 : 200

This window was tested for hazardous materials
