**ARBORICUTURAL IMPACT ASSESSMENT  
REPORT**

**NEWCASTLE COURTHOUSE REDEVELOPMENT  
NIHON UNIVERSITY**

**CHRUCH STREET NEWCASTLE NSW**

**17<sup>th</sup> NOVEMBER 2018**

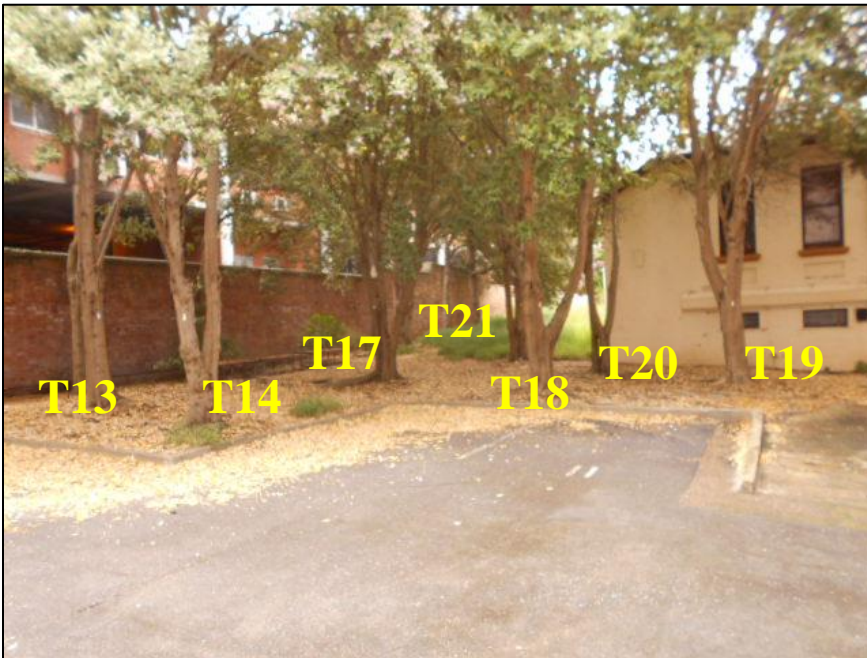
Due to their small live crown size (less than 40m<sup>2</sup>) individually Tree Nos. 13, 14 & 20 are considered to have low retention values.

**Photo 1 - Trees within the development footprint**

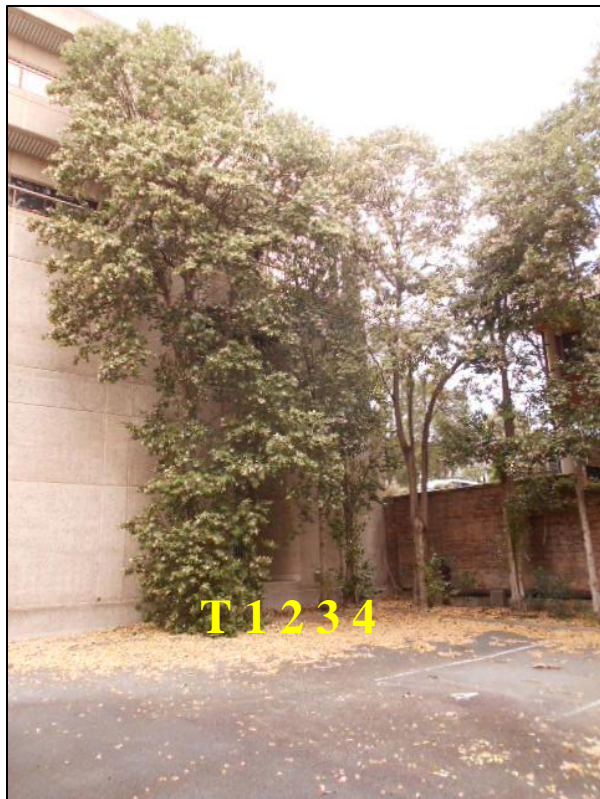
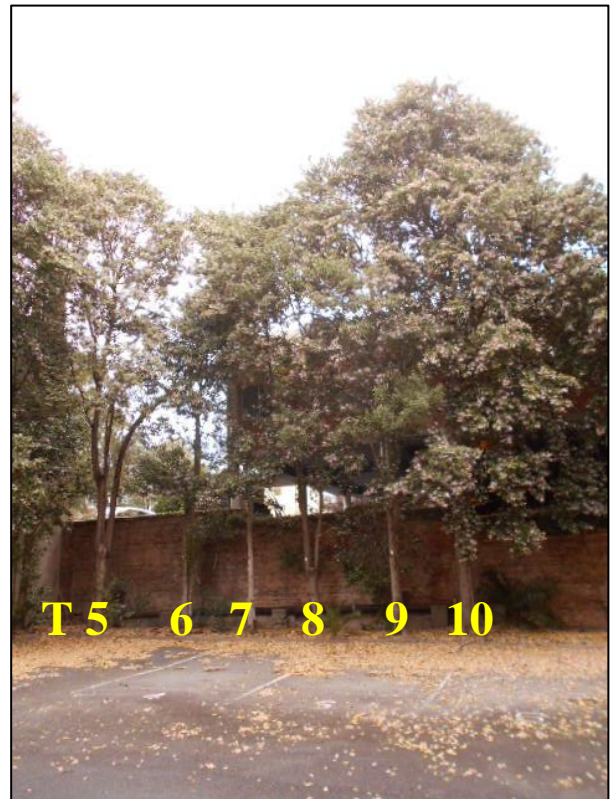
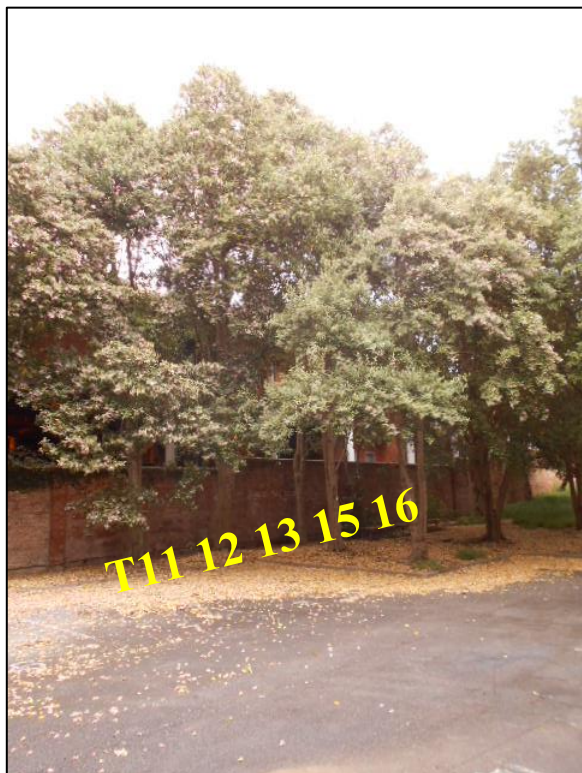
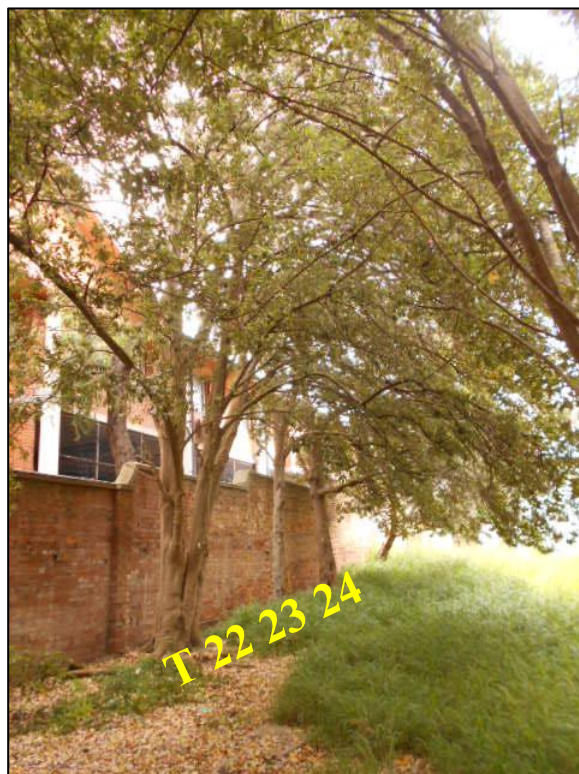
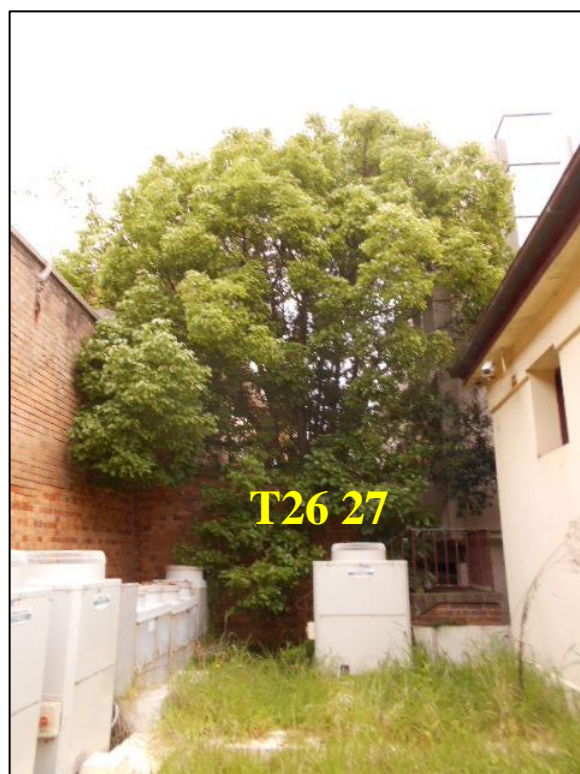
The main area of concern is damage that may be caused to structural roots and canopy structure.

**Photo 2 – Trees adversely impacted upon by development**

**Photo 3 – Trees adversely impacted upon by development**

**Photo 4 – Trees adversely impacted upon by development**

**Photo 5 – Trees adversely impacted upon by development**

**Photo 7 – Trees adversely impacted upon by development**

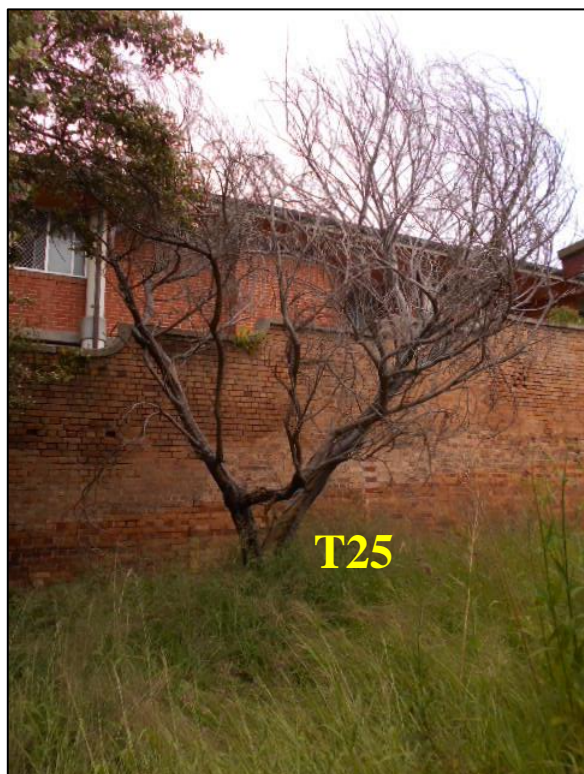
Tree No. 25 is a dead tree and would be removed regardless of the impacts of development

**Photo 6 – Dead tree**

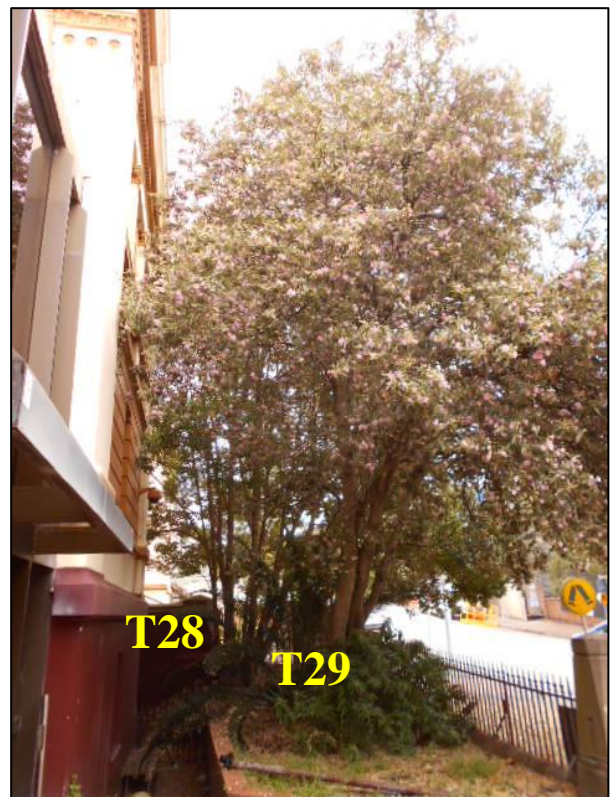
The proposed earthworks will encroach into the SRZ's of these trees that is likely to result in cutting or damage to roots.

Due to their invasive seeds Tree No. 29 (*Cinnamomum camphora*) is generally considered to be an undesirable species and combined with its poor canopy structure and habit and form has been assessed as having a very low retention value and not considered suitable species for long term retention in its current position.

**Photo 8**  
**Trees adversely impacted**  
**upon by development**

Whilst their removal will be noticeable from street it is will provide space for new plantings with species of Japanese origins proposed to be established as part of the overall landscape theme.

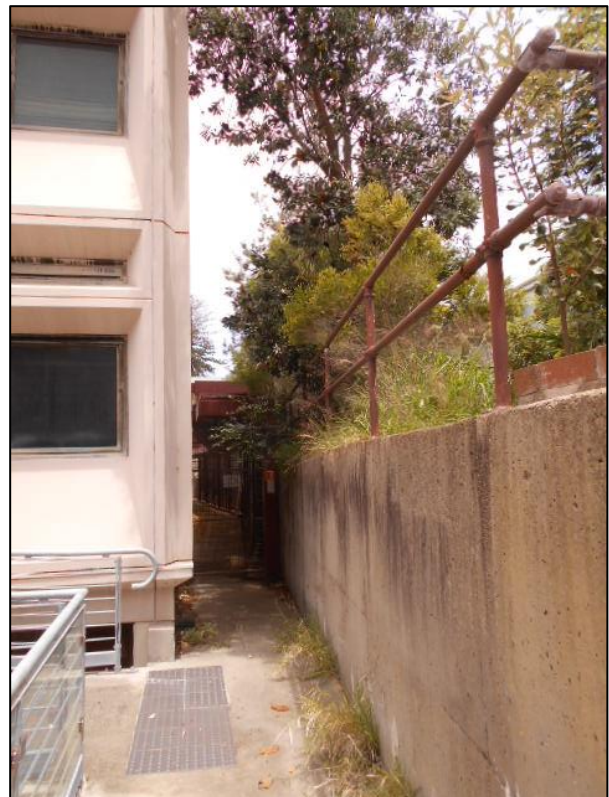
In considering the potential impacts it is likely that the wall and associated foundation footings would act as a form of root barrier preventing radial spread of roots. Roots are forced to grow down and/ or linearly along the wall.

Based on observation made given that the small size of the trees and the limitations on the depth of root growth it is considered that roots are not likely to have penetrated deep enough into the soil and extent into the subject property. As such it is considered that the development of the site would not have any impact on these trees.

**Photo 9**  
**Trees on neighbouring**  
**property to west not expected**

However care will need to be taken to ensure damage upper parts of the tree is avoided during the demolition stage.

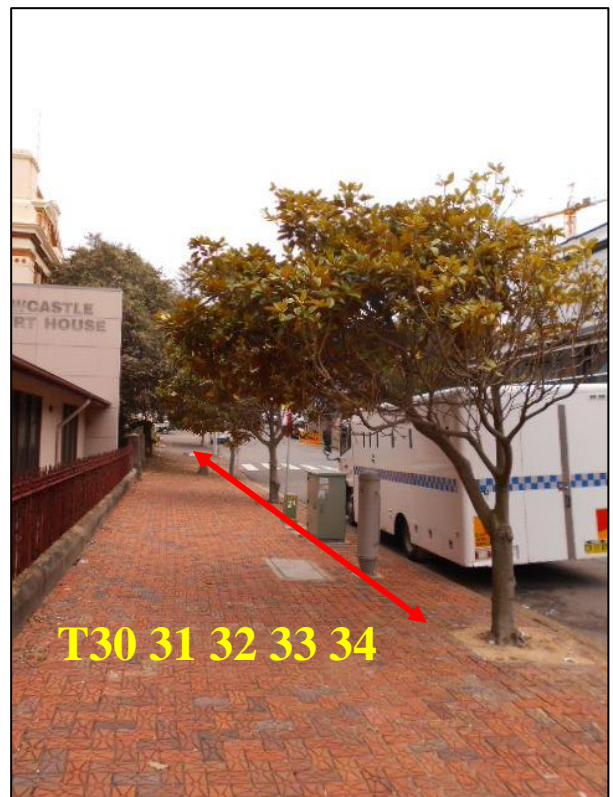
As part of the overall development the existing street footpath is to be renewed. Although excavation is not expected to be extensive extreme care must be taken to avoid damage to roots. Typically, most roots are found within the top 900mm of soil, and most of the fine roots active in water and nutrient absorption are in the top 300mm of soil. Large roots can also be encountered close to the surface.

**Photo 10**  
**Renewal of footpath**  
**next to street trees**

To avoid excessive damage to roots the demolition of the existing path and construction of the new path must be undertaken with extreme care to avoid severance or damage to roots within the SRZ and excessive damage to roots within the TPZ.

It is possible that the existing pavement can be removed without significantly impacting on the trees however must be lifted in a manner that will not cause damage to roots.

Removal of pavement should not be undertaken by means of crushing or shattering or by other means that involve pounding as the force of pounding impacts could result in damage to roots that may be close to the surface or compaction of soil (Photo 10)
