Hazardous Building Materials (HBM) Register

Bankstown City Campus Development
Bankstown NSW 2200

Prepared for
Western Sydney University

Project 86462.01
May 2019

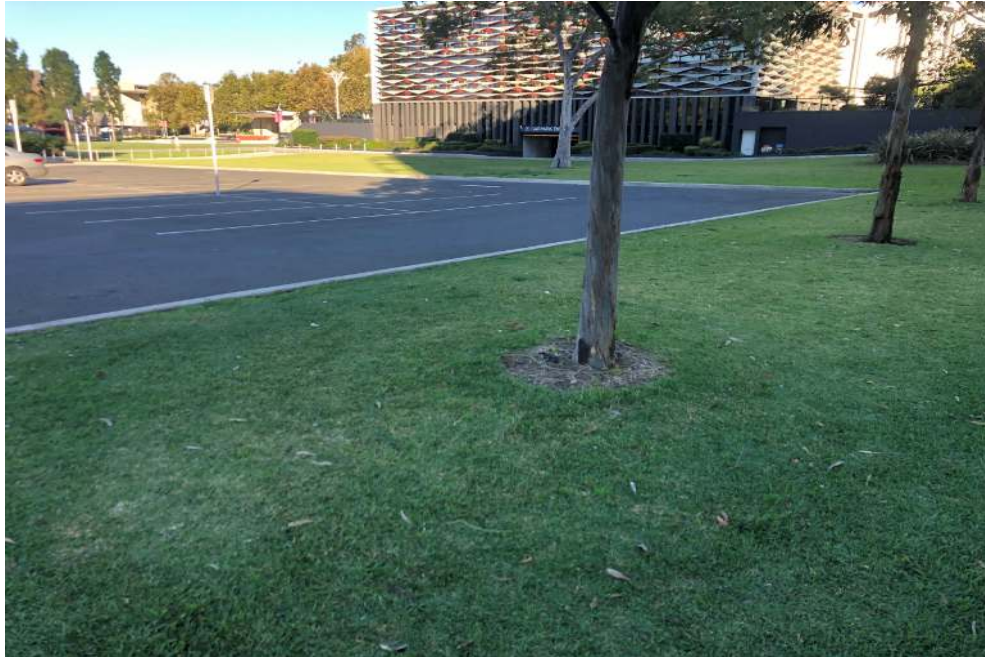
Photograph 1 - Site area - looking south west

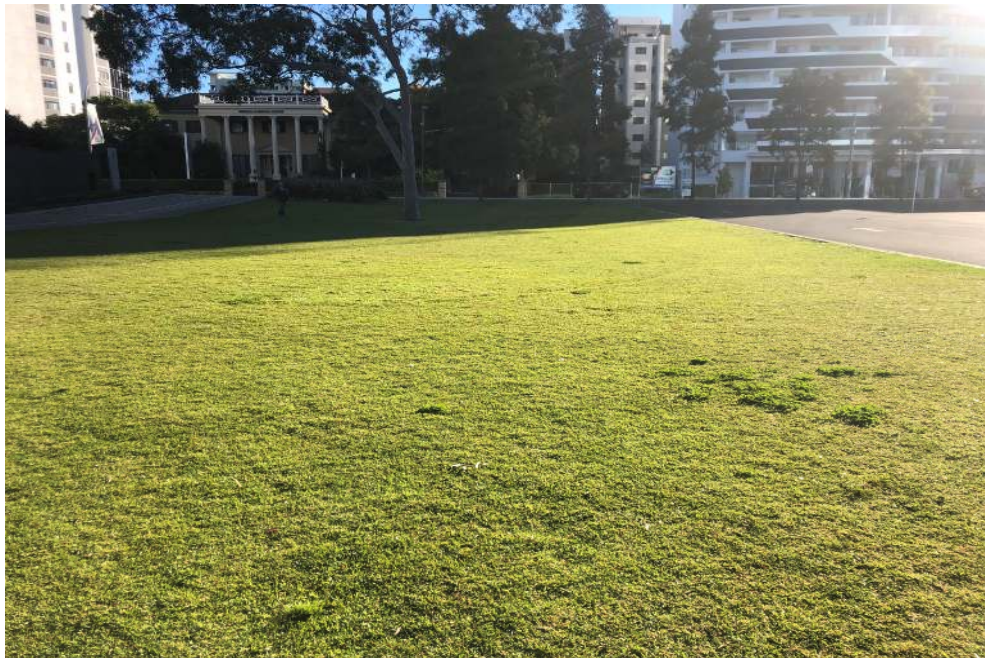
Photograph 2 - Site area - looking north
