Health Infrastructure

Hazardous Building Materials Assessment

December 2018

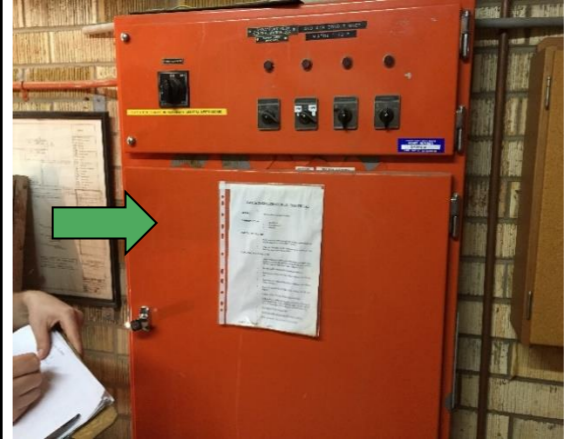
RESULT <0.1% lead content, not lead-containing paint as described in AS/NZS 4361.2:2017 Guide to hazardous paint management - Part 2: Lead paint in residential, public and commercial buildings.

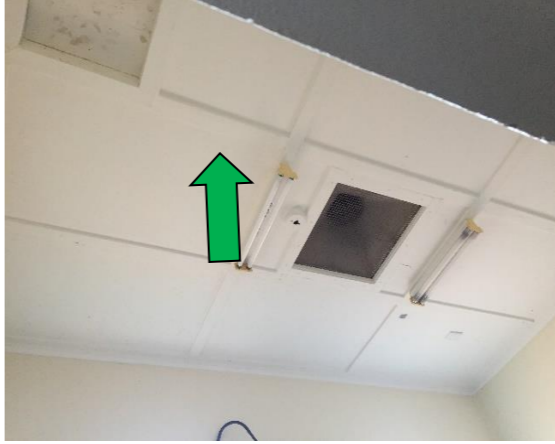
RESULT <0.1% lead content, not lead-containing paint as described in AS/NZS 4361.2:2017 Guide to hazardous paint management - Part 2: Lead paint in residential, public and commercial buildings.

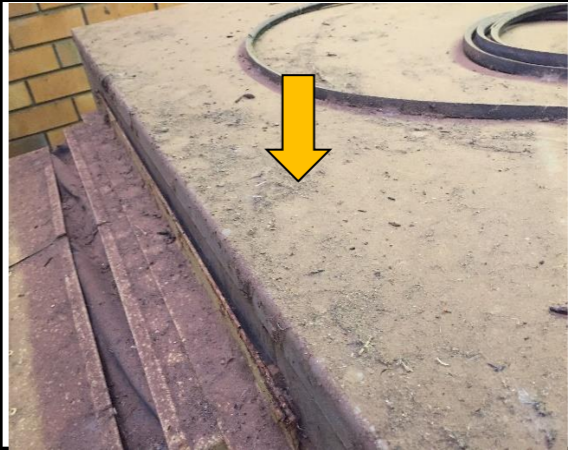
Results is <300 mg/kg guideline for residential or childcare sites based on the soil contamination criteria of the <i>National Environment Protection Measure 2013</i> . Due to the non homogenous nature of lead in dust contamination and the age of the building, undertake task specific risk assessment and remove under controlled conditions in accordance with AS 4361.2, Guide to Hazardous Paint Management - 2017 Part 2: Public, residential and commercial buildings prior to disturbance
Building No.25, TRACS													
Internal	Ceiling cavity	Dust to surfaces	27	82521	270 mg/kg lead content	300 m ²	U	P	F	L	Low

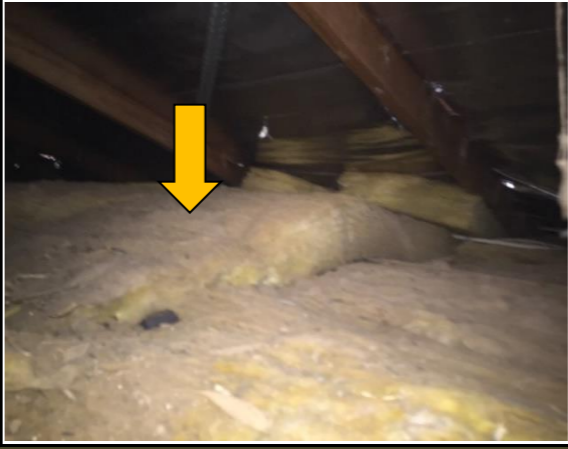
Results is <300 mg/kg guideline for residential or childcare sites based on the soil contamination criteria of the <i>National Environment Protection Measure 2013</i> . Due to the non homogenous nature of lead in dust contamination and the age of the building, undertake task specific risk assessment and remove under controlled conditions in accordance with AS 4361.2, Guide to Hazardous Paint Management - 2017 Part 2: Public, residential and commercial buildings prior to disturbance
