Tree Assessment Report

St Matthew's Catholic School, Mudgee

Site Address: 48 Bruce Rd Mudgee NSW 2850.

Date of Site Inspection: 27th November 2019

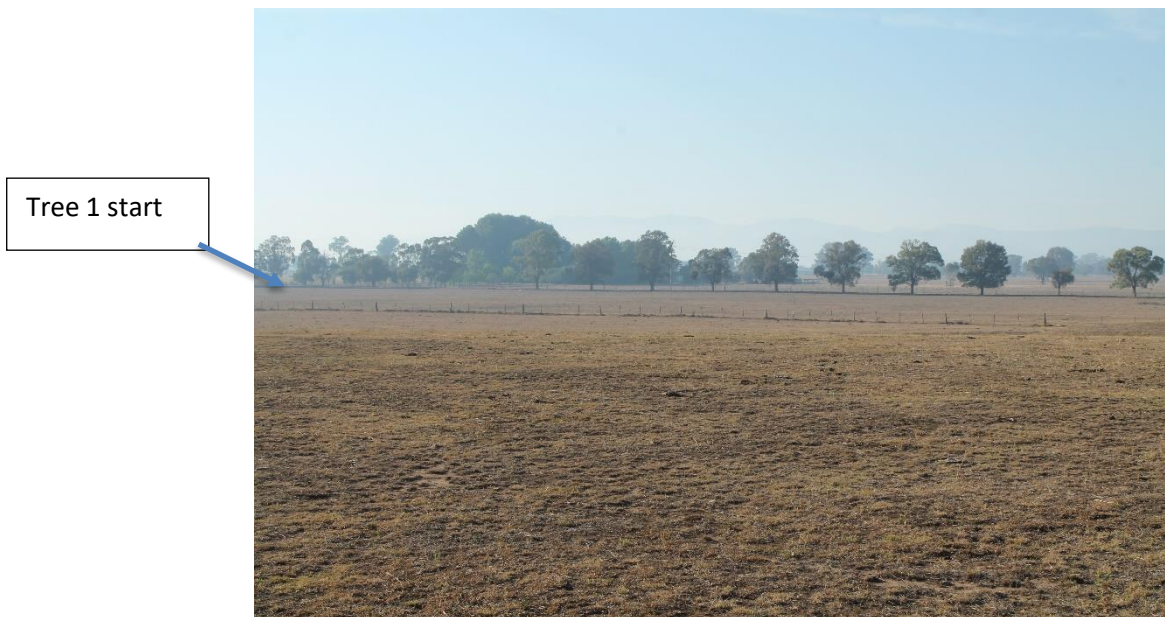
Tree 1 start

Eucalyptus nicholii: Trees (1-19) bordering Bruce Rd looking south

- *Eucalyptus nicholii* is not indigenous to Mudgee area, (Trees 1-35) are bordering 2x boundaries fence lines, the trees have been assessed as in moderate to poor condition but still retain the amenity of the area , several trees are dead and several trees with significant faults, power lines adjacent the trees in Broadhead Rd will require regular pruning by the utility company. These trees have been planted and assume without testing the average age to be 30 years old, typical age is medium longevity. Trees bordering Bruce Rd boundary (1-19) are a mix of good to poor condition with several tree having structural related problems. *Eucalyptus nicholii* is listed as Vulnerable (NSW) in its natural habitat of the New England and Northern Tablelands districts. (*Retention Value Medium*)

- *General comment is that Eucalyptus nicholii life span is medium longevity, typically 35-45 years outside their natural environment, I have estimated these trees to be maximum 30 years old without testing. Remedial care will be required and ongoing to maintain these trees.*
- *Any landscape proposal to replace these Eucalyptus nicholii trees and maintain the amenity of the street scape could be considered a suitable option for the long term amenity of the area.*

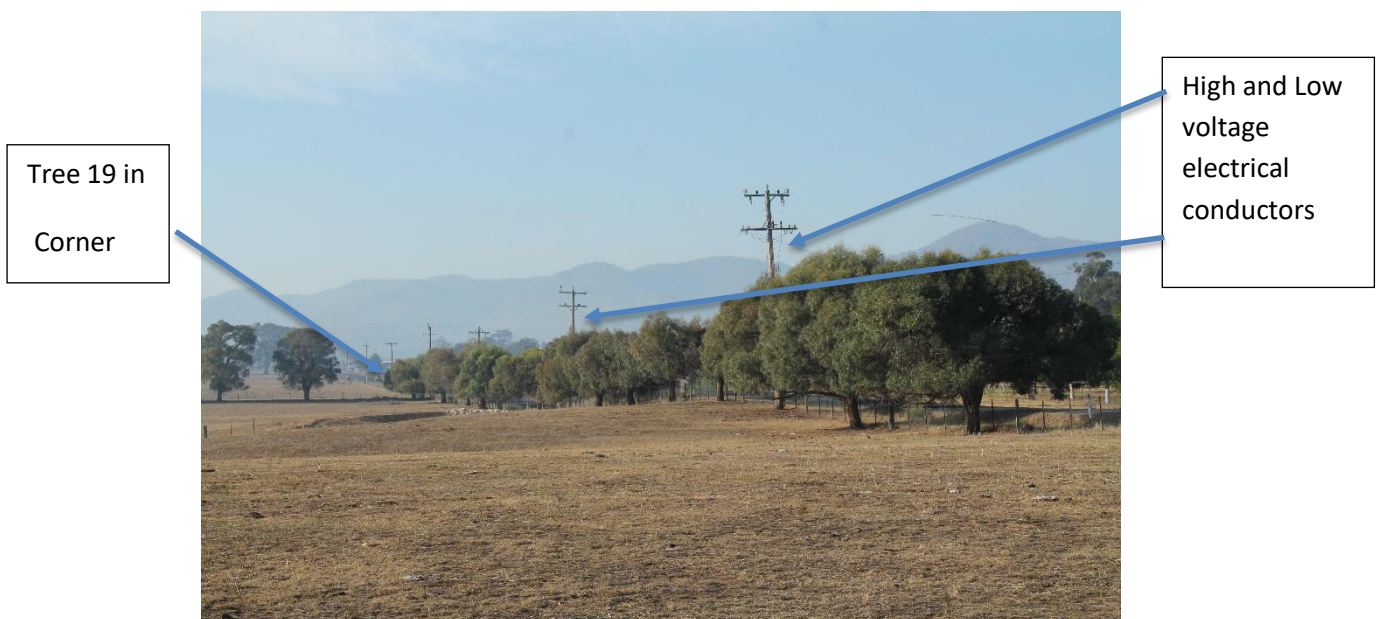
Tree 19 in
Corner

High and Low
voltage
electrical
conductors

Eucalyptus nicholii: Trees (20-35) bordering Broadhead Rd looking south west.

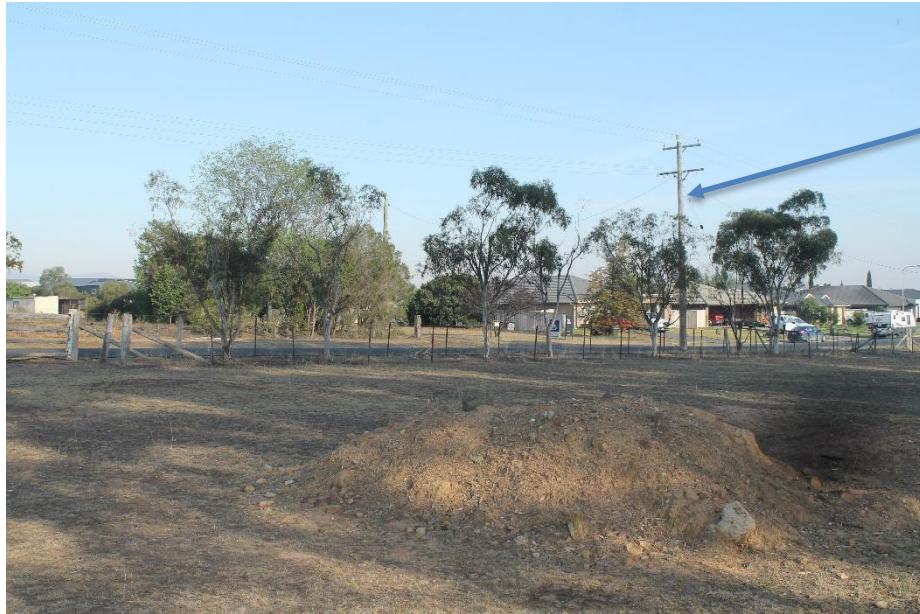
High and Low
voltage
electrical
conductors

Eucalyptus scoparia: Trees (36-43) bordering Broadhead Rd looking north west.

- *Eucalyptus scoparia* is not indigenous to Mudgee area, (Trees 36-43) these trees have been assessed as in moderate to poor condition with several trees dead, the planting location adjacent electrical conductor is not suitable. *Eucalyptus scoparia* in their natural environment on the Northern Table lands district and is listed Vulnerable. (NSW). (*Retention Value Low*)

These are immature /semi mature trees, introduced to the Mudgee area, they are in poor condition, with several dead trees in the mix, planted adjacent electrical conductors requires utility company pruning to maintain clearances regularly, retention value is low and TULE short term with substantial remedial care.

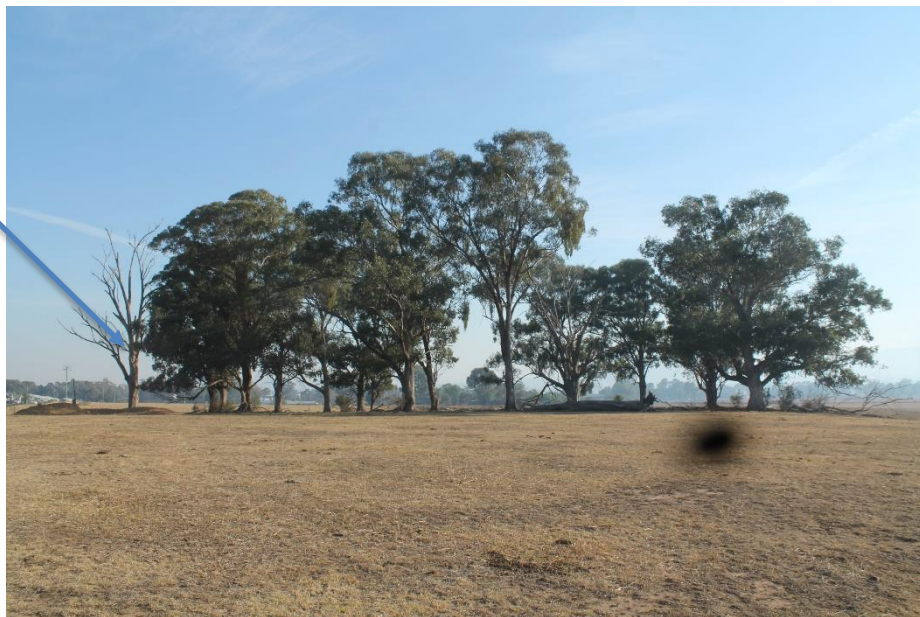
Dead tree
(STAG)
Retain
make safe.
Active
habitat

Eucalyptus microcarpa: Trees (44-62) on North West ridge looking

- *Eucalyptus microcarpa* is indigenous to Mudgee area, (Trees 44-62) are growing in their natural environment. I have assessed these trees in general as in good to moderate condition, several trees are dead (STAGS,) habitat hollows are present in several identified trees (*refer to Tree Survey or Conclusions*), ***Eucalyptus microcarpa* Grassy Woodlands** is listed as Endangered biological Community clarification requires an Ecologist for identification of habitat, flora and fauna species. (*Retention Value High*)

Refer to the Tree Survey Assessment Table for remediation recommended. Several dead trees require to be made safe and retained as habitat.
