WestConnex M4-M5 Rozelle Interchange – 260-262 Victoria Road, Rozelle

Archival Recording and Salvage Report

Prepared for John Holland CPB Joint Venture

March 2021—Final

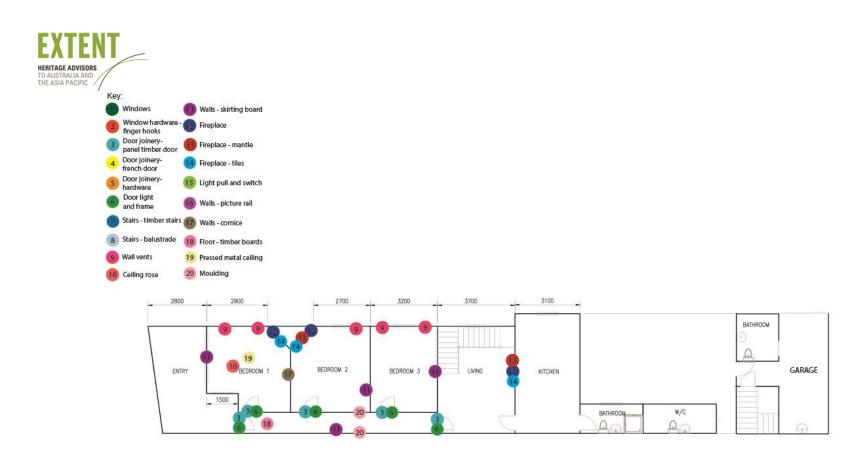
GROUND FLOOR, 260 VICTORIA ROAD, ROZELLE

Ref#	Feature	Quantity	Thumbnail
11	Walls - skirting board	4 rooms	
12	Fireplace	3	
13	Fireplace – mantle * The fireplace mantle within the front room of 260 Victoria Road is in poor condition and is not considered to be salvageable.	3 total 2 salvageable	DAMAGED – DO NOT SALVAGE SALVAGE SALVAGE

Ref #	Feature	Quantity	Thumbnail
			SALVAGE
	Fireplace – tiles * The fireplace in bedroom 2 has historic tiles. Bedroom 1 and Living have been replaced with modern tiles, but historic tiles may be present beneath.	1 set visible Potentially 3 sets, if viable	
			CHECK BENEATH
14			
			CHECK BENEATH
15	Light pull and switch	0	N/A

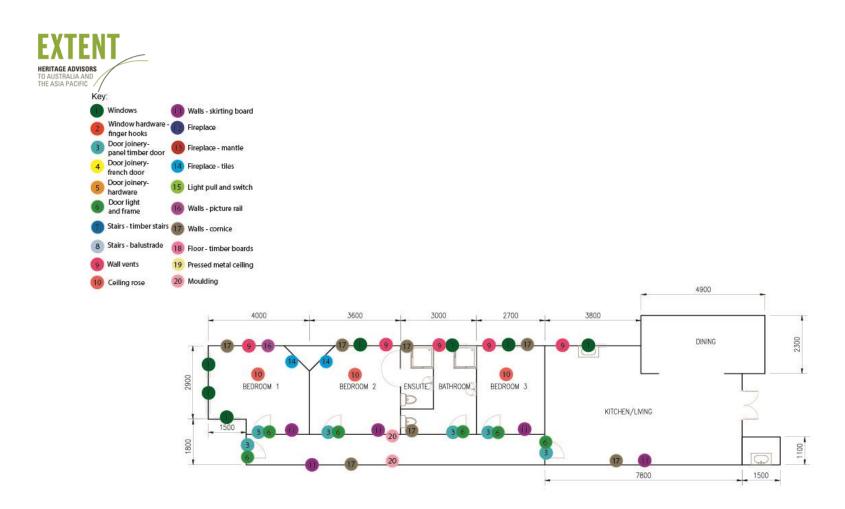
GROUND FLOOR, 262 VICTORIA ROAD, ROZELLE

Ref #	Feature	Quantity	Thumbnail
	* Not present.		
9	Wall vents	5	
10	Ceiling rose	3, if viable	
11	Skirting board	5 rooms	
12	Fireplace * The fireplaces at 262 Victoria Road appear to have been removed. If they are found behind the wall then they should be salvaged.	0	N/A
13	Fireplace – mantle * Not present.	0	N/A
