Stormwater Channel off Lilyfield Road

Photographic Archival Recording and Salvage Report

Prepared for John Holland CPB Joint Venture (JHCPBJV)

March 2021 - FINAL

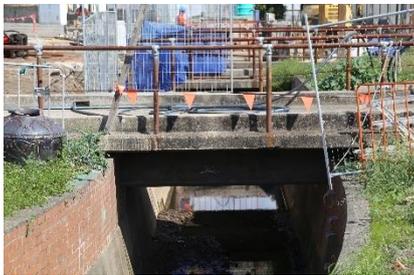
Image name	Direction	Details	Thumbnail
001_LR_SC_2019	SW	Reinforced concrete bridge over the channel.

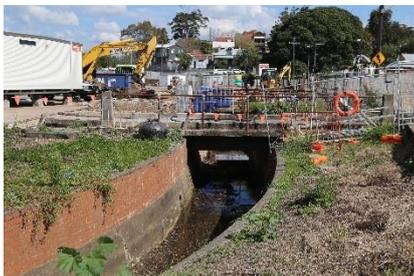
002_LR_SC_2019	SW	View of reinforced concrete bridge in the channel.

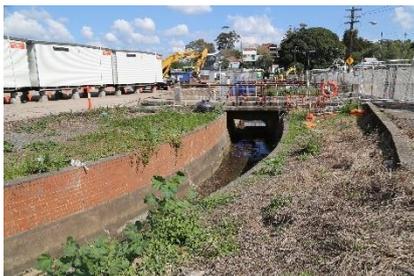
003_LR_SC_2019	SW	Stormwater channel with English bond pattern brick top and concrete base.

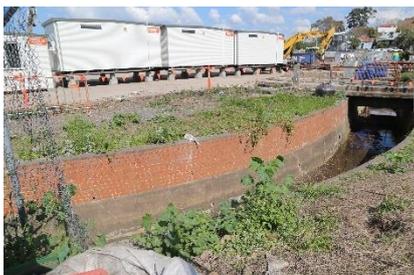
004_LR_SC_2019	SW	Stormwater channel with English bond pattern brick top and concrete base.

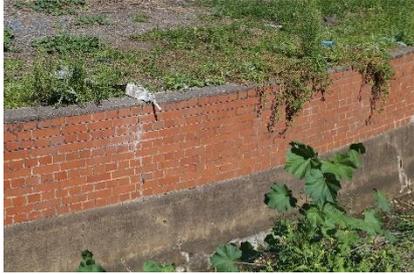
Image name	Direction	Details	Thumbnail
005_LR_SC_2019	SW	Stormwater channel with English bond pattern brick top and concrete base.

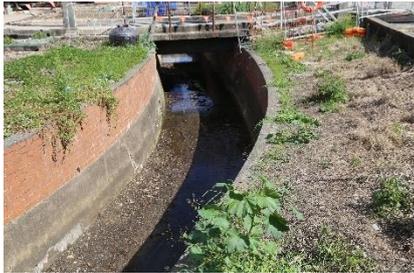
007_LR_SC_2019	SW	Base of the channel filled with sediment.

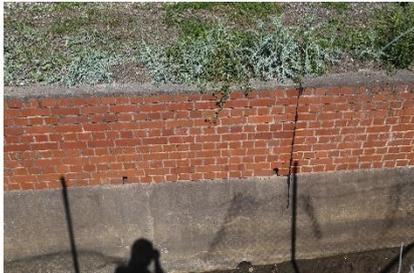
008_LR_SC_2019	S	Detail of the brickwork. The bricks are modern and have a burnished finish.

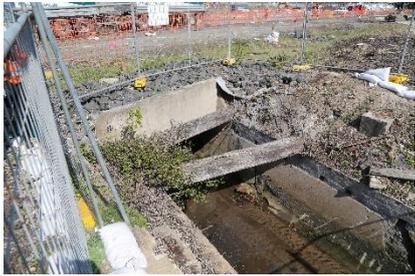
Image name	Direction	Details	Thumbnail
030_LR_SC_2019	SW	Timber beam joists and concrete headwall.

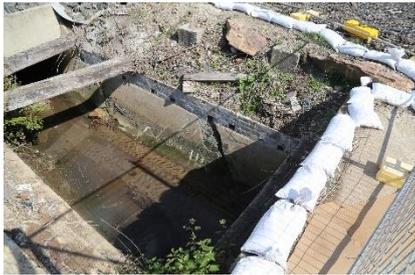
031_LR_SC_2019	SW	Base of the exposed section of channel showing sediment build up.

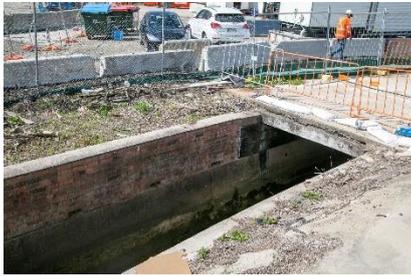
Image name	Direction	Details	Thumbnail
035_LR_SC_2019	E	Stormwater Channel portal with timber beam joist. Note the timber beams used as channel wall.

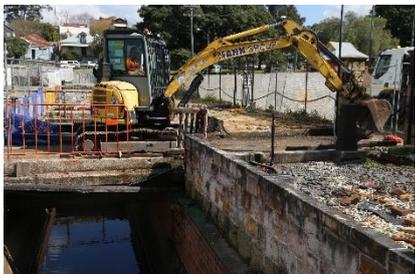
053_LR_SC_2019	SW	Remnant of timber picket fence on the bridge.

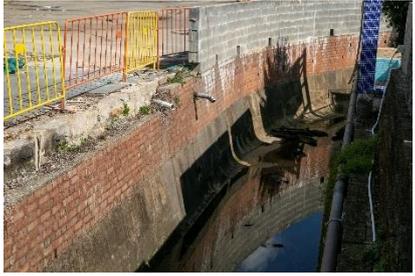
061_LR_SC_2019	SW	Penetration into the stormwater channel.

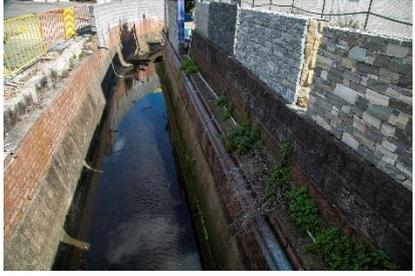
062_LR_SC_2019	SW	Services clamped and bolted to the exterior of the wall.

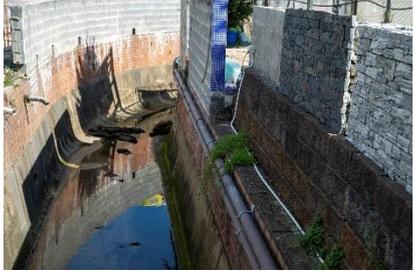
063_LR_SC_2019	NW	Services clamped and bolted to the exterior of the wall.

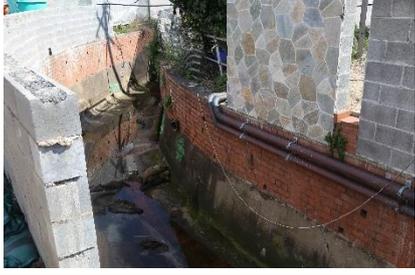
064_LR_SC_2019	NW	Services clamped and bolted to the exterior of the wall.

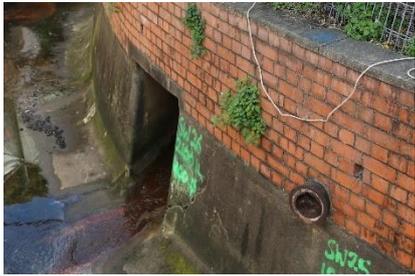
Image name	Direction	Details	Thumbnail
065_LR_SC_2019	NW	Intersection of capped and exposed stormwater channels. metal outlet pipe located at the base of the brick wall.

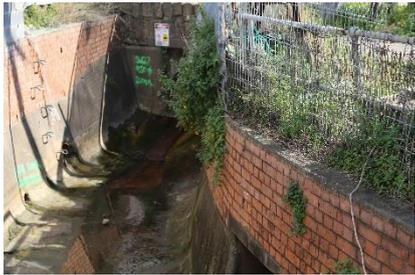
066_LR_SC_2019	NW	Vegetation growth of the brick section of the stormwater channel.

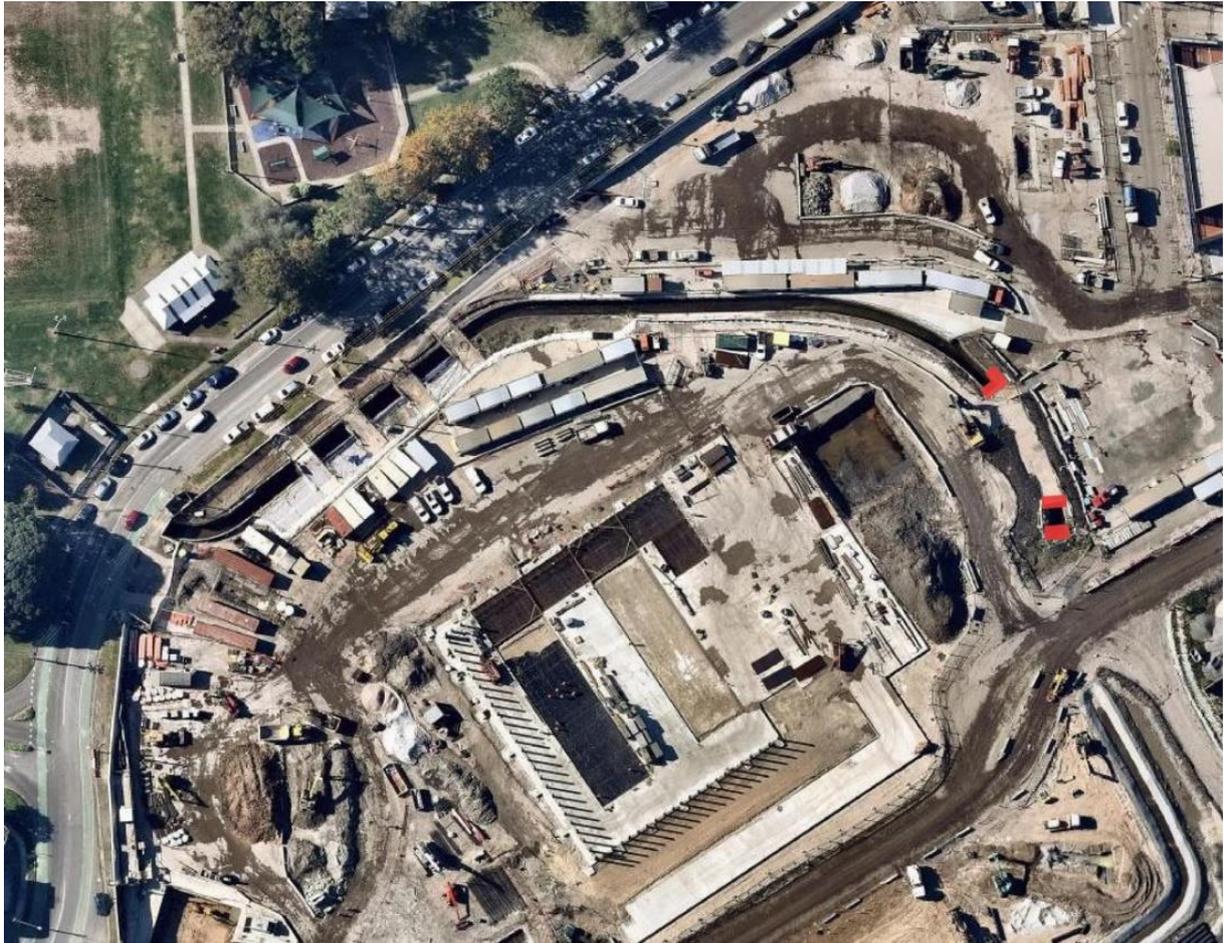
The only items of historic fabric within the stormwater Channel off Lilyfield Road are the large hardwood timber beams incorporated into the channel as joists or as upper sections of the channel wall. It is recommended that this material is salvaged, and the processes described in section 8.2 and 8.3 of this report are followed to ensure the proper treatment of this material.

Figure 3 provides an outline of where these timber beams were identified during the August inspection. Owing to the nature of the channel's construction, there exist sections which are capped and could not be inspected. These sections of the channel could include more timber beams. In addition to the beams identified in Figure 3, any other timber beams of a similar nature that are uncovered as the channel is demolished should also be salvaged.

Figure 3. Areas identified in red show the locations for timber beams found in the channel.

- All timbers should be removed carefully to ensure its condition is not compromised. In particular, where it will maintain the integrity of the beam, each timber should be disconnected or be de-bonded from the stormwater channel.
- A Heritage Advisor should be notified if other potential original (and salvageable) building fabric, which has not been identified in the salvage report, is identified during works. A photograph of this item should be emailed to the Heritage Advisor for assessment of its salvage potential prior to disposal.
- Timber beams that have detritus from the Lilyfield road water channel attached or adhered to it should be washed with water.
