$\label{eq:product} \textbf{Appendix} ~ \textbf{G} - \text{Contamination} ~ \text{Assessment}$

То	Hunter Water Corporation				
Copy to					
From	Alison Monkley	Tel	+61 2 49799990		
Subject	Belmont Drought Response Desalination Plant - Contamination Review	Job no.	2219573

Hunter Water Corporation Belmont Drought Response Desalination Plant Contamination Assessment

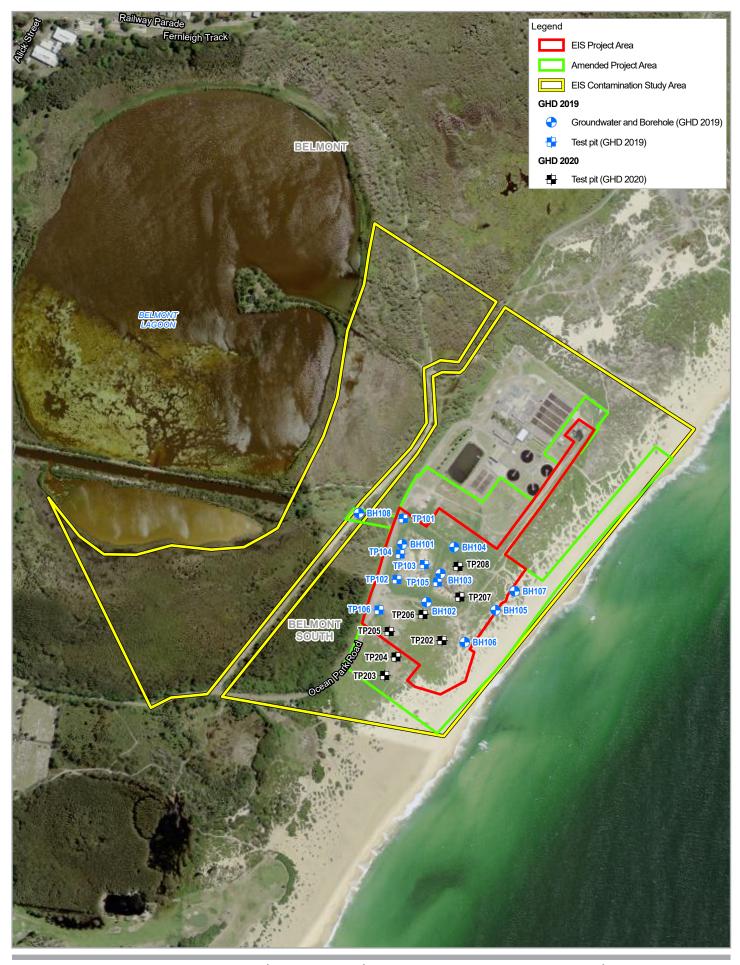
Figure 3-2 Data source: LPI: DTDB / DO PP, 2018public\_NSW\_Imagery: © Department of Customer Se

Groundwater was encountered in all but two of the test locations (TP101 and TP106). Water levels were logged at the desalination plant site between 0.95 mbgl (BH101) to 4.1 mbgl (BH105).

No asbestos was detected in soil samples analysed. However, one fragment of non-friable potential ACM was observed between TP106 and GW102 within the proposed desalination plant site and other small fragments of non-friable potential asbestos containing material (ACM) were found on the surface near GW108 (70 m west of the construction footprint opposite the proposed desalination plant site). These fragments were bonded and given that there was no fibres identified in soils, the risk to workers is considered to be low and can be managed through an unexpected finds protocol in a contaminated soil management plan (CSMP).

Concentrations of copper and zinc were above both recreational and commercial/industrial land use EILs in TP106\_0.0-0.2 / FD20. TP106 was located adjacent to an access track and the results are considered to be due to the presence of fill consisting of silty sand with gravel including asphalt, concrete, bricks and rock.

Concentrations of copper (BH104\_0.0-0.2) and TRH F3 (BH104\_0.0-0.2 and BH104\_0.2-0.3) in fill samples from BH104 were above urban residential land use. This location was located on the northern boundary of the former evaporation ponds. Fill at this location was described as dark grey to brown silty sands and sands.

Concentrations of TRH F3 above the urban residential ESL in BH102\_0.0-0.2 which was located south of the evaporation ponds. Fill at this location was described as brown to grey sand with rootlets and trace plastic and wire.

- Soils at TP106 which would be classified as Restricted Solid waste based on a lead concentration of 287 mg/kg (General Solid Waste Contaminant Threshold is 100 mg/kg)<sup>1</sup>.
- Soils where asbestos is identified would also be classified as asbestos waste.
- Soils where acid sulfate soils are identified would be classified as acid sulfate soil waste.
