CONTAMINATION PLAN

New Maitland Hospital
State Significant Infrastructure Application – Stage 2

Multiplex Constructions Pty Limited

**New Maitland Hospital
Part Lot 401 site inspection and addendum to contamination investigations, and Lot
7314 site condition inspection – February 2018**

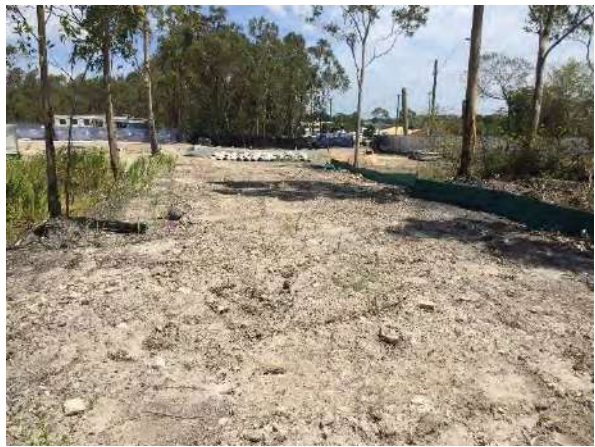
Photograph 1. Western corner of Part Lot 401, access track to Metford Road gate (for access to Lot 7314). Reed-lined channel on left (east of access track). View southwest.

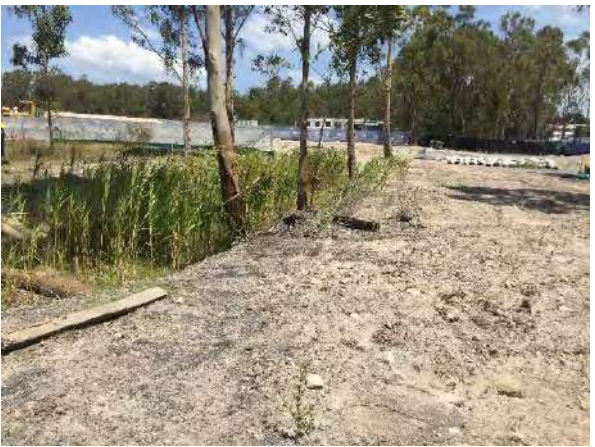
Photograph 2. Reed-lined channel east of the access track. Lot 7314 site compound in background. View south.

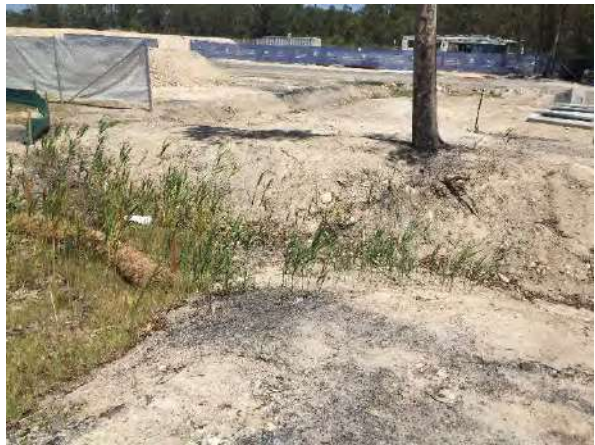
Photograph 3. Southern end of the reed-lined channel, continuing into (downgradient) unlined channel. Lot 7314 site compound in background. View south.

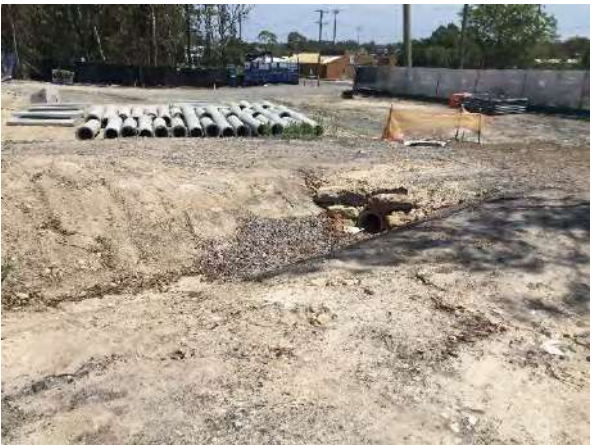
Photograph 4. Unlined channel and concrete pipe culvert under access track. Metford Road gate in background. View southwest.

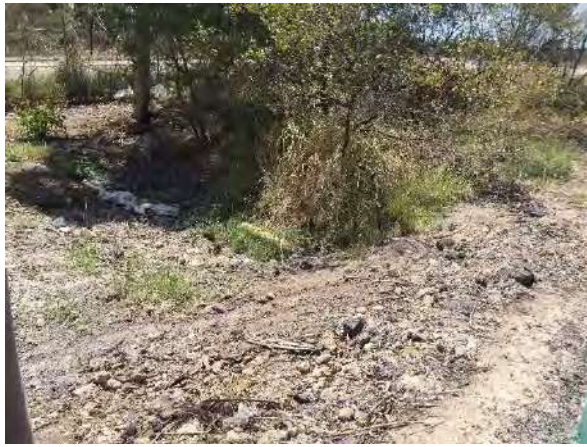
Photograph 5. Plastic pipe culvert under access track, small collection area to west of access track. View north.

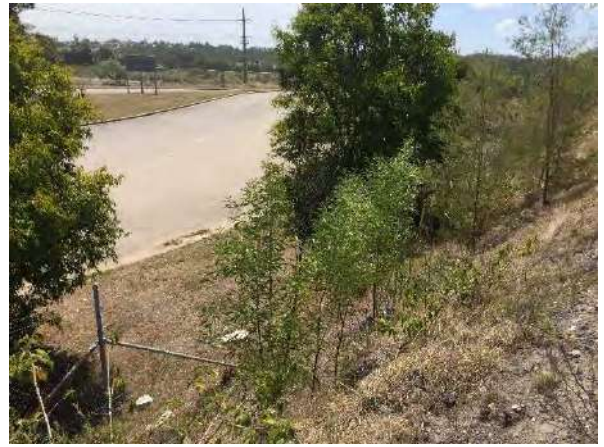
Photograph 6. Former CSR access road, now main access to Lot 401 (northern corner), viewed from the fill mound/berm in northern corner of Part Lot 401 (berm continues northeast along northwestern boundary of Lot 401). View north.

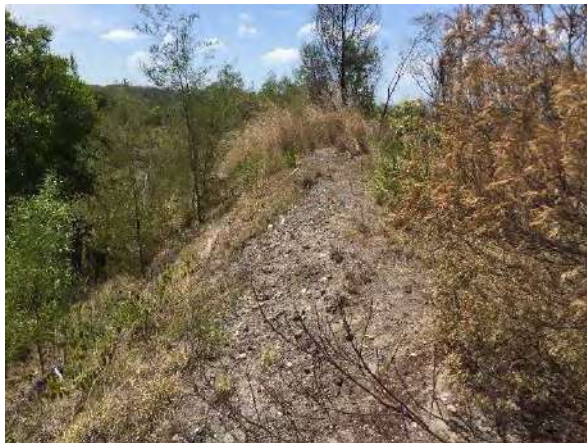
Photograph 7. Fill mound/berm running along northwestern boundary of Lot 401. Surface predominantly soil with brick fragments. View northeast.

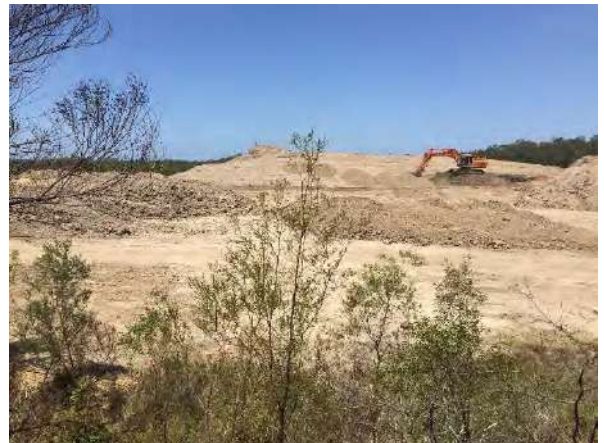
Photograph 8. Central portion of Part Lot 401 viewed from the fill mound/berm. Various stockpiles from Lot 401 remediation, predominantly fill material awaiting screening. View southeast.

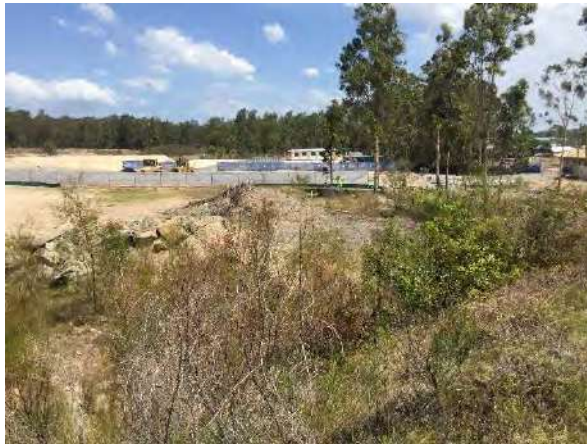
Photograph 9. Western portion of Part Lot 401 viewed from the fill mound/berm. Various waste stockpiles, including vegetation (from clearing), soil and concrete. Lot 7314 site compound in background. View southwest.

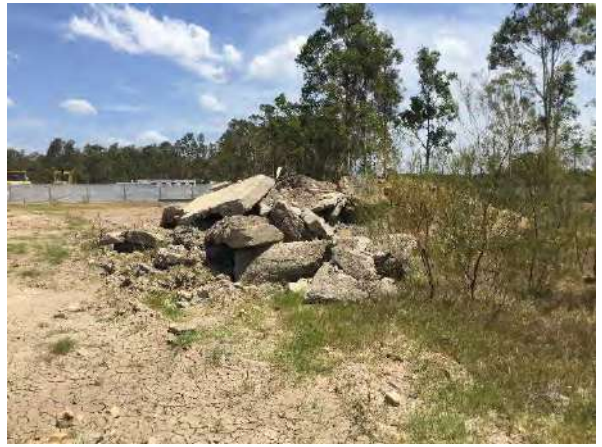
Photograph 10. Concrete waste stockpile in western portion (northern corner) of Part Lot 401. View southwest.

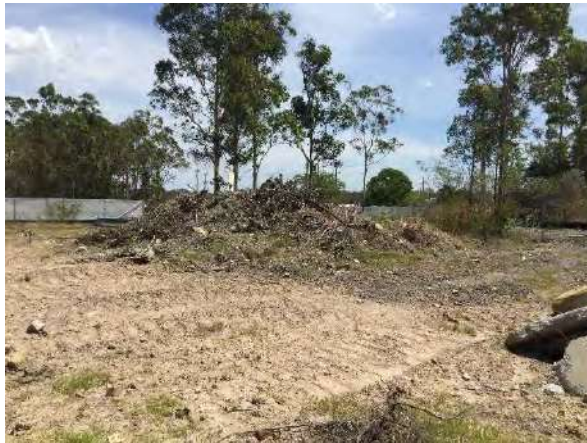
Photograph 11. Soil and vegetation waste stockpiles in western portion of Part Lot 401. View west.

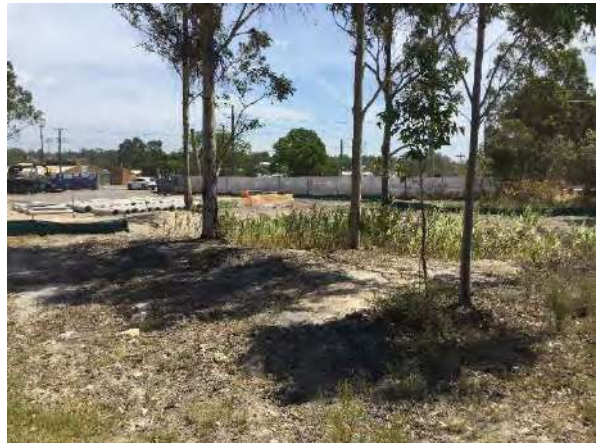
Photograph 12. Reed-lined channel and access track. Metford Road gate in background. View west.

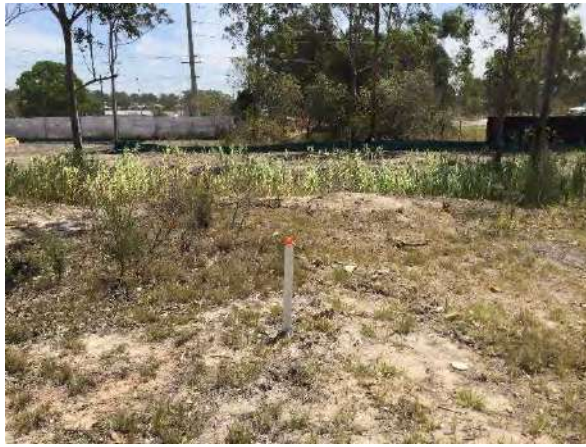
Photograph 13. Groundwater monitoring well MW62 (see DLA Figure 1 “Groundwater Monitoring Well Locations” 10/12/2015), adjacent (east of) the reed-lined channel. View west.

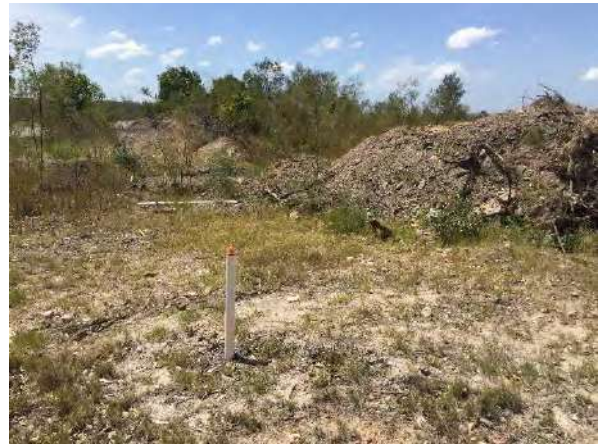
Photograph 14. MW62. Soil and vegetation waste stockpiles. Fill mound/berm in background. View north.

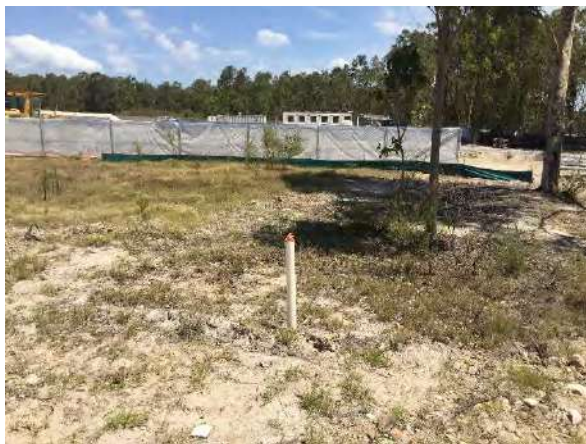
Photograph 15. MW62. Reed-lined channel to right of frame. Security fence along southwest boundary of Part Lot 401 and northeastern boundary (western portion) of Lot 7314. Lot 7314 site compound in background. View southwest.

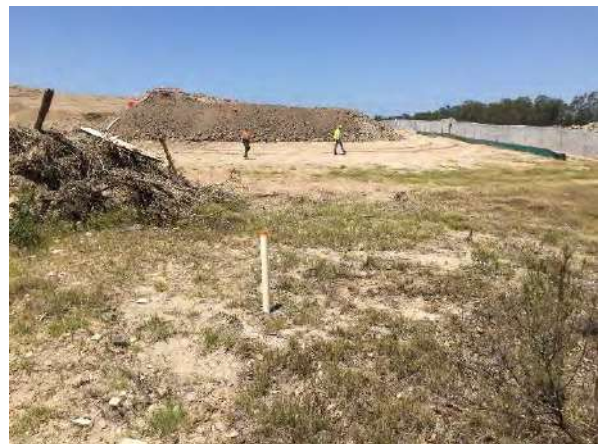
Photograph 16. MW62. Waste soil and vegetation stockpiles on left, fill material stockpiles from Lot 401 remediation in background. Security fence continuing along southwest boundary of Part Lot 401 and northeastern boundary (western portion) of Lot 7314. View southeast.

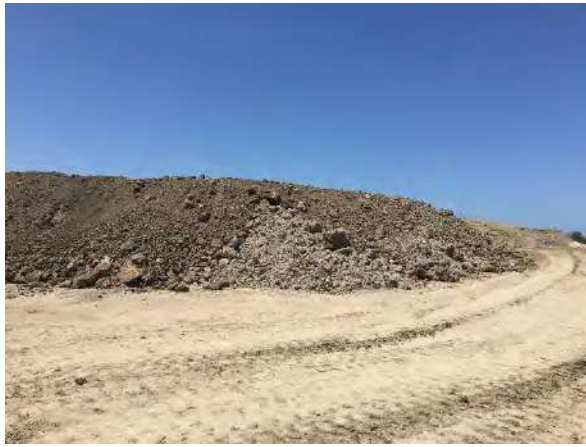
Photograph 17. Fill material stockpile from Lot 401 remediation. View southeast.

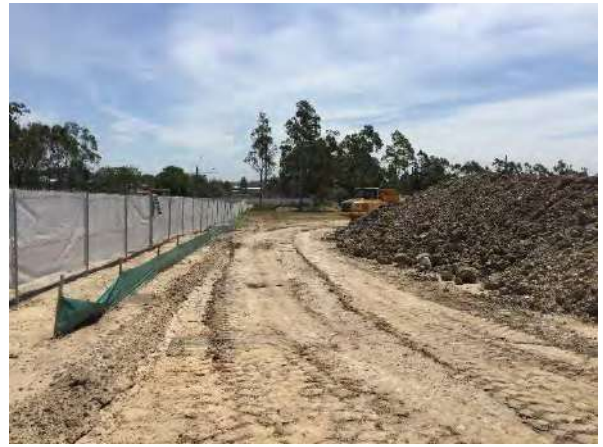
Photograph 18. Southwestern boundary (fence) of Part Lot 401. Fill material stockpiles from Lot 401 remediation on right. Metford Road in background. View northeast.

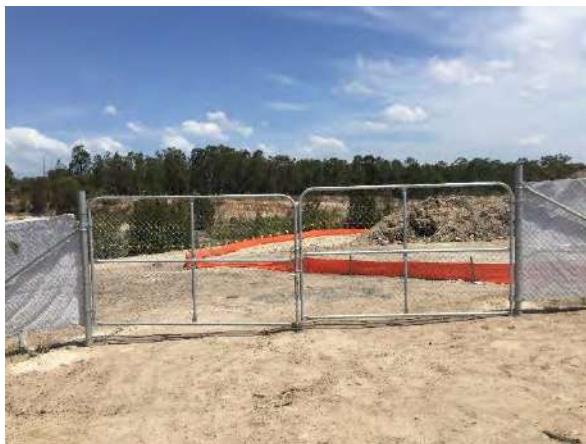
Photograph 19. 'Top gate' in boundary fence between Part Lot 401 and Lot 7314. Soil and vegetation waste stockpile (from clearing) on Lot 7314 in background (refer to Section 3, Table 2).

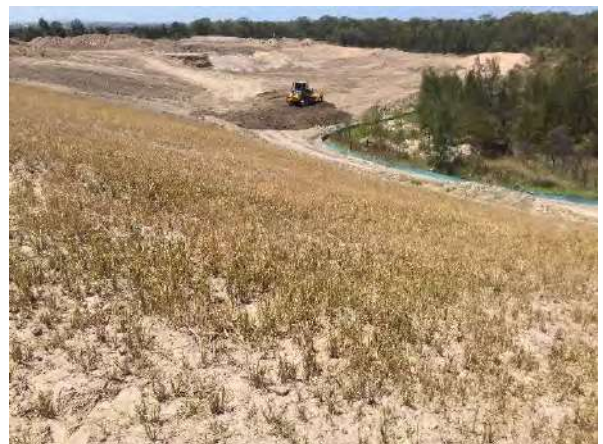
- Test Pits 191 and 213 were excavated within a 'bund' in the eastern portion of Part Lot 401. DLA noted the bund seemed to be comprised of two separate bunds most likely constructed at different times. The material from natural bedrock to approximately 4 m (about half way up the bund) seems to have been predominantly clean clays with low foreign material content. The upper half (approx. 4 to 5 m at TP191/TP213 location) seems to have been a lower quality source material, with mixed refuse including plastic, steel, emptied material storage bags and sacks, an old crushed 5000 L underground storage tank (UST), and large quantities of broken brick scattered throughout some layers. DLA considered it was highly possible that more USTs may be located in this area given the noted hydrocarbon odour through this upper bund material in at least three (3) separate test pits along the length of the bund. **GHD notes that this 'bund' has been now excavated to natural rock and reinstated with soil (and seeded) – refer to Section 2.2.**

Photograph 20. Embankment in eastern portion of Part Lot 401, recently excavated to rock, top-soiled and seeded (as noted in Section 0). View northeast.

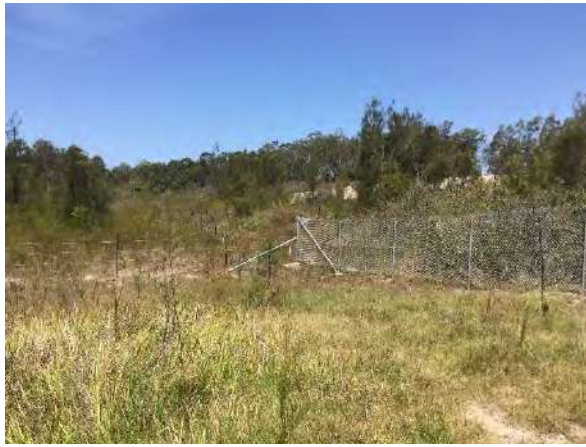
Photograph 21. Southern corner of Part Lot 401. Extent of security fence along the southwestern boundary of Part Lot 401. Continues to northeast as post-wire fence. View south (into Lot 7314).

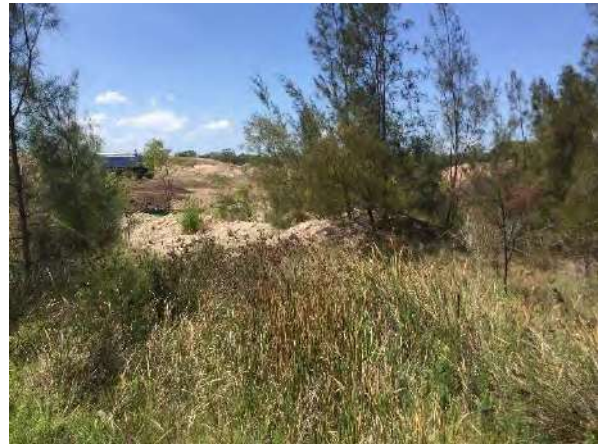
Photograph 22. Fill stockpiles in eastern portion of Part Lot 401, believed to be from previous site works (not specifically associated with Lot 401 remediation). View northeast.

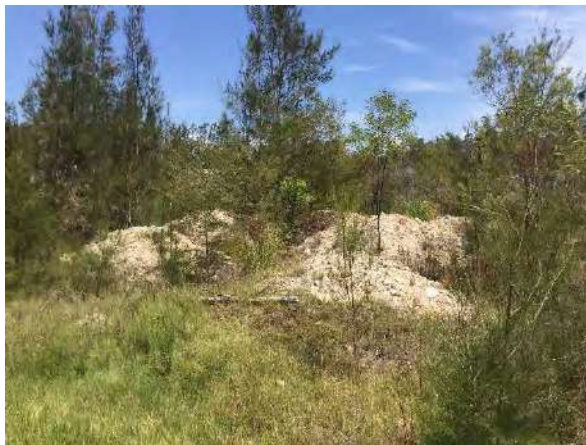
Photograph 23. Fill stockpiles in eastern portion of Part Lot 401. Lot 7314 in background. View southeast.

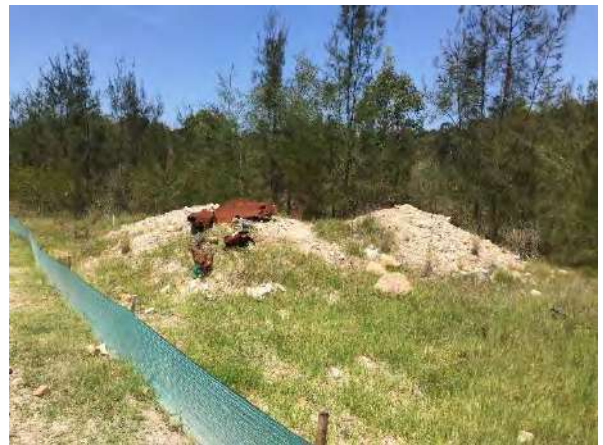
Photograph 24. Fill stockpiles in eastern portion of Part Lot 401. Scrap metal on surface. Lot 7314 in background (northern corner of eastern portion). View southeast.

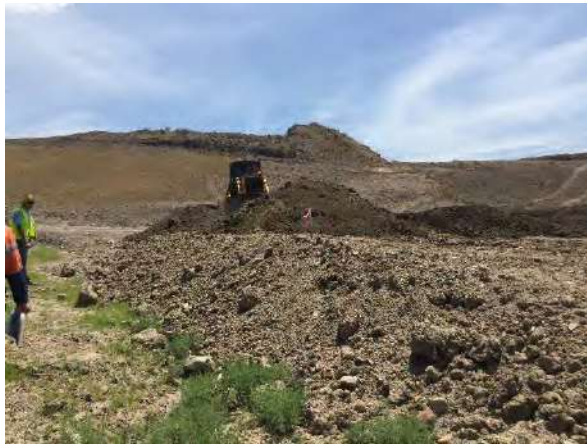
Photograph 25. Eastern corner of Part Lot 401 viewing along estimated northeastern boundary (of the Part Lot). Seeded embankment and fill material stockpiles (from Lot 401 remediation) in background (left and centre respectively). View northwest.

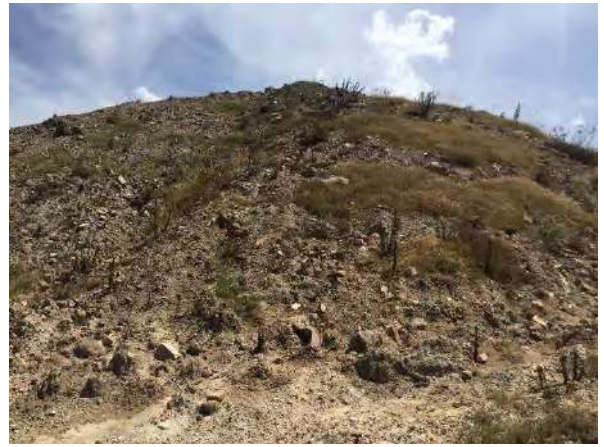
Photograph 26. Fill material from Lot 401 remediation, awaiting processing. View west.

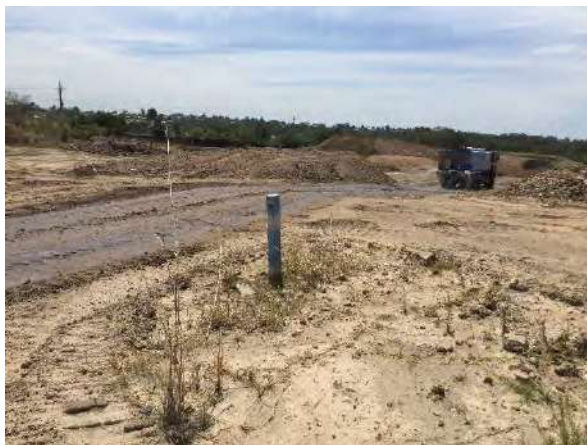
Photograph 27. Groundwater monitoring well MW61 (see DLA Figure 1 “Groundwater Monitoring Well Locations” 10/12/2015). Remainder of Lot 401 in background. View north.

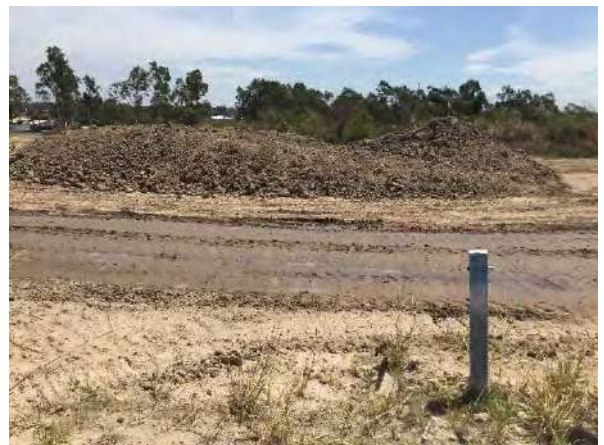
Photograph 28. MW61, viewing approximately along northeastern boundary of Part Lot 401 (no survey markers at time of inspection). Fill material stockpiles from Lot 401 remediation in background. View northwest.

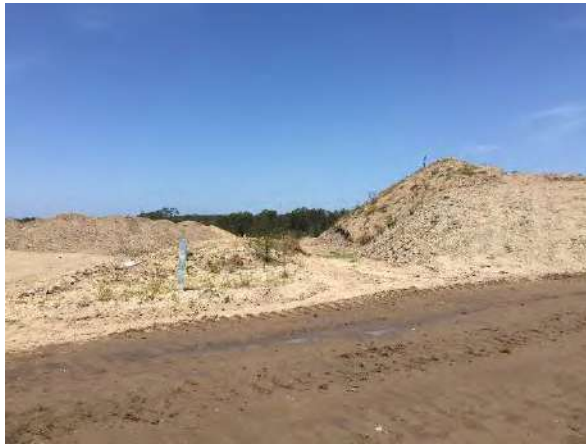
Photograph 29. MW61 (on left). Fill material stockpiled above the seeded embankment (as noted in Photograph 25 and Photograph 26). View south.

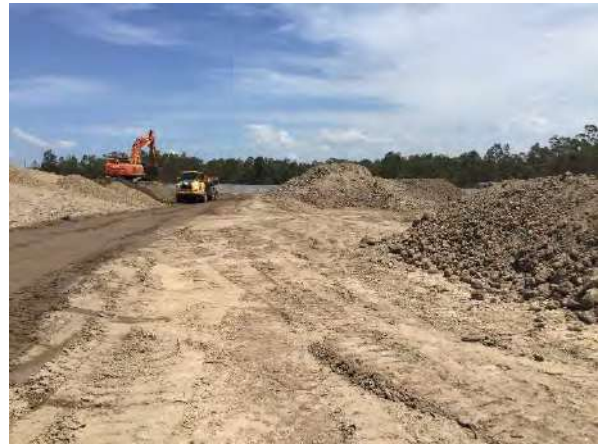
Photograph 30. Central portion of Part Lot 401. Fill material stockpiles from Lot 401 remediation. Southwestern boundary security fence in background. View southwest.

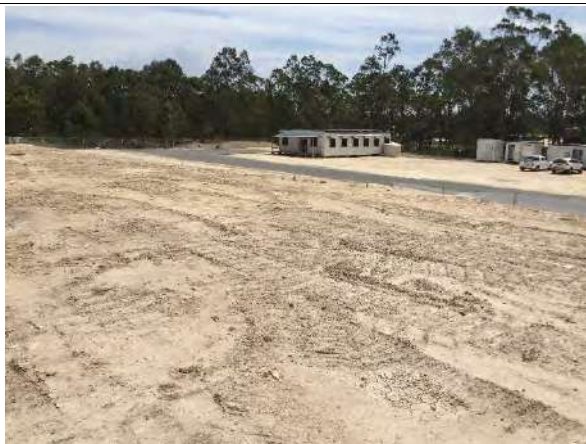
Photograph 31. Lot 7314 site compound (land clearing noted in previous inspection). View west.

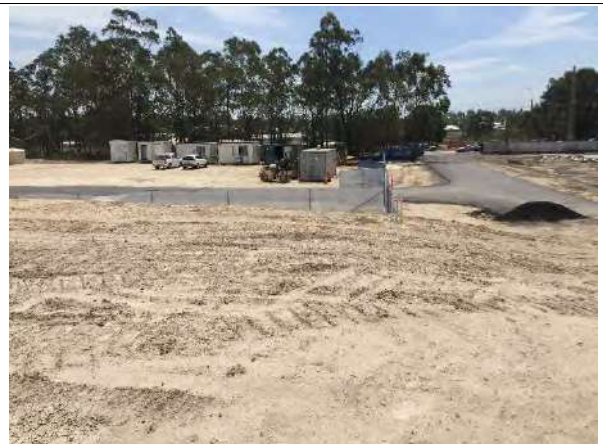
Photograph 32. Lot 7314 site compound. Metford Road gate in background (right). View northwest.

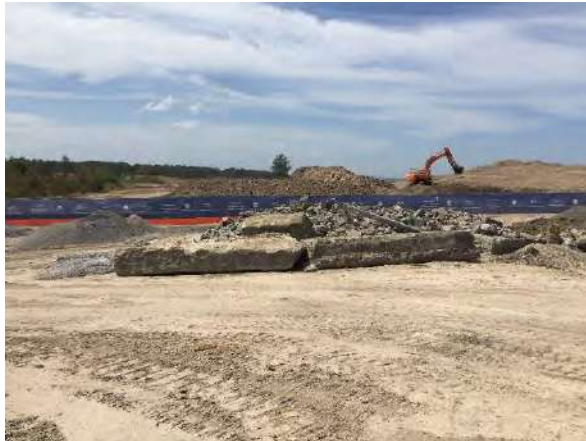
Photograph 33. Waste concrete stockpiles in northwestern portion of Lot 7314. Part Lot 401 in background (beyond security fence). View northeast.

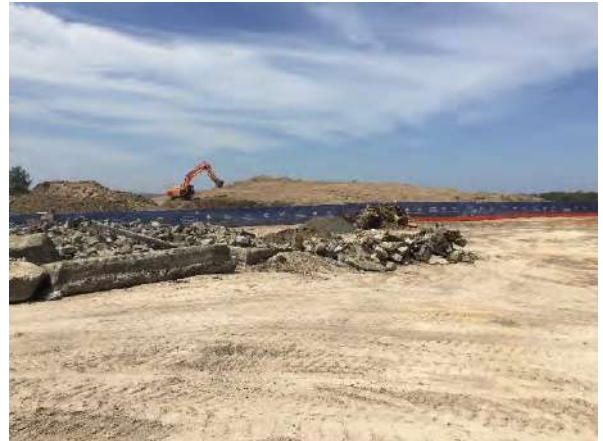
Photograph 34. Waste concrete, soil and vegetation waste stockpiles in northwestern portion of Lot 7314. View east.

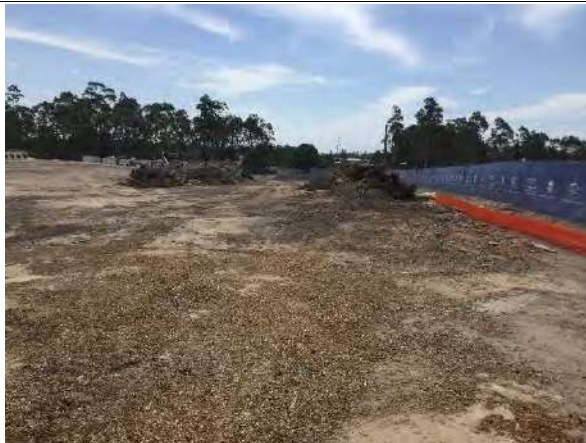
Photograph 35. Waste (concrete, soil and vegetation) stockpiles in northwestern portion of Lot 7314. Part Lot 401 southwestern boundary fence on right. Metford Road gate in background. View northwest.

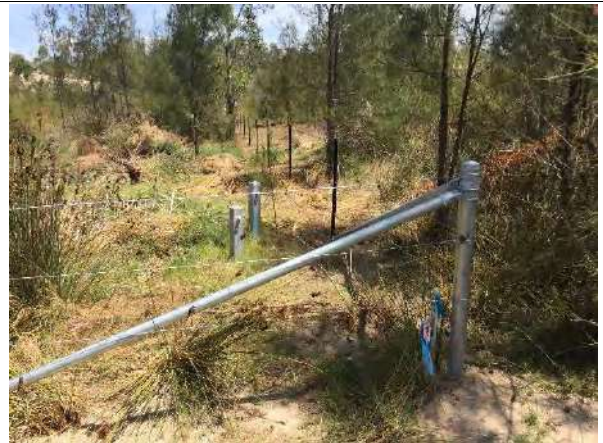
Photograph 36. Groundwater monitoring wells MW404D and MW404S in northern corner of Lot 7314 dog-leg (viewed from eastern corner of Part Lot 401). View southwest.

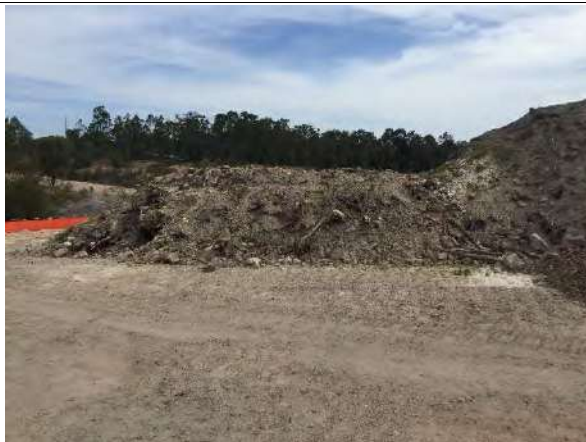
Photograph 37. Soil and vegetation waste stockpile east of the site compound, as noted in Photograph 19 (from Part Lot 401). View southwest.

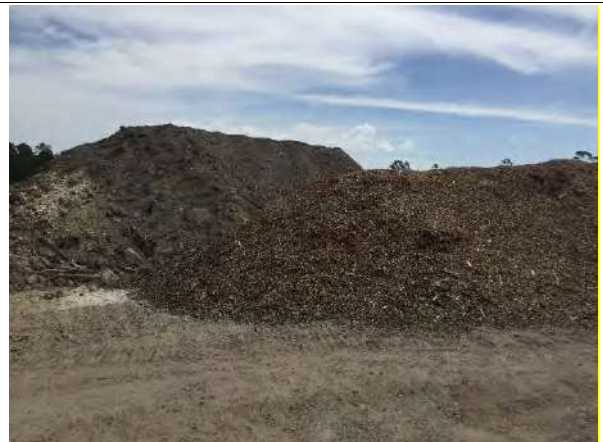
Photograph 38. Soil and vegetation waste stockpile east of the site compound (left) and mulched wood stockpile from vegetation clearing (right). View southwest.

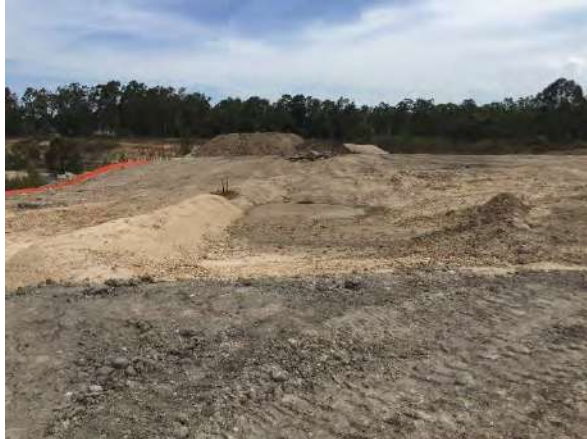
Photograph 39. Sediment basin / dam southeast of the site entrance (Metford Road gate), as viewed from adjacent the soil and vegetation stockpile (above). Fill material stockpiles in background (as noted in Photograph 42). View southwest

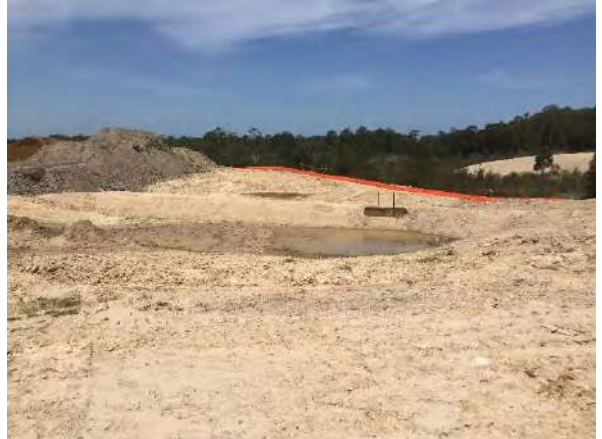
Photograph 40. Sediment basin / dam southeast of the site entrance. Soil and vegetation waste stockpile (left, as noted in Photograph 37) and covered carbonaceous material (right, as noted in Photograph 43 and Photograph 44) in background. View northeast.

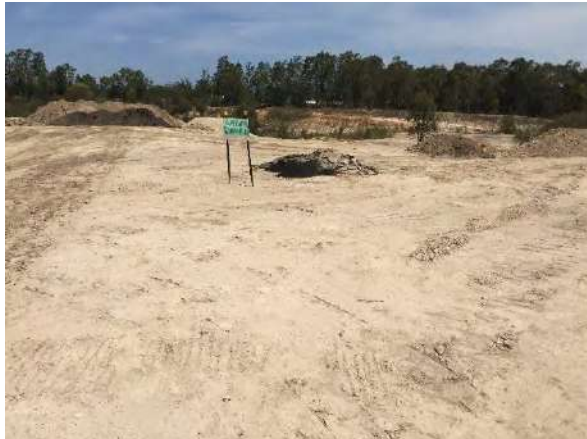
Photograph 41. Various waste stockpiles (predominantly fill soil, with exception of asphalt waste in centre of photograph) southeast of the site compound. Stockpiles in background-left noted in Photograph 39. View southeast.

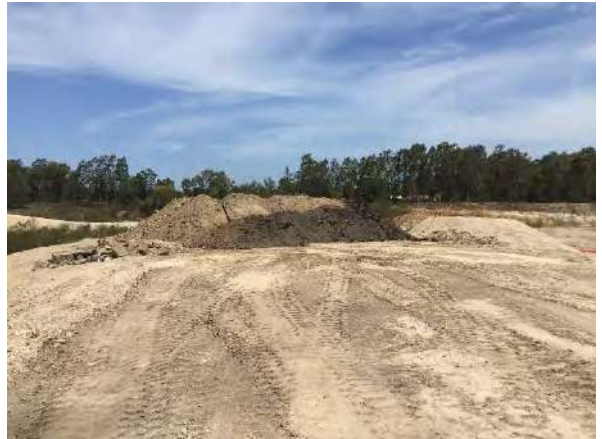
Photograph 42. Various waste soil stockpiles (as noted in Photograph 39 and Photograph 40) from land clearing and leveling. View southwest.

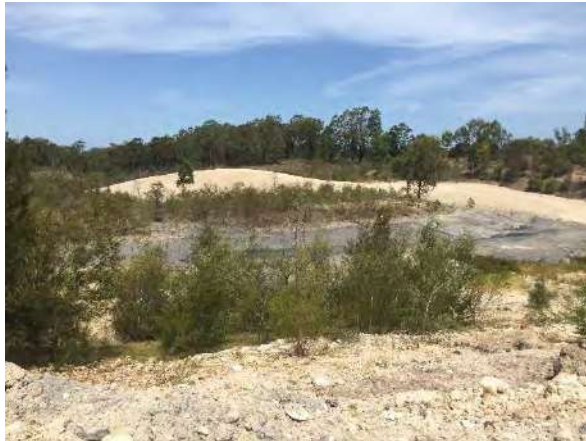
Photograph 43. Former water body in centre of Lot 7314 (noted in previous inspection as having been drained) – channel cut to prevent future ponding. The large carbonaceous material stockpile and outcrop (in background) covered with sandstone fill (presumably sourced from the site, but not confirmed). View southeast.

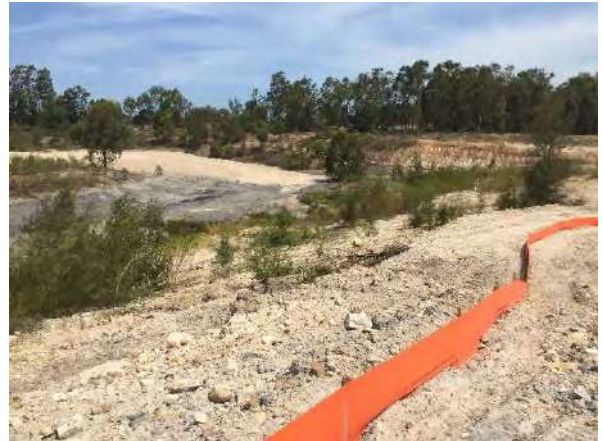
Photograph 44. As per previous photograph. Southern cutting on right. View south.

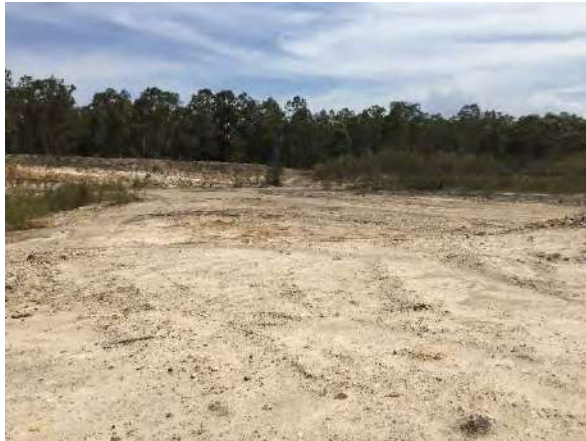
Photograph 45. View through central portion of Lot 7314 (now cleared and generally levelled). Southern cutting in background (left). View southwest.

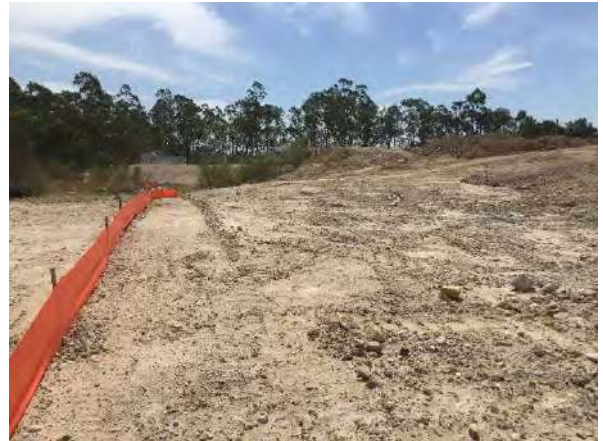
Photograph 46. Central portion of Lot 7314. Site compound in background. View northwest.

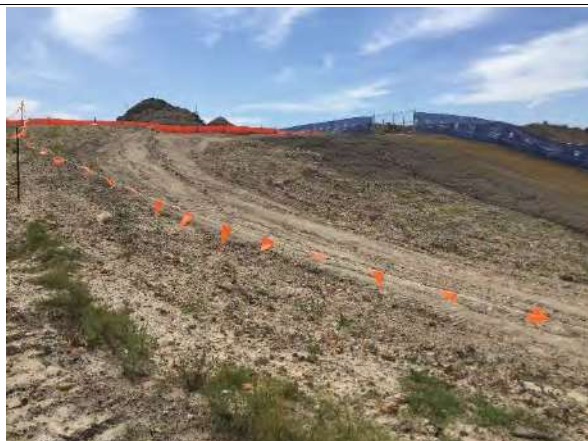
Photograph 47. Northern portion of Lot 7314, south of Part Lot 401. Soil and vegetation waste stockpile (left, as noted in Photograph 37 and Photograph 40) and Part Lot 401 southwestern boundary and 'top gate' (right, as noted in Photograph 19) in background. View north.

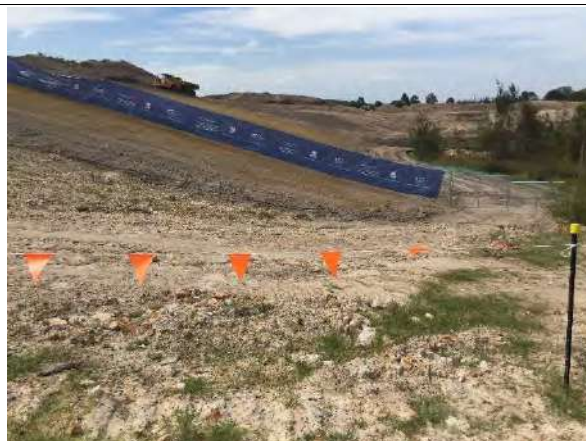
Photograph 48. Seeded embankment (as noted in Photograph 20 and Photograph 25) partially in Lot 7314, predominantly in Part Lot 401 (beyond security fence). 'Bottom gate' to Part Lot 401 on right. View northeast.
