Project 81719.13
29 October 2019
R.001.docx
MPG

Pavement Condition and Dilapidation Survey
Proposed New Maitland Hospital
Metford Road, Metford

Douglas Partners Geotechnics Environment Groundwater		Dilapidation Survey Clubhouse and Surrounds New Maitland Hospital, Metford Client: Multiplex Constructions	Project: 81719.13 Page: 1 Rev: 0 Date: 23-Oct-19
Table 1 - List of Observed Defects and General Conditions Photographs			
Defect No.	Description	Photo No.	
	Clubhouse	1	
1	Paint on northern wall of detached shed	2	
2	Damage to gutter on shed	3	
3	Paint blue and white on asphalt surrounds	4	
4	Post missing	5	
5	Cracking in concrete southern end	6	
6	Cracking in concrete apron (near changeroom entry)	7	
7	More cracking in concrete apron (near changeroom entries)	8	
8	Crack in concrete near inspection point	9	
9	Damage to guttering	10	
10	Crack in concrete apron northern end	11	
11	soil exposed near water tank	12

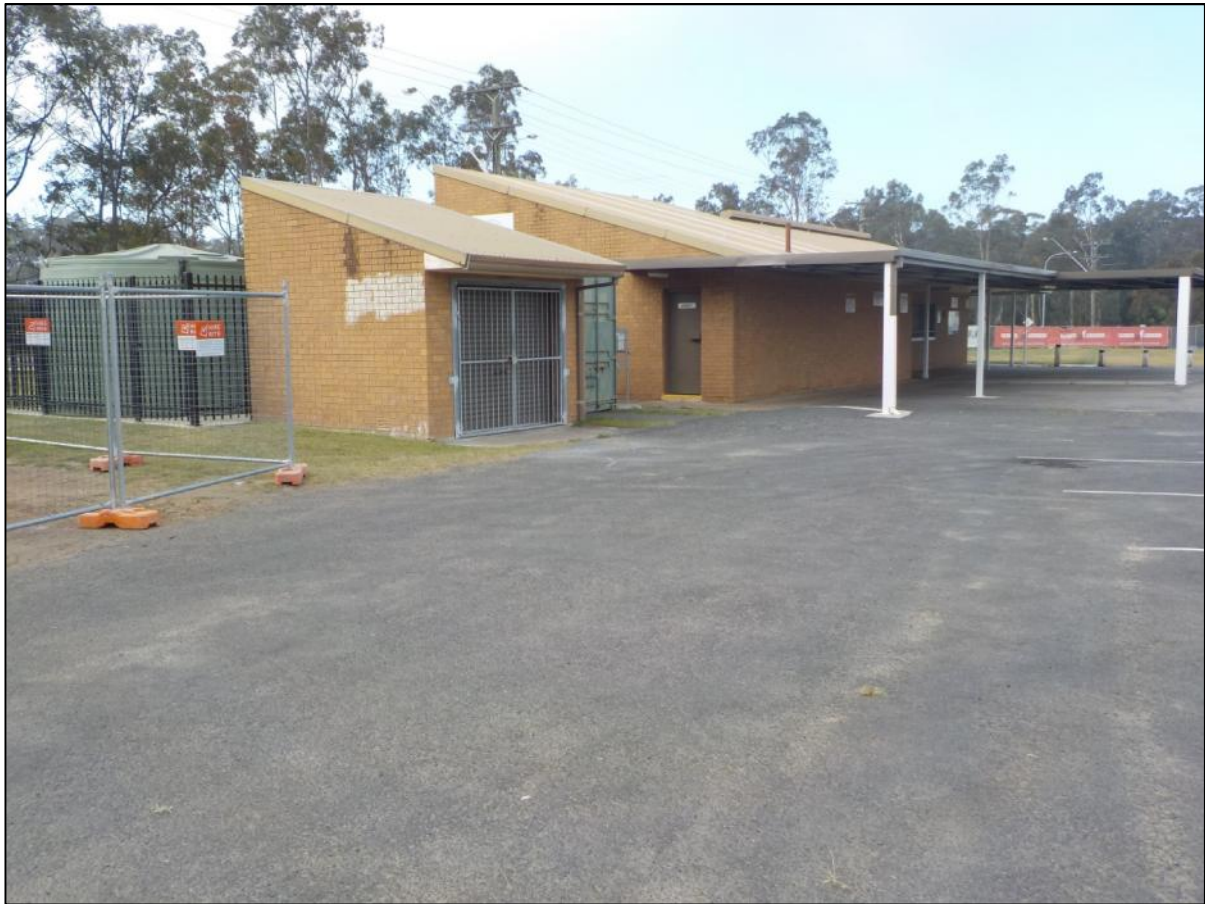
Figure 2: Existing clubhouse building and detached equipment shed

The results of the survey identified that the external walls of the structure are in good condition with a number of defects as described on the attached Dilapidation Report Summary sheets.

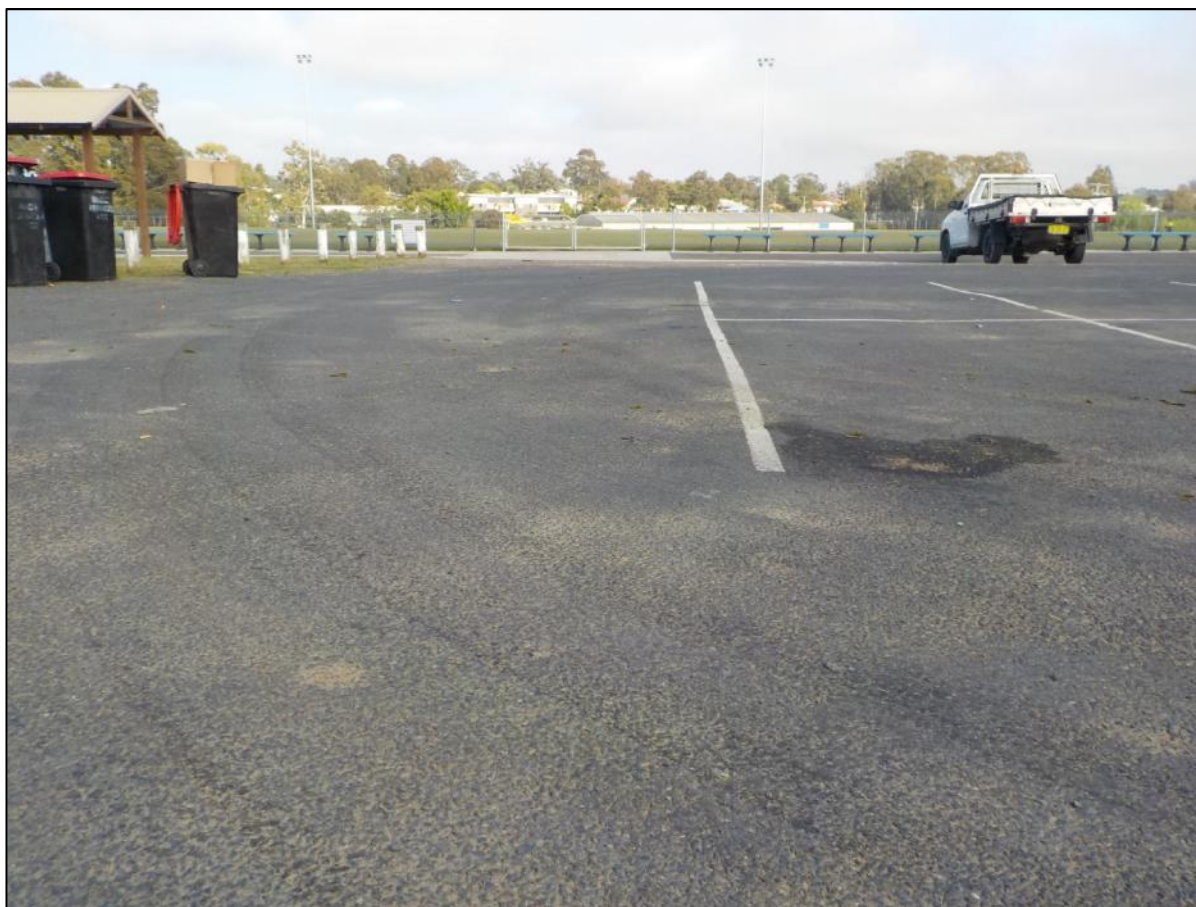
Figure 3: Existing car park associated with the clubhouse

The pavement is generally in a poor conditions with a number of ruts, areas where the wearing course and underlying pavement have been badly damaged and stone loss within the pavement surface.

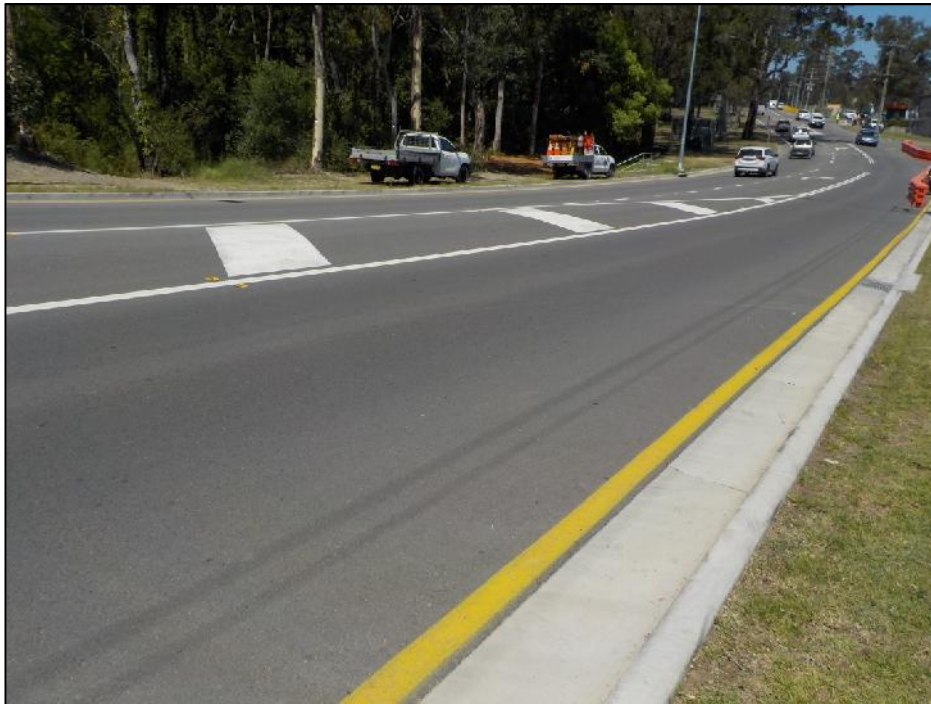
Figure 4: General view of Metford Road

The pavement is generally in a good condition. Minor defects within the adjacent kerb and gutter and road side service lids were noted as well as minor bleeding / stone loss within the asphalt wearing course.

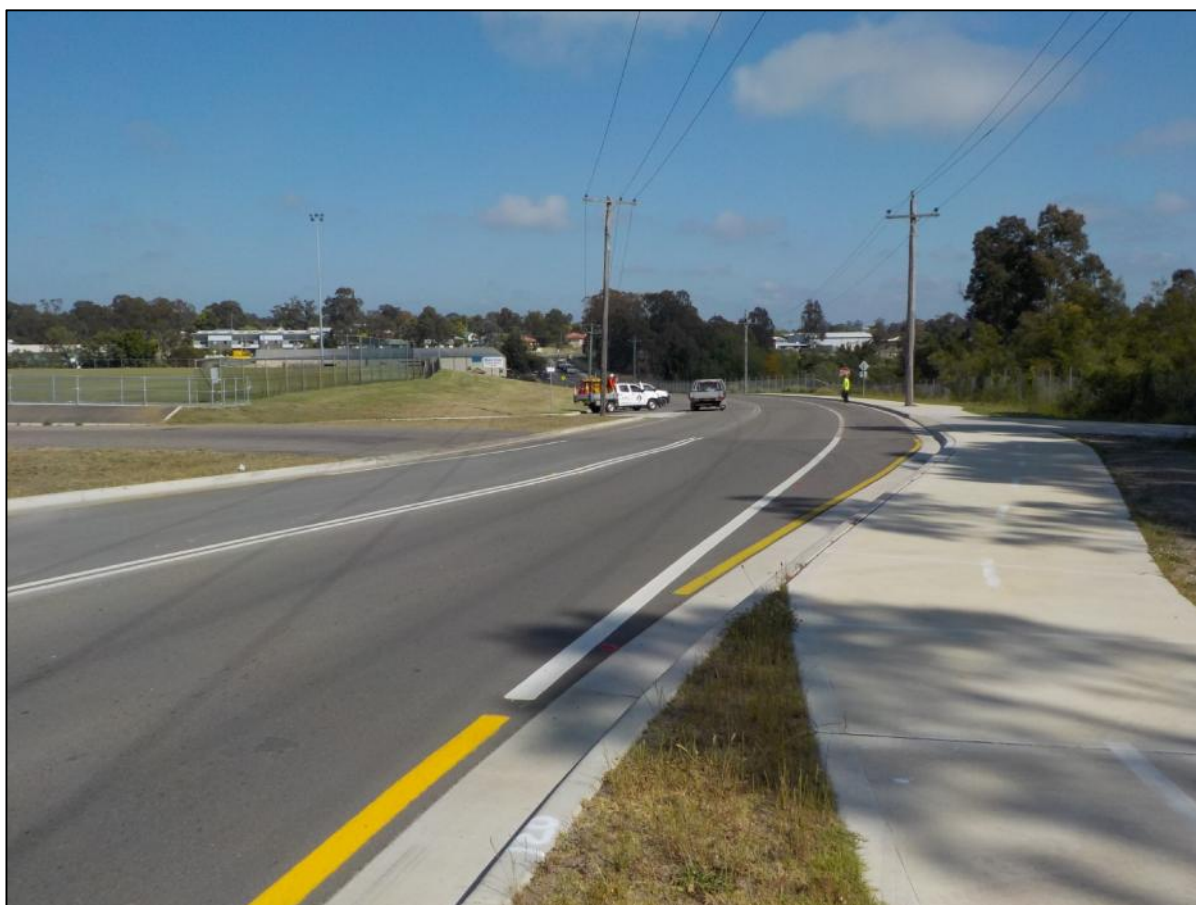
Figure 6: View of Fieldsend Street, looking west

The pavement is generally in a reasonable to good condition with some defects in the pavement surface including minor rutting, stone loss and areas on the edge of the pavement where grass is growing through the wearing course. Minor defects were also observed within the adjacent kerb and gutter and road side service lids.

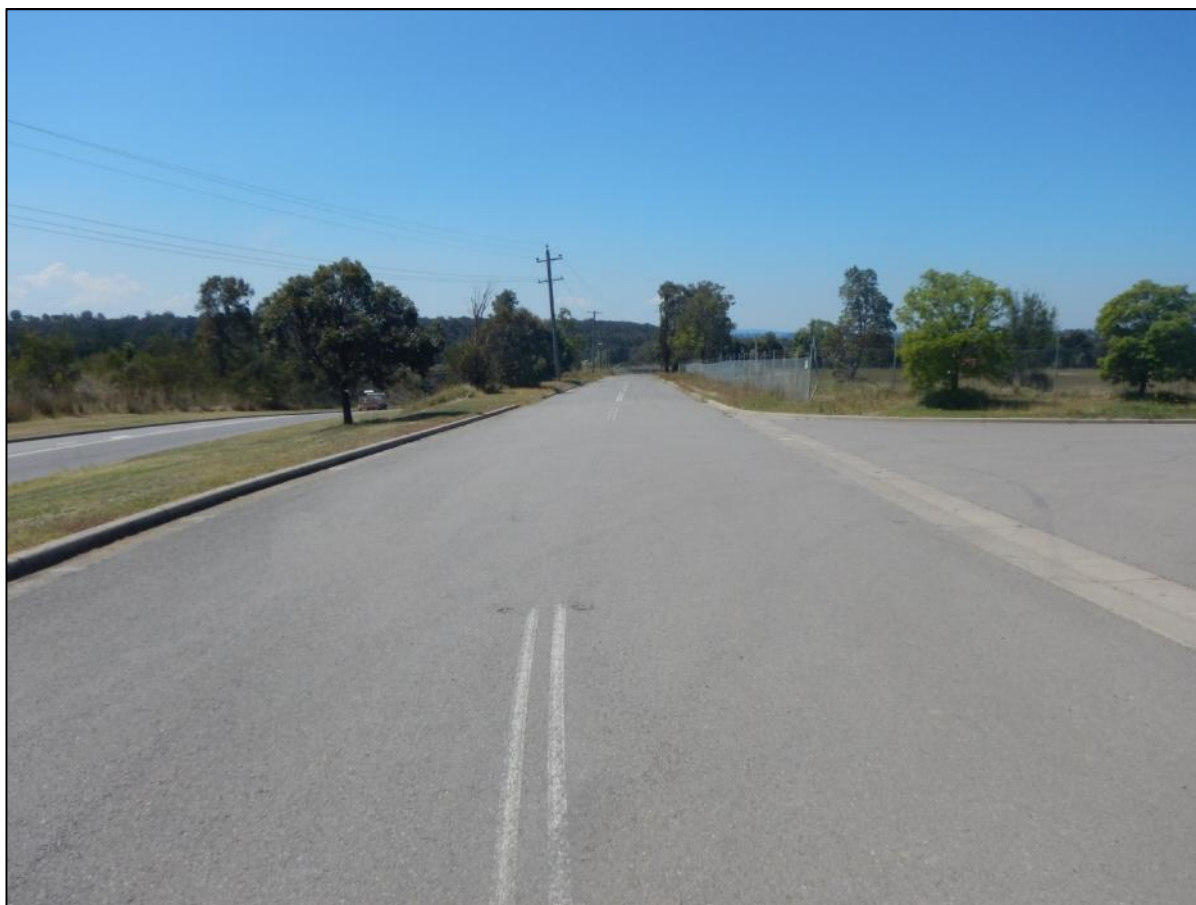
Figure 8: Former PGH access road

The pavement is in a good condition with minor defects on the existing kerb and gutter.

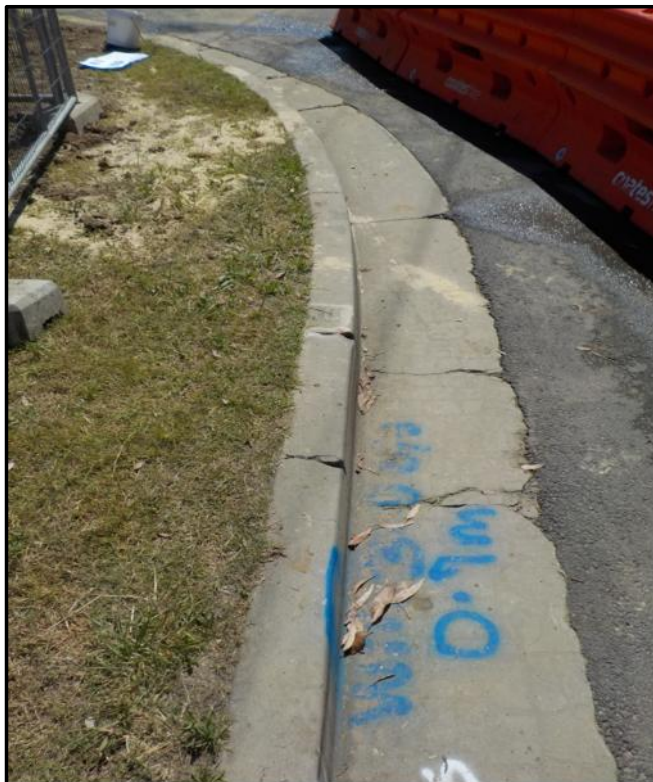
Photo 32

-	Metford Road		
-	View of change of seal	31	
20	Cracking in kerb	32	
21	Saw cut in pavement	32A	
22	Work site, service trench and damaged kerb	33	
23	Sand around service trench	34	
24	Loose SSM	35	
25	Stormwater inlet pit	37

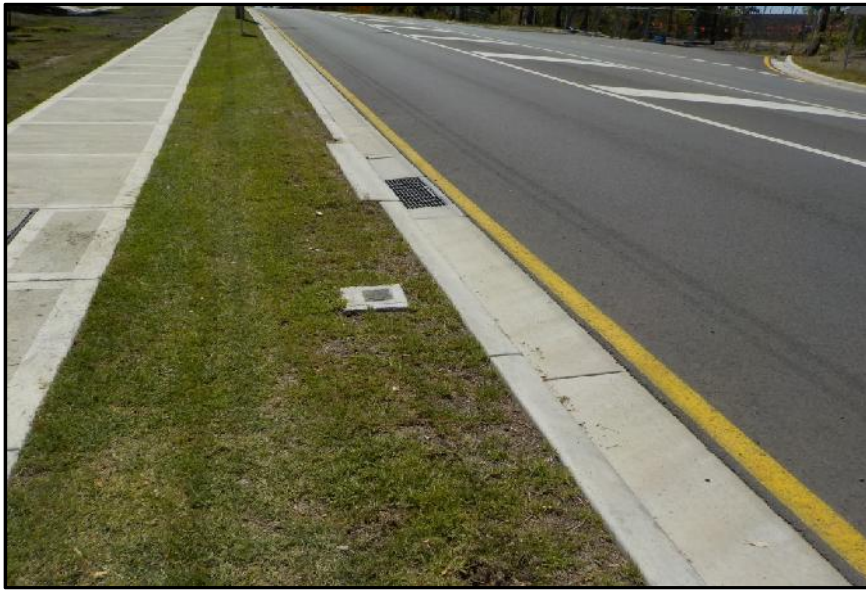
Photo 43

-	Hydrant cover - in use	38	
-	Stormwater inlet and loose SSM	39	
-	View of turf between footpath and kerb	40	
26	Loose SSM, Stormater inlet pit	43	
27	Damaged Telstra pit cover	44	
28	Minor bleeding at centreline in white paint area	45	
29	Cracking in kerb	46	
30	Minor bleeding	47	
31	Minor cracking in kerb	48	
32	Loose SSM, stormwater inlet pit	49

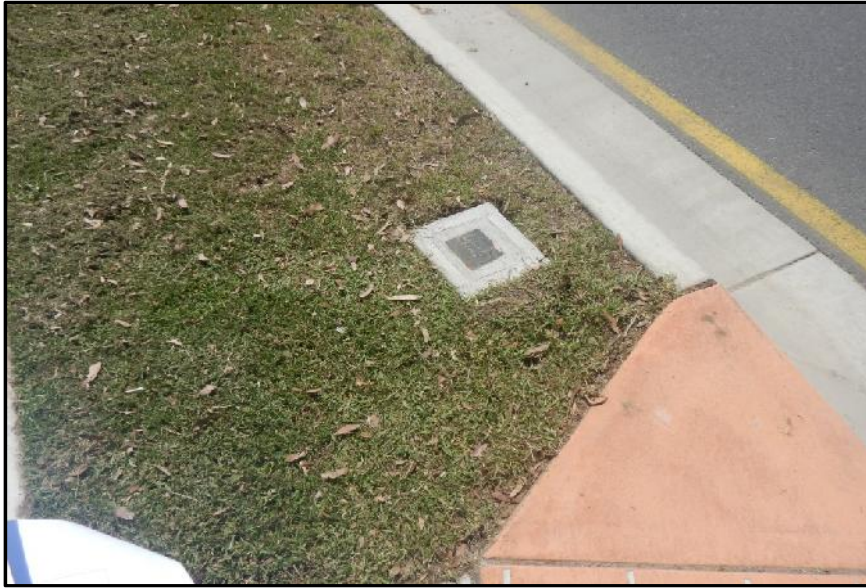
Photo 60D

-	General view of Metford Road, looking south from roundabout	60B	
-	Stop valves	60C	
39	Loose SSM marker	60D	
-	Concrete centre of roundabout	61

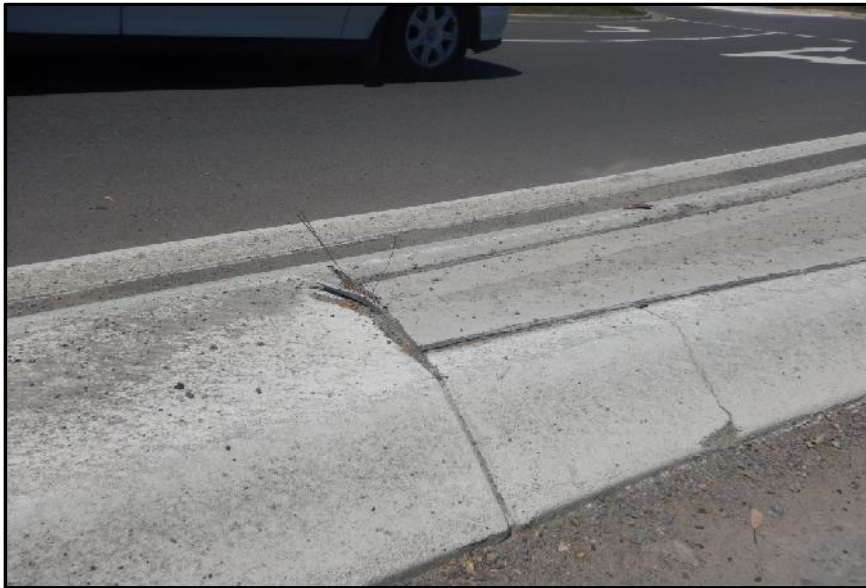
Photo 65

Defect No.	Description	Photo No.
-	View of road	62
-	View of road	63
40	Loose SSM marker	63A
-	Telstra pit	63B
-	Telstra pit	63C
-	View of roundabout	64
41	Expansion strip coming out of median	65
42	Loose SSM marker	65A
43	Cracking in kerb	66
44	Change of seal	67
45	Loose SSM cover	68
46	Tar on old turning lane	69
47	Crack in median	70
48	Patch	71
-	Paton, general view	71A
-	General view from CH 380 facing south	72
49	Paton, change in seal	72A
50	Oil mark on road	73
-	Optus pit cover	73A
51	Cracking in kerb	74
-	Gas service marker	74A
52	Loose SSM marker	74B
53	Depression in road	75
54	Minor stone loss	76
55	Raised edge on change of seal	77
56	Crack in kerb	78
-	Stormwater grate	78A
-	Exposed hydrant point	78B
57	Dirt on road	79
-	Stormwater inlet	79A
-	Gas marker	79B
-	Pole	79C
-	Electrical column	79D
-	Loose SSM, stormwater inlet	80
58	Longitudinal cracking	80A

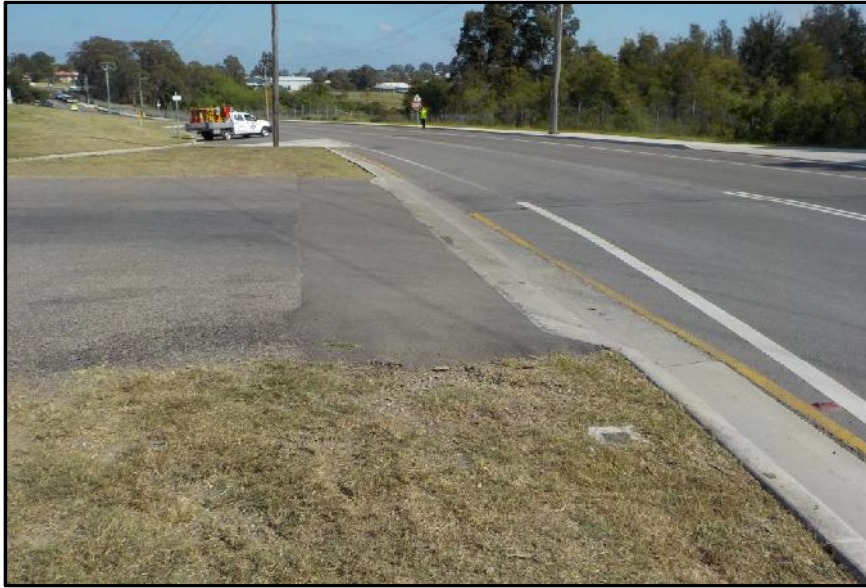
Photo 94

-	General view facing south	91	
-	General view facing south	91A	
-	General view facing west	92	
-	General view facing east	93	
67	Patched driveway	94	
-	Change of seal	95	
68	Patches	96	
69	Cracking in concrete	97	
70	Cracking in culvert which is also clogged	98	
71	Cracking in culvert	99	
72	Cracking in concrete	100	
73	Flushing	100A

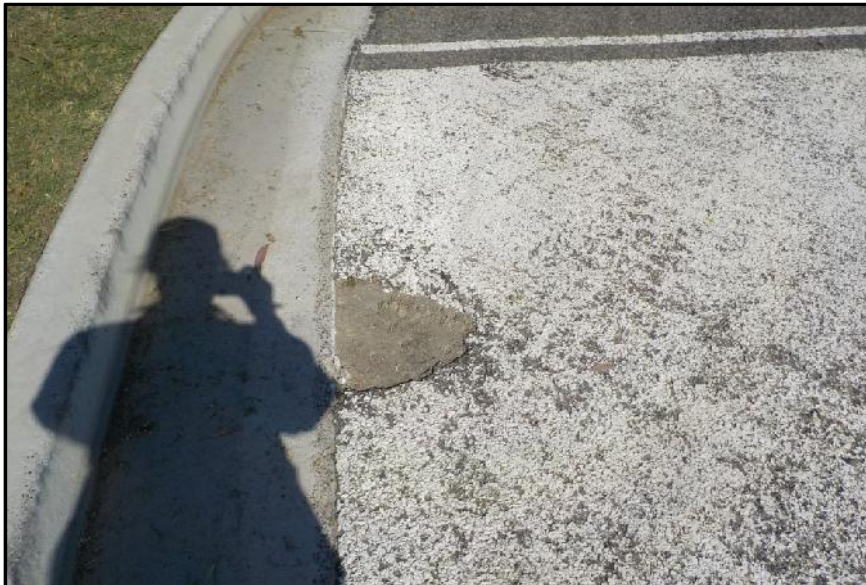
Photo 101A

-	View of parking area	101	
74	Pothole	101A	
75	Shoving / rutting in parking area	102	
76	Rut near centreline	103	
77	Cracking in kerb	104	
78	Cracking in kerb	105

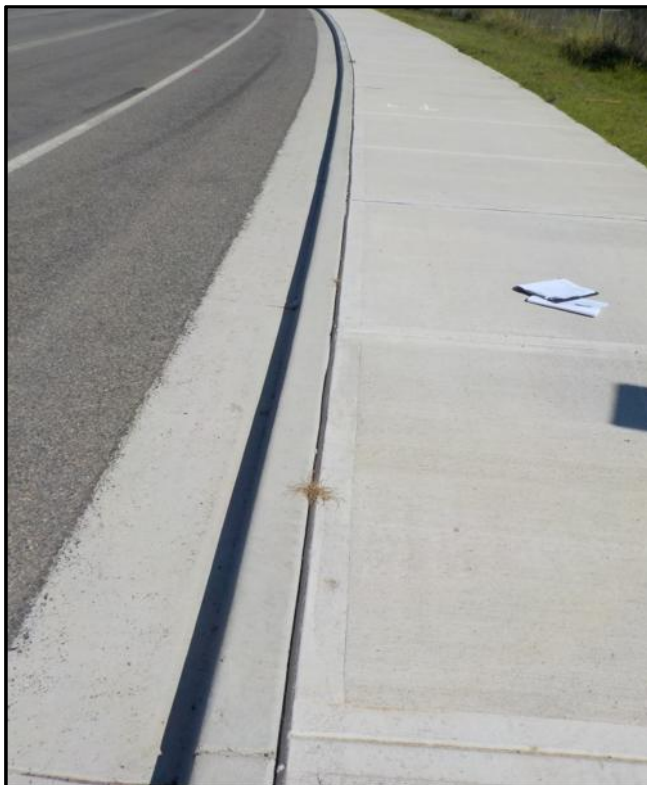
Photo 107

-	Telstra Pit	106	
79	Grass in kerb (dead)	107	
80	Rut in shoulder	108	
81	Patches and grass in road (car parking area)	109	
-	Stormwater pit	110	
82	Flushing in road	110A	
83	Grass in footpath	110B
