Meeting Agenda**Date:** 07/07/2020**Time:** 2:25pm – 3:15pm**Location:** 3 Government Road, Cobar, NSW, 2835

Meeting Objective/s: To reassess cracking inside and outside of the property. This visit is a follow up visit from the 17/06/2019.

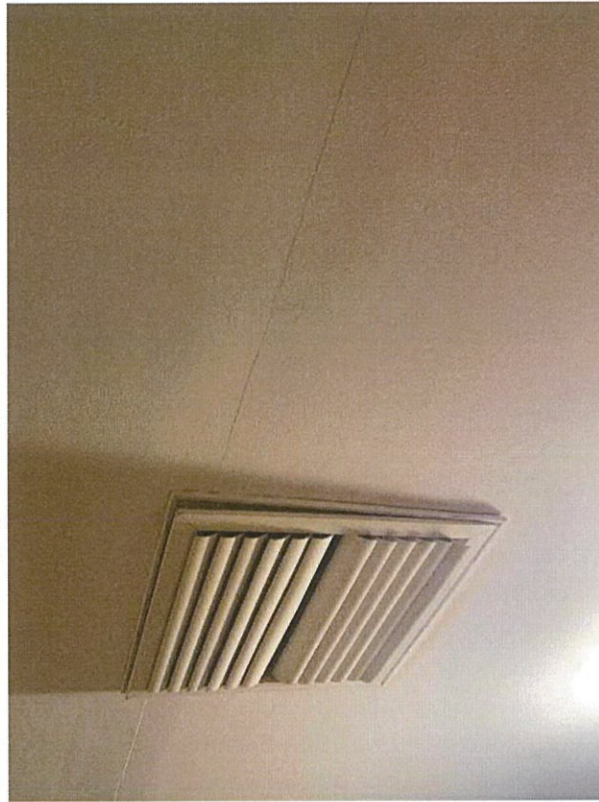
Figure 1: Bedroom 2, air conditioner vent loosened and crack present

1. In Bedroom 2, Midge has recently painted the roof and fixed the damage from the leak as described in the visit on the 17/06/2020. Since undertaking these works, a crack has developed (running vertically with the door) and the frame for the air conditioner vent has loosened (Figure 1). Midge explained the air conditioner vent frame had already fallen once, indenting a small mark in the end of the bed frame.

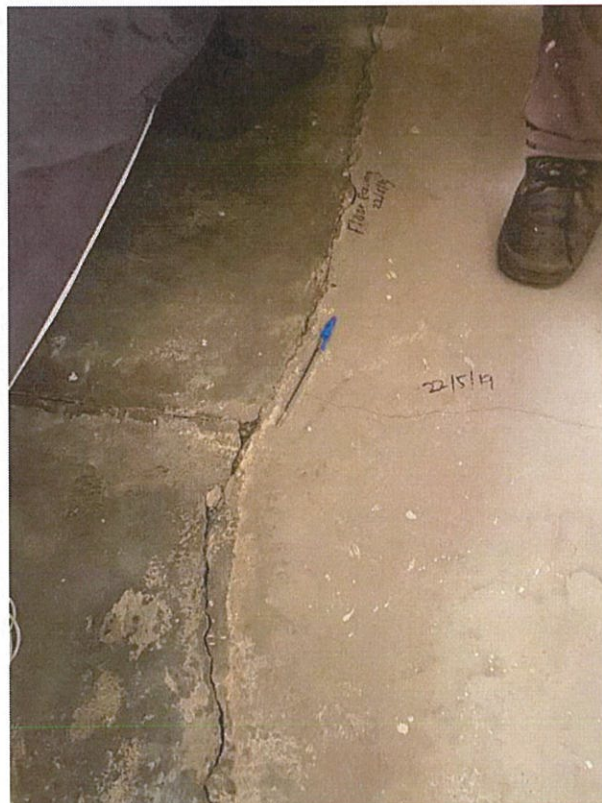
Figure 2: Bedroom 3, Floor Cracking

2. In Bedroom 1, the floor cracking was revisited (Figure 2). The key concern raised by Midge was the extent to which the floor was lifting and moving (Figure 3).

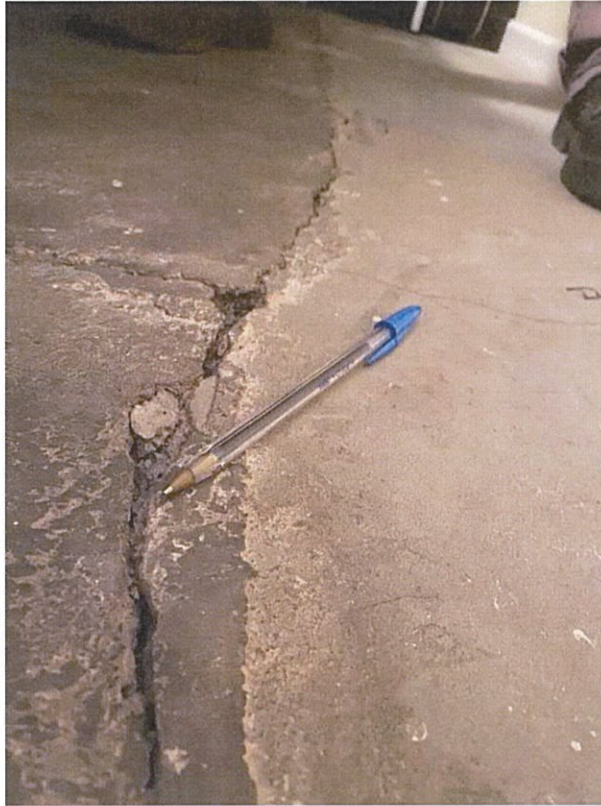
Figure 3: Bedroom 2, Concerns of floor lifting

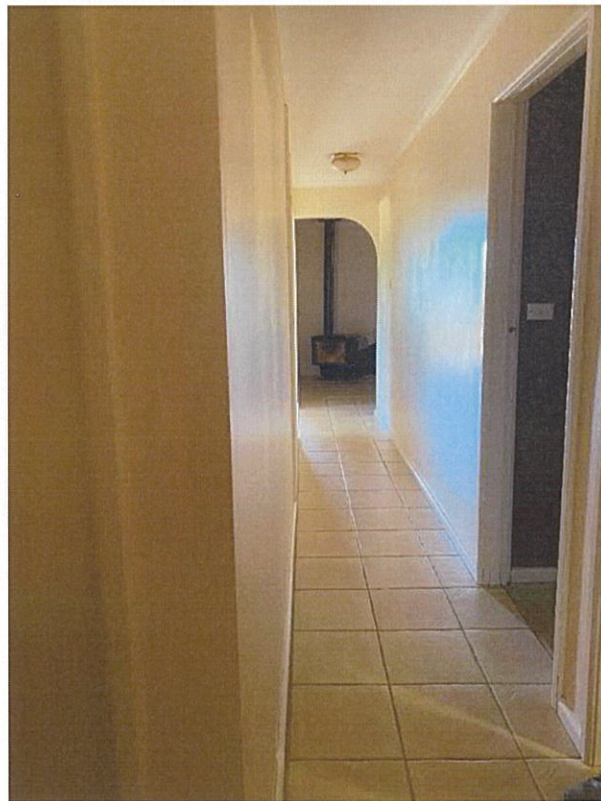
3. The key item addressed in the hallway was the structure changes in the wall. It was explained that looking down the hall from the toilet, the left-hand wall slumped inwards in places (Figure 4). Midge explained that she understood this was the Gyprock breaking between the structural beams.

Figure 4: Hallway, Concerns of slumping on left side wall

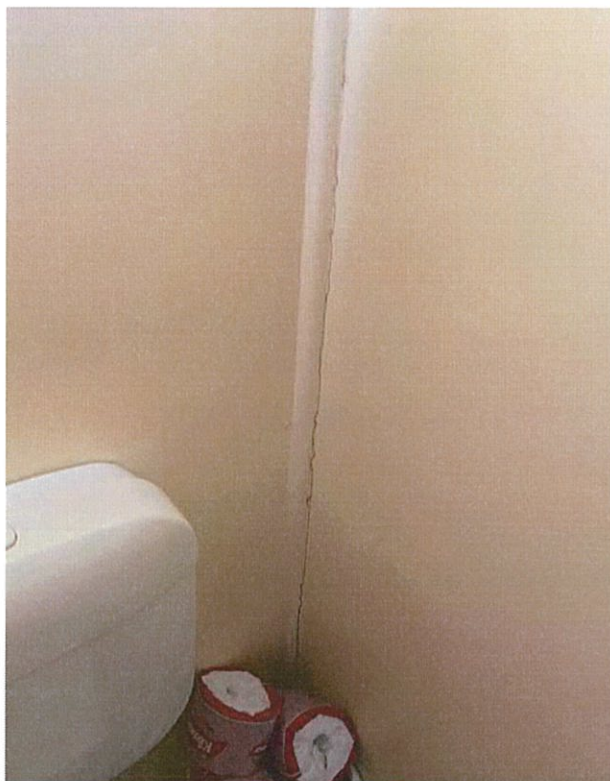
4. In the Toilet, the cracking in the right-hand corner was revisited (Figure 5).
5. In the Bathroom, the cracking above the shower (corner join) was revisited (Figure 6). The tiles on the shower were photographed against a pen to show the scale of movement (Figure 7).

Figure 5: Toilet, cracking in right hand corner

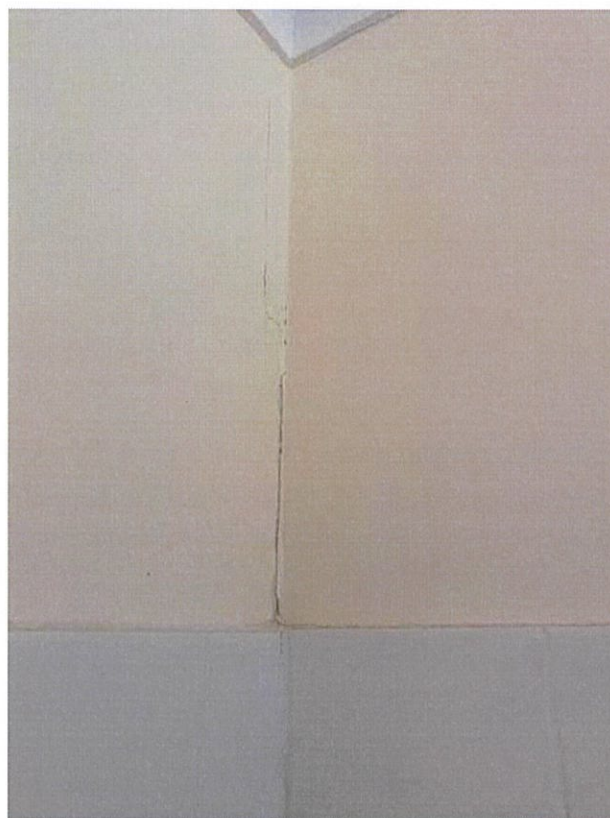
Figure 6: Bathroom, cracking above the shower

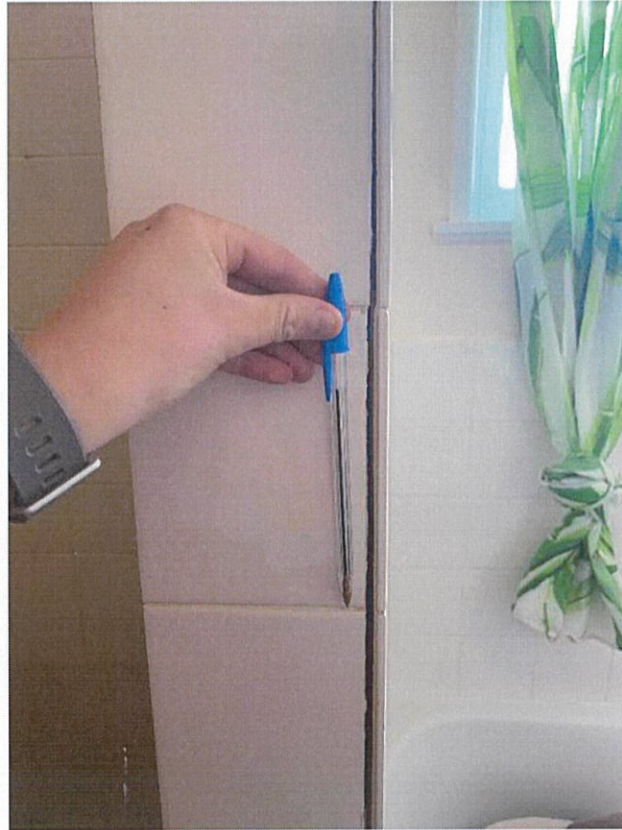
Figure 7: Bathroom, shower tiles movement

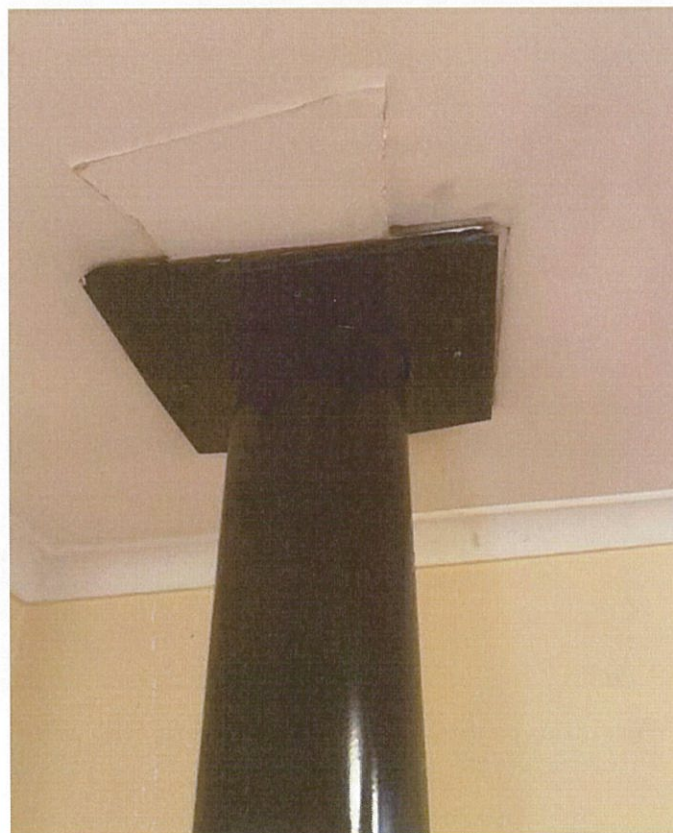
6. Bedroom 3 was not visited.
7. The fireplace was revisited. Midge explained the plate around the chimney flue had previously fallen (Figure 8).
8. In the Loungeroom, photographs were taken of nails protruding through the wall and roof (Figure 9, 10 & 11).

Figure 8: Loungeroom, plate around chimney flue

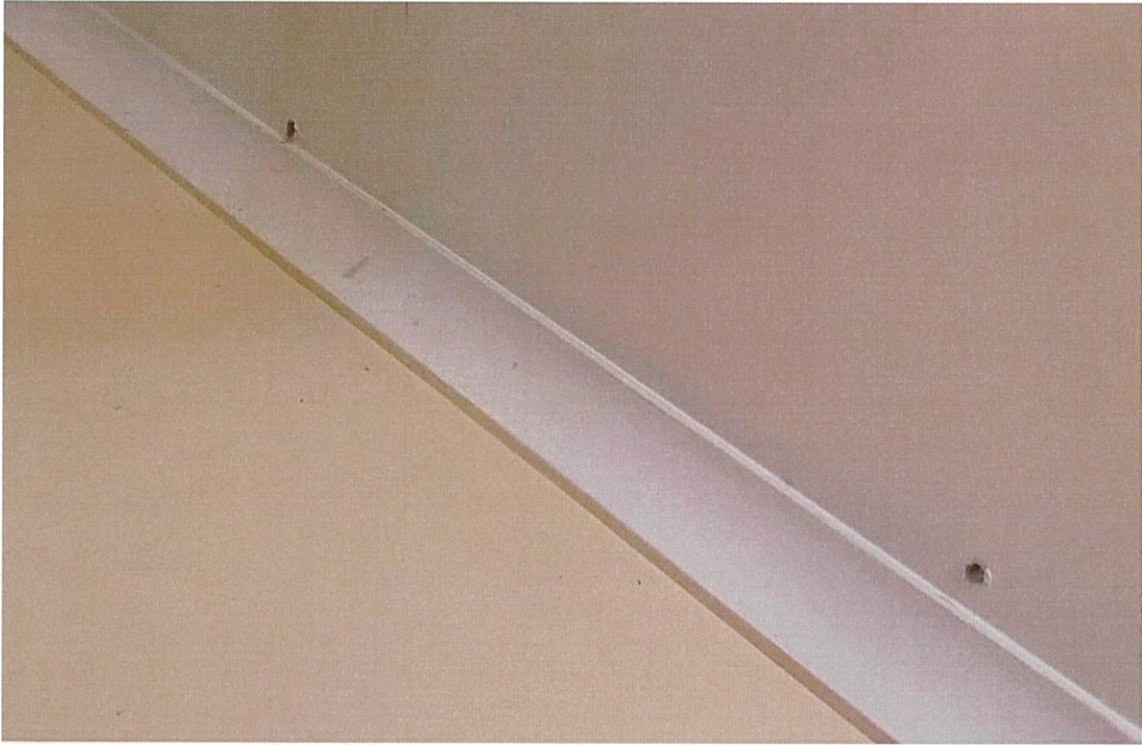
Figure 9: Loungeroom, nails protruding from roof (above chimney)

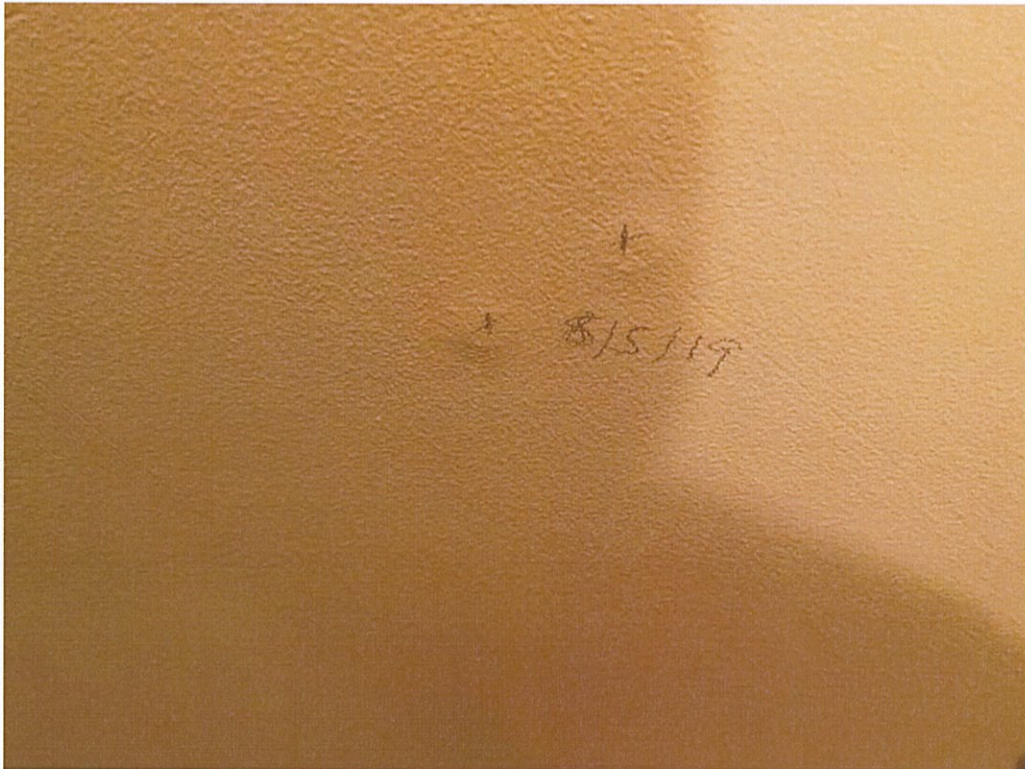
Figure 10: Loungeroom, nails protruding through wall

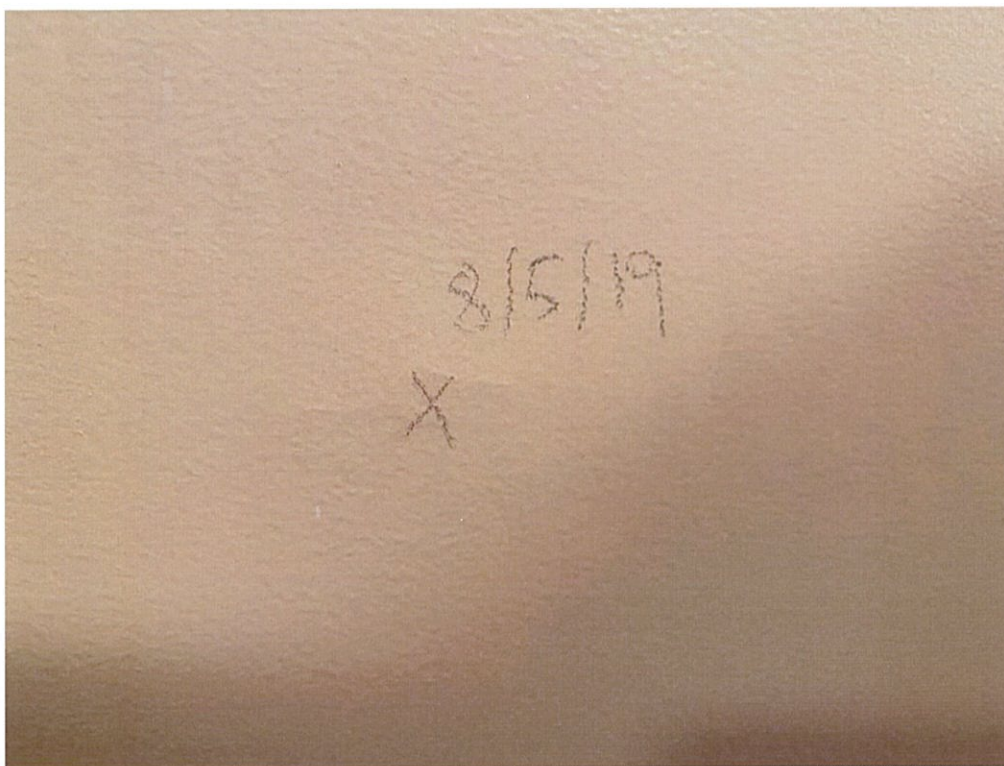
Figure 11: Loungeroom, nails protruding through wall

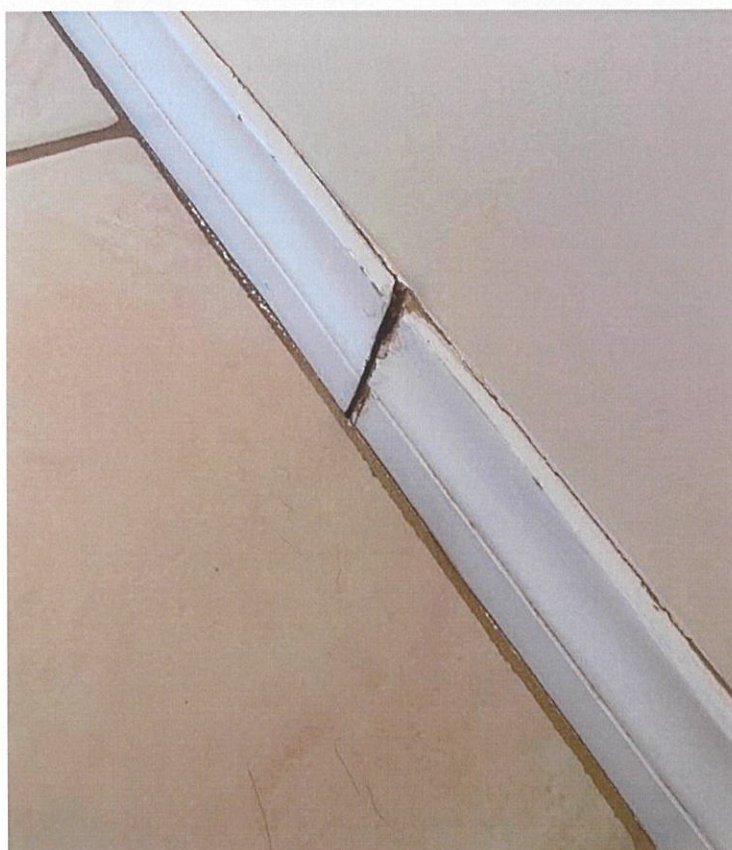
9. The front door foyer was visited to photograph a gap in the skirting board (Figure 12) as well as a crack in the join in the arch way (Figure 13). This area was not visited on the 17/06/2020.

Figure 12: Front door foyer, gap in skirting board

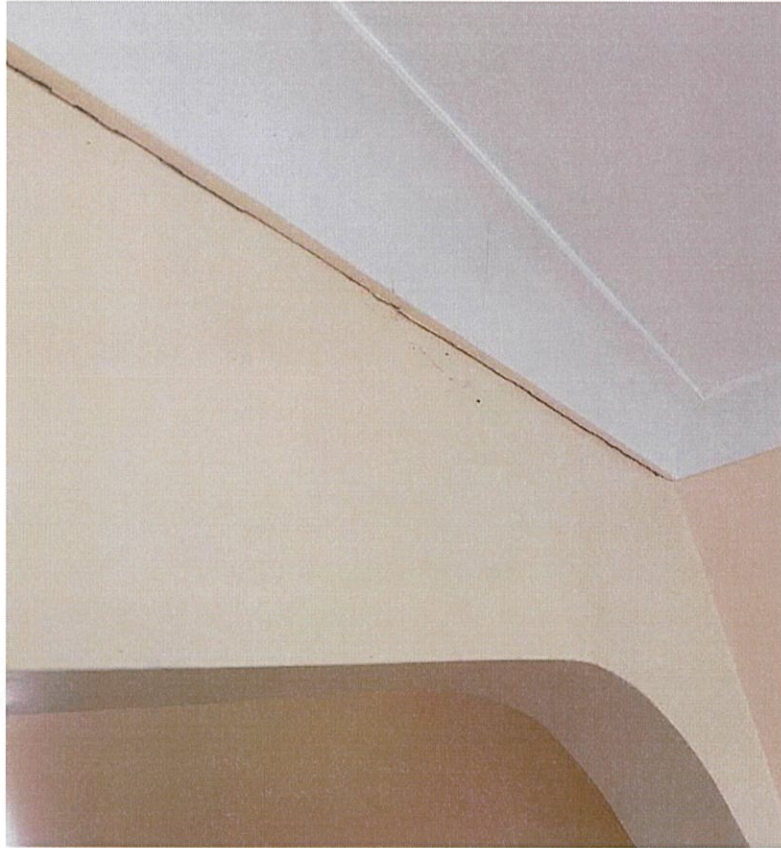
Figure 13: Front door foyer, crack above archway

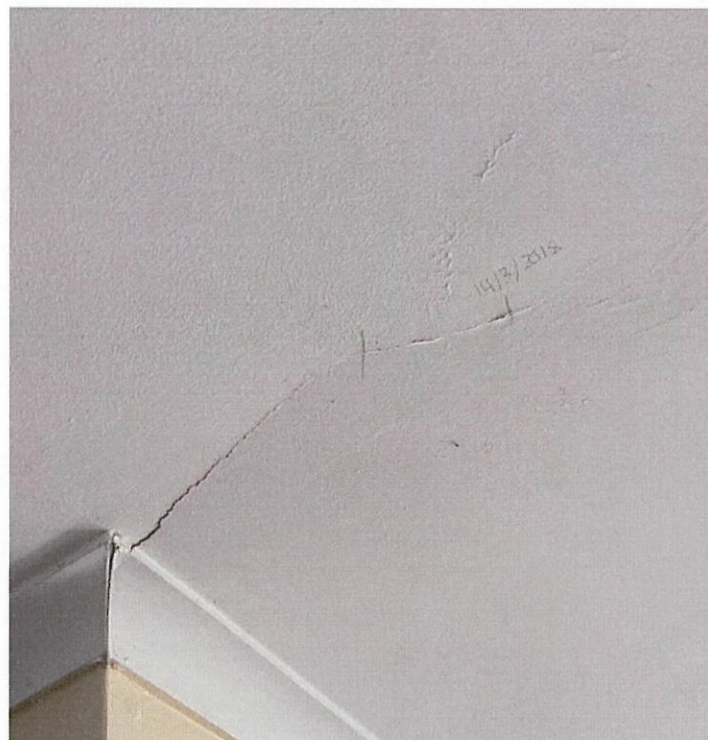
10. Photographs were taken of the existing crack in the Kitchen roof (Figure 14 & 15). Midge indicated a photo frame had also fallen due to a previous firing, resulting in the bottom of the frame breaking (Figure 16). Midge also indicated there was a crack/separation between the tiles connecting the kitchen and loungeroom (Figure 17). Leading to the outside area, a crack near the kitchen door frame was photographed (Figure 18).

Figure 14: Kitchen, crack in roof

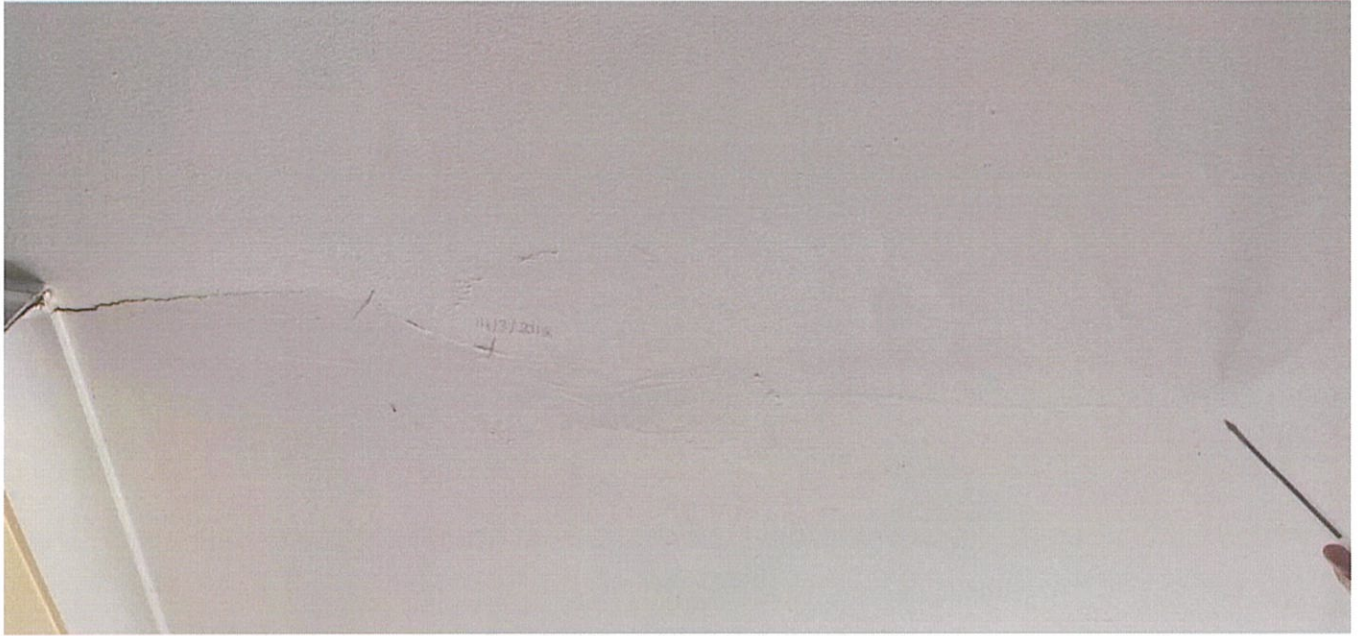
Figure 15: Kitchen, crack in roof

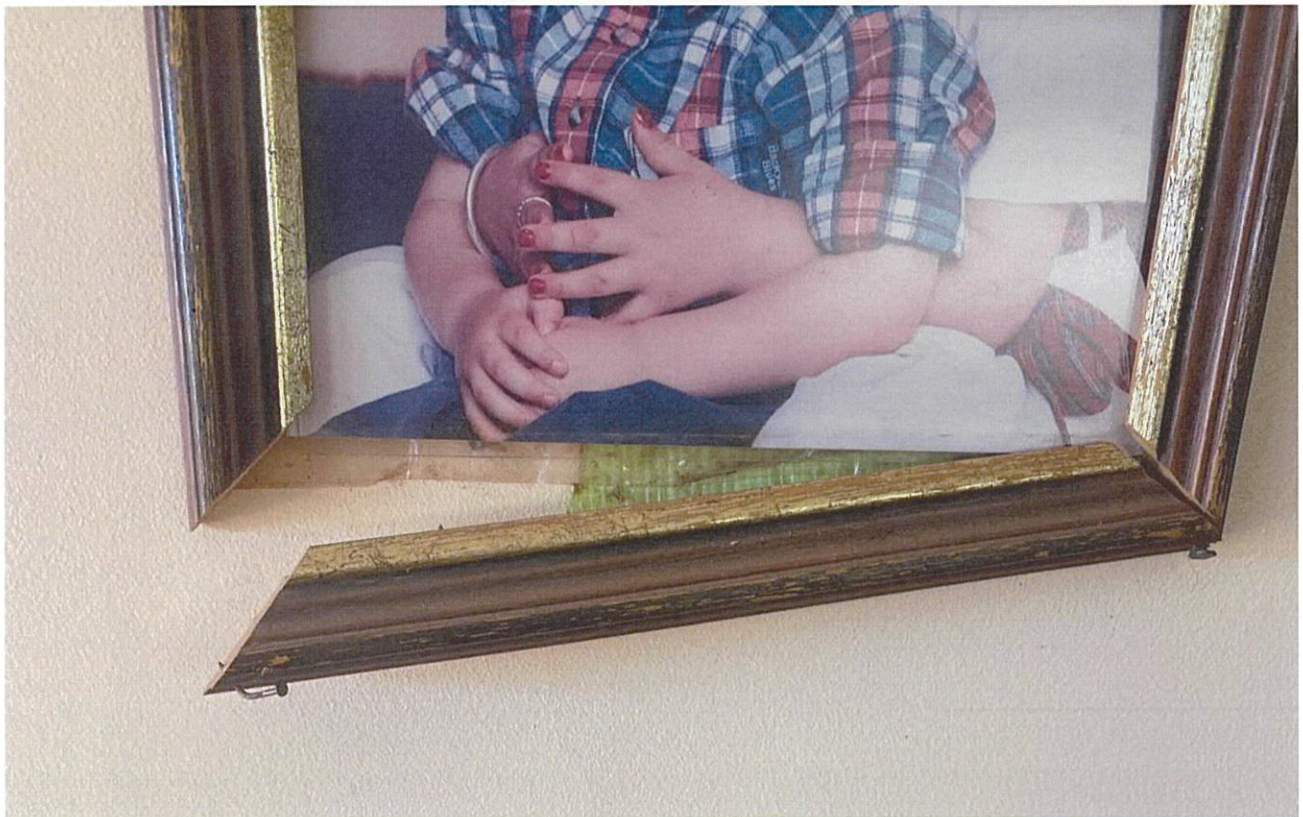
Figure 16: Kitchen, broken photo frame

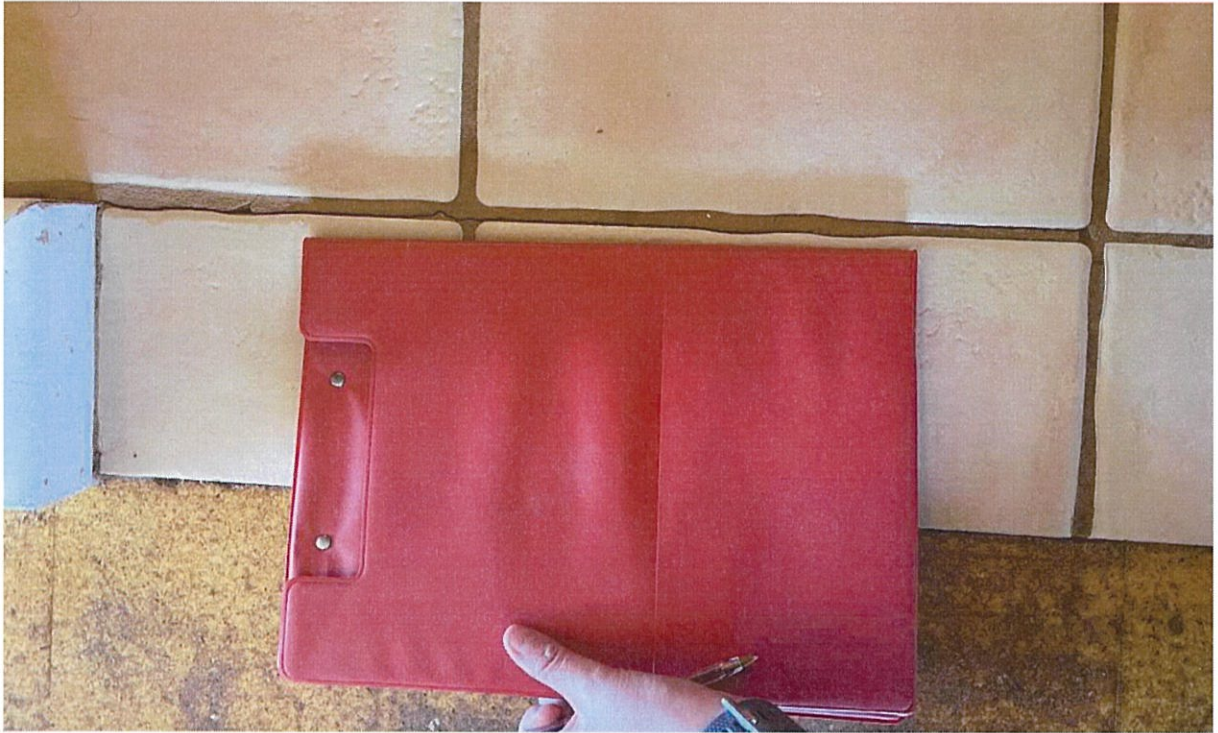
Figure 17: Kitchen/Loungeroom, separation in tiles

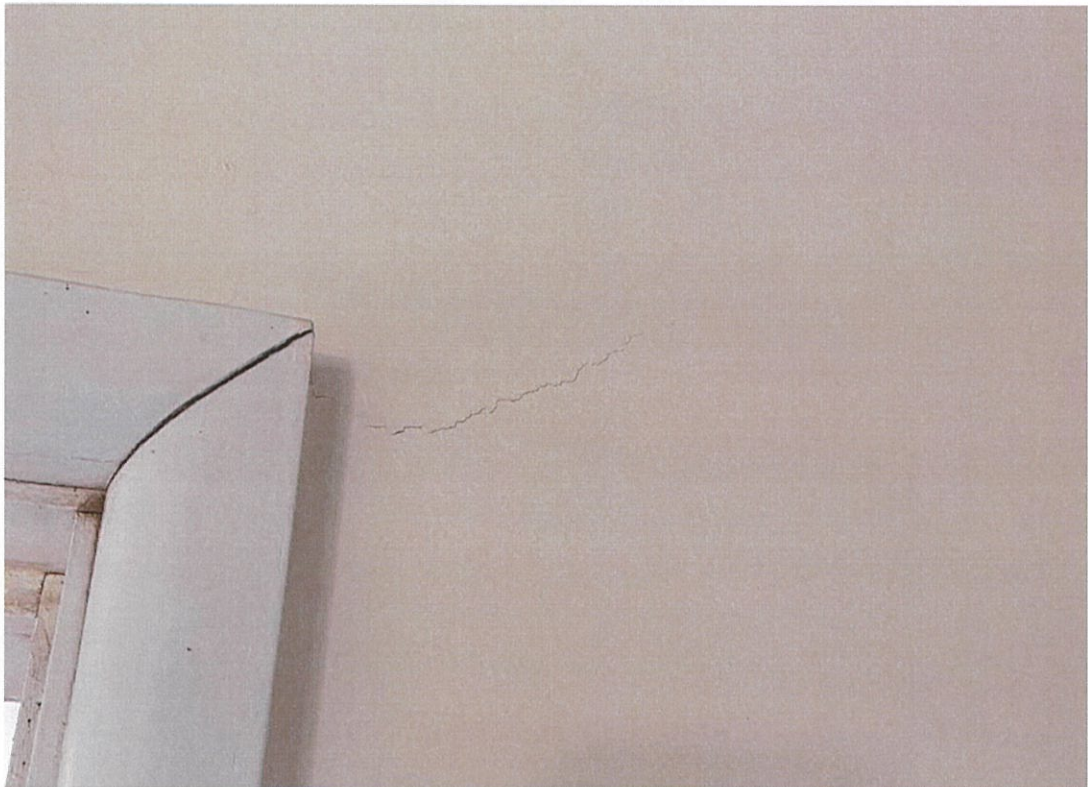
Figure 18: Kitchen, door frame leading to backyard

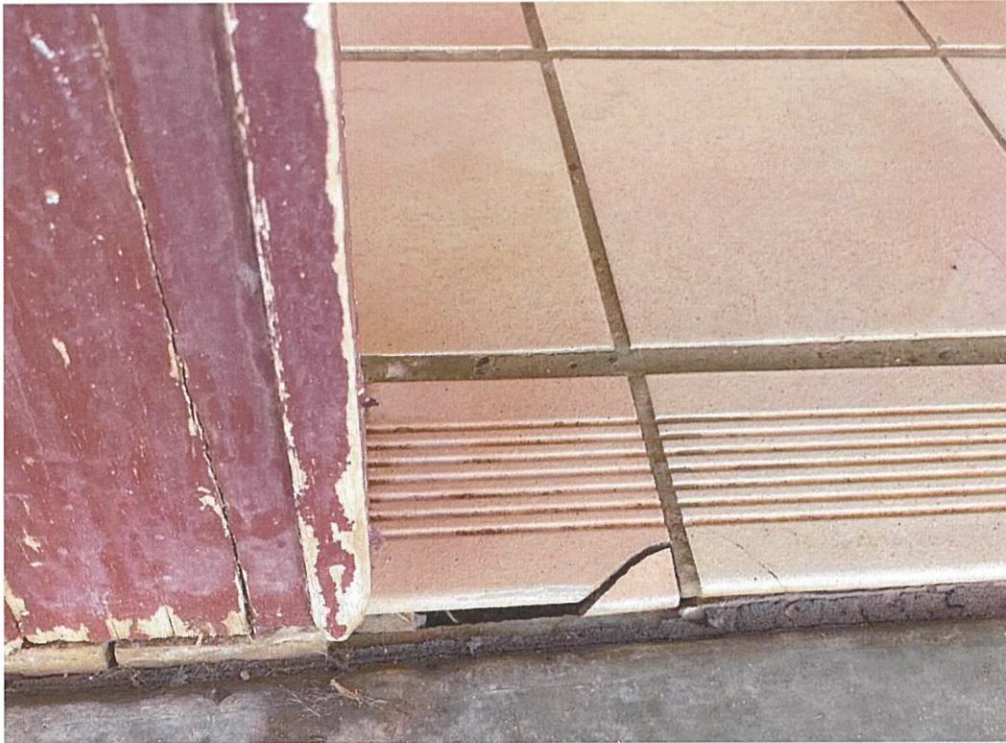
11. In the backyard, a photo was taken of the broken tile/concrete near the structural post (Figure 19). This area was not visited on the 17/06/2020.
12. Under the carport, a series of photographs were taken to document cracks (Figures 20, 21, 22 & 23). Photographs were also taken on the concrete that wraps around to the front door. (Figures 24, 25, 26 & 27).

Figure 19: Outside area, broken tile

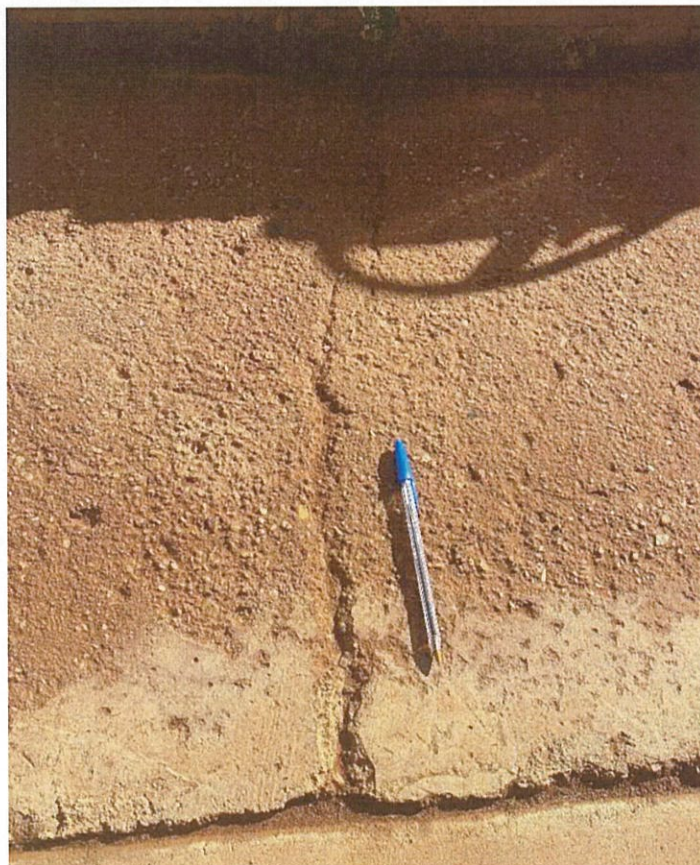
Figure 20: Carport, cracking in concrete

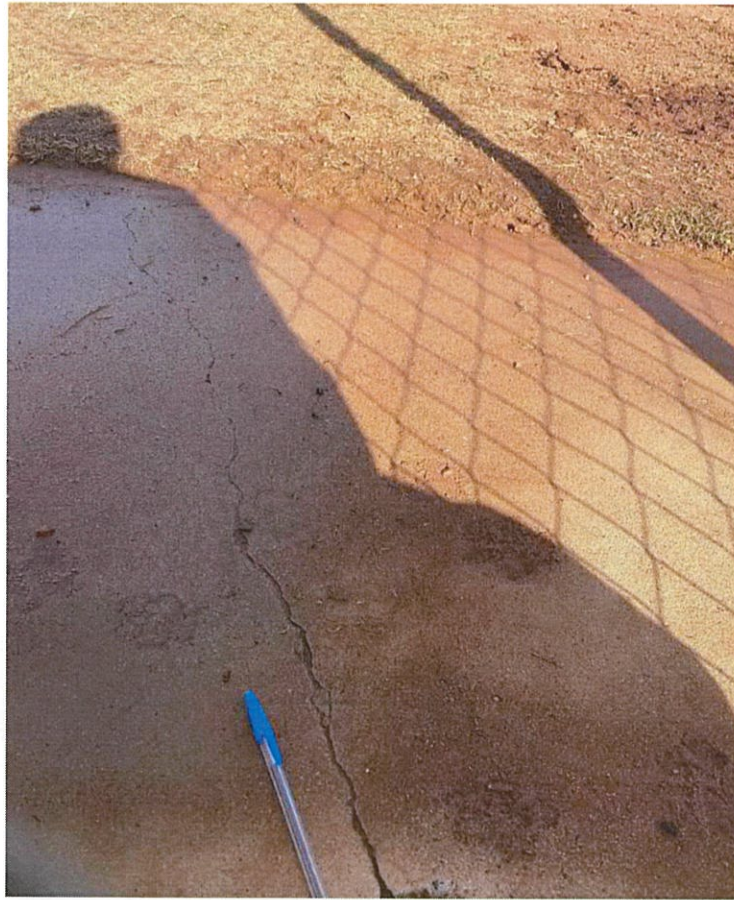
Figure 21: Carport leading to backyard, cracking in concrete

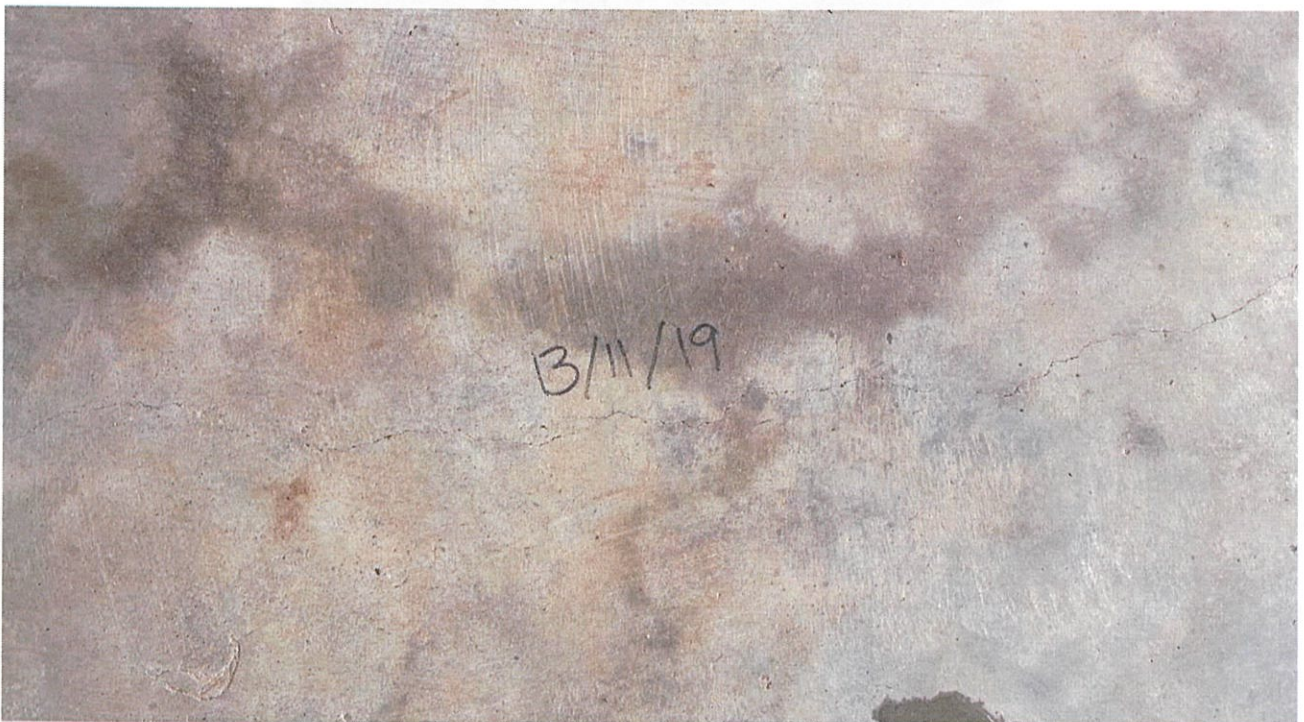
Figure 22: Carport, cracking in concrete

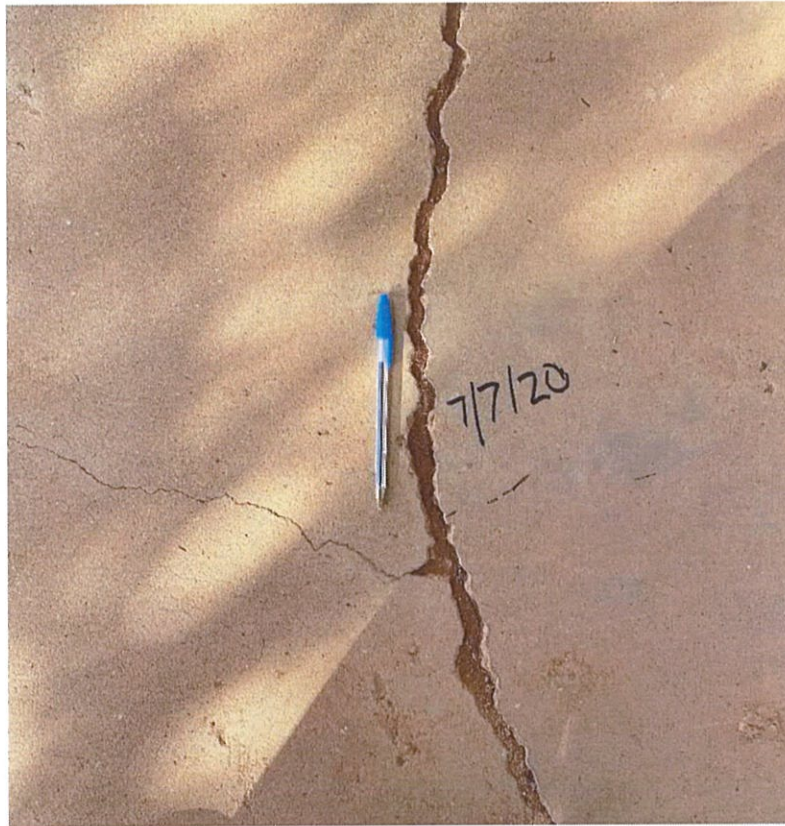
Figure 23: Carport, cracking in concrete

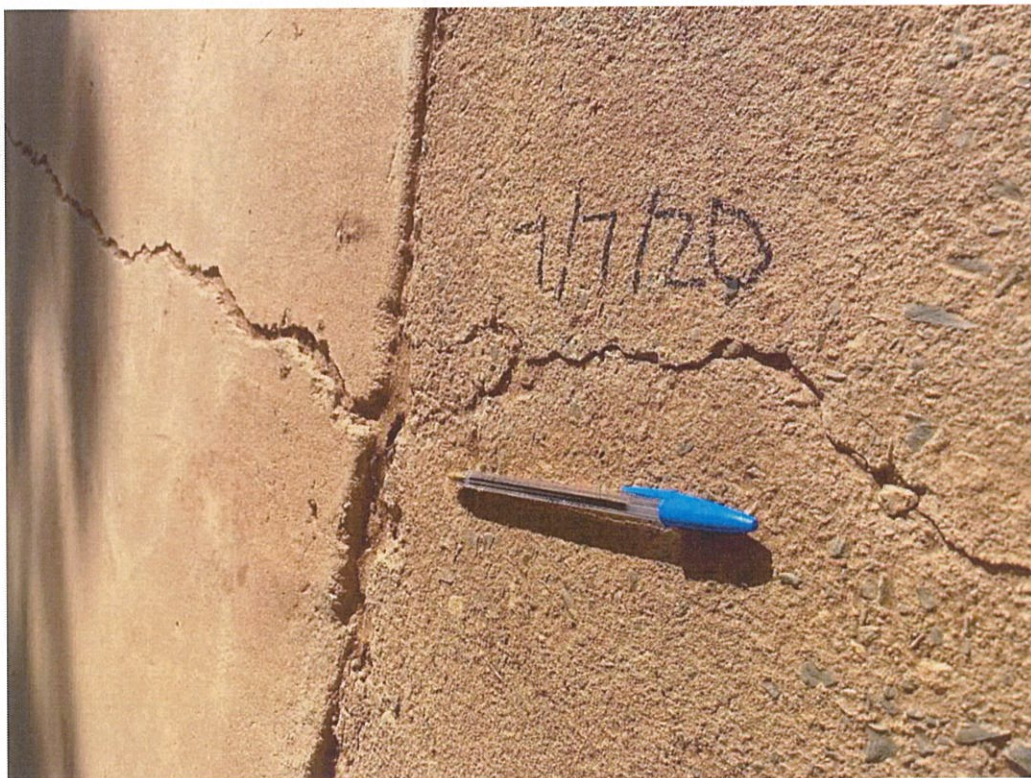
Figure 24: Carport/Verandah, cracking in concrete

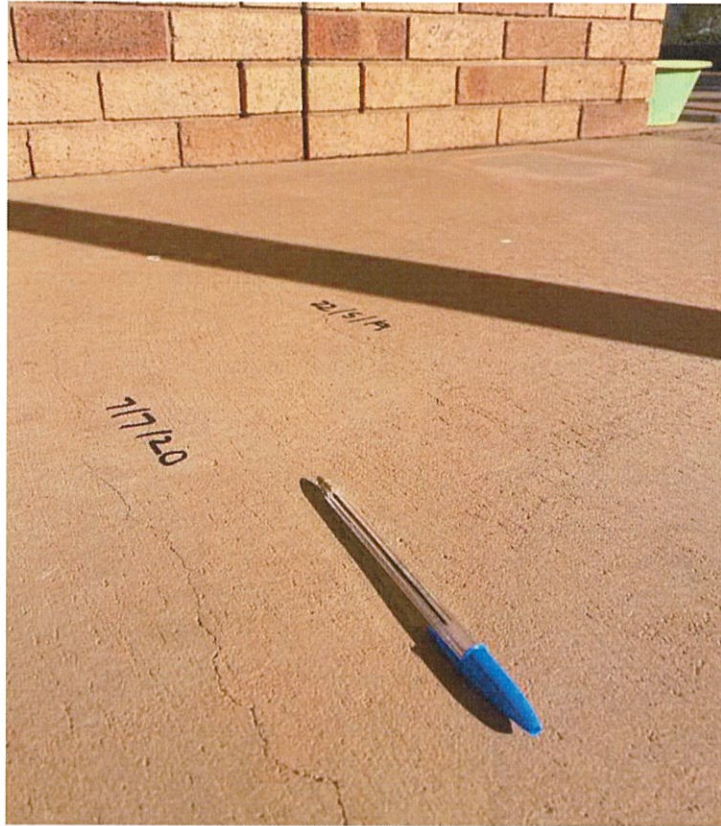
Figure 25: Front Verandah, cracking in concrete

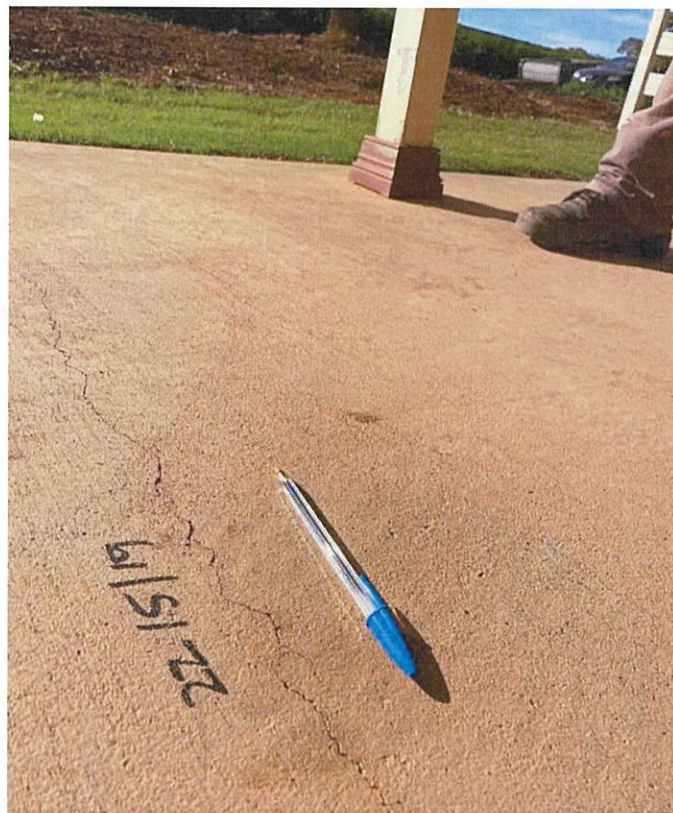
Figure 26: Front Verandah, cracking in concrete

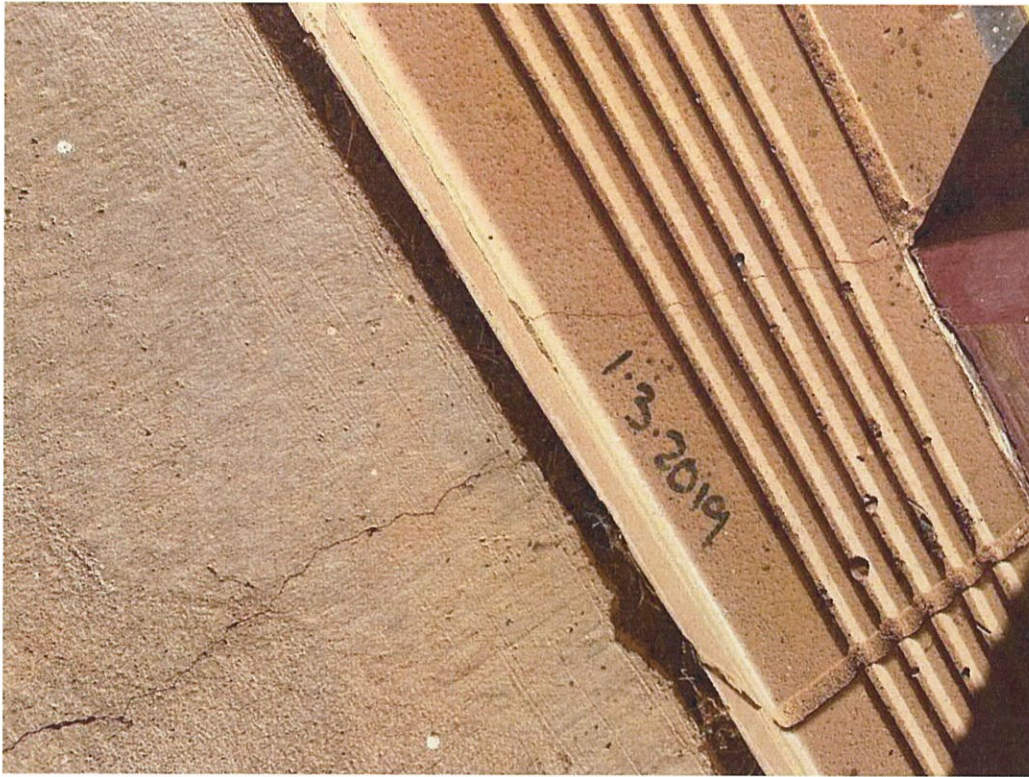
Figure 27: Front Verandah/tiles at front door, cracking in concrete/tiles
