4. ROAD SAFETY

Item 5.4.1. Brayton Road, and item 5.4.2. Ambrose/Red Hills Road, extracted from the *Traffic Impact Statement* (007, App F, page 44) dated 23 September 2020 are false and, in our opinion, a deliberate attempt to mislead.

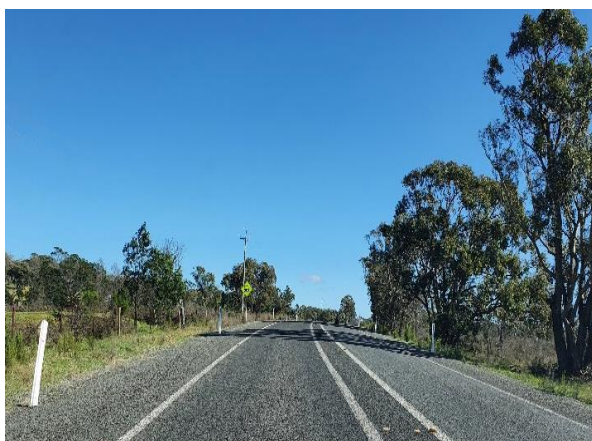
Along the transport route (between Gunlake quarry access and Marulan township)

The photo above and to the left is an extremely small snapshot of Brayton Road and is not reflective of the actual condition of the road. The photo above and to the right is what Brayton Road was like pre-Gunlake Quarries and has withstood decades of local traffic, farm vehicles, (including road registered tractors and stock carriers), haulage of construction goods for housing developments as well as haulage of heavy equipment for major projects such as the Marulan Gas Fired Power Station on Canyonleigh Road, Brayton, approx. 5 kms

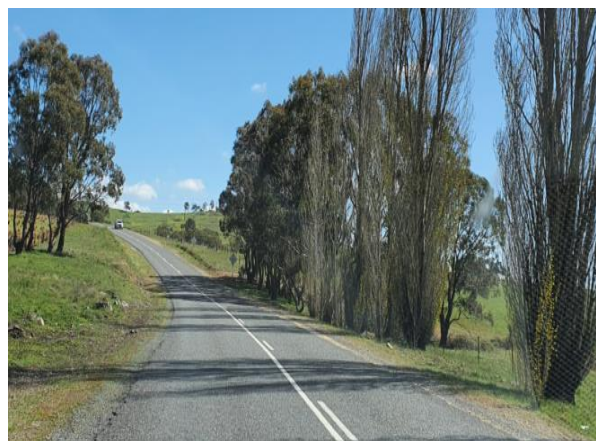
Non-transport route (north of Gunlake quarry access)

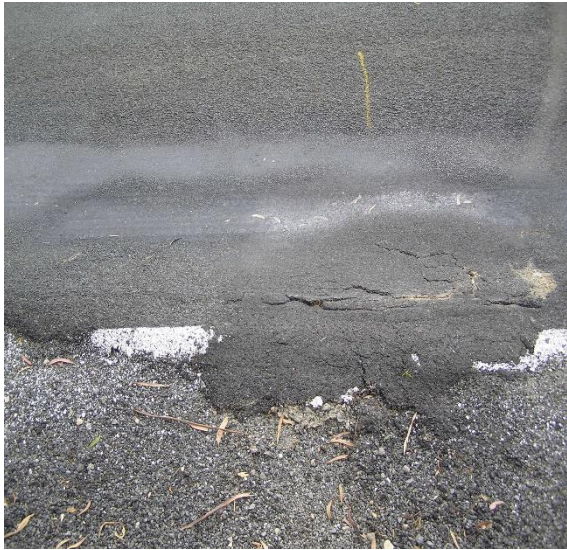
Photo #1 – Brayton Road damage – Jan 2021

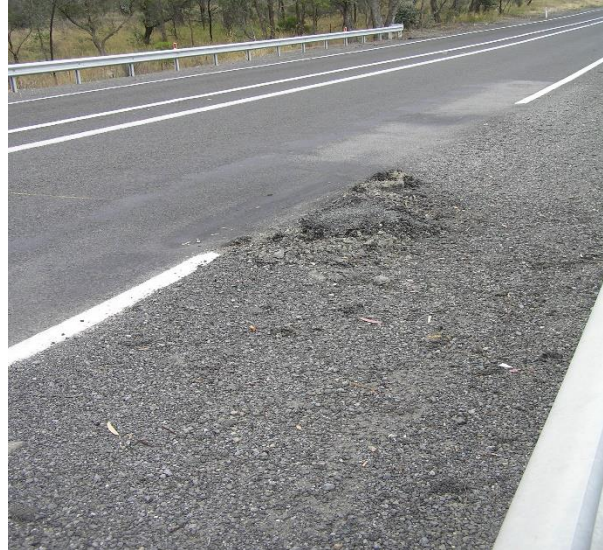
Photo #2 – Brayton Road damage – Jan 2021

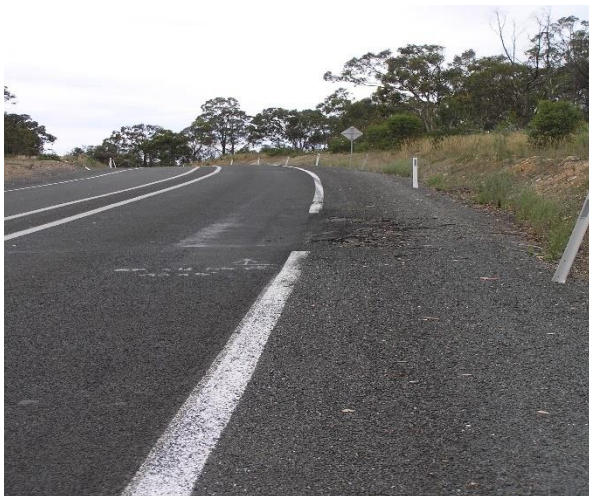
Photo #3 – Brayton Road damage – Jan 2021

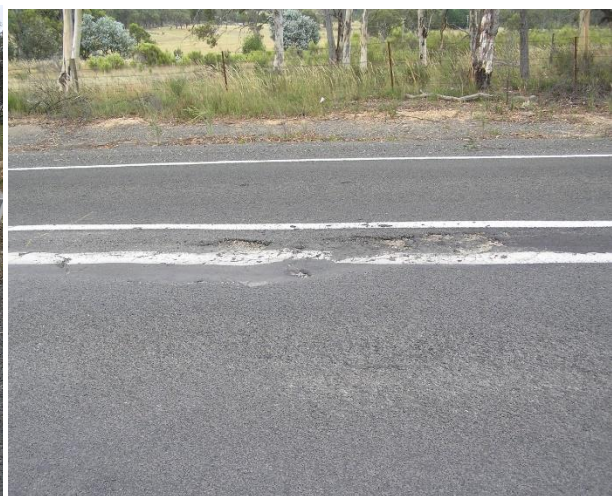
Photo #4 – Brayton Road damage – Jan 2021

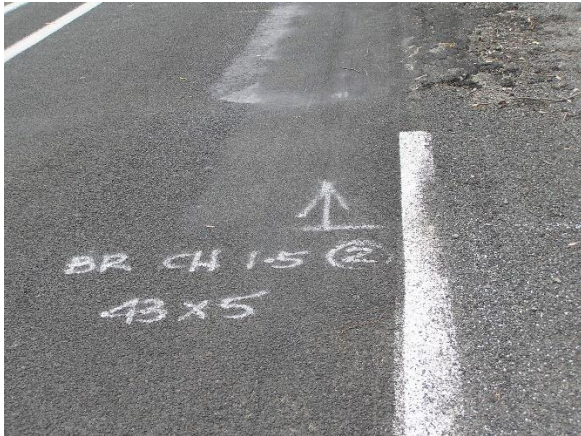
Photo #5 – Brayton Road damage – Jan 2021

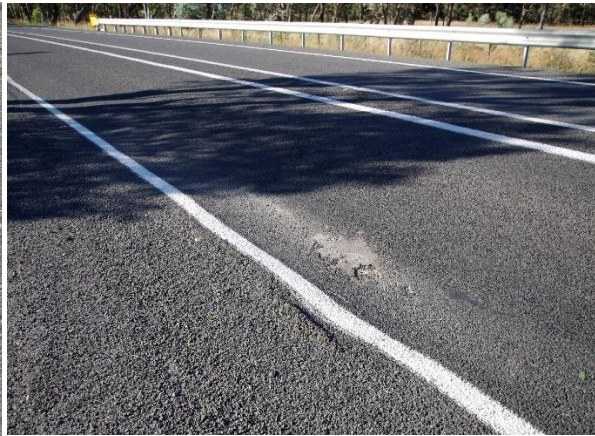
Photo #6 – Brayton Road damage – Jan 2021

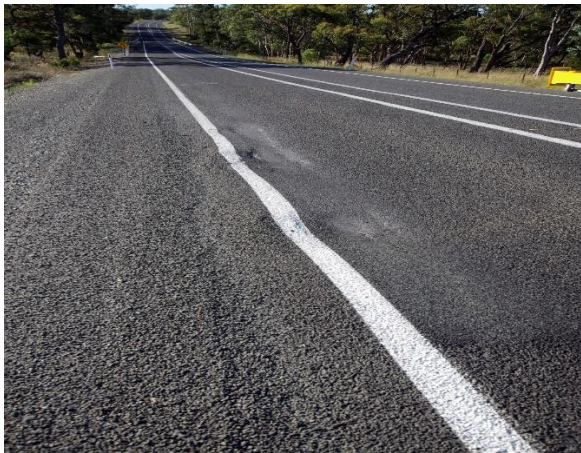
Photo #7 – Brayton Road damage – Jan 2021

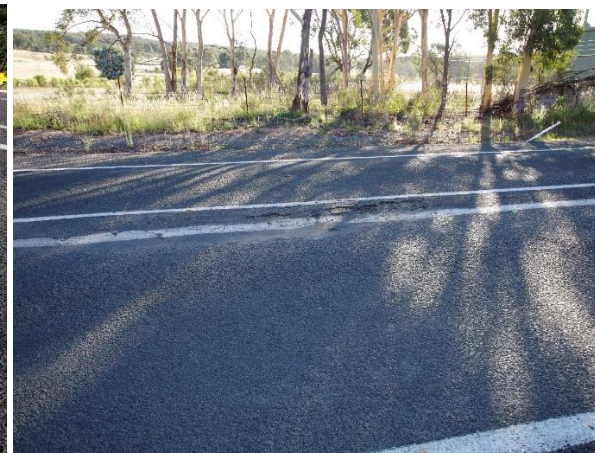
Photo #8 – Brayton Road damage – Jan 2021

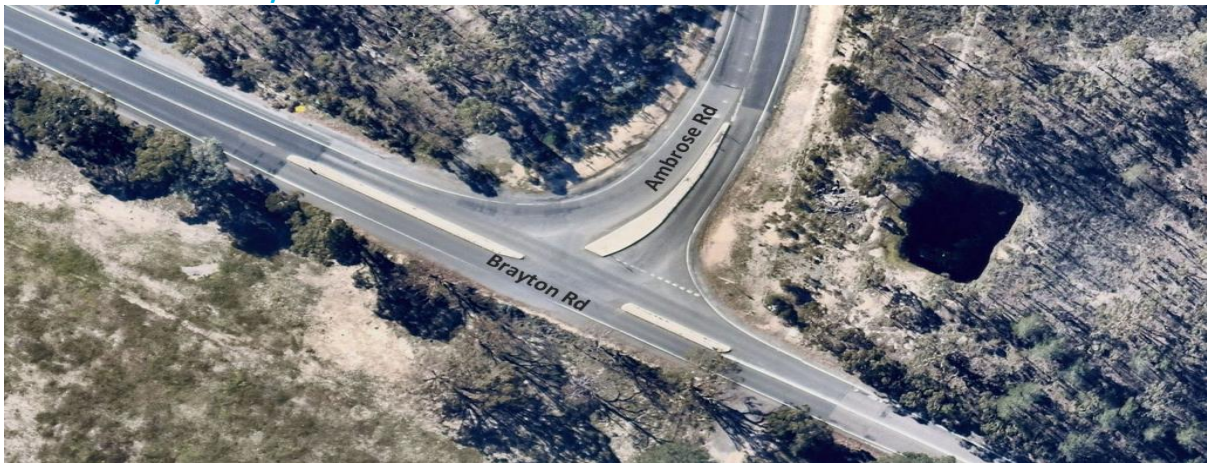
Plate 2.6 Brayton Road/Ambrose Road intersection

Plate 2.6 below is an aerial photo and does not show the damage on the road surface as trucks cut the corner when turning left from Brayton Road into Ambrose Road.

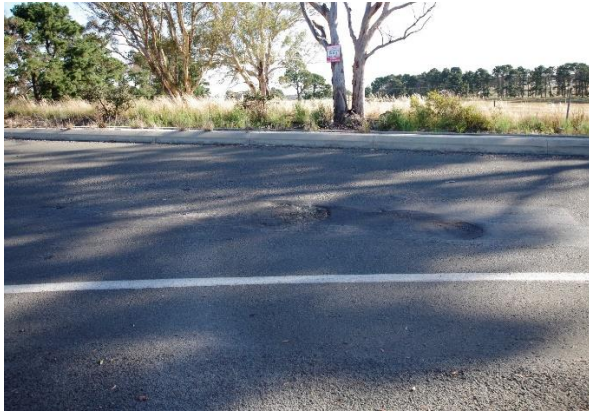
Although photos #9 - #12 were taken in January 2021, the engineer's markings in white on the road, visible in some photos, were taken sometime around October/November 2020, one year on from the resealing programme.

Photo #9 – Ambrose Rd damage – Jan 2021

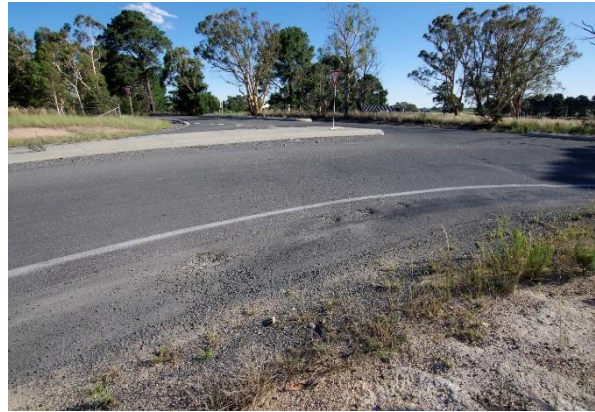
Photo #10 – Ambrose Rd damage – Jan 2021

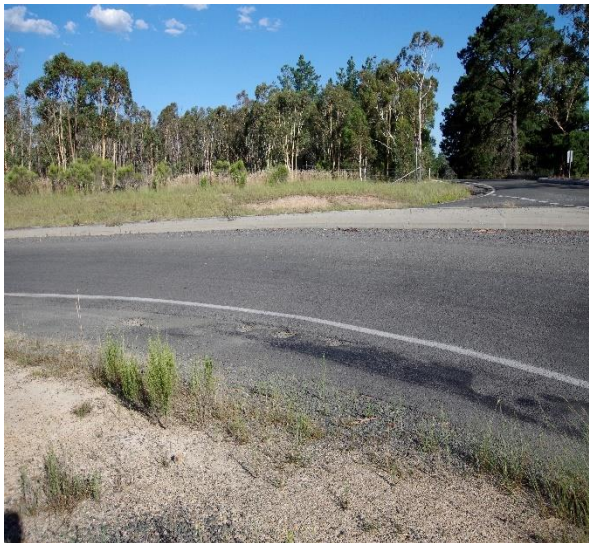
Photo #11 – Ambrose Rd damage – Jan 2021

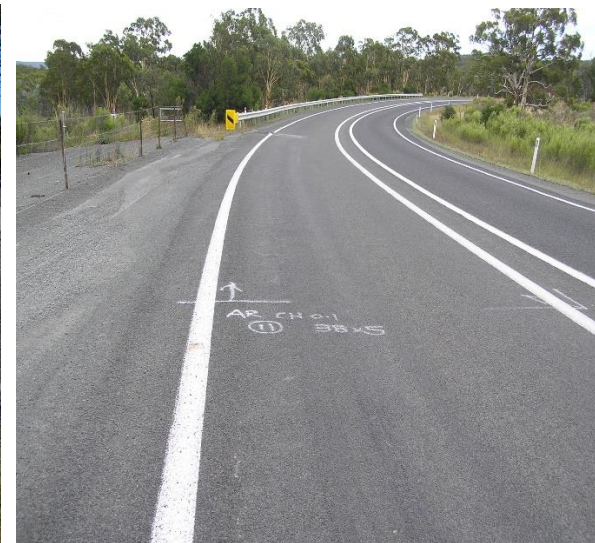
Photo #12 – Ambrose Rd damage – Jan 2021

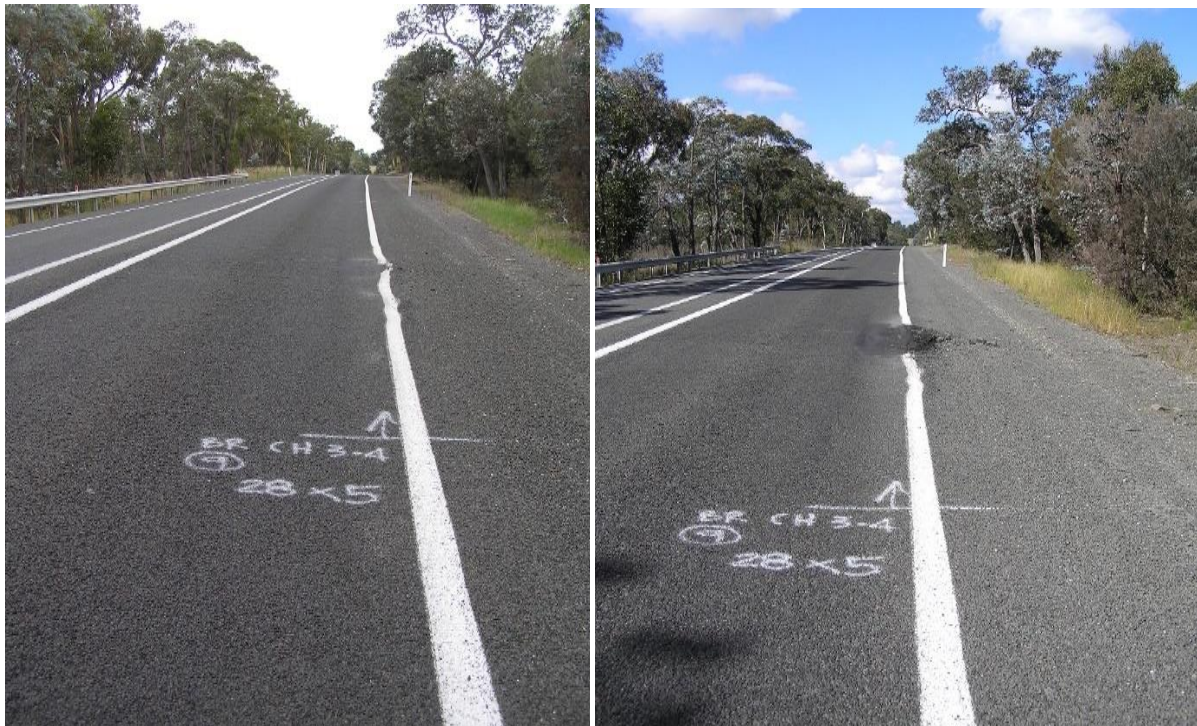
Yet, the road surface of the primary haulage route continues to deteriorate. Although some minor repairs had been carried out, in as much as some potholes being filled and the fog lines along the shoulders repainted, the majority of the pavement remained in poor condition. Patching may have gone some way to alleviating the road safety issue however it was extremely short-lived. Photos taken on 18 April 2021 clearly show how much deterioration had re-occurred in a matter of weeks. (See before and after photos #13 and #14 below).

Brayton Road_Photo #13_26Jan2021 (Before)

Brayton Road_Photo#14_18Apr2021 (After)

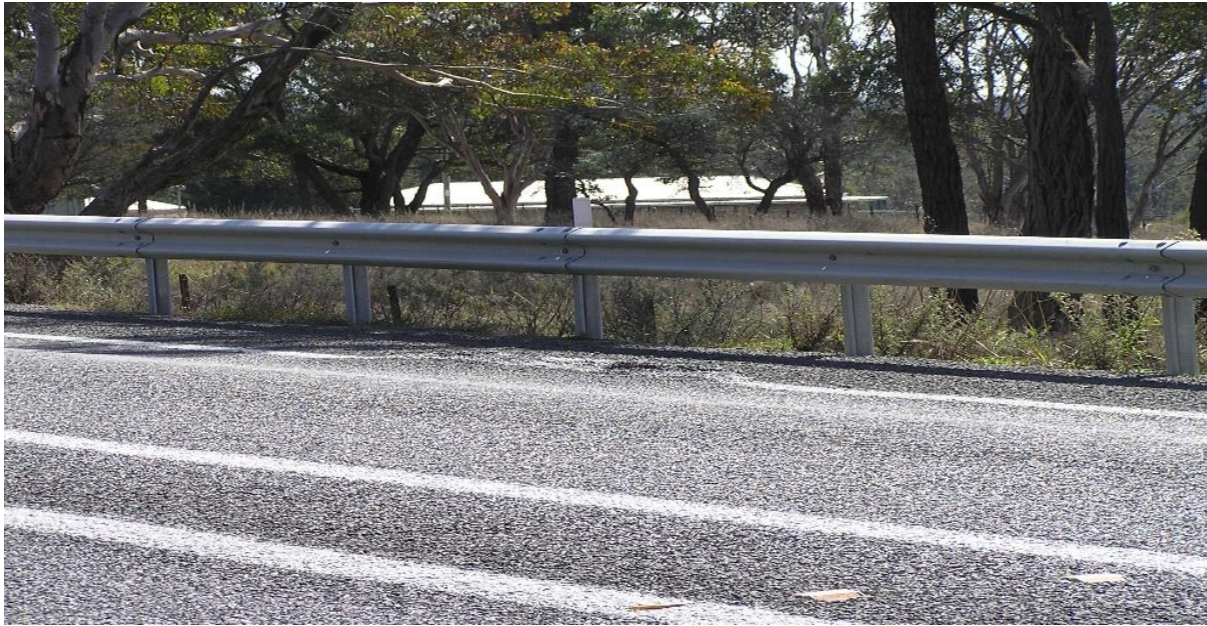
There was also one location along our road frontage where the surface was in such poor condition that when drivers cannot avoid the damage, the trailers of the trucks appear to tilt downwards towards the shoulder of the road due to the depth of the rut. These occurrences were becoming more frequent as the surface worsened and was clearly noticeable, particularly when drivers approached the damaged section at speed. This was also a very dangerous situation due to the narrowness of the lane, the narrow shoulder and close proximity to the guard rail. (See photo #15).

Brayton Road_Photo #15_ deep rut close to guard rail. _18Apr2021

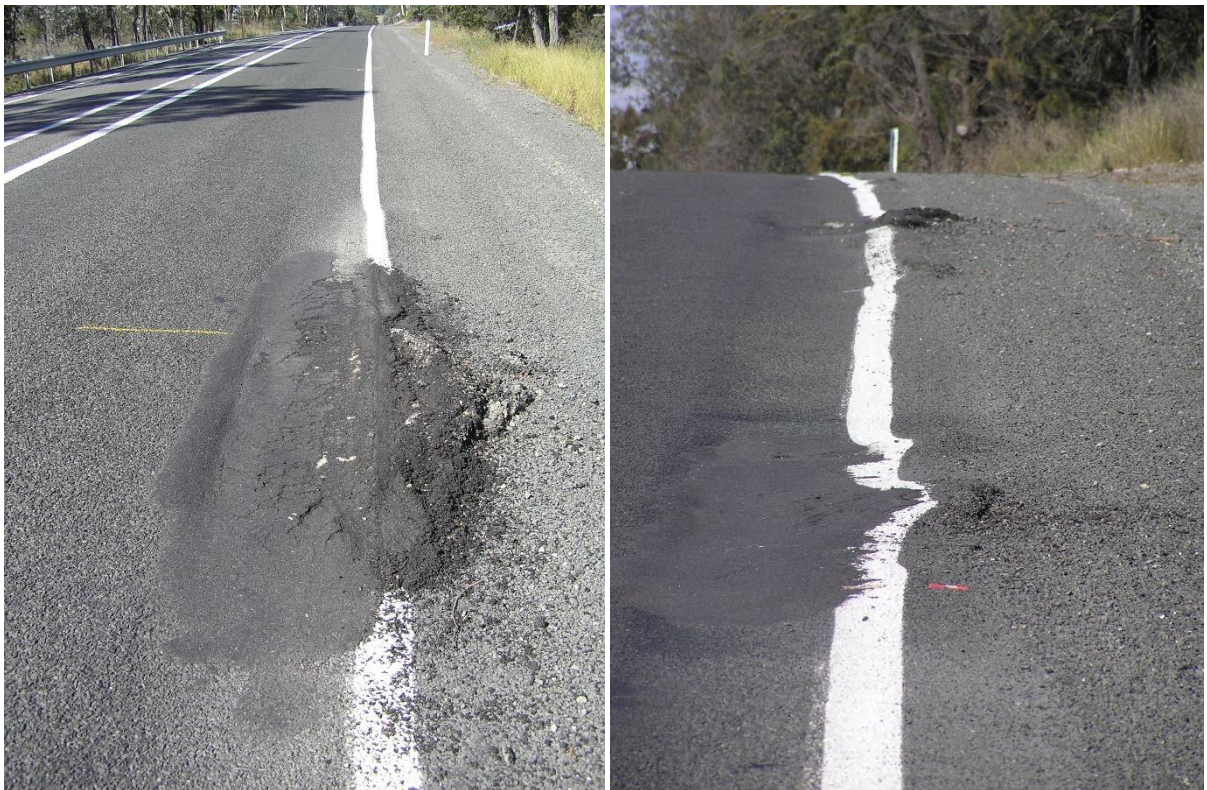
Apart from the increase in cumulative noise impacts from truck tailgates banging and vehicles rumbling over long sections of broken and uneven surfaces, around 300m or more, encompassing both sides of the road, there is an escalating problem with trucks avoiding the damaged sections along the shoulder and riding the centre line instead. This is an extremely dangerous practice particularly during times of adverse weather conditions, i.e fog and mist. (See photos #16 and #17 below).

Brayton Road_Photos #16 and #17_Damaged sections after patching_18Apr21

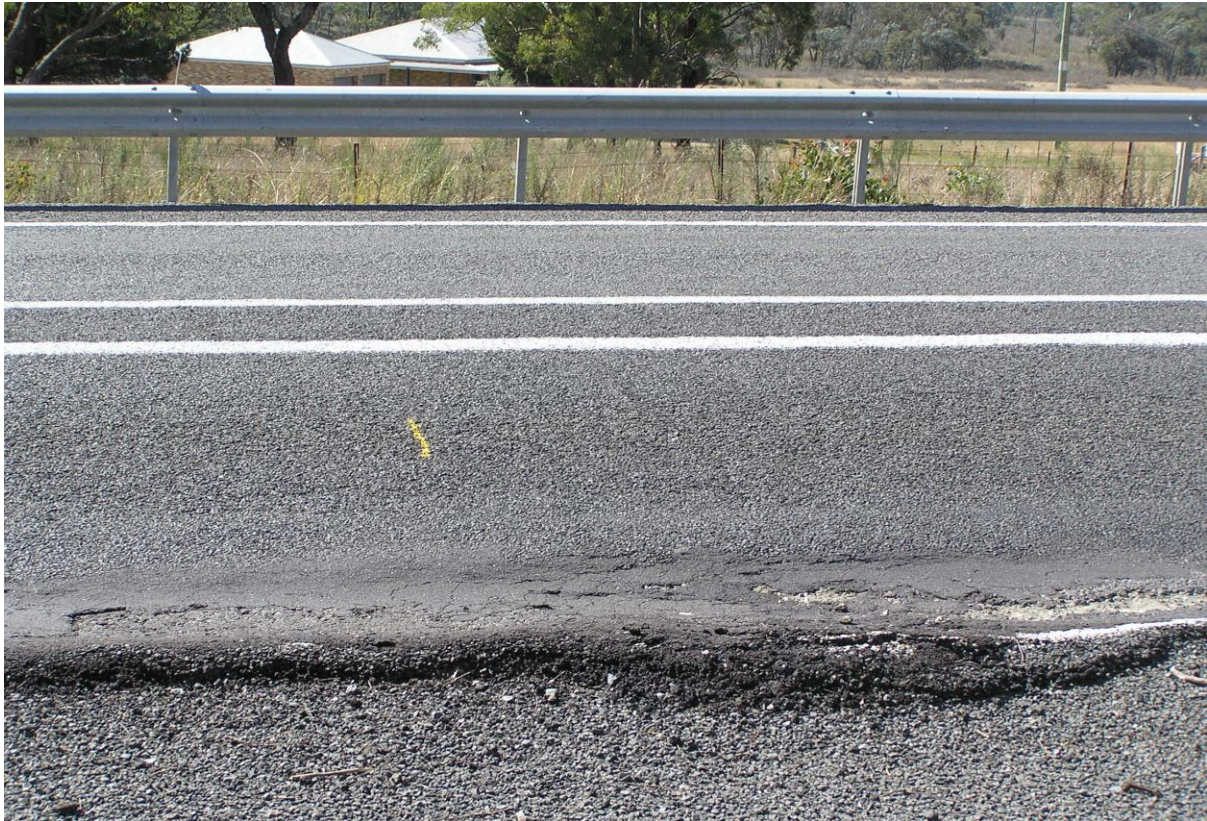
All of these, and more, sections of damaged road have a substantial noise impact on our residence which is only metres away from the road. (See photo #18 below).

Photo #18_Example of damage close to residence_18Apr21

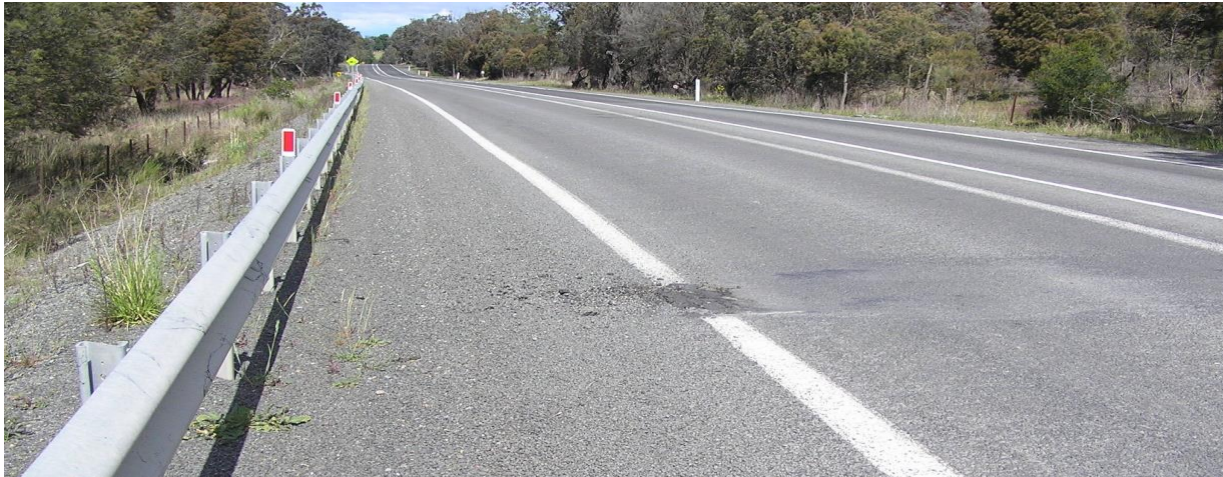
Photo #32 – Brayton Road_Oct 2021

The primary haulage route has remained in an ongoing state of disrepair, no sooner was it upgraded that it required patching, then resealing in October/November 2019, and more patching over and over again. Given the history and number of repairs and maintenance to the primary haulage route, we believed that the rehabilitation works carried out in April 2021 would also be short-lived. We were convinced that additional works would be required, once again, far sooner than expected as has been the case, not just in the past 3 years, but ever since operations at Gunlake Quarries commenced in 2007. As predicted, further roadworks are required to repair even more damage to the pavement, as per photos #26 to # below taken in October 2021.

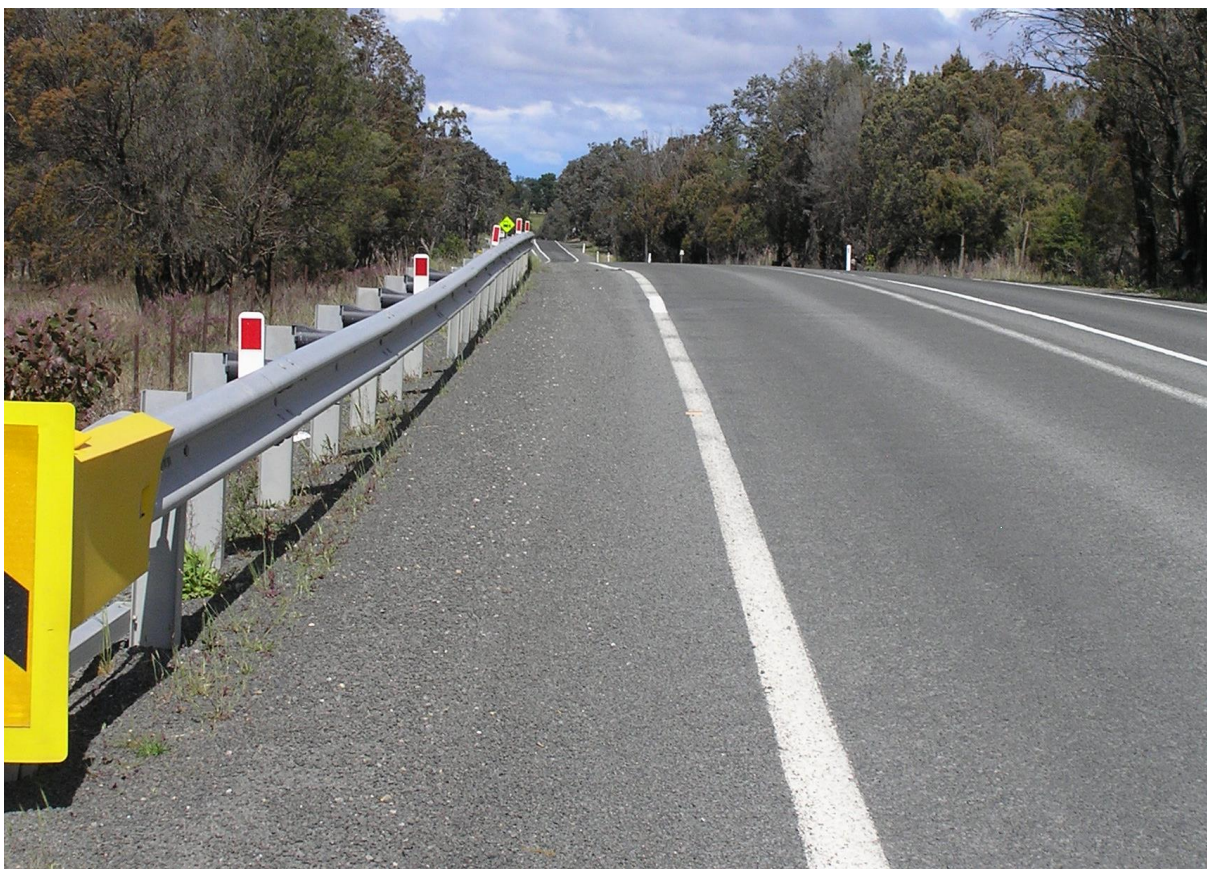
Photo #33 – Corrugation (evident in fog line) along length of Brayton Road producing rolling ‘thunder-like’ noise_Oct 2021

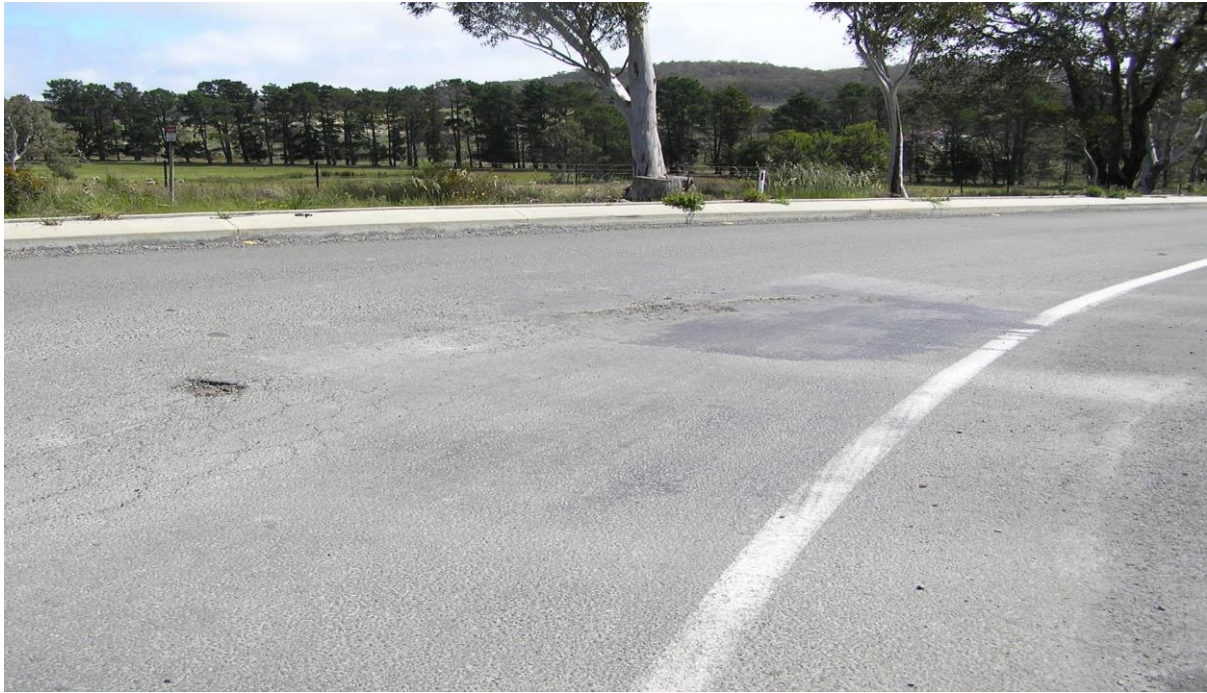
Photo #34 – Approach to Brayton Road/Ambrose Road intersection – opposite residential subdivision_Oct2021

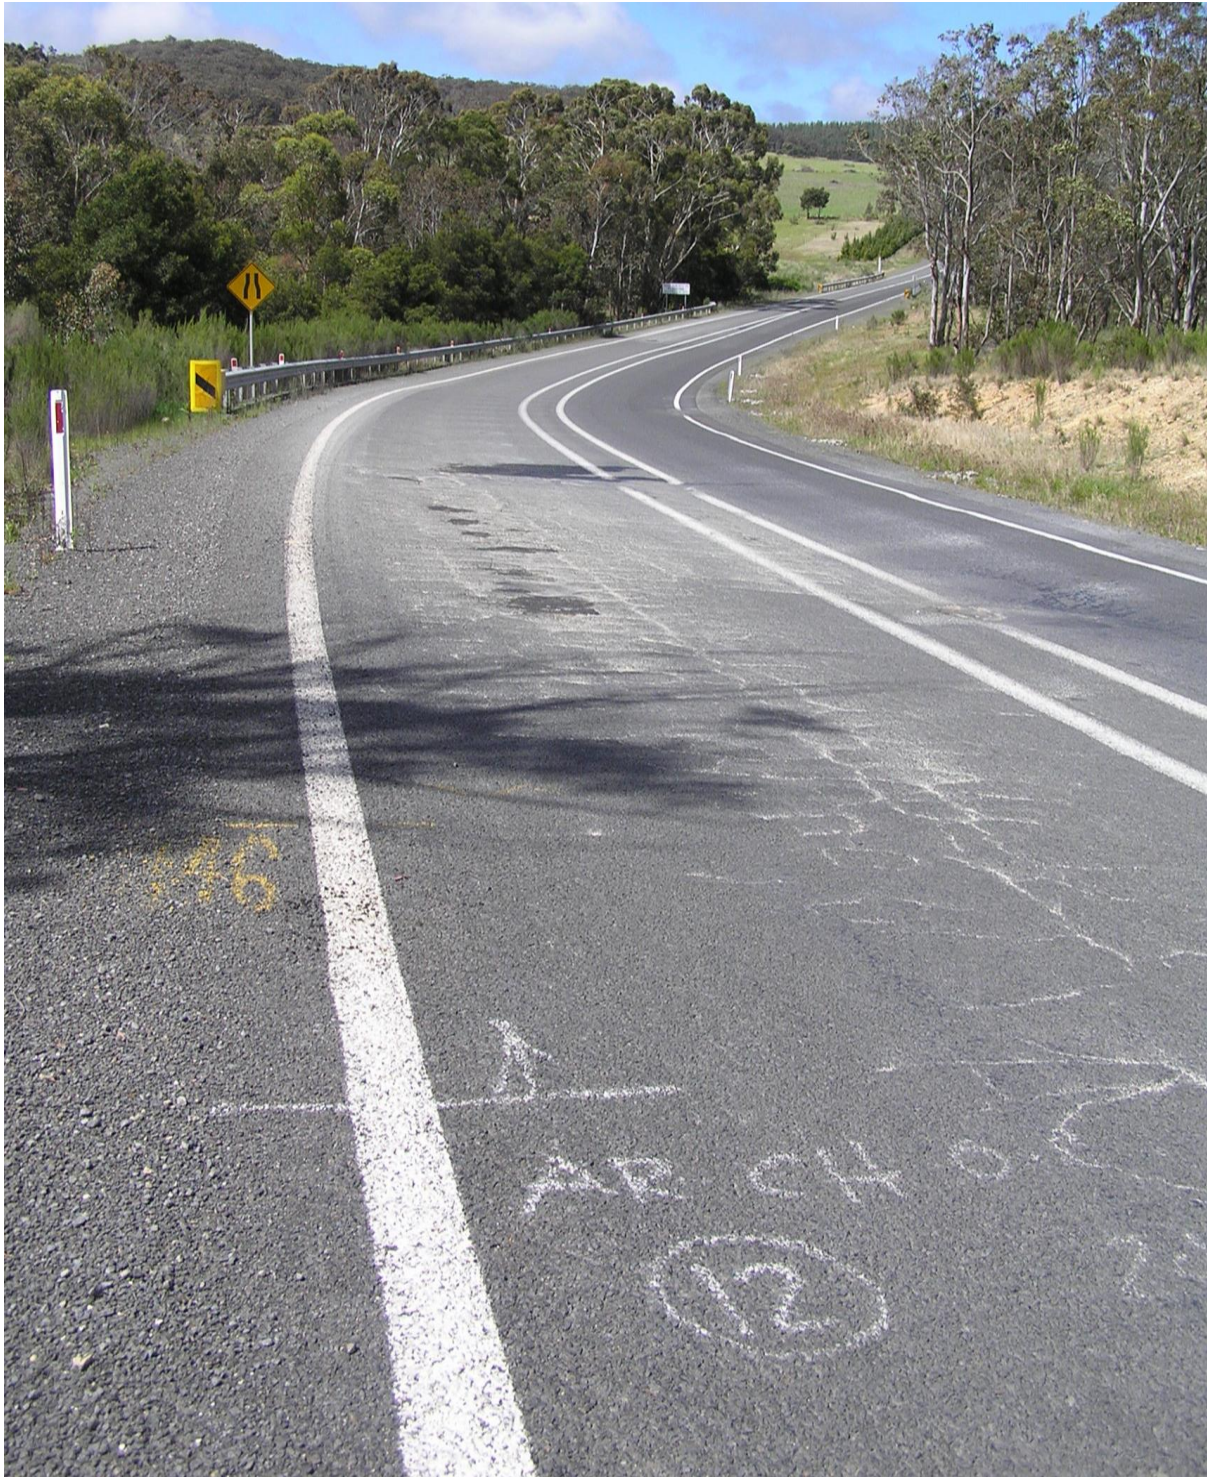
Photo #37 – Approach to narrow bridge_Ambrose Road (East) and approach to Ambrose Road/Brayton Road intersection _Oct 2021

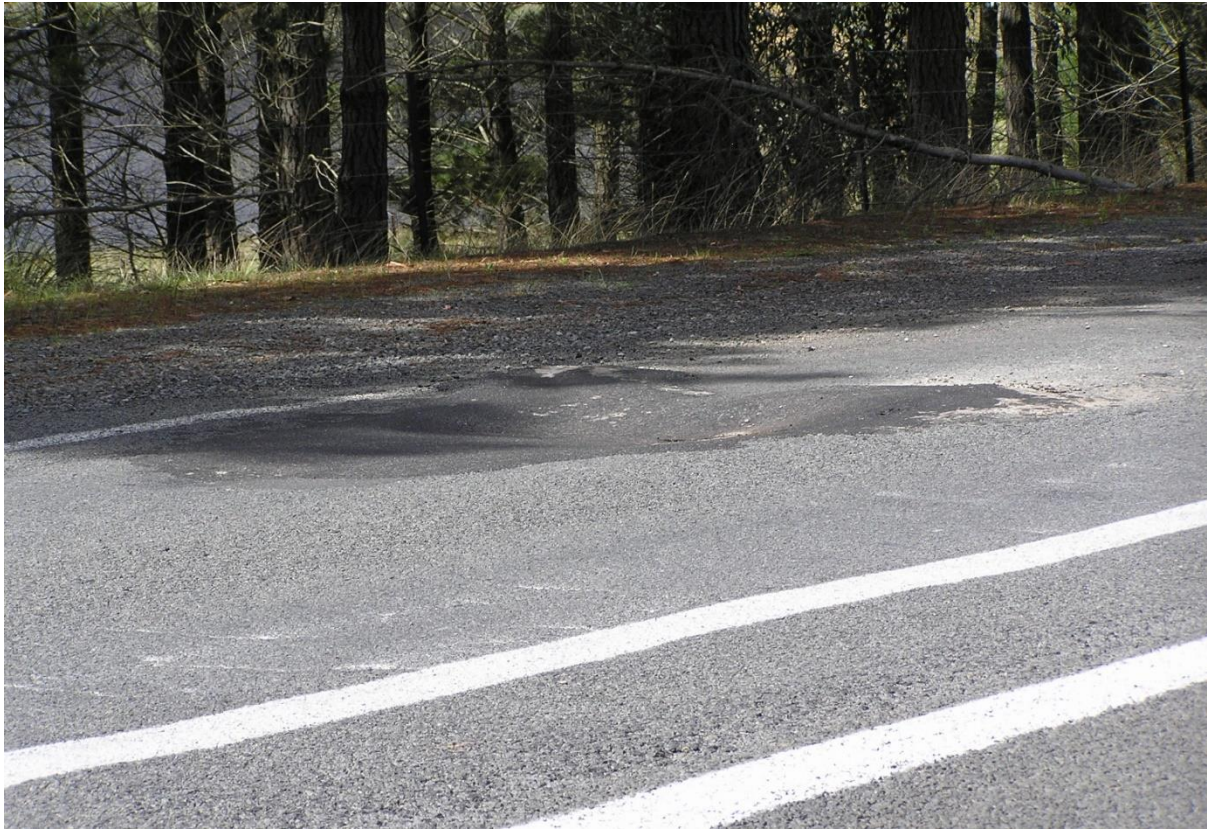
Photo #37 – Large pothole – Ambrose Road (Red Hills Road) approach to Hume Highway_Oct 2021
