APPENDIX N - Visual Photographs of Quarry from Neighbouring Sites

Stockpile
Clay-Shale Extraction
Epic Mines
Lot 1-DP 838 361
Commonwealth Land

INDEPENDENT ENVIRONMENTAL AUDIT

For Epic Mining

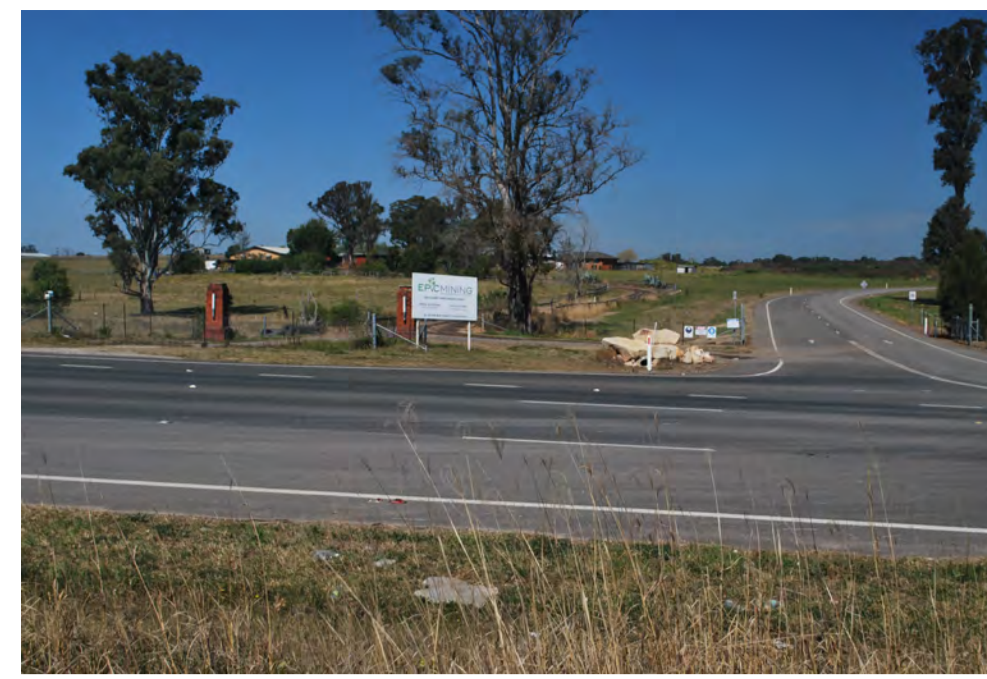
Photo 3- View from Elizabeth Drive at the entrance looking south- stockpiles not visible

Interrupted distant views of the stockpile are available from Elizabeth Drive, as shown in Photos 3, 4 & 5. The impact visibility is Low. All other external views are obscured by the natural topography &/or constructed earth berms as shown on the plan and in Photo 2. The impact is None.

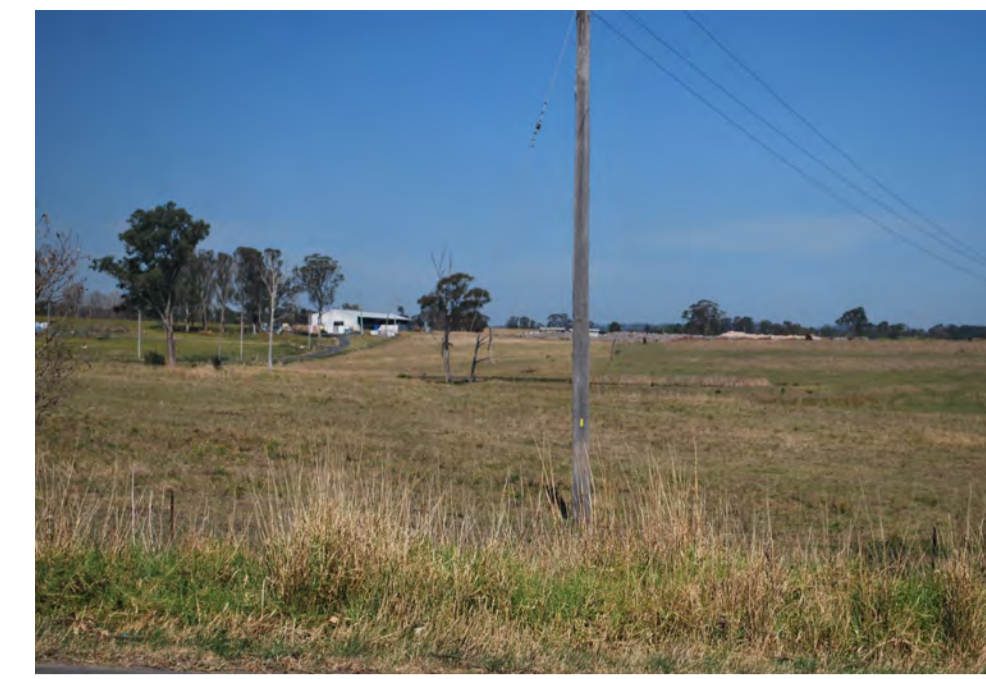
Photo 4- View from Elizabeth Drive showing distant stockpiles

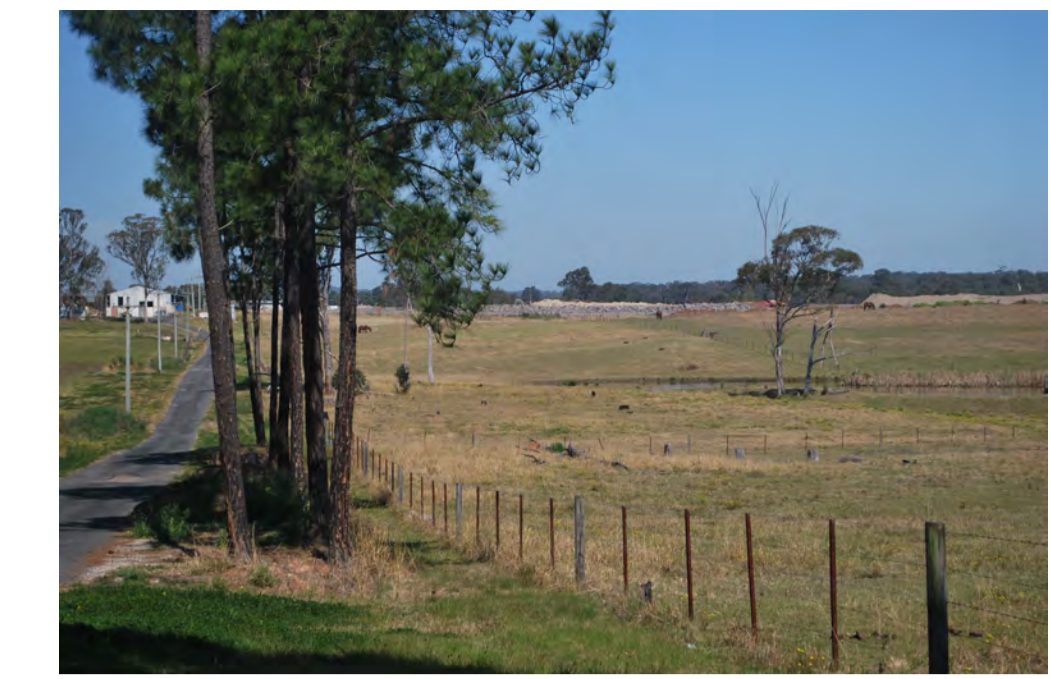
Photo 5- View from Driveway on Elizabeth Drive showing distant stockpiles

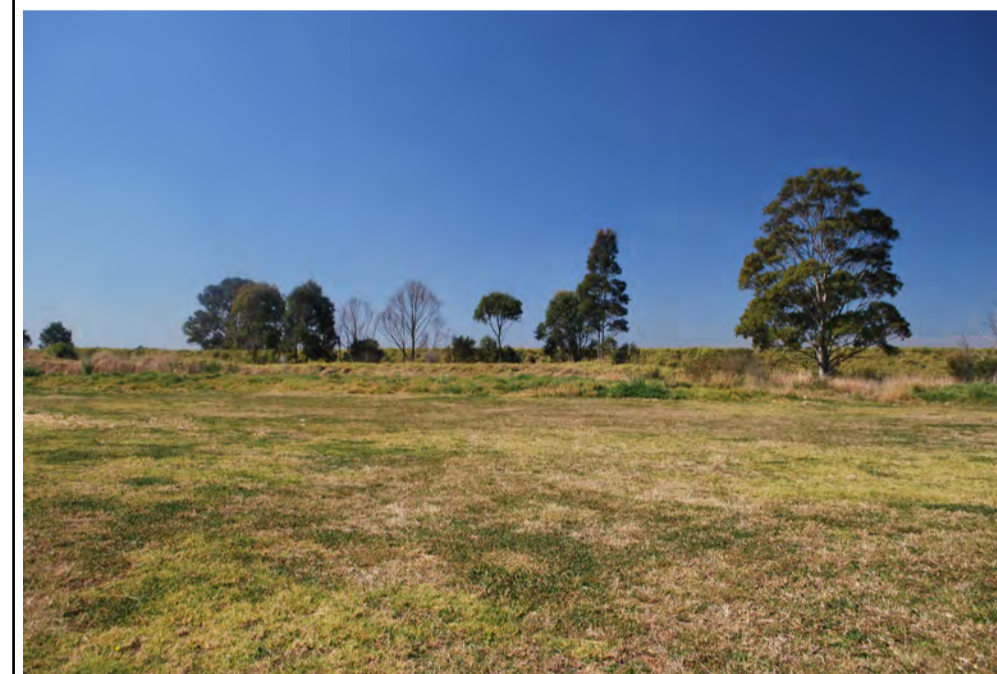
Photo 2- Earth berm obscures view from Hubertus Country Club

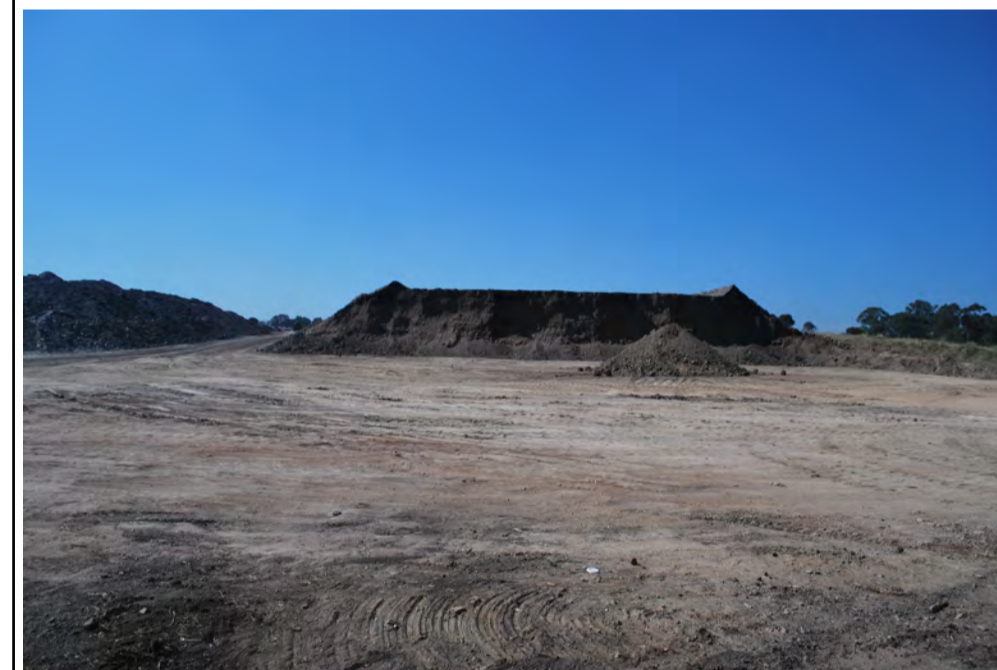
Photo 1- View from the base of stockpile 1 looking east

The immediate view from the base of the stockpiles is shown in Photo 1. This represents the Extreme visual of the stockpile. This view is only available from Oaky Creek directly beneath the stockpiles, otherwise this view is blocked by the riparian vegetation and topography to the west. Stockpile 1 is visible from the leased residences at the end of Ferndale Street (Photo 8) and Jackson Road (Photo 9). Existing vegetation makes the impact from Jackson Road Low and from Ferndale St Moderate.

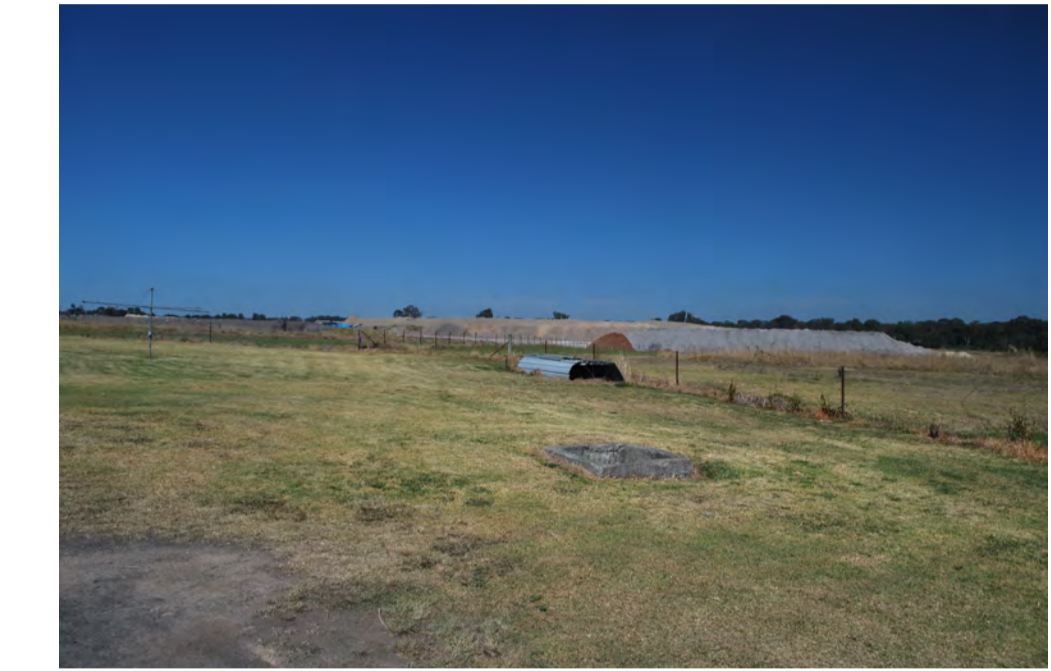
Photo 6- Internal view from Commonwealth leased residence

Photo 6 is taken from the leased residences north of the stockpile looking towards the south and shows a High visual impact. Photo 7 is taken immediately to the east of the stockpile. There is no residence located for over 600m or road for 1000m further east. The impact from the east of the site looking west is Very Low to None. All internal views from the west looking east are none.

The visual external impact is Low to None so no mitigation measures are necessary with regard to them. The visual impact from leased residences on Commonwealth land is Low to Moderate south of the stockpile and High directly north of the piles. To reduce the internal visual impact it is recommended that clump plantings of 3 to 5 indigenous trees along the existing berm to the south and scattered clump plantings to the north be undertaken to mitigate these visual impacts. The feasibility of implementing this recommendation is dependent on the acceptability of these plantings under any future plans for the Commonwealth site.

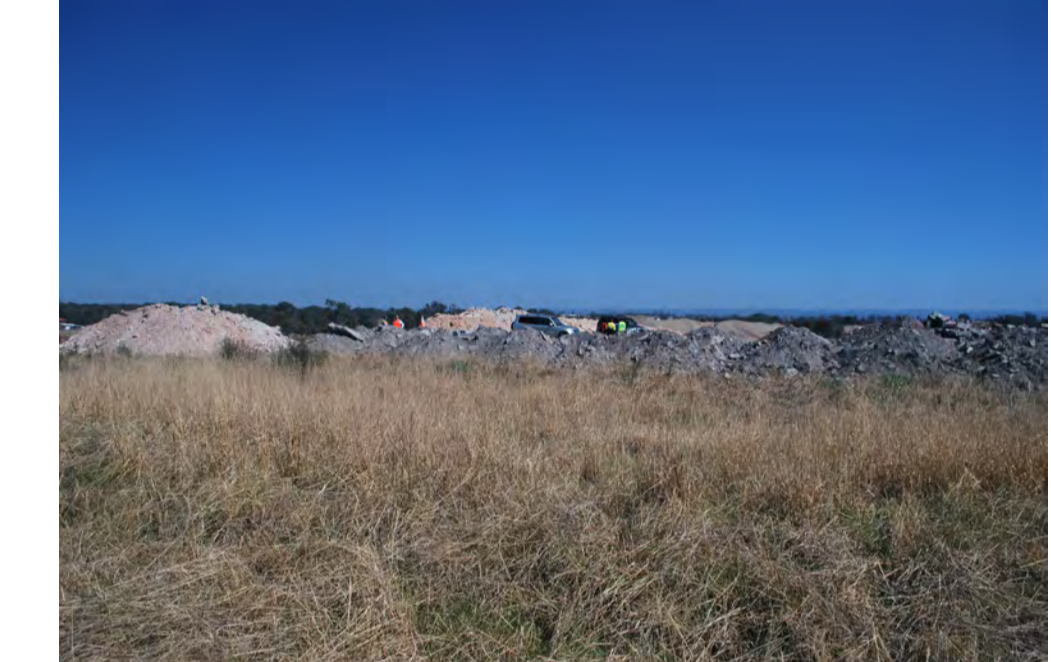
Photo 7- Internal view looking west from the highest point on the site

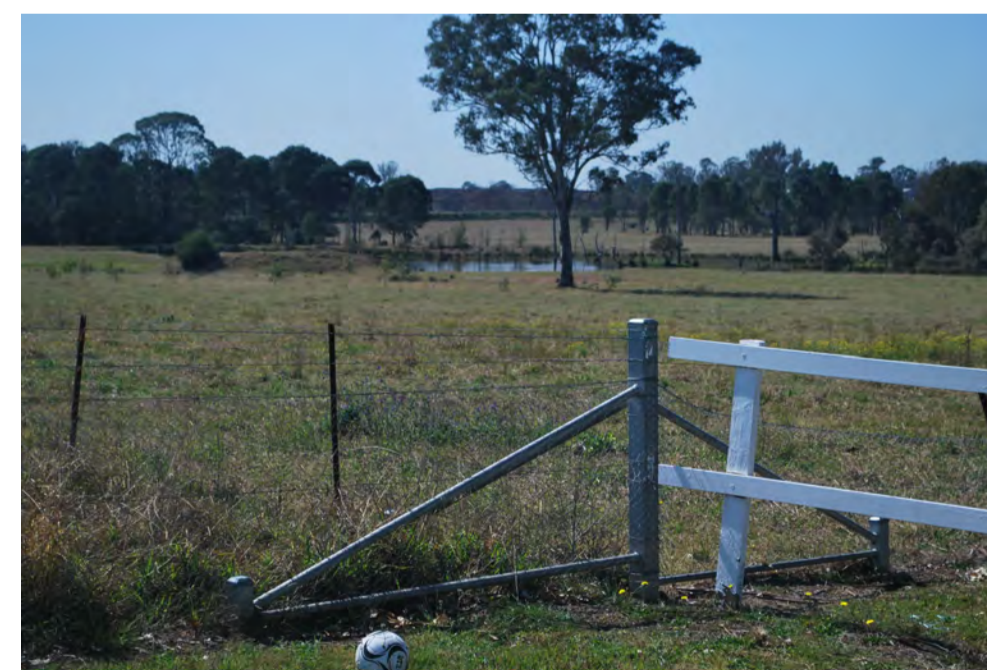
Photo 9- View from corner post of Jackson Road, Commonwealth leased residence.

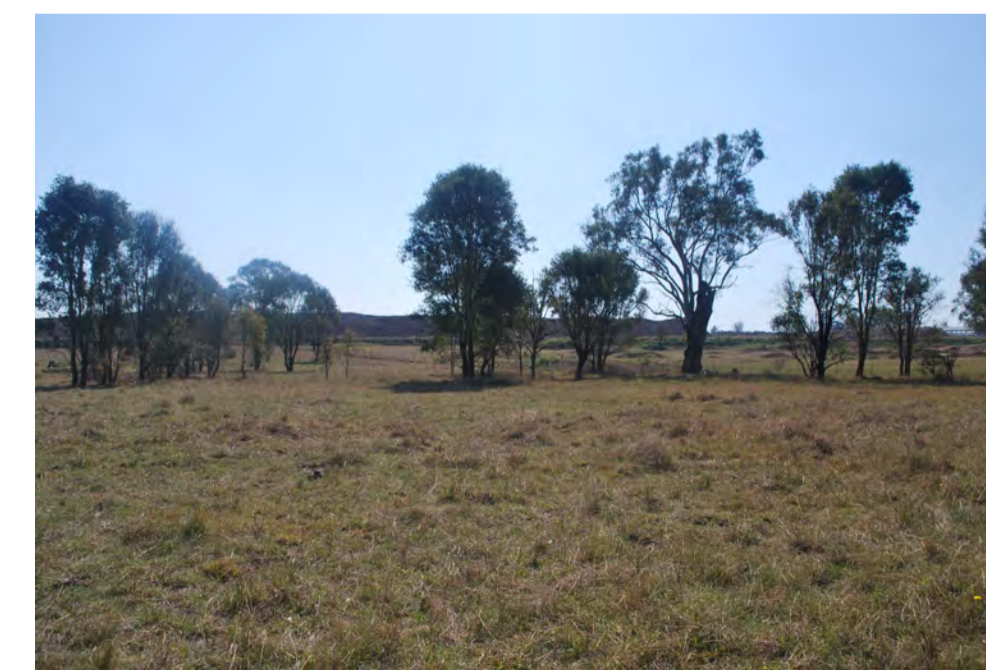
Photo 8- View from back paddock of Ferndale Street, Commonwealth leased residence.

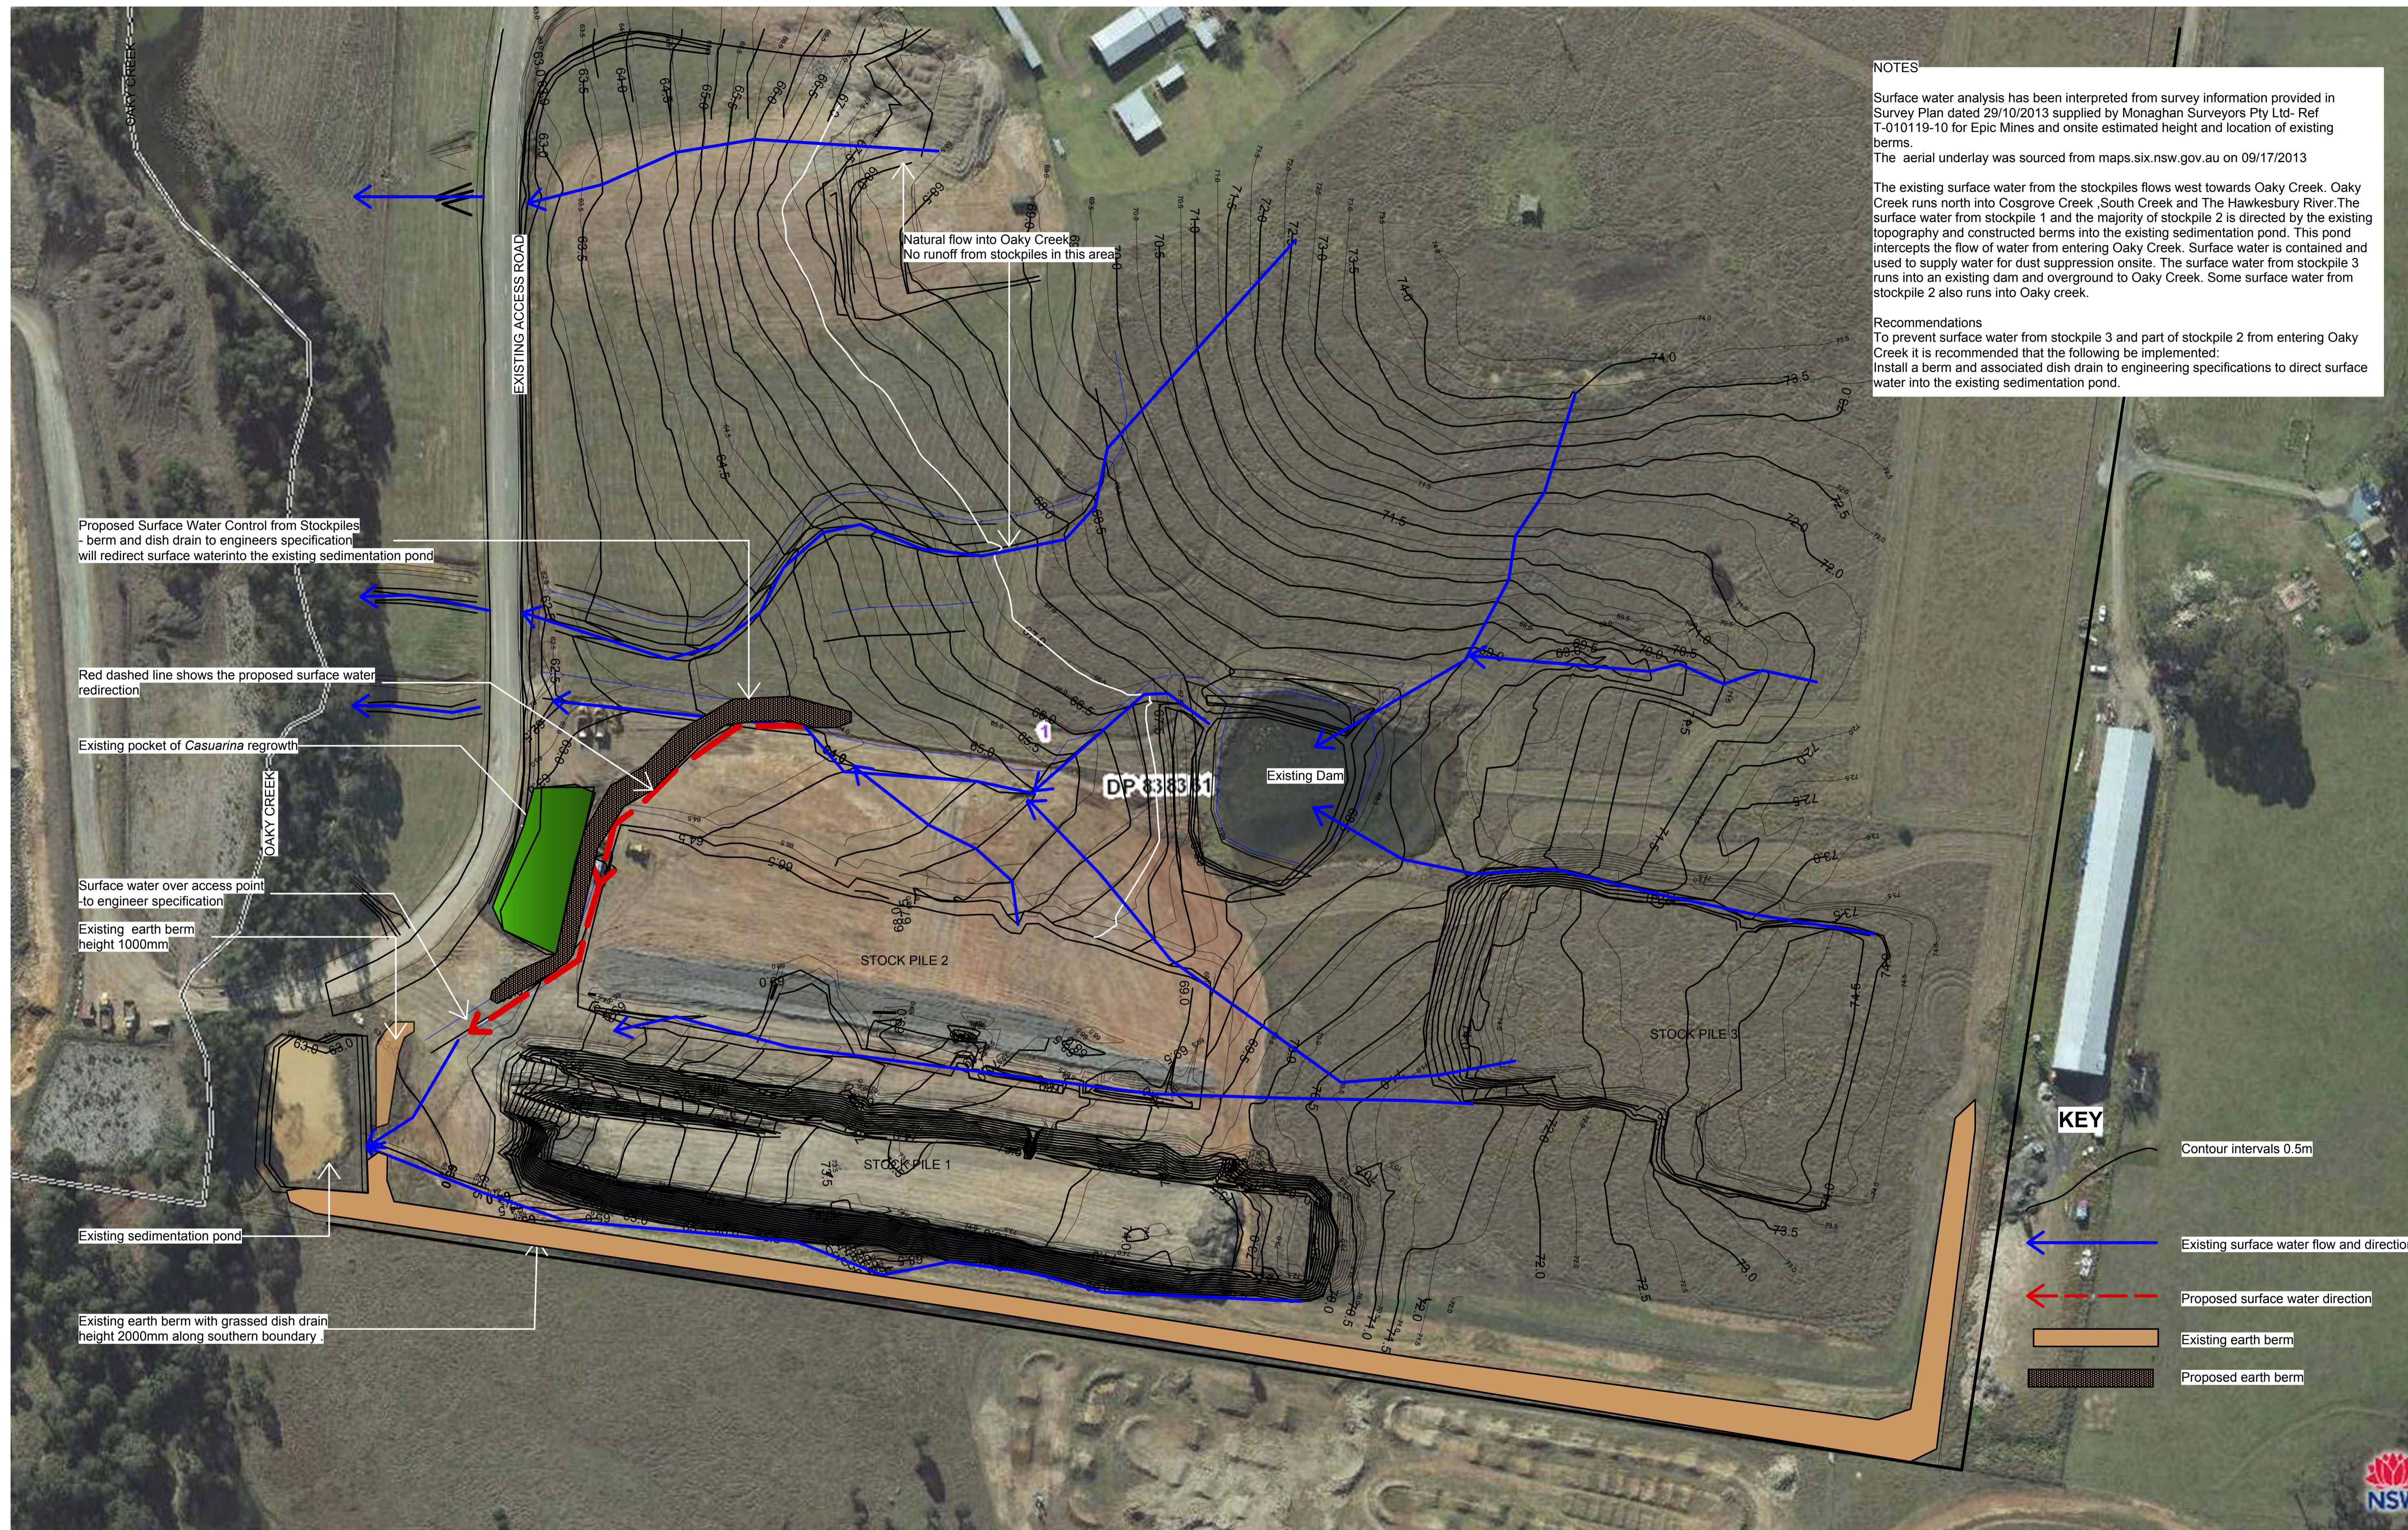
TITLE
Surface Water Plan

The existing surface water from the stockpiles flows west towards Oaky Creek. Oaky Creek runs north into Cosgrove Creek, South Creek and The Hawkesbury River. The surface water from stockpile 1 and the majority of stockpile 2 is directed by the existing topography and constructed berms into the existing sedimentation pond. This pond intercepts the flow of water from entering Oaky Creek. Surface water is contained and used to supply water for dust suppression onsite. The surface water from stockpile 3 runs into an existing dam and overground to Oaky Creek. Some surface water from stockpile 2 also runs into Oaky creek.

Recommendations
To prevent surface water from stockpile 3 and part of stockpile 2 from entering Oaky Creek it is recommended that the following be implemented:
Install a berm and associated dish drain to engineering specifications to direct surface water into the existing sedimentation pond.

Proposed Surface Water Control from Stockpiles - berm and dish drain to engineers specification will redirect surface water into the existing sedimentation pond
