Project 86043.01

30 July 2018

R.005.Rev0 SCP:cm

Groundwater Monitoring Proposed Residential Development Ivanhoe Estate, Macquarie Park

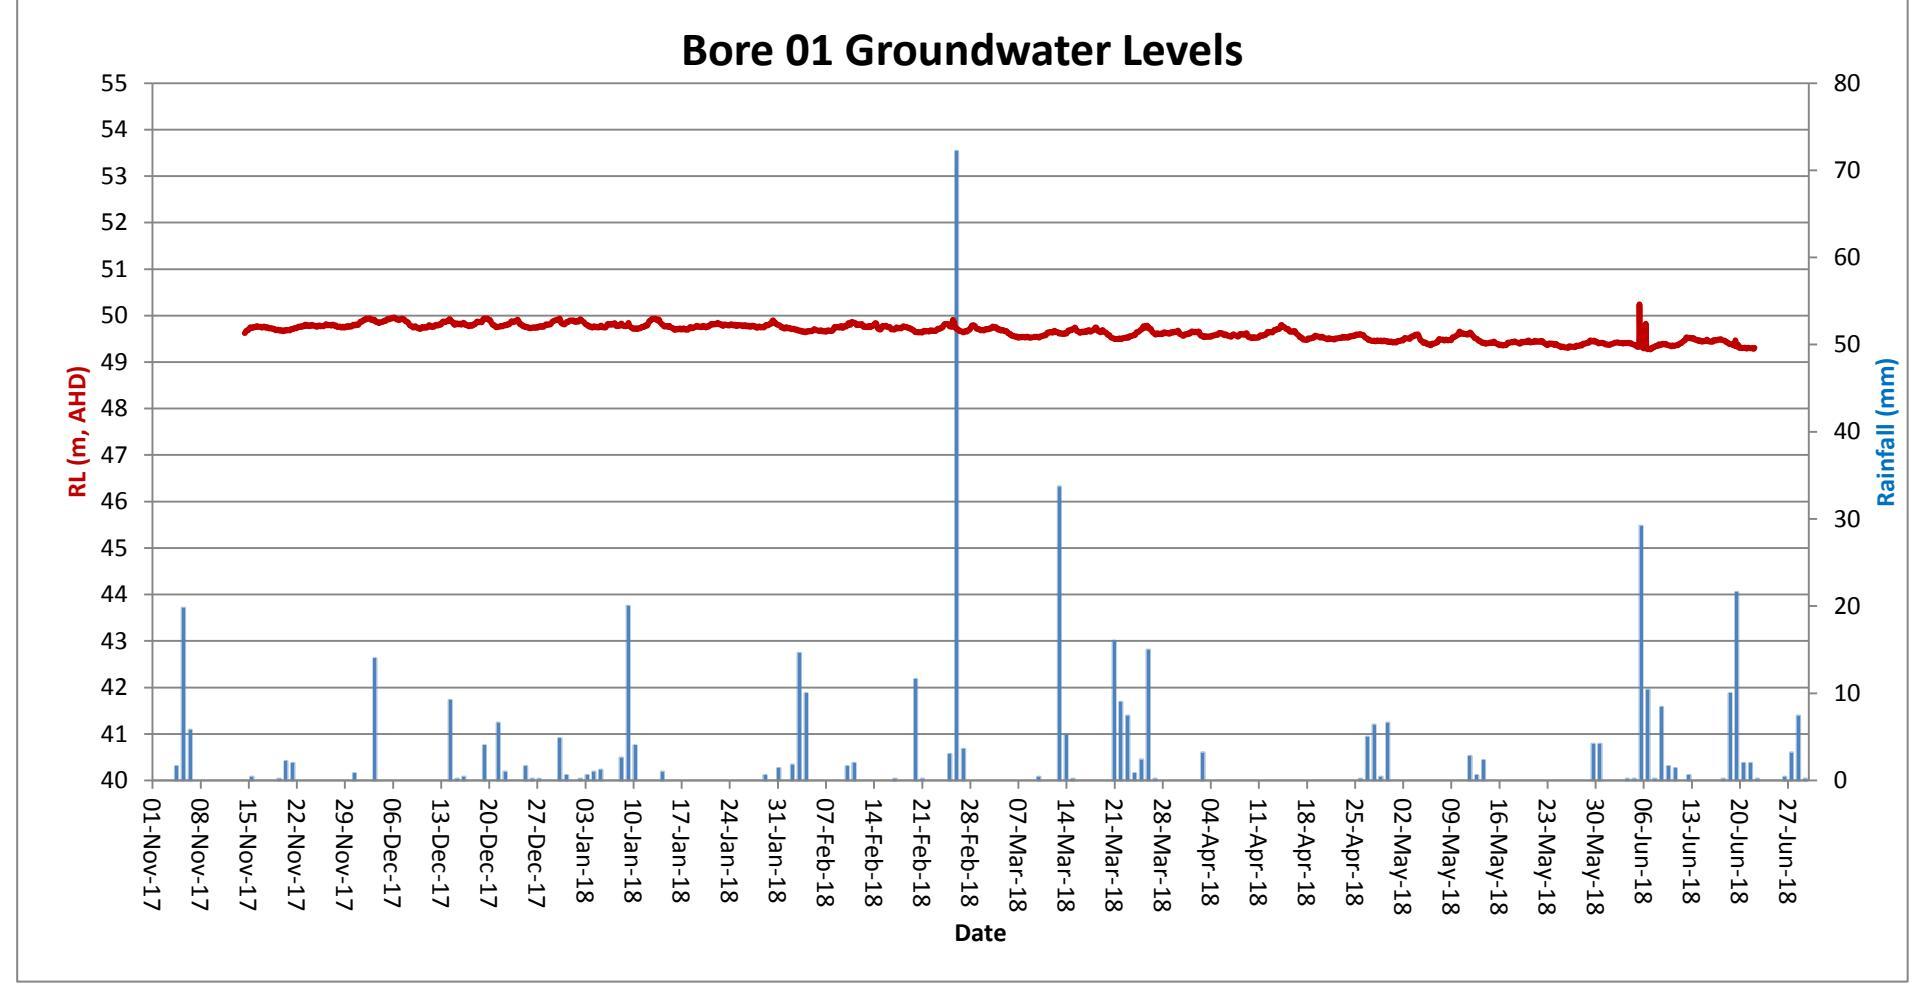
Figure 1: Groundwater Monitoring Results at Bore 01

- At Bore 01, unusual readings were obtained in June 2018 following rainfall. It is considered likely that this is due to the surficial damage observed at the standpipe, with dislodgement of the standpipe cover possibly resulting in surface water inflow to the standpipe.

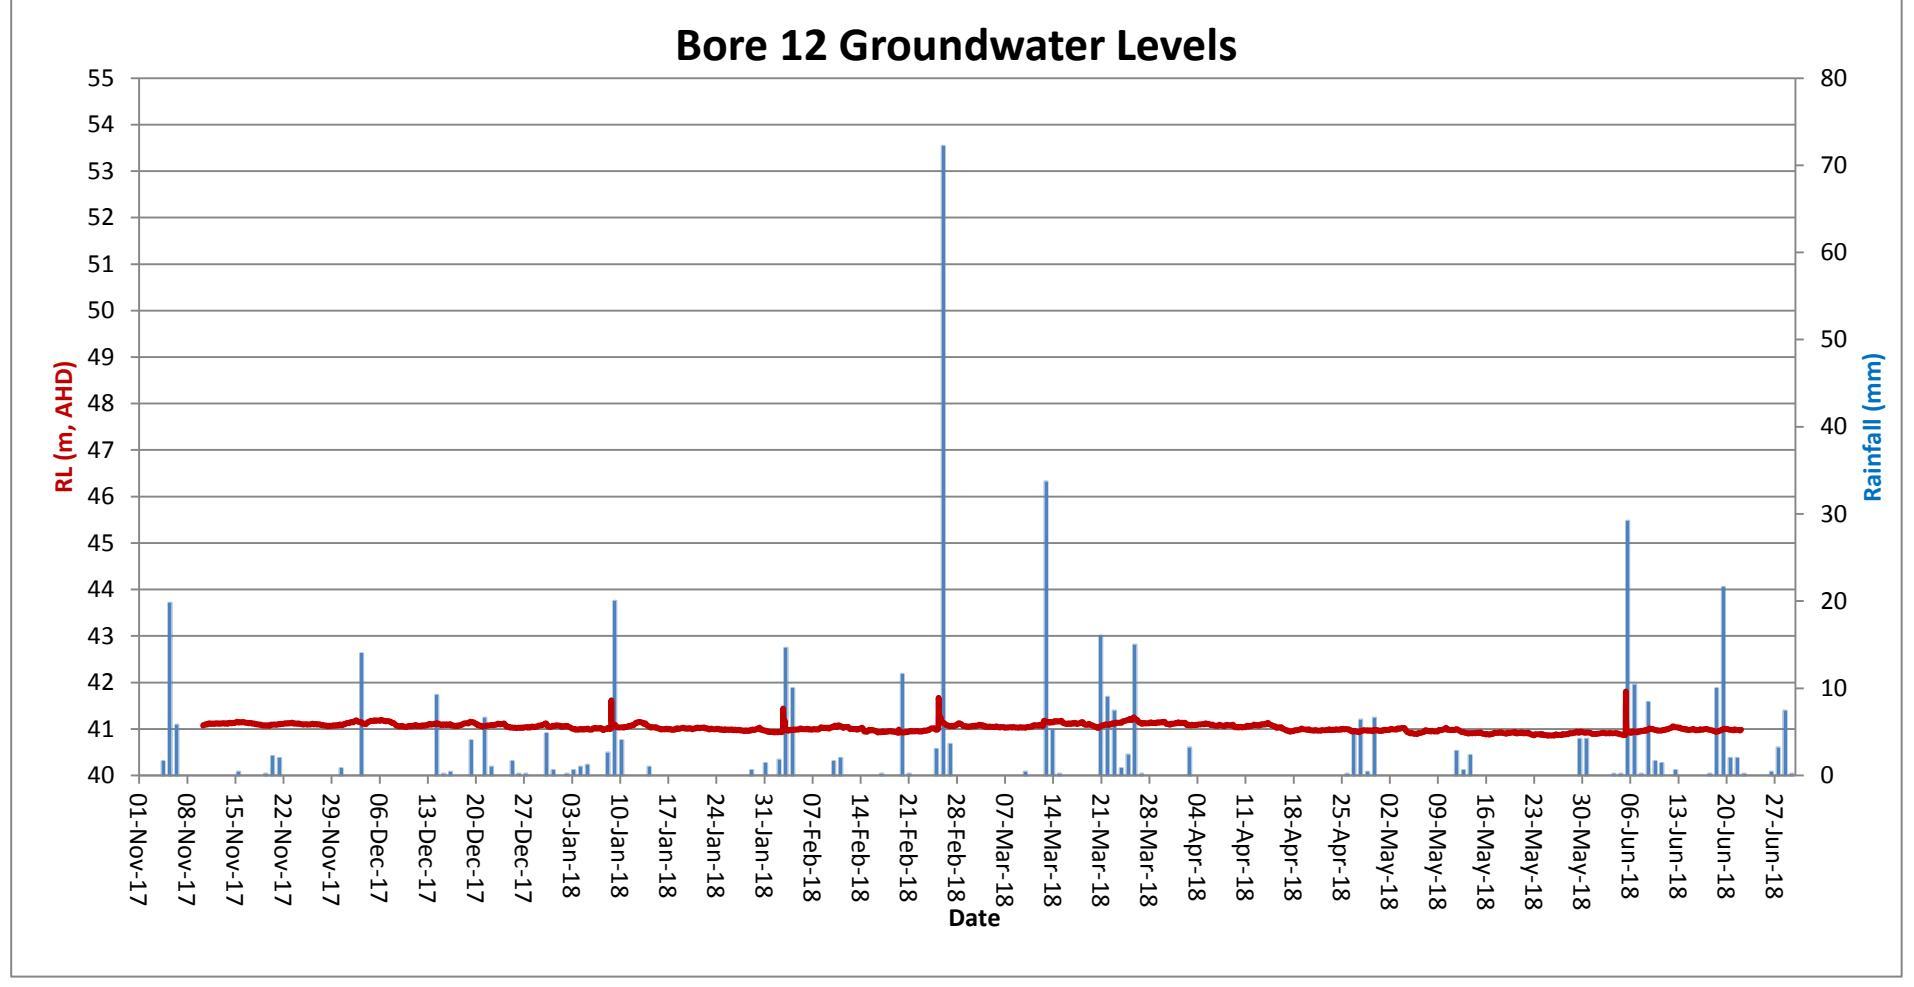
Figure 5: Groundwater Monitoring Results at Bore 12

- At Bore 12, elevated groundwater readings followed some rainfall events, with water levels rising by up to 0.6 m, then rapidly dissipating to more typical groundwater levels. The standpipe construction at this location includes a bentonite seal down to sandstone. Presuming that the seal has performed adequately, the cause of the elevated water levels may be due to local ground conditions (eg groundwater infiltration through joints or bedding planes in the sandstone) and its proximity to the creek and/or the adjacent stormwater drains.
