RE: Marist Catholic College North Shore (SSD-10473). Response to Submissions and peer review. NSW Government, Department Planning, Industry and Environment (DPIE)

APPENDIX A: SUMMARY TABLE Marist Catholic College North Shore (SSD-10473). Response to Submissions.

This Schedule of Conservation Works is a list of work that is required to correct damage and deterioration to St. Mary's Presbytery, Marist Catholic College, 270 Miller Street, North Sydney NSW

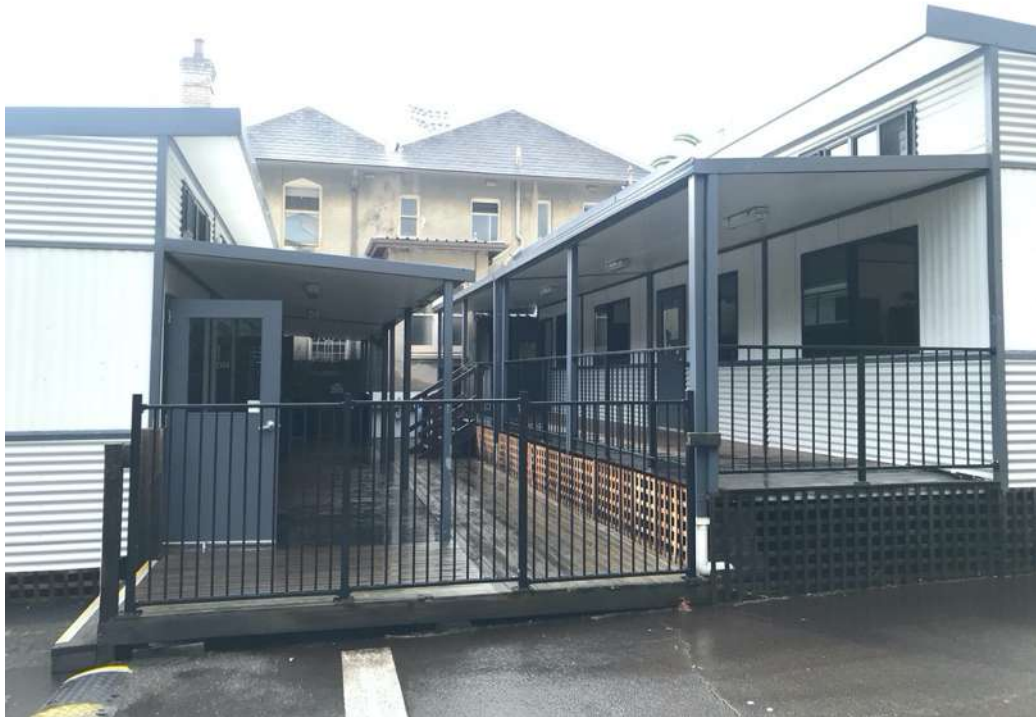
Rear view of the Presbytery building with existing demountable buildings, decking and fencing.

- The proposed works will remove the intrusive demountable buildings, decking and fencing to the rear western elevation of the building and replace them with a well considered, articulated and high quality design that forms part of the materiality and architectural style of the proposed suite of buildings for the site. The proposed canteen structure connects lightly to the presbytery, via a glazed walkway on the less significant, western elevation and is not visible from the public domain.
- The proposed Canteen building sits below the eave height of the Presbytery, which reduces the Canteen's bulk form and scale in relation to the presbytery.

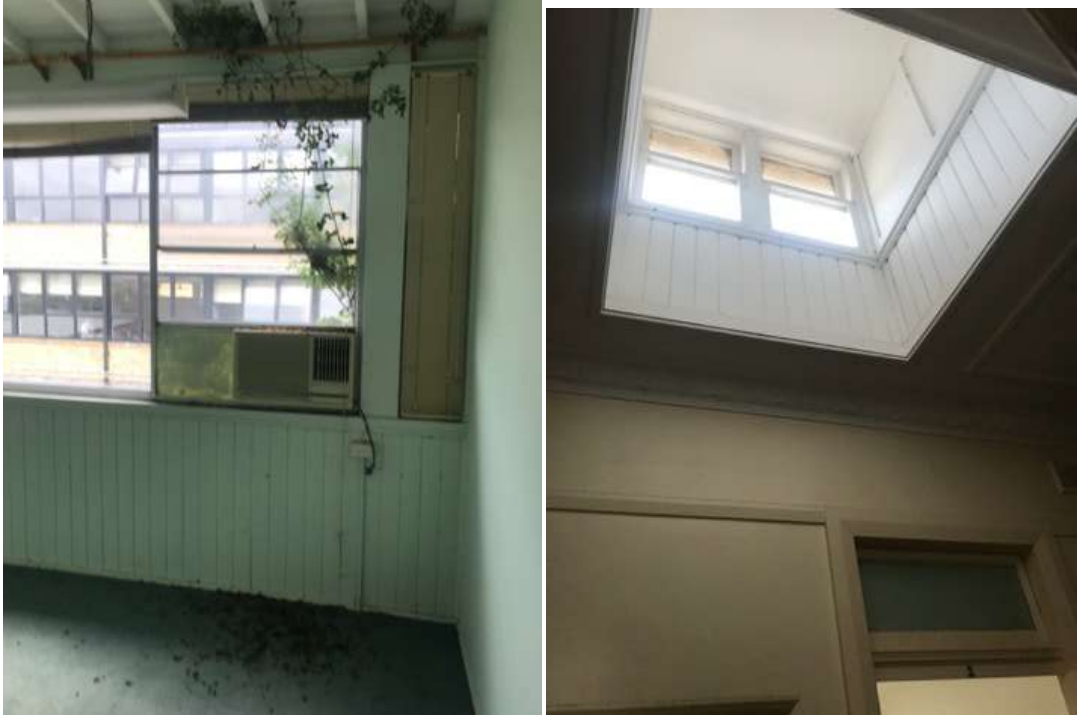
First Floor Balcony in fill with aluminium framed windows and air conditioning unit
	First Floor Hallway Lantern/skylight
	HERITAGE RESPONSE - St. Mary's Catholic Primary School
	<p>St. Mary's Catholic Primary School - Detailed description</p> <p>St. Mary's Catholic Primary School is a rectangular, two storey school building with twin terracotta tile gable parapet roofs to Ridge Street and dormer windows on the eastern roof elevation. There are two chimney stacks on the western side of the roof. The masonry elevations are ornately articulated with a mixture of painted brick and stucco finishes. The timber double hung windows are either arched or flat arched with wide rendered frames.</p> <p>The buildings most notable feature is the pair of ornate parapet gables ends on Ridge Street, that curve toward the gutter line and a third gable with a projecting eave roof to the east elevation. West corner is two storeys, with faceted bay window and oval window to the ground floor and segmented triptych arched window above.</p> <p>This building is designed in the Federation Romanesque style which is predominantly found in ecclesiastical buildings. The architectural style is American inspired through the work of architect H.H. Richardson in the 1870's.</p> <p>The Architectural character is defined by simple and weighty robustness of masonry forms and restrained medieval motifs. Depicted in the Primary School building by the arched windows and high pitched gable parapet roof.</p> <p>St. Mary's Catholic Primary School - Condition/ Integrity</p> <p>The St. Mary's Primary School has mixed integrity. Internally the classrooms, timber framed windows, architraves and skirtings have been retained. Modification has occurred internally to allow electrical upgrades, mechanical ventilation and new learning technology to be installed in the classrooms.</p>

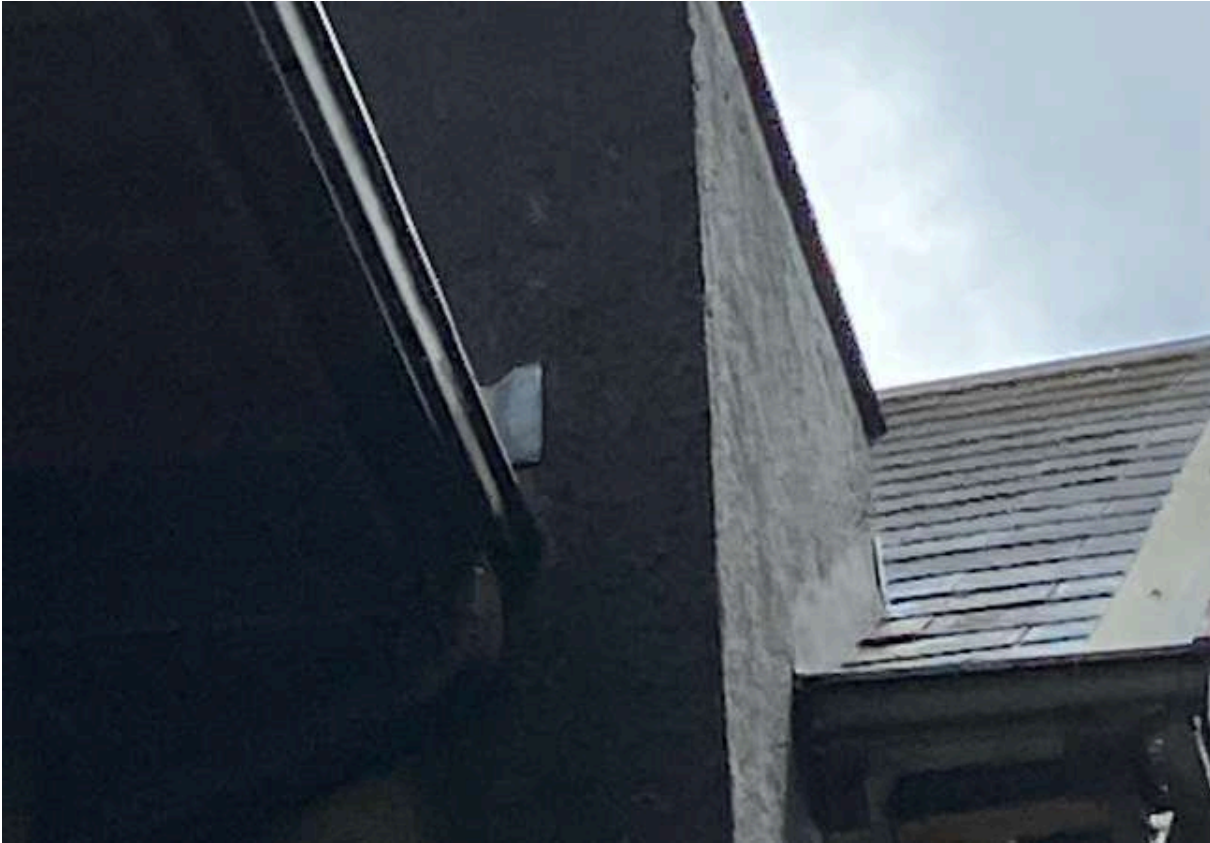
Photo. 3. The slate roof appears to be in a serviceable condition. The roof slate and all associated flashings are to be inspected by a heritage roof slate contractor.

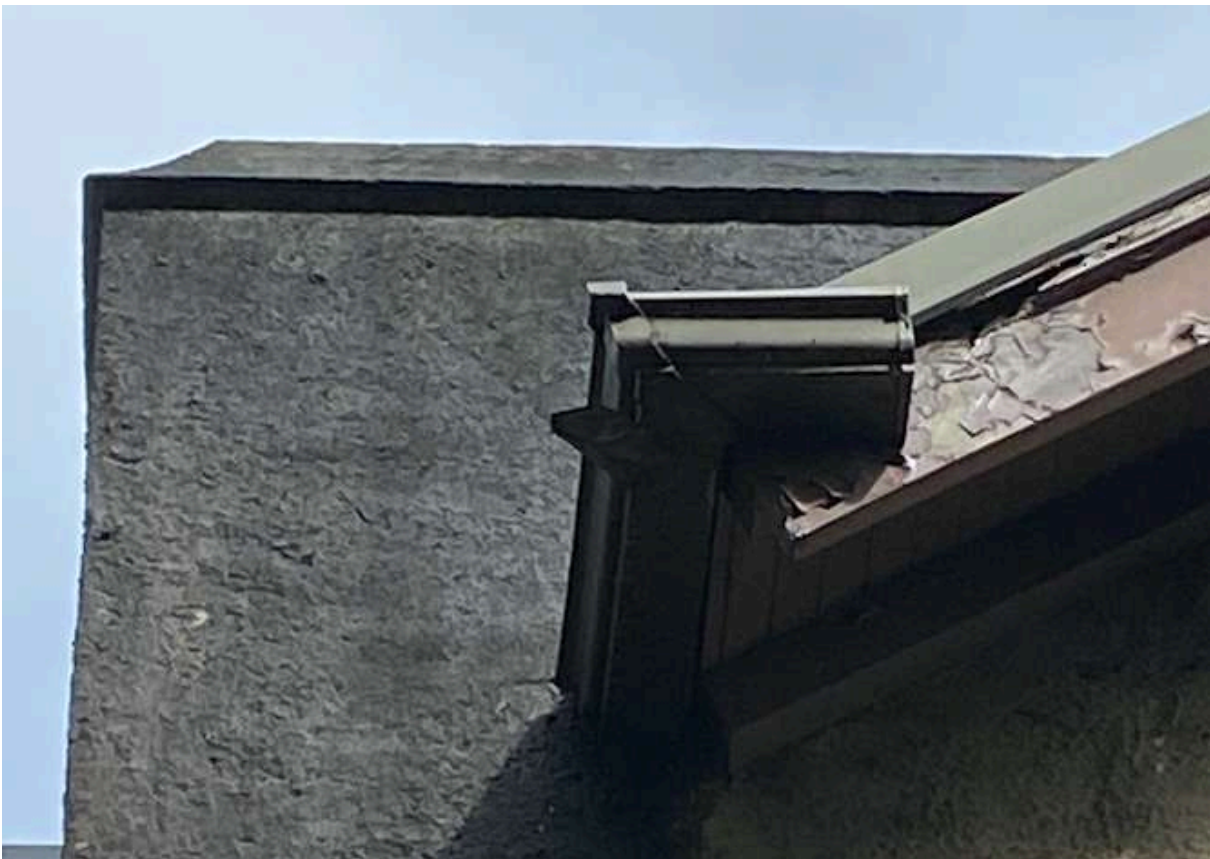
Photo. 4. The gutters and down-pipes are inappropriate and are to be replaced with a copper gutter system.

<p>LOCATION: Rain Goods</p> <p>WORK REQUIRED: The colorbond gutters and rusting down-pipes are inappropriate and are to be replaced with a copper gutter system. This gutter system is to be adequate to accommodate the roof drainage and is to be approved by the nominated heritage consultant.</p> <p>This work is to be executed by a licensed roofing contractor with a proven record of satisfactory work to heritage buildings.</p> <p>Standards: AS/NZS 2179.1-2014 Metal Rainwater Goods and AS/NZS 3500.3.2015. Stormwater Drainage</p>

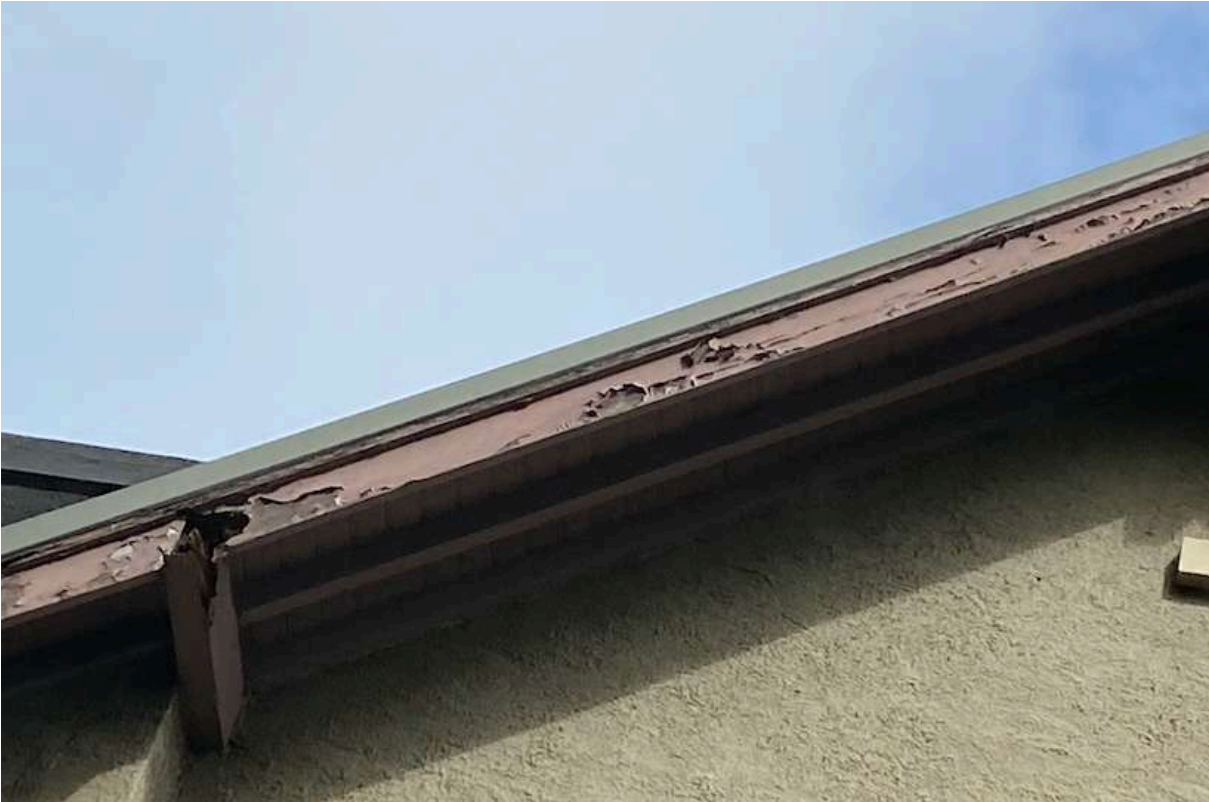
Photo. 5. All barge boards, fascia and eaves lining boards are to be inspected for damage and repaired where required by an experienced contractor with a proven record of satisfactory work on heritage buildings prior to properly preparing and repainting.

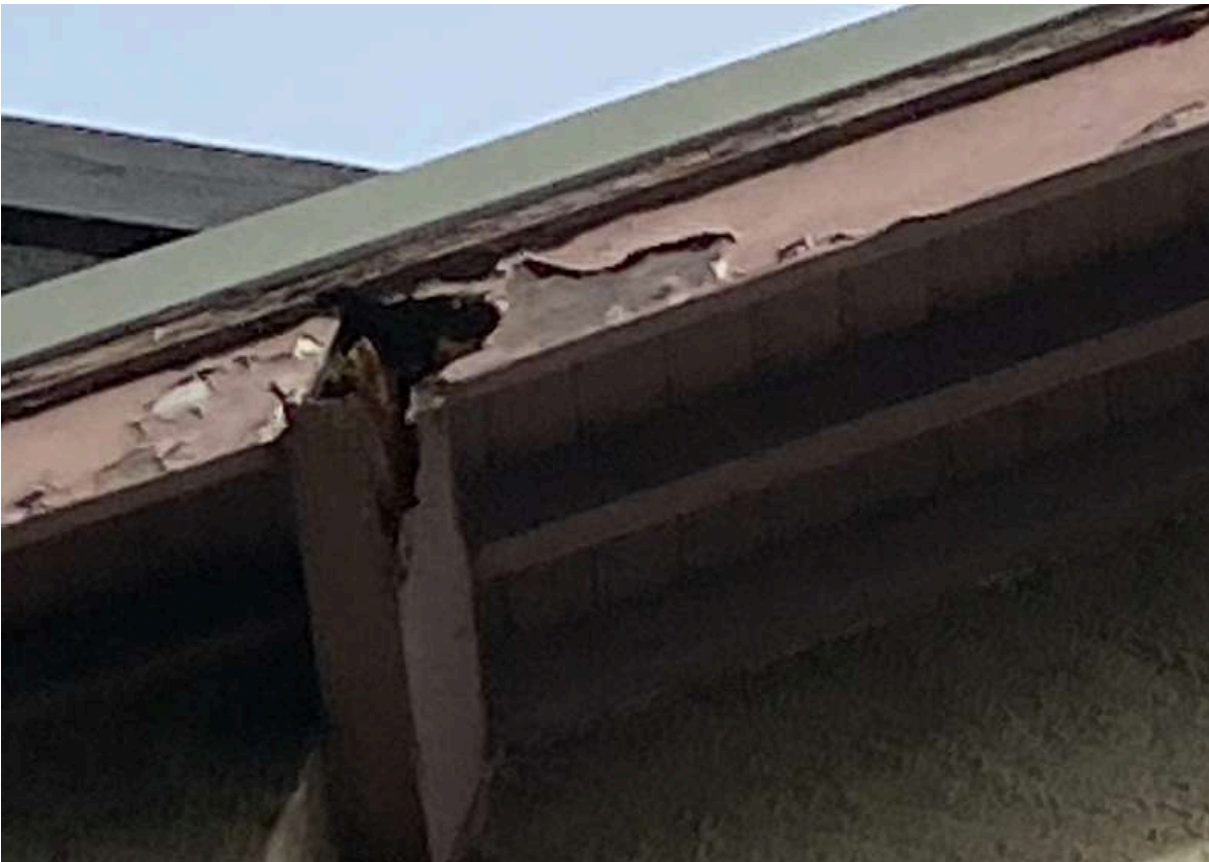
Photo. 6. The rot damaged timber supporting the exposed rafters at the front (east elevation) of the Presbytery is to be repaired.

<p>LOCATION: Roof Timbers</p> <p>WORK REQUIRED: The rot damaged timber supporting the exposed rafters at the front (east elevation) of the Presbytery is to be repaired.</p> <p>Repair of heritage fabric is preferred to replacing elements with matching 'like-for-like' material.</p> <p>This work is to be executed by an experienced licensed contractor with a proven record of satisfactory work to heritage buildings.</p> <p>Standard: AS 1684.2—2021 Timber framing</p>		
Issue:	March 2022

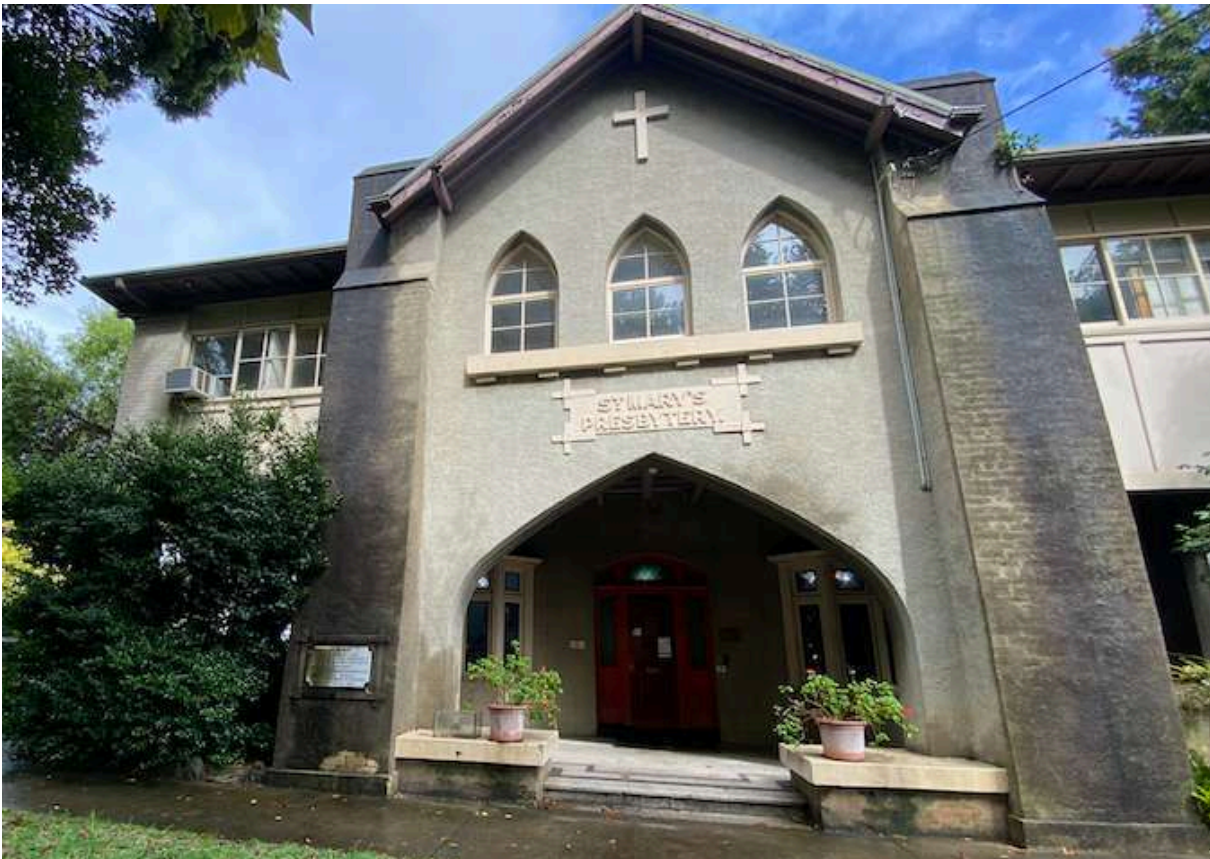
Photo. 7. All of the external brickwork and masonry is to be professionally cleaned by an experienced contractor with a proven record of satisfactory work on heritage buildings.

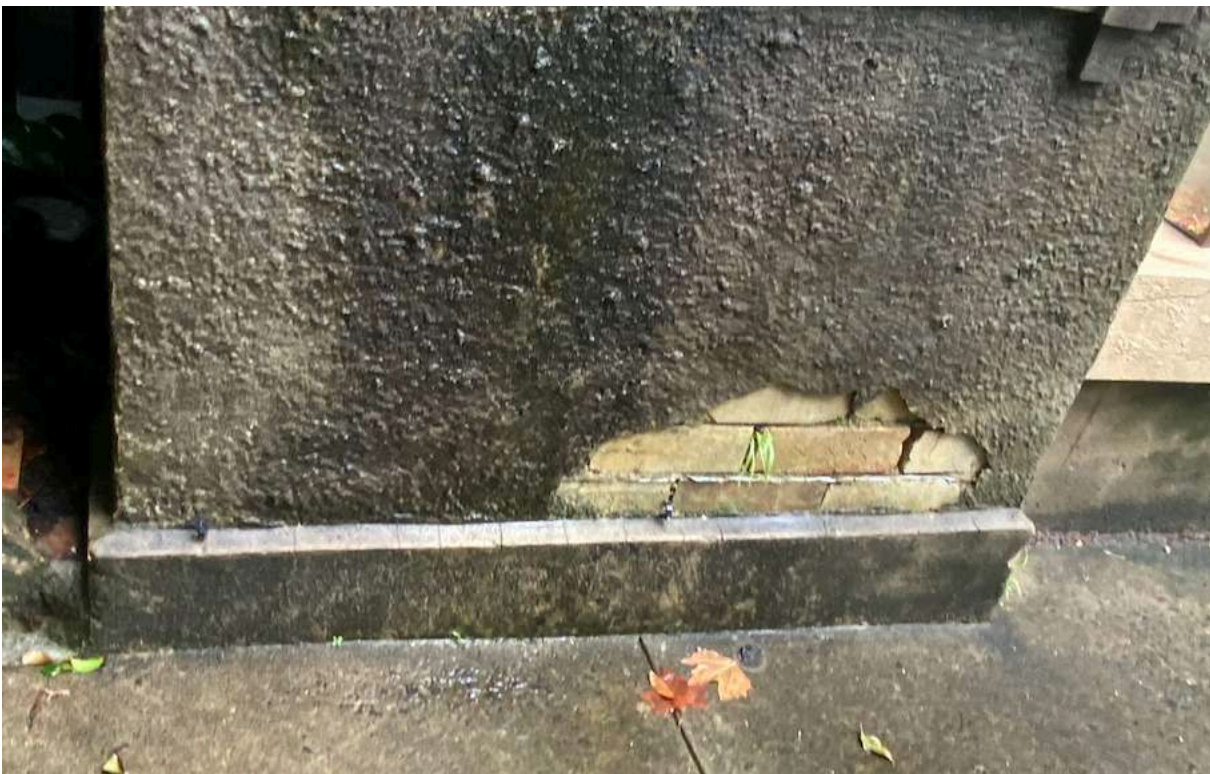
Photo. 8. Damaged tyrolean render is to be repaired by an experienced contractor with a proven record of satisfactory tyrolean render repairs.

LOCATION: Eastern Elevation WORK REQUIRED: Damaged tyrolean render is to be repaired by an experienced contractor with a proven record of satisfactory tyrolean render repairs. Standard: AS 3700-2018 Masonry Structures

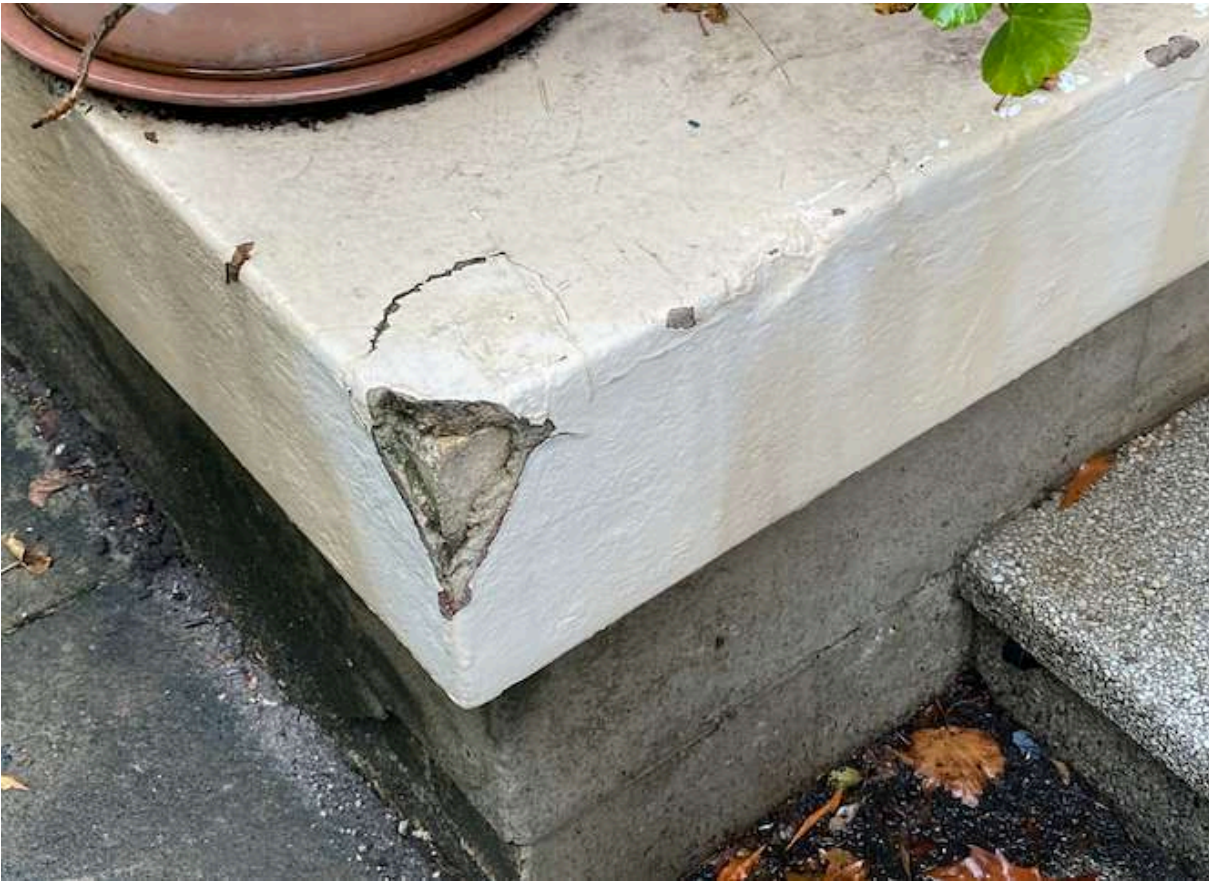
Photo. 9. Damaged render is to be repaired by an experienced contractor with a proven record of satisfactory render repairs.

LOCATION: Eastern Elevation WORK REQUIRED: Damaged render is to be repaired by an experienced contractor with a proven record of satisfactory render repairs to heritage buildings. Standard: AS 3700-2018 Masonry Structures

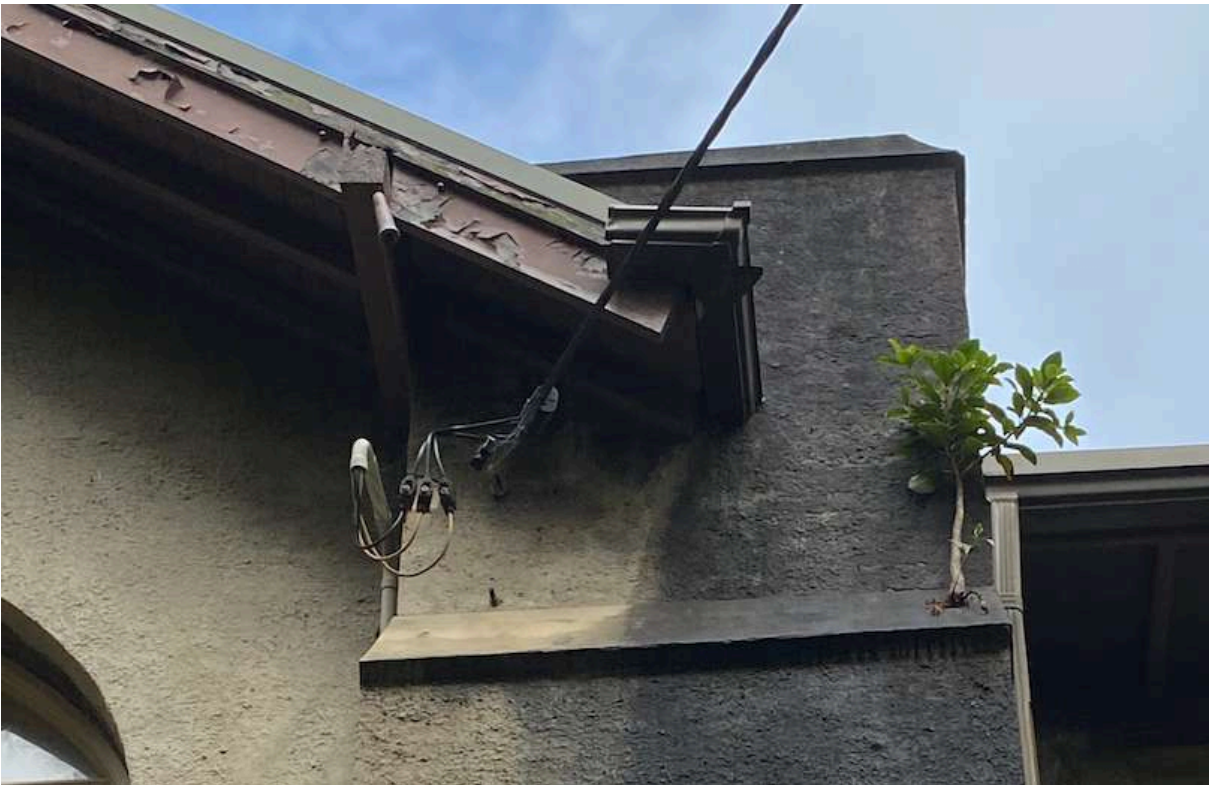
Photo. 10. Vegetation growing on the masonry is to be removed and the cracks repaired.

<p>LOCATION: Entire Presbytery</p> <p>WORK REQUIRED: Vegetation growing on the masonry is to be removed and the cracks repaired.</p> <p>This work is to be executed by an experienced licensed contractor with a proven record of satisfactory work to heritage buildings.</p> <p>Standard: AS 3700-2018 Masonry Structures</p>

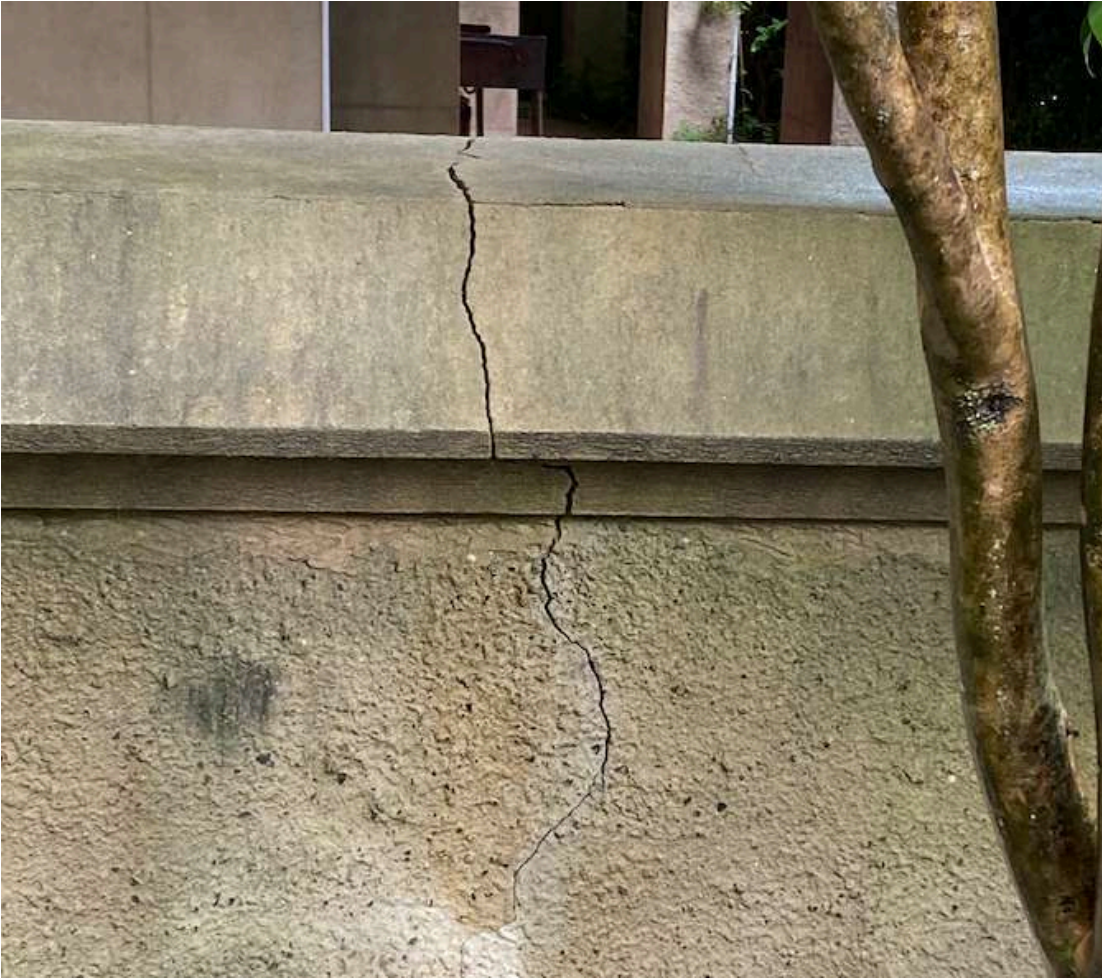
Photo. 11. Cracks in masonry are to be repaired with minimal disturbance to original heritage fabric.

<p>LOCATION: Eastern Elevation</p> <p>WORK REQUIRED: Cracks in masonry are to be repaired with minimal disturbance to original heritage fabric.</p> <p>This work is to be executed by an experienced licensed contractor with a proven record of satisfactory work to heritage buildings.</p> <p>Standard: AS 3700-2018 Masonry Structures</p>

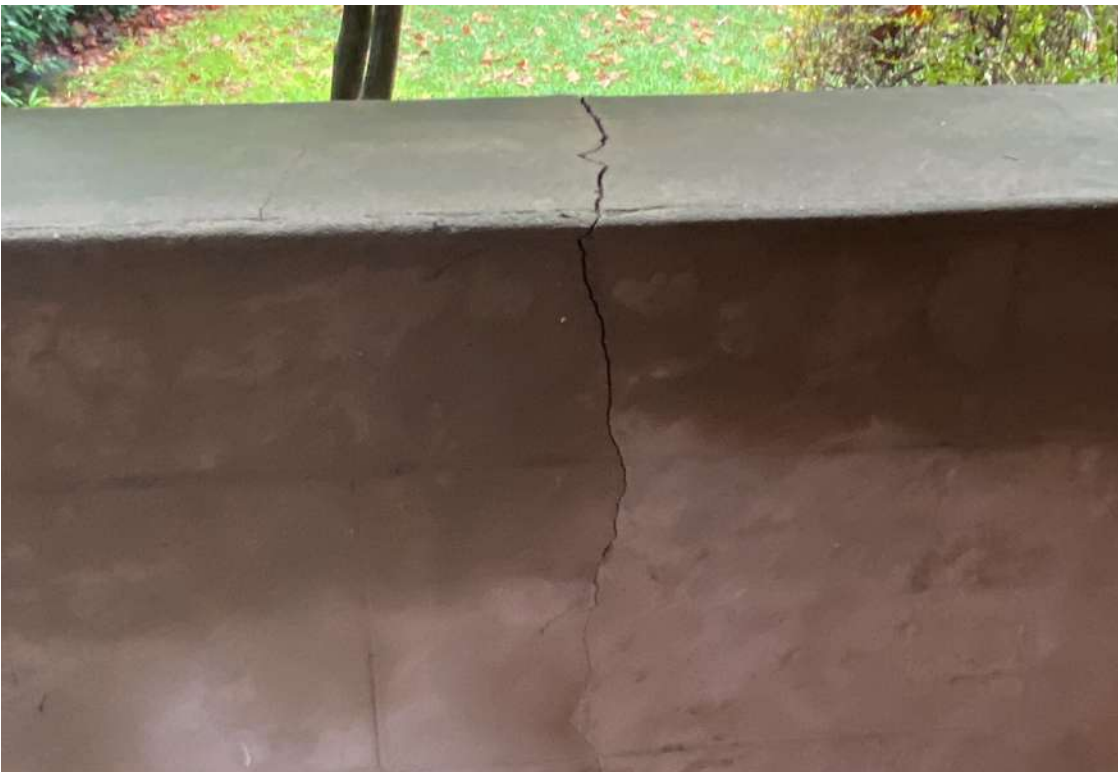
Photo. 12. Cracks in masonry are to be repaired with minimal disturbance to original heritage fabric.

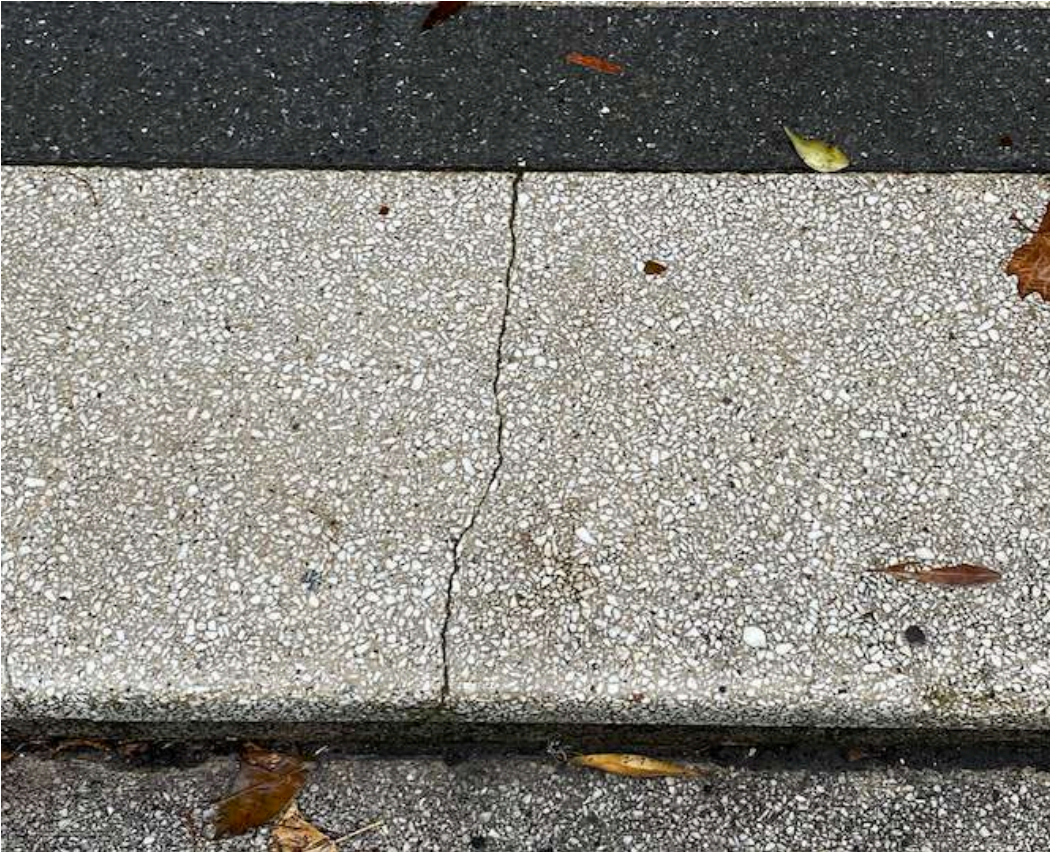
Photo. 13. The crack in the terrazzo step at the entry to the Presbytery is to be invisibly repaired by an experienced terrazzo repair contractor with a proven record of satisfactory terrazzo repairs.

<p>LOCATION: Verandahs</p> <p>WORK REQUIRED: The crack in the terrazzo step at the entry to the Presbytery is to be invisibly repaired by an experienced terrazzo repair contractor with a proven record of satisfactory terrazzo repairs.</p> <p>Standard: AS 3700-2018 Masonry Structures</p>

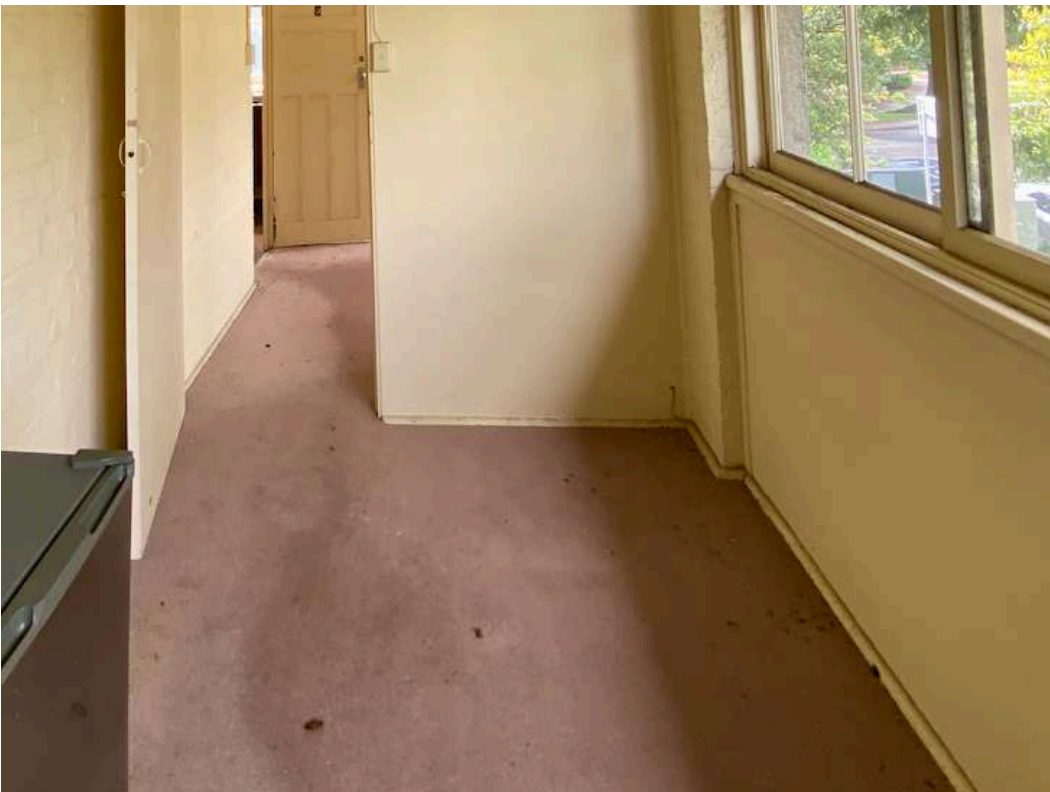
Photo. 14. Prior to the removal of the existing windows to reinstate the first floor verandahs on the northern and southern elevations (demolition) both internal and external cladding is to be examined to ensure the cladding material is not asbestos sheet.

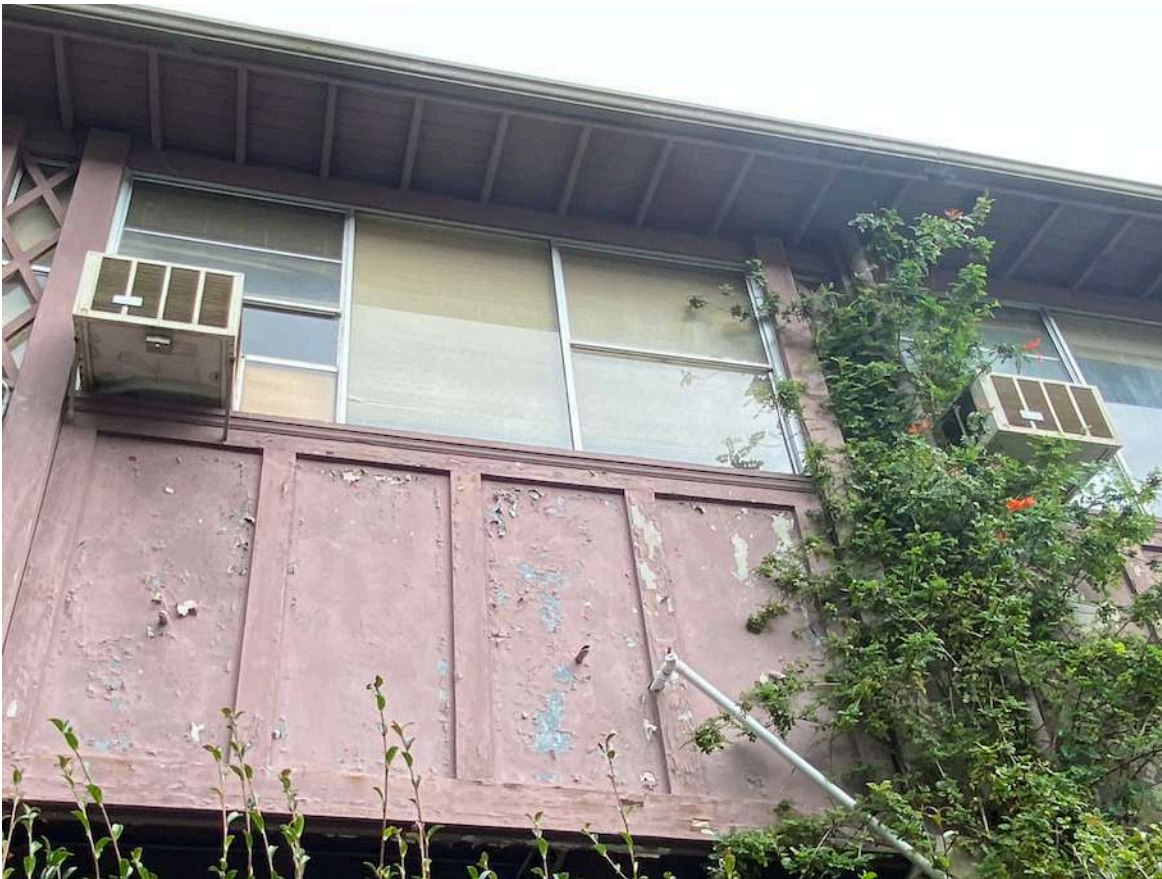
Photo. 15. Prior to the removal of the existing windows to reinstate the first floor verandahs on the northern, east and southern elevations (demolition) both internal and external cladding is to be examined to ensure the cladding material is not asbestos sheet.

<p>LOCATION: Proposed Open Verandahs</p> <p>WORK REQUIRED: Prior to the removal of the existing windows to reinstate the first floor verandahs on the northern, east and southern elevations (demolition). Both internal and external cladding is to be examined by a licensed asbestos inspector to ensure the cladding material is not asbestos sheet.</p> <p>Standard: AS 4964-2004 Asbestos identification</p>		
Issue:	March 2022

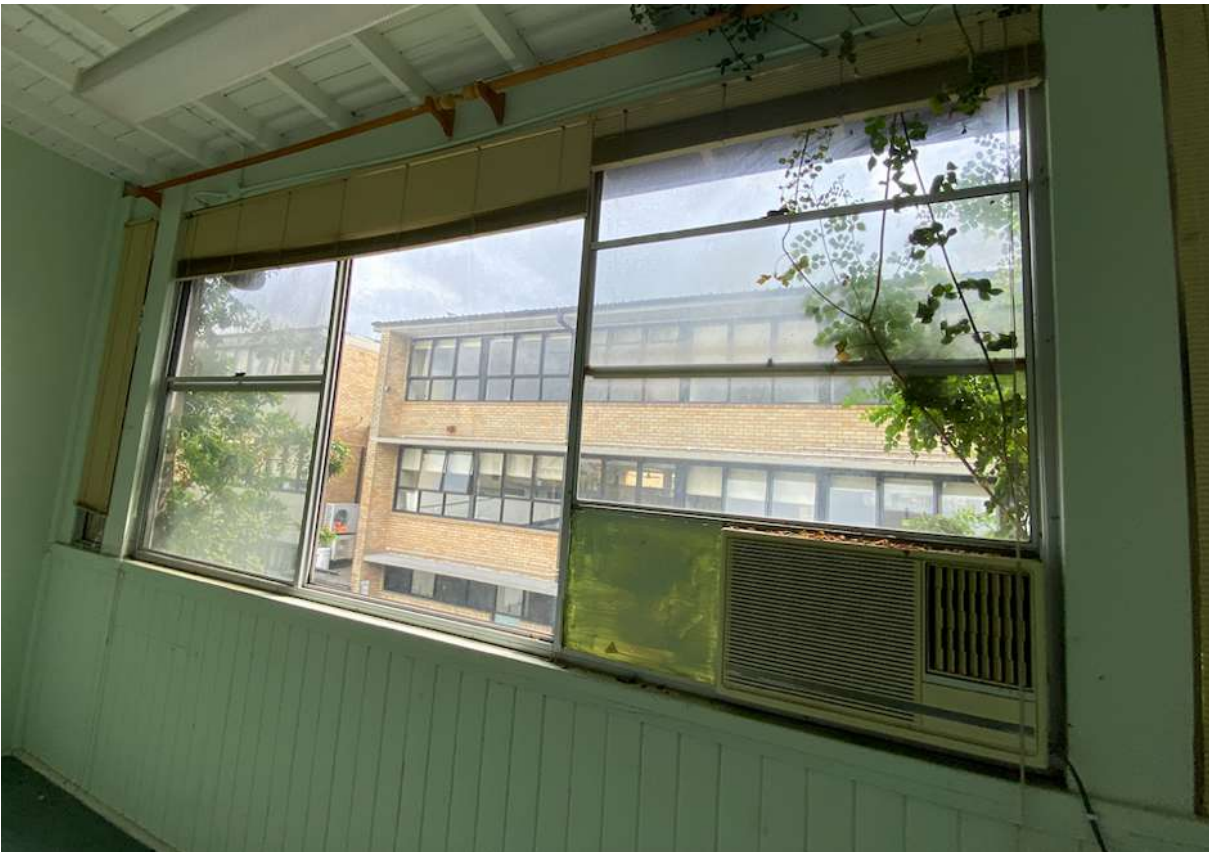
Photo. 17. All aluminium windows and air-conditioning units are to be removed.

LOCATION: Entire Presbytery WORK REQUIRED: All aluminium windows and air-conditioning units are to be removed. This work is to be executed by an experienced licensed contractor with a proven record of satisfactory work to heritage buildings. Standards: AS 1684.2—2021 Timber framing and AS 2601 – 2001 Demolition Standard checklist.

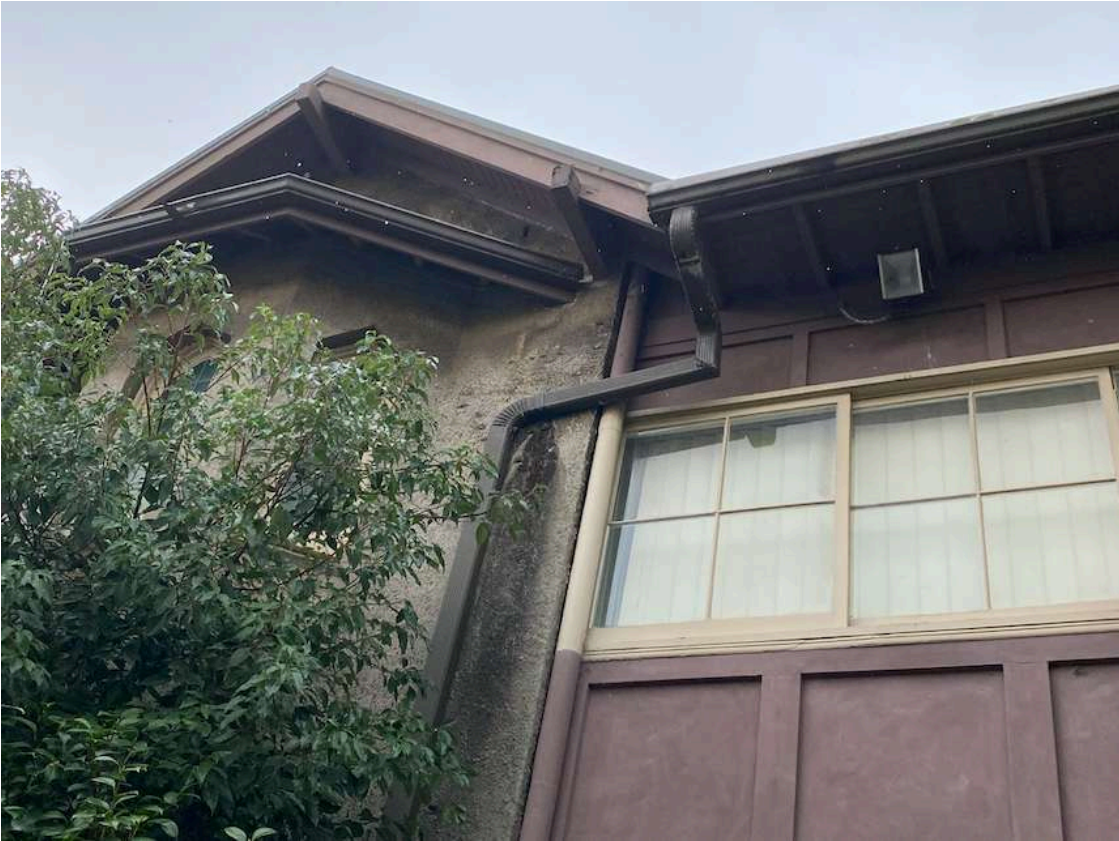
Photo. 34. All the exterior cladding and timber work is to be inspected by an experienced contractor with a proven record of satisfactory work on heritage buildings and any required repairs completed prior to properly preparing and repainting

- All the exterior cladding and timber work is to be inspected by an experienced contractor with a proven record of satisfactory work on heritage buildings and any required repairs completed prior to properly preparing and repainting, (photo 34-35).

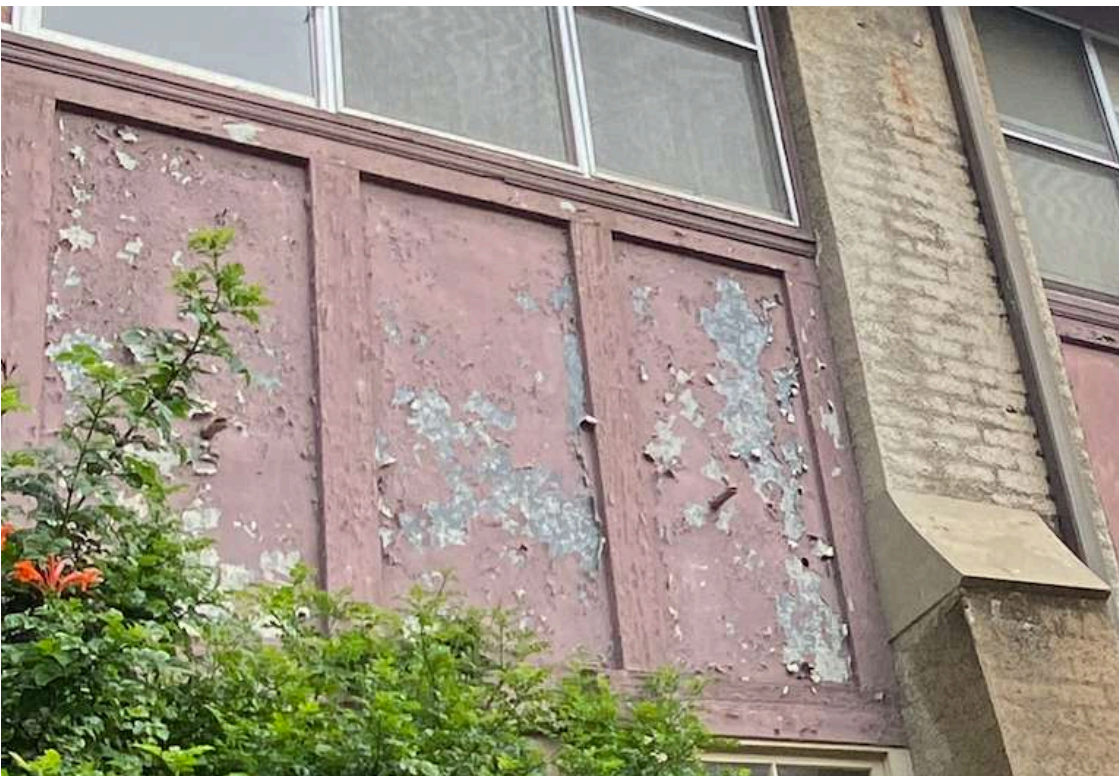
Photo. 35. All the exterior cladding and timber work is to be inspected by an experienced contractor with a proven record of satisfactory work on heritage buildings and any required repairs completed prior to properly preparing and repainting.

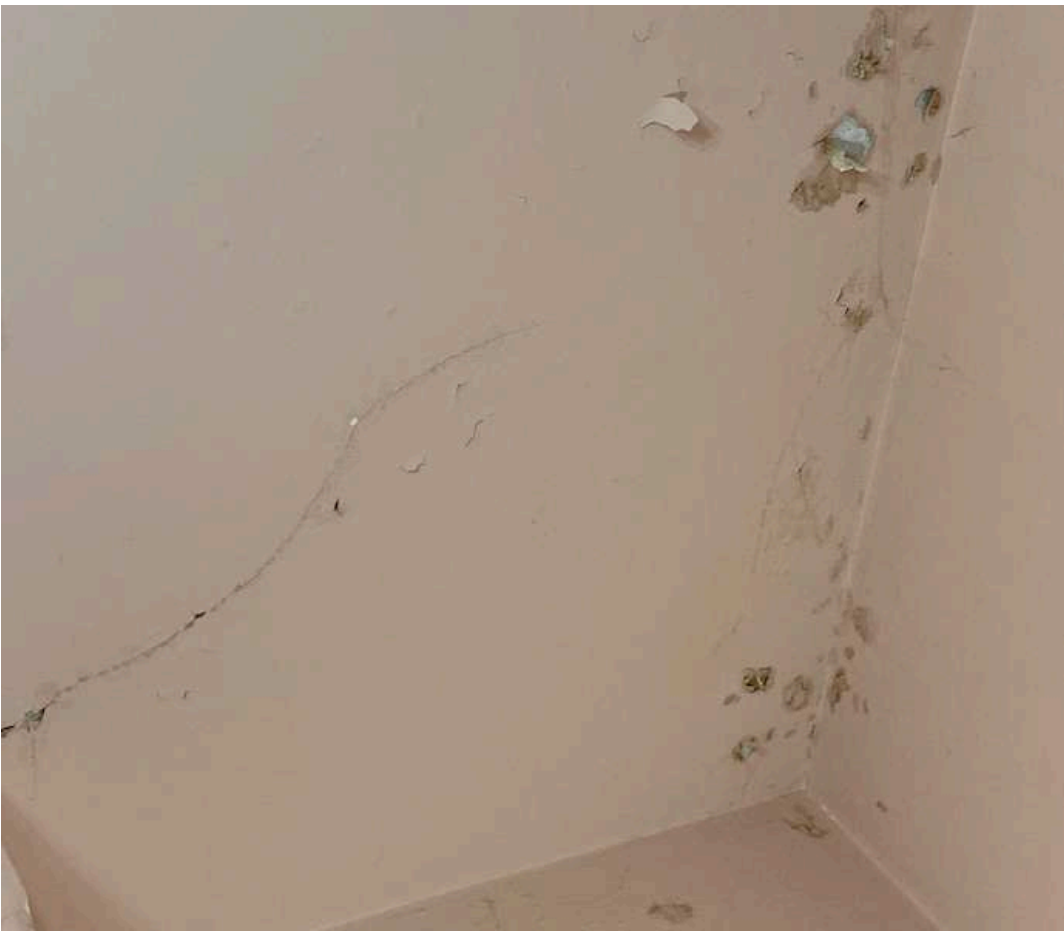
Photo. 37. The water damaged ceiling in the ground floor room on the southern side is to be repaired and the hand basin in the room directly above investigated for water leaks.

<p>LOCATION: Ground floor</p> <p>WORK REQUIRED: The water damaged ceiling in the ground floor room on the southern side is to be repaired and the hand basin in the room directly above investigated for water leaks.</p> <p>This work is to be executed by an experienced contractor with a proven record of satisfactory work to heritage buildings.</p> <p>Standard: HB 161-2005 Guide to Plastering</p>

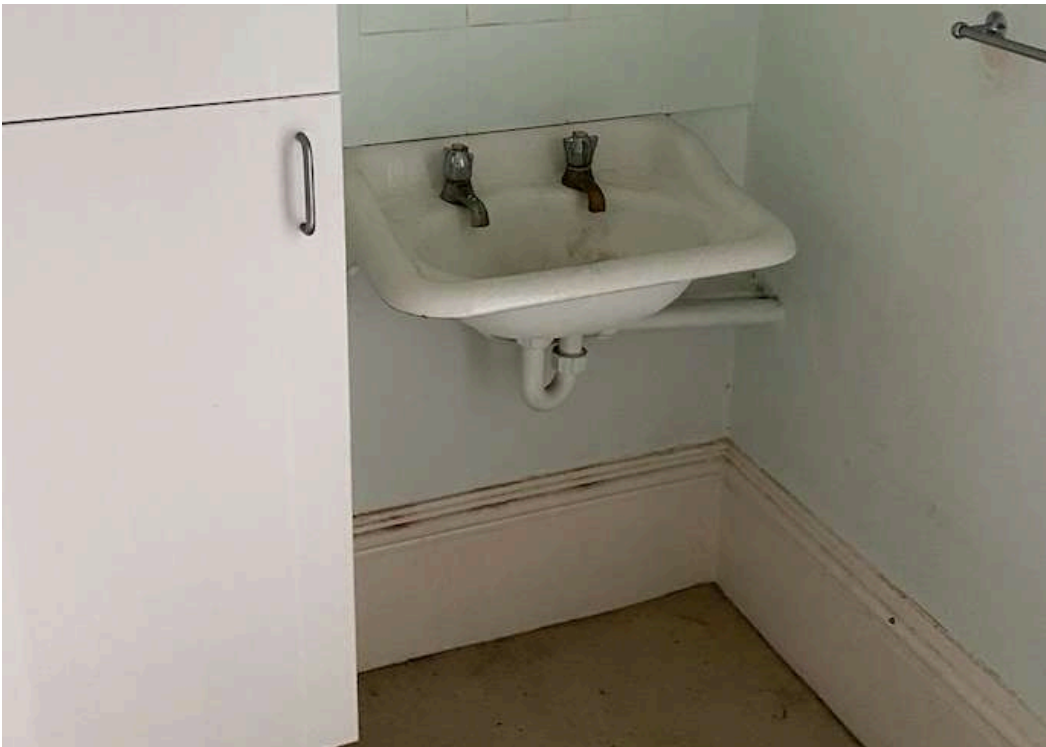
Photo. 38. The water damaged ceiling in the ground floor room on the southern side is to be repaired and the hand basin in the room directly above investigated for water leaks.

<p>LOCATION: First Floor</p> <p>WORK REQUIRED: The water damaged ceiling in the ground floor room on the southern side is to be repaired and the hand basin in the room directly above investigated for water leaks. This work is to be executed by an experienced licensed plumbing contractor with a proven record of satisfactory work to heritage buildings.</p> <p>Standard: AS/NZS 3500 Set – 2018 Plumbing and drainage</p>		
Issue:	March 2022

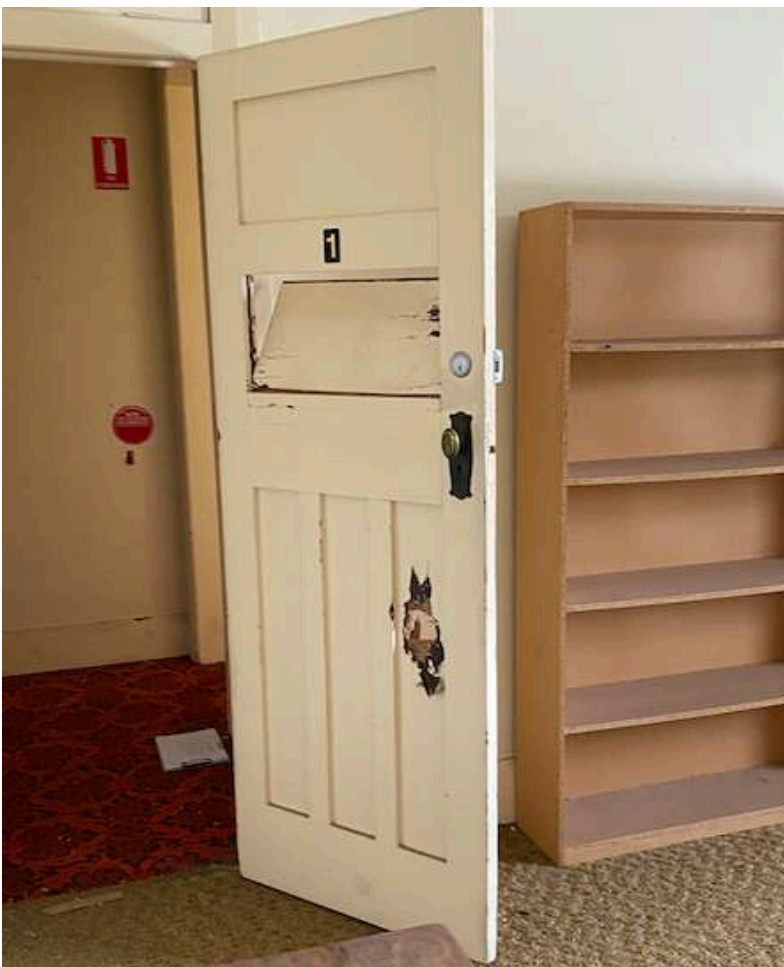
Photo. 39. The damaged heritage door on the first floor at the rear of the Presbytery is to be replaced with a matching heritage door. Preferably a heritage door sourced from a heritage building supply centre.

LOCATION: First Floor WORK REQUIRED: The damaged heritage door on the first floor at the rear of the Presbytery is to be replaced with a matching heritage door. Preferably a heritage door sourced from a heritage building supply centre. Standard: AS 1684.2—2021 Timber framing

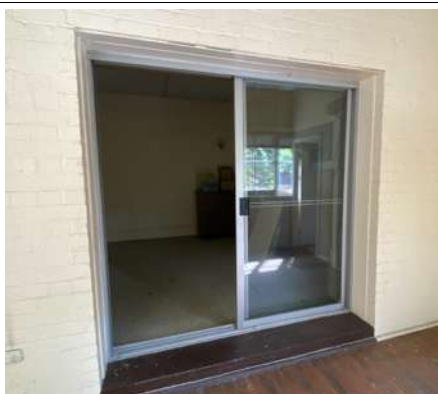
<p>LOCATION: Proposed Open Verandahs</p> <p>WORK REQUIRED: The Aluminium sliding door at the north end of the eastern elevation on the first floor is to be removed. Details of the proposed new timber door or window are to be approved by the nominated heritage consultant.</p> <p>Standards: AS 1684.2—2021 Timber framing and AS 2601 – 2001 Demolition Standard checklist.</p>
