RE: Marist Catholic College North Shore (SSD-10473). Response to Submissions and peer review. NSW Government, Department Planning, Industry and Environment (DPIE)

APPENDIX A: SUMMARY TABLE Marist Catholic College North Shore (SSD-10473). Response to Submissions.

This Schedule of Conservation Works is a list of work that is required to correct damage and deterioration to St. Mary's Presbytery, Marist Catholic College, 270 Miller Street, North Sydney NSW

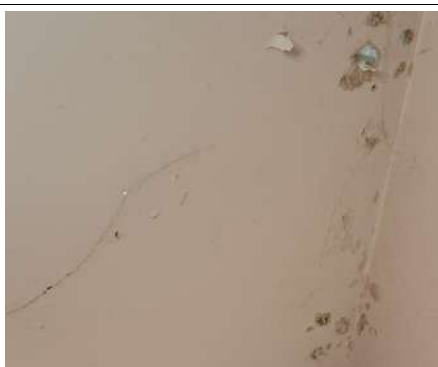
<p>LOCATION: Ground floor</p> <p>WORK REQUIRED: The water damaged ceiling in the ground floor room on the southern side is to be repaired and the hand basin in the room directly above investigated for water leaks.</p> <p>This work is to be executed by an experienced contractor with a proven record of satisfactory work to heritage buildings.</p> <p>Standard: HB 161-2005 Guide to Plastering</p>

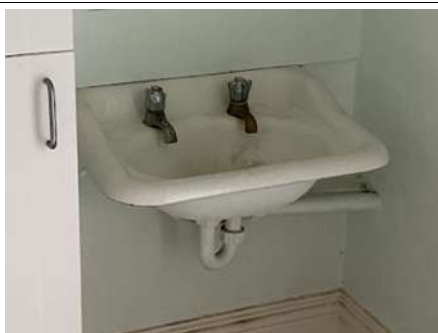
<p>LOCATION: First Floor</p> <p>WORK REQUIRED: The water damaged ceiling in the ground floor room on the southern side is to be repaired and the hand basin in the room directly above investigated for water leaks. This work is to be executed by an experienced licensed plumbing contractor with a proven record of satisfactory work to heritage buildings.</p> <p>Standard: AS/NZS 3500 Set – 2018 Plumbing and drainage</p>		
Issue:	March 2022

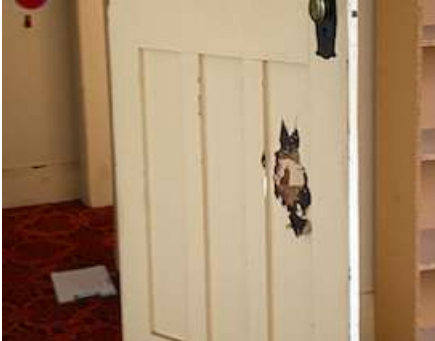
LOCATION: First Floor WORK REQUIRED: The damaged heritage door on the first floor at the rear of the Presbytery is to be replaced with a matching heritage door. Preferably a heritage door sourced from a heritage building supply centre. Standard: AS 1684.2—2021 Timber framing
