# Arboricultural Impact Assessment

Site Address: 10 Lomas Lane Nulkaba, NSW

Client: St Philips Christian College

Date: September 2022

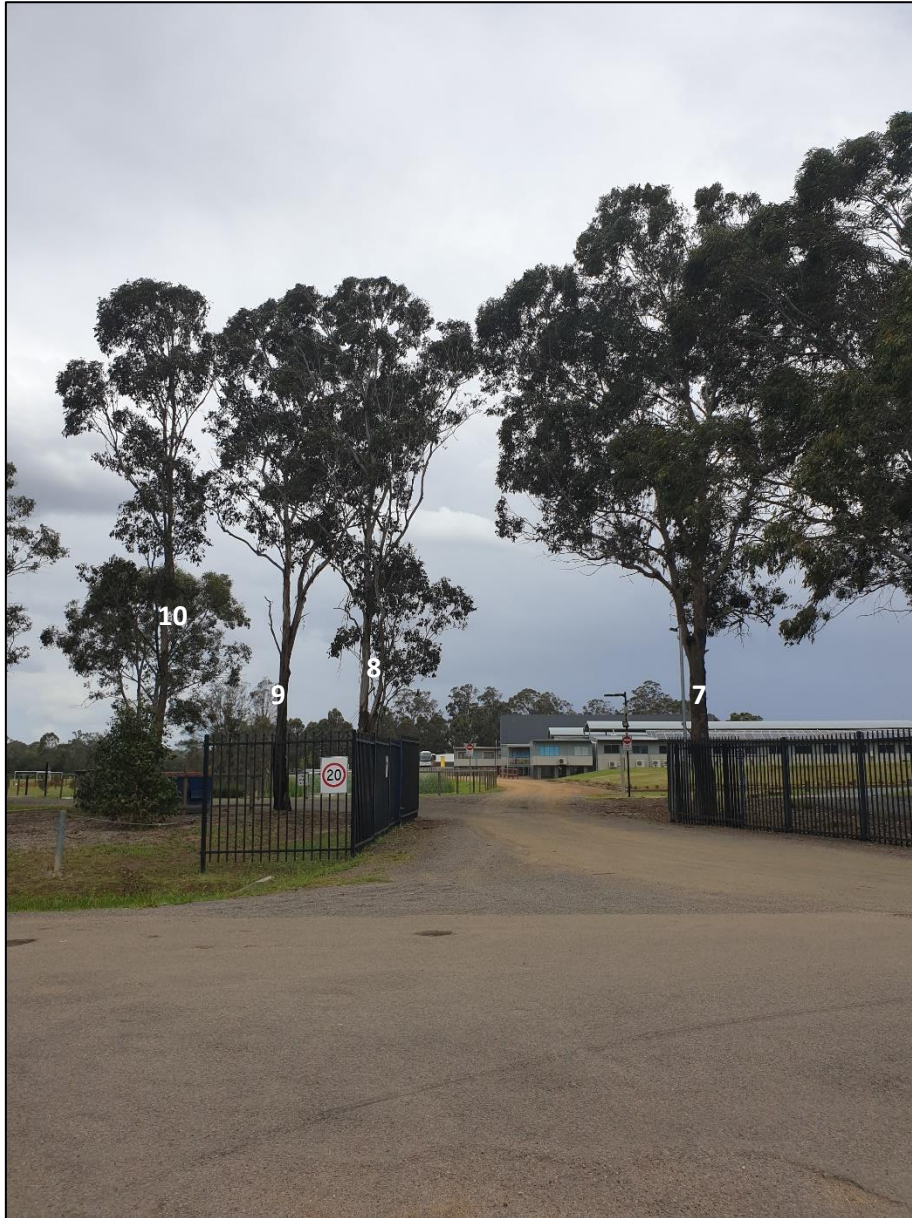
Figure 1 Trees 7 – 10 *Eucalyptus moluccana* adjacent to the site entry

| No | Common Name | Species | DBH (M) | TPZ (M) | SRZ (M) | HEIGHT (M) | SPREAD (M) | Vigour | Age Class | SULE | Comments |
|---|---|---|---|---|---|---|---|---|---|---|---|
| 7 | Grey Box | <i>Eucalyptus moluccana</i> | 0.56 | 6.72 | 2.81 | 20 | 11 | g | m | 2a | Minor deadwood noted, canopy bias to South |
| 8 | Grey Box | <i>Eucalyptus moluccana</i> | 0.38 | 4.56 | 2.43 | 18 | 10 | g | m | 2a | Minor deadwood noted, otherwise appears structurally sound |
| 9 | Grey Box | <i>Eucalyptus moluccana</i> | 0.5 | 6 | 2.74 | 18 | 9 | av | m | 3a | Sparse canopy, wound seam at base |
| 10 | Grey Box | <i>Eucalyptus moluccana</i> | 0.31 | 3.72 | 2.37 | 12 | 5 | av | sm | 2a | Minor deadwood noted suppressed by nearby trees |

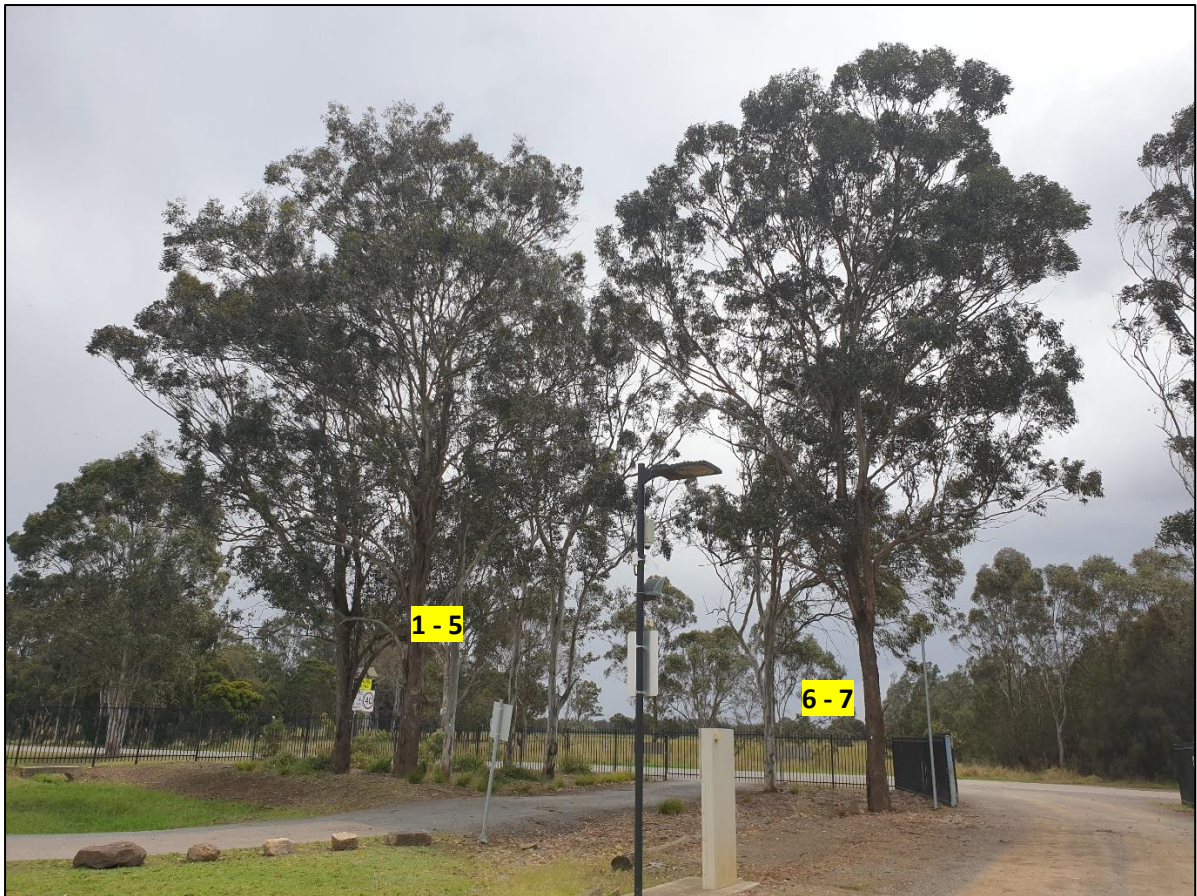
| No | Common Name | Species | DBH (M) | TPZ (M) | SRZ (M) | HEIGHT (M) | SPREAD (M) | Vigour | Age Class | SULE | Comments |
|---|---|---|---|---|---|---|---|---|---|---|---|
| 6 | Forest Red Gum | <i>Eucalyptus tereticornis</i> | 0.4 | 4.8 | 2.43 | 15 | 11 | g | m | 2a | Minor deadwood noted, canopy bias to North. |

| No. | Species | Health and Vigour | Condition | Suitability | Sustainability | Landscape rating | Retention Value | Encroachment level* | Proposal |
|---|---|---|---|---|---|---|---|---|---|
| 6 | <i>Eucalyptus tereticornis</i> | Good | Good | High | 15-40 years | 2 | High | 30% TPZ<br>13%SRZ | Removal |
| 7 | <i>Eucalyptus moluccana</i> | Good | Good | High | 15-40 years | 2 | High | 50% TPZ<br>50% SRZ | Removal |

**Figure 3 Trees 6 – 7 will be subject to encroachment from construction of the proposed roadway**

That Trees 6 to 14 and 24-27 are approved for removal to facilitate the proposed development in its current form subject to the provision of compensatory replacement planting of endemic native trees within the boundary of the subject site.

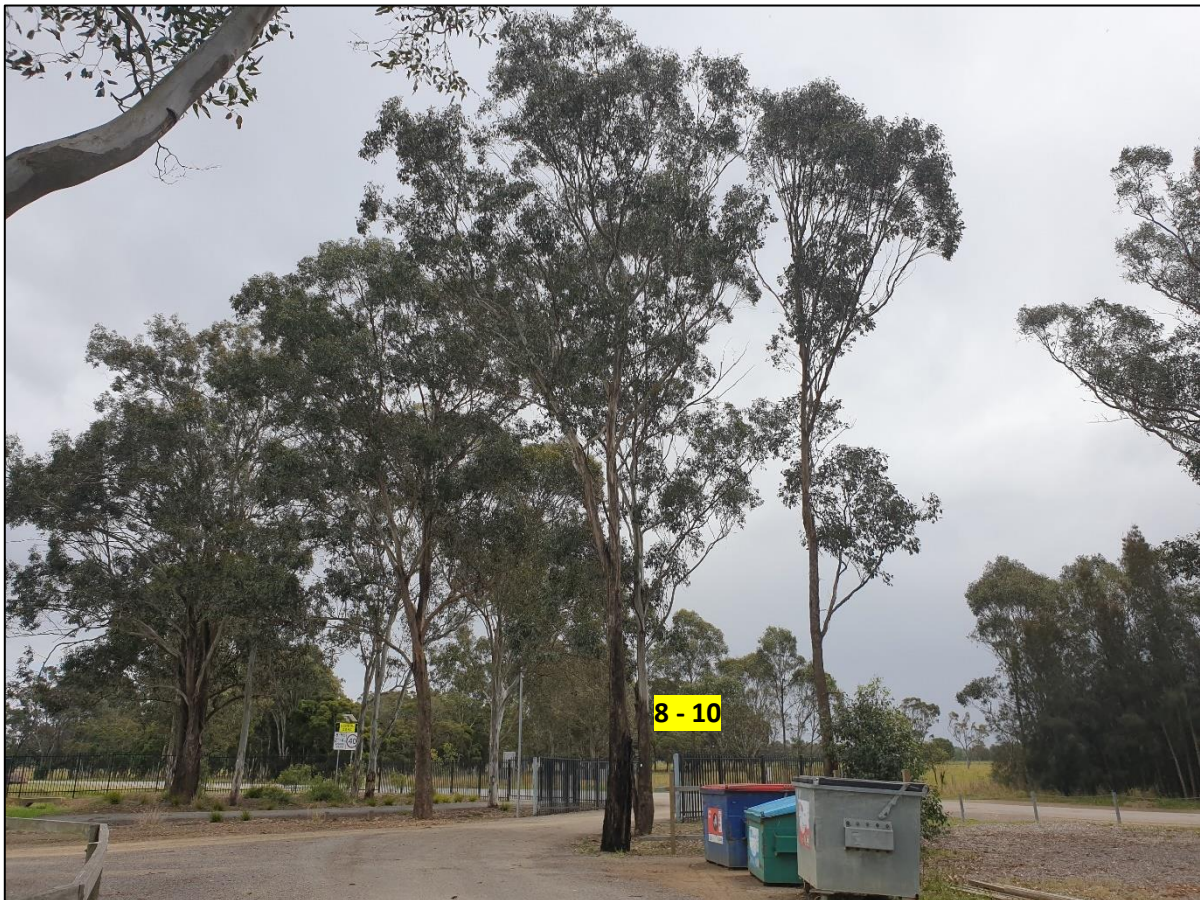
| No. | Species | Health and Vigour | Condition | Suitability | Sustainability | Landscape rating | Retention Value | Encroachment level* | Proposal |
|---|---|---|---|---|---|---|---|---|---|
| 8 | <i>Eucalyptus moluccana</i> | Good | Good | High | 15-40 years | 2 | High | 60% TPZ/SRZ | Removal |
| 9 | <i>Eucalyptus moluccana</i> | Average | Good | High | 5-15 years | 3 | Moderate | 100% TPZ/SRZ | Removal |
| 10 | <i>Eucalyptus moluccana</i> | Average | Good | High | 15-40 years | 2 | High | 65% TPZ/SRZ | Removal |

**Figure 4 Trees 8- 10 will be subject to encroachment from construction of the proposed roadway**

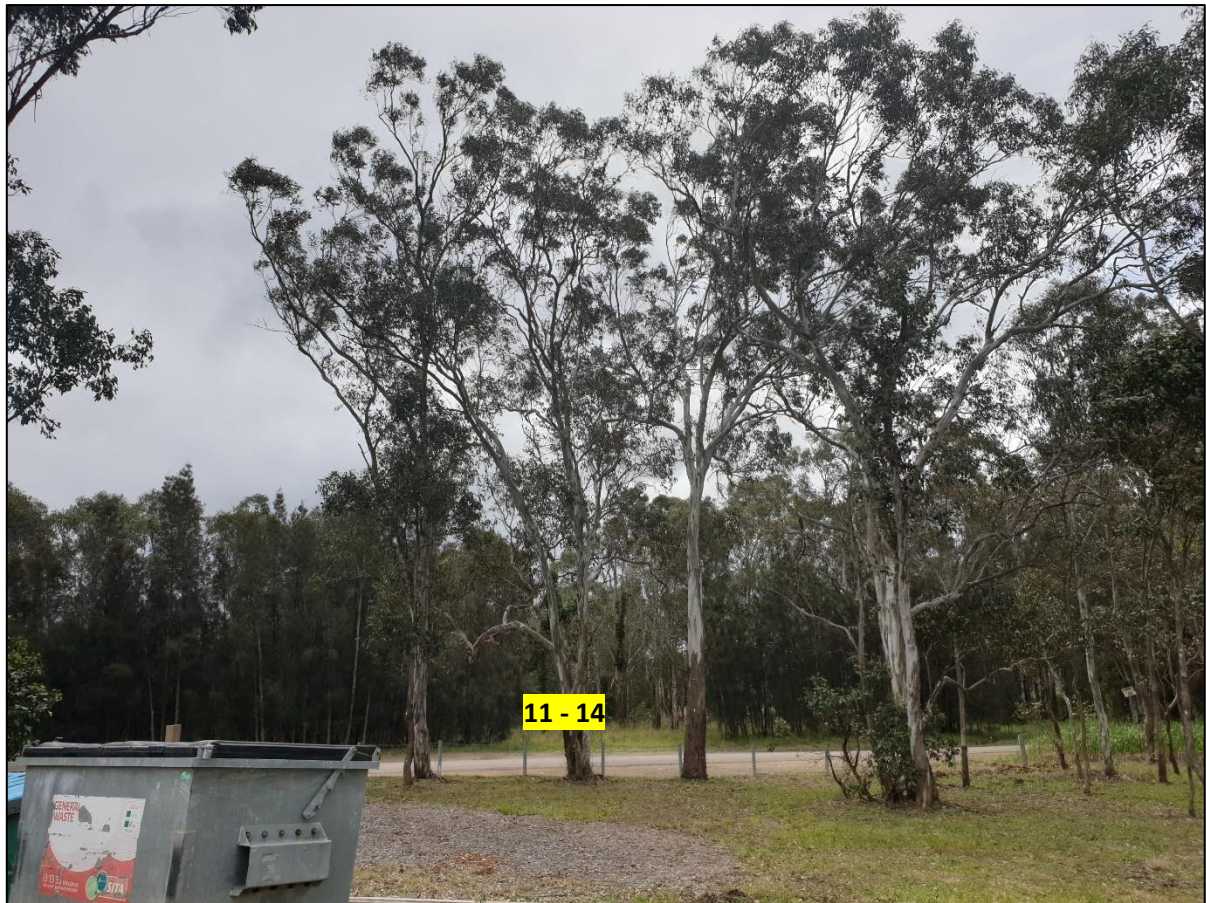
| No | Common Name | Species | DBH (M) | TPZ (M) | SRZ (M) | HEIGHT (M) | SPREAD (M) | Vigour | Age Class | SULE | Comments |
|---|---|---|---|---|---|---|---|---|---|---|---|
| 11 | Grey Box | <i>Eucalyptus moluccana</i> | 0.15 | 2 | 1.61 | 8 | 2 | g | j | 2a | Appears structurally sound |
| 12 | Forest Red Gum | <i>Eucalyptus tereticornis</i> | 0.38 | 4.56 | 2.37 | 16 | 9 | g | m | 2a | Minor deadwood noted, otherwise appears structurally sound |
| 13 | Forest Red Gum | <i>Eucalyptus tereticornis</i> | 0.68 | 8.16 | 2.67 | 16 | 11 | av | m | 3a | Minor deadwood noted, included fork union at 1.5 metres |
| 14 | Forest Red Gum | <i>Eucalyptus tereticornis</i> | 0.2 | 2.4 | 1.85 | 10 | 2 | av | sm | 2a | Minor deadwood noted suppressed by nearby trees |

| No. | Species | Health and Vigour | Condition | Suitability | Sustainability | Landscape rating | Retention Value | Encroachment level* | Proposal |
|---|---|---|---|---|---|---|---|---|---|
| 11 | <i>Eucalyptus moluccana</i> | Good | Good | High | 15-40 years | 2 | High | 100% TPZ/SRZ | Removal |
| 12 | <i>Eucalyptus tereticornis</i> | Good | Good | High | 15-40 years | 2 | High | 57% TPZ/SRZ | Removal |
| 13 | <i>Eucalyptus tereticornis</i> | Average | Good | High | 5-15 years | 3 | Moderate | 40% TPZ<br>22%SRZ | Removal |
| 14 | <i>Eucalyptus tereticornis</i> | Average | Good | High | 15-40 years | 2 | High | 19% TPZ<br>11% SRZ | Removal |

**Figure 5 Trees 11 - 14 will be subject to encroachment from construction of the proposed roadway**

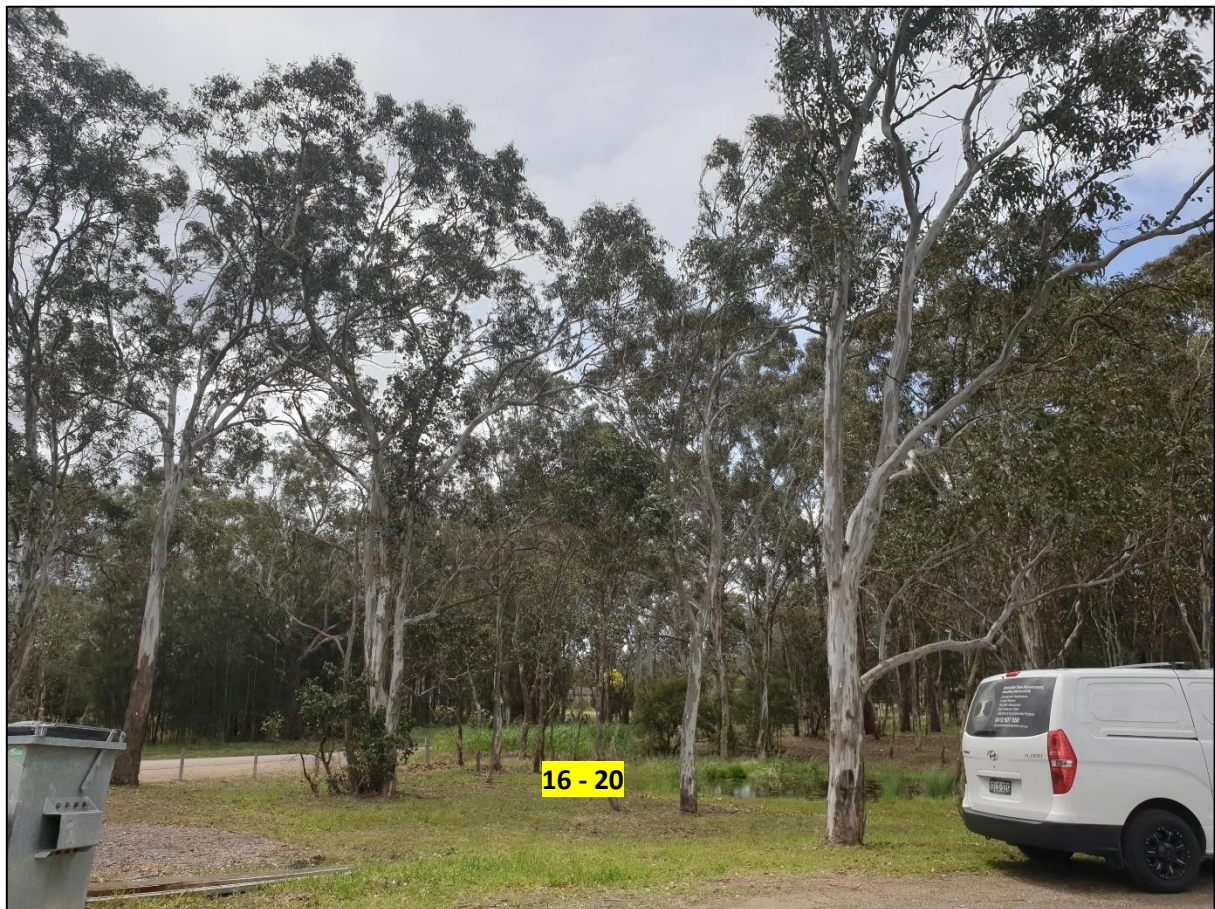
| No | Common Name | Species | DBH (M) | TPZ (M) | SRZ (M) | HEIGHT (M) | SPREAD (M) | Vigour | Age Class | SULE | Comments |
|---|---|---|---|---|---|---|---|---|---|---|---|
| 16 | Forest Red Gum | <i>Eucalyptus tereticornis</i> | .48,<br>.12 | 5.88 | 2.63 | 16 | 12 | g | m | 2a | Minor deadwood noted, otherwise appears structurally sound |
| 17 | Forest Red Gum | <i>Eucalyptus tereticornis</i> | 0.25 | 3 | 2.00 | 9 | 1 | p | om | 4a | Damaged, entire canopy comprised of epicormic growth |
| 18 | Grey Box | <i>Eucalyptus moluccana</i> | 0.1 | 2 | 1.68 | 5 | 1 | g | j | 1a | Appears structurally sound |
| 19 | Forest Red Gum | <i>Eucalyptus tereticornis</i> | 0 | 3.12 | 2.13 | 14 | 9 | av | m | 2a | Sparse canopy, minor deadwood noted |
| 20 | Forest Red Gum | <i>Eucalyptus tereticornis</i> | 0.31 | 3.72 | 2.37 | 16 | 9 | g | m | 2a | Minor deadwood noted, canopy bias to South |

**Figure 6 Trees 16 – 20 will be retained in conjunction with the proposed development**

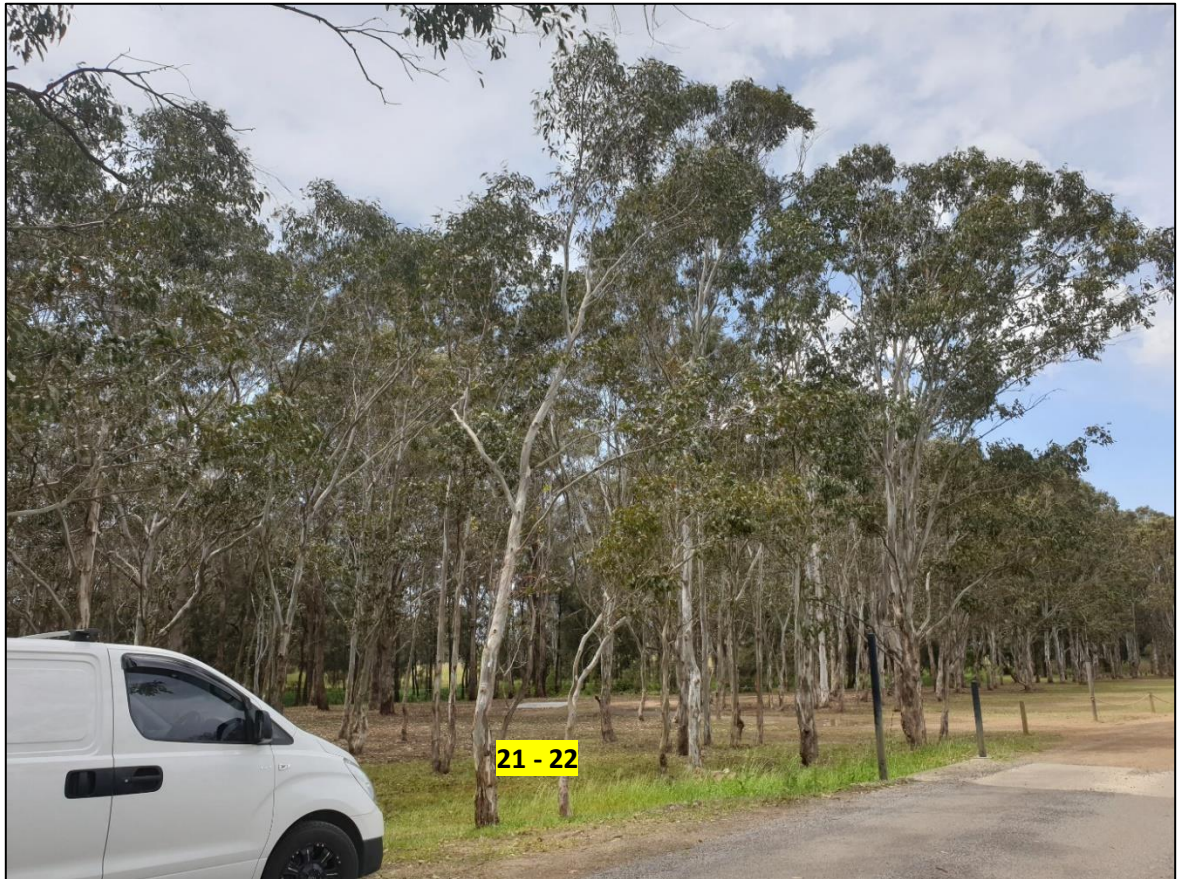
| No | Common Name | Species | DBH (M) | TPZ (M) | SRZ (M) | HEIGHT (M) | SPREAD (M) | Vigour | Age Class | SULE | Comments |
|---|---|---|---|---|---|---|---|---|---|---|---|
| 21 | Forest Red Gum | <i>Eucalyptus tereticornis</i> | 0.2 | 2.4 | 1.94 | 9 | 4 | g | sm | 2a | Minor deadwood noted, otherwise appears structurally sound |
| 22 | Forest Red Gum | <i>Eucalyptus tereticornis</i> | 0.1 | 2 | 1.50 | 3 | 1 | g | j | 1a | Appears structurally sound |

| No. | Species | Health and Vigour | Condition | Suitability | Sustainability | Landscape rating | Retention Value | Encroachment level* | Proposal |
|---|---|---|---|---|---|---|---|---|---|
| 21 | <i>Eucalyptus tereticornis</i> | Good | Good | High | 15-40 years | 2 | High | *26% TPZ<br>18% SRZ | Retention |
| 22 | <i>Eucalyptus tereticornis</i> | Good | Good | High | 40+ years | 2 | High | *19% TPZ<br>SRZ 10% | Retention |

**Figure 7 Trees 21-22 *Eucalyptus tereticornis* are proposed for retention**

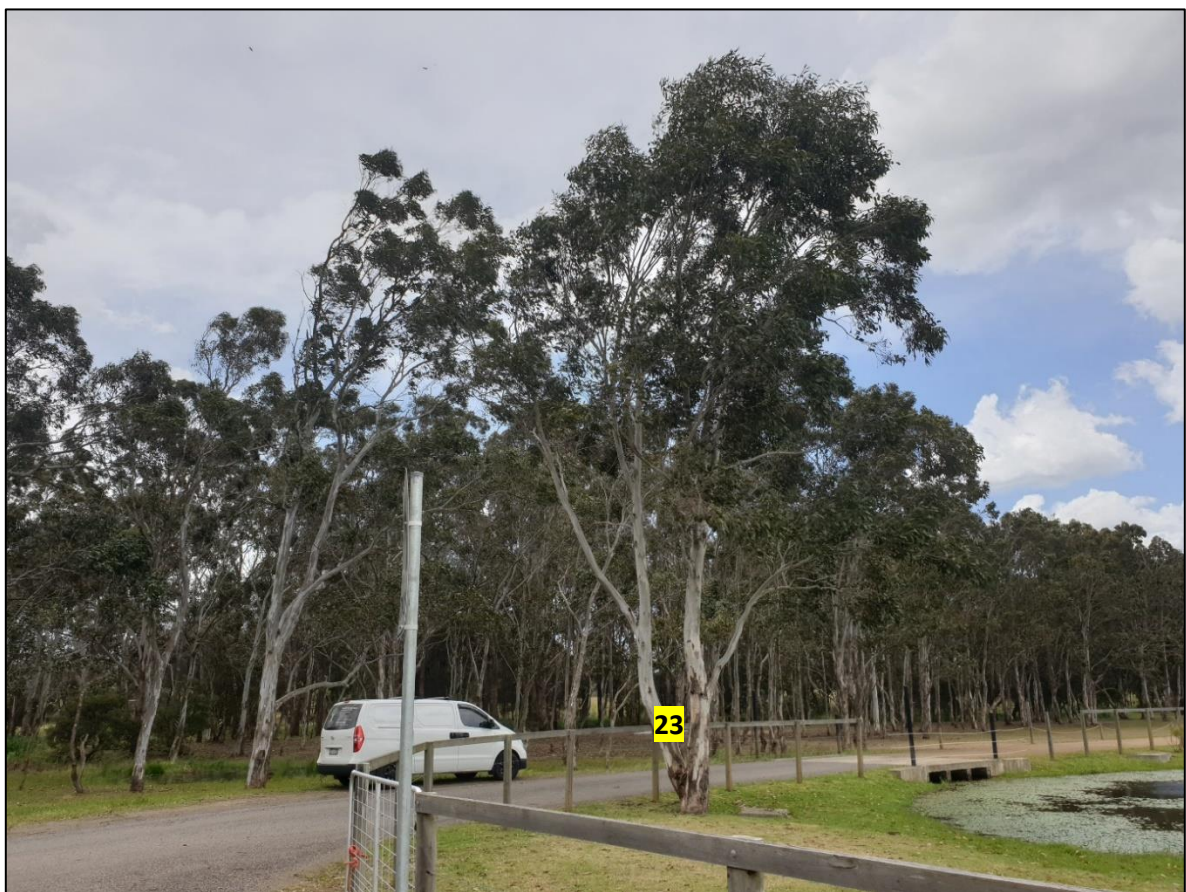
| No | Common Name | Species | DBH (M) | TPZ (M) | SRZ (M) | HEIGHT (M) | SPREAD (M) | Vigour | Age Class | SULE | Comments |
|---|---|---|---|---|---|---|---|---|---|---|---|
| 23 | Forest Red Gum | <i>Eucalyptus tereticornis</i> | .33,<br>.37 | 6 | 2.59 | 12 | 9 | g | m | 1a | Co-dominant trunks from base, no included bark, appears structurally sound |

| No. | Species | Health and Vigour | Condition | Suitability | Sustainability | Landscape rating | Retention Value | Encroachment level* | Proposal |
|---|---|---|---|---|---|---|---|---|---|
| 23 | <i>Eucalyptus tereticornis</i> | Good | Good | High | 40+ years | 1 | High | *29% TPZ<br>6%SRZ | Retention |

**Figure 8 Tree 23 *Eucalyptus tereticornis* is proposed for retention**

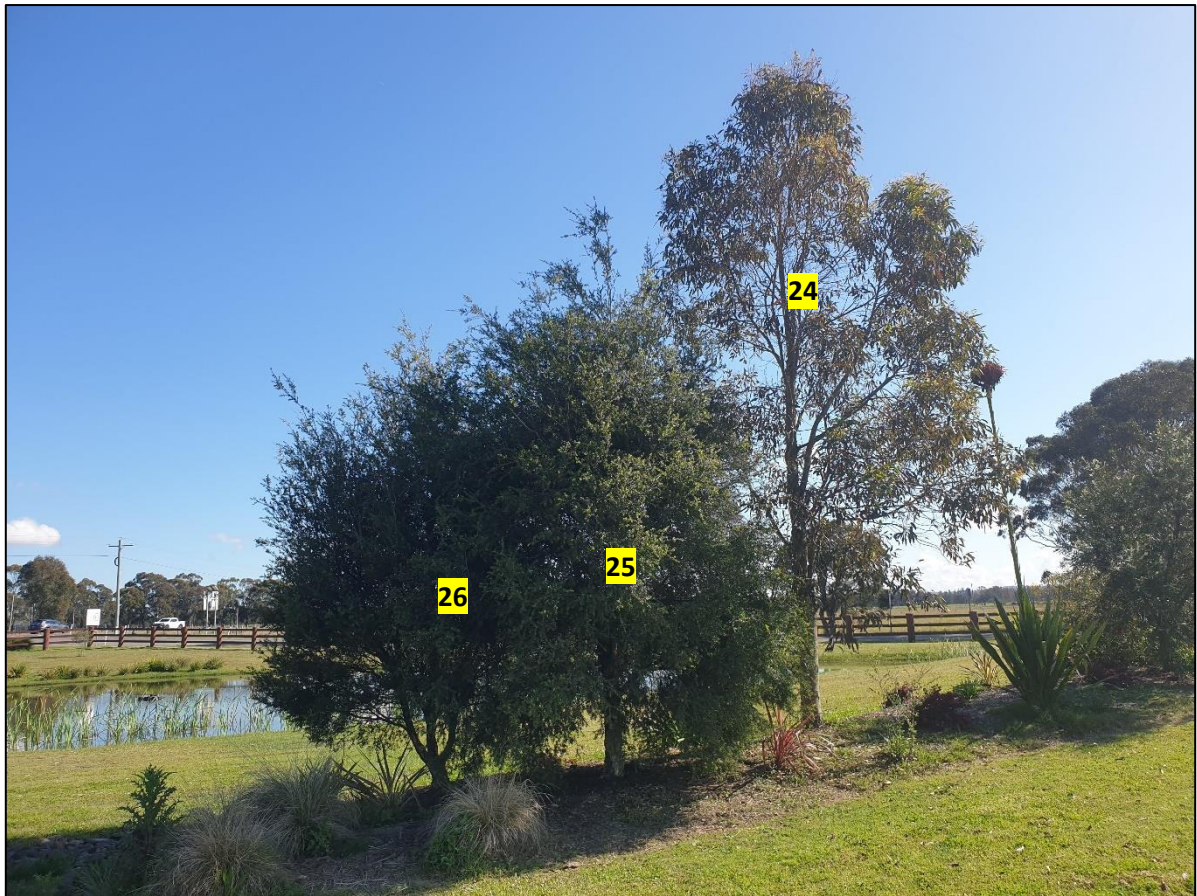
| No | Common Name | Species | DBH (M) | TPZ (M) | SRZ (M) | HEIGHT (M) | SPREAD (M) | Vigour | Age Class | SULE | Comments |
|---|---|---|---|---|---|---|---|---|---|---|---|
| 24 | Grey Gum | <i>Eucalyptus punctata</i> | 0.2 | 2.4 | 1.7 | 5.4 | 4 | g | sm | 1a | Appears structurally sound, co-dominant leaders |
| 25 | Prickly-leaved Paperbark | <i>Melaleuca stypheliodes</i> | 0.1 | 2 | 1.5 | 3.6 | 3 | g | sm | 5a | Appears structurally sound |
| 26 | Prickly-leaved Paperbark | <i>Melaleuca stypheliodes</i> | 0.1 | 2 | 1.5 | 3.2 | 2 | g | sm | 5a | Appears structurally sound |

| No. | Species | Health and Vigour | Condition | Suitability | Sustainability | Landscape rating | Retention Value | Encroachment level* | Proposal |
|---|---|---|---|---|---|---|---|---|---|
| 24 | <i>Eucalyptus punctata</i> | Good | Good | High | 40+ years | 4 | Moderate | 100% TPZ/SRZ | Removal |
| 25 | <i>Melaleuca stypheliodes</i> | Good | Good | High | 15-40 years | 4 | Moderate | 100% TPZ/SRZ | Removal |
| 26 | <i>Melaleuca stypheliodes</i> | Good | Good | High | 15-40 years | 4 | Moderate | 100% TPZ/SRZ | Removal |

**Figure 9 Trees 24 *Eucalyptus punctata*, 25-26 *Melaleuca styphelioides***

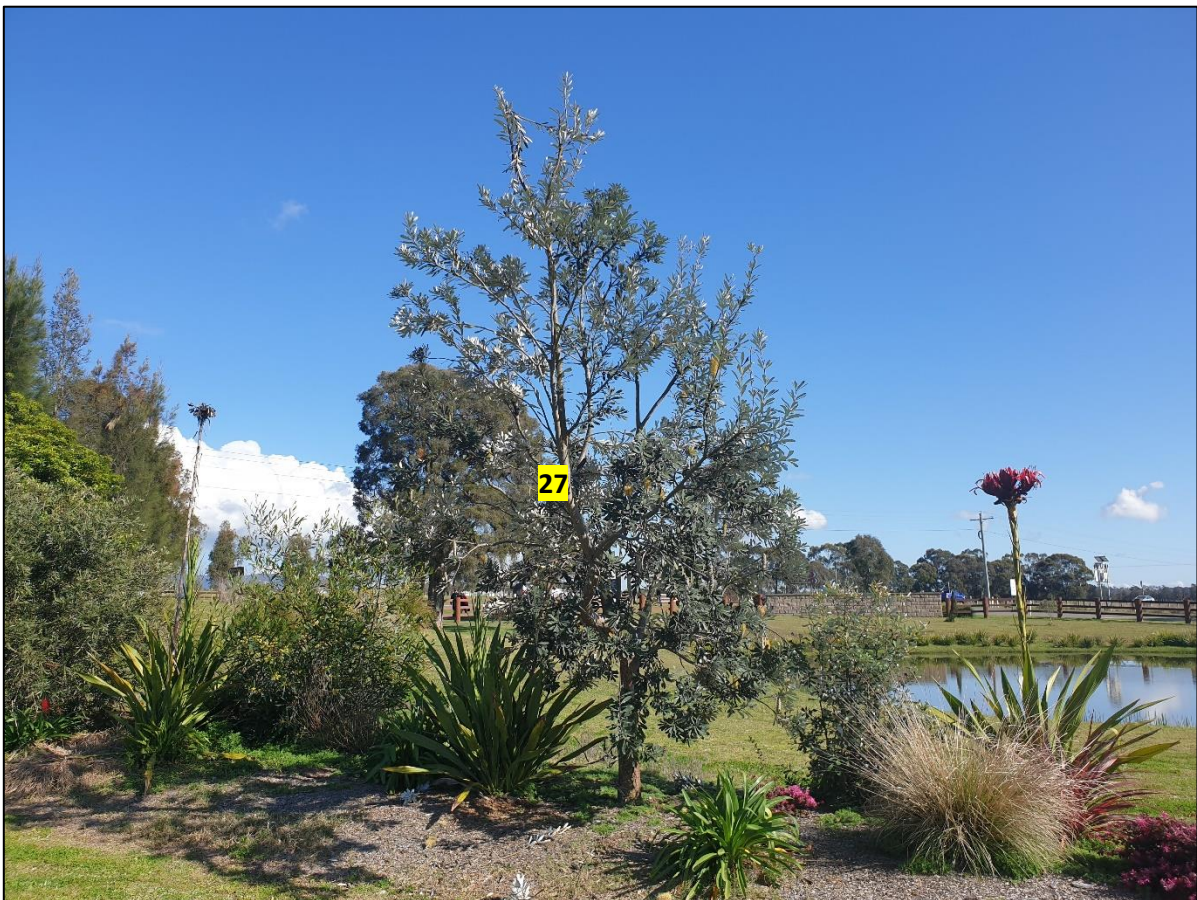
| No | Common Name | Species | DBH (M) | TPZ (M) | SRZ (M) | HEIGHT (M) | SPREAD (M) | Vigour | Age Class | SULE | Comments |
|---|---|---|---|---|---|---|---|---|---|---|---|
| 27 | Coast Banksia | <i>Banksia integrifolia</i> | 0.12 | 2 | 1.5 | 3 | 3 | g | sm | 5a | Appears structurally sound, minor asymmetry |

| No. | Species | Health and Vigour | Condition | Suitability | Sustainability | Landscape rating | Retention Value | Encroachment level* | Proposal |
|---|---|---|---|---|---|---|---|---|---|
| 27 | <i>Banksia integrifolia</i> | Good | Good | High | 15-40 years | 4 | Moderate | 100% TPZ/SRZ | Removal |

**Figure 10 Tree 27 *Banksia integrifolia***
