Harbourside

## Excavation Phase - Construction Noise and Vibration Management Plan

## 16.8 APPENDIX H – HAZARDOUS BUILDING MATERIAL SURVEY (JBS&G)

Mirvac Retail Sub SPV Pty Ltd  
Hazardous Building Materials Survey  
Harbourside Shopping Centre Redevelopment  
2-10 Darling Drive,  
Sydney, NSW

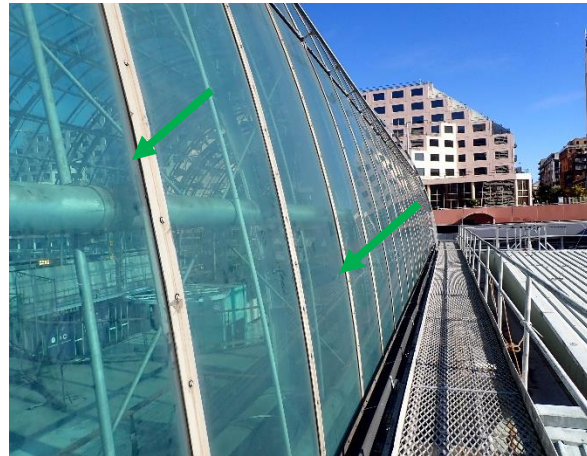
Photo 2: Harbourside – non-asbestos containing black mastic sealant to external glass windows/panels

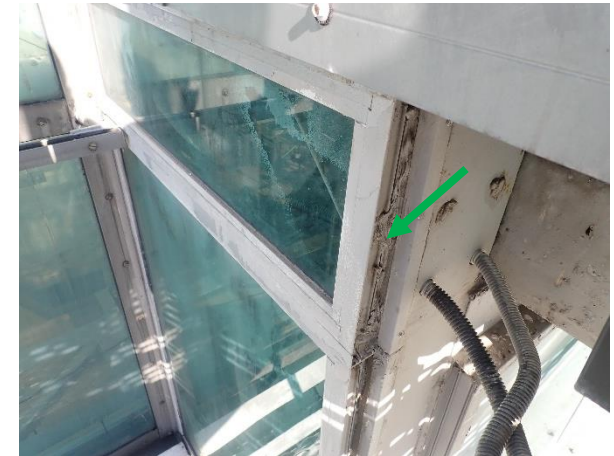
Photo 3: Harbourside – non-asbestos containing grey mastic sealant to the external steel framework

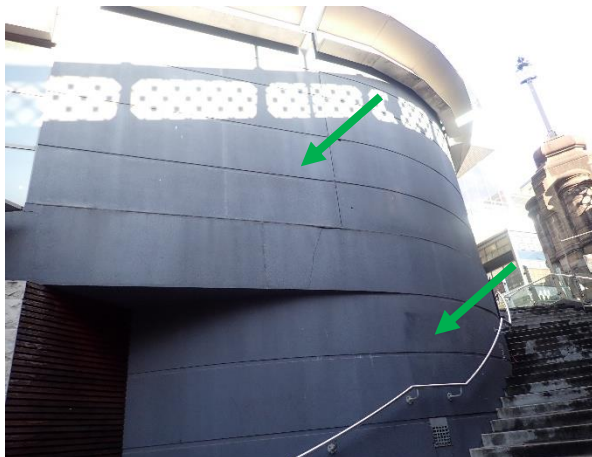
Photo 4: Harbourside – non-asbestos containing compressed fibre cement sheeting to the external cladding

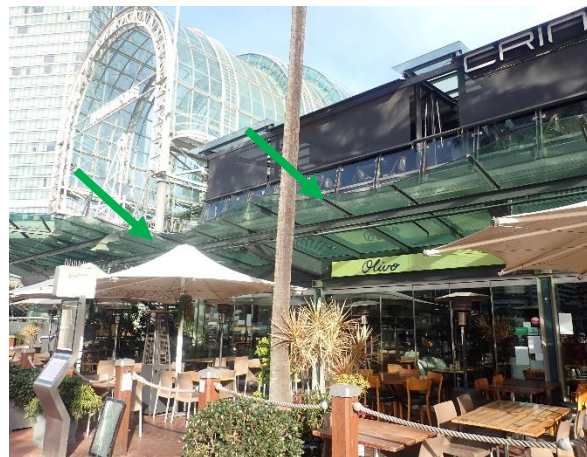
Photo 5: Harbourside – non-asbestos containing black mastic sealant to the glass panel awnings

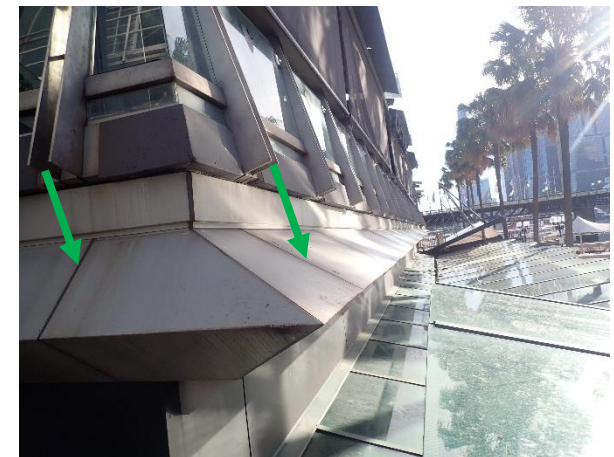
Photo 6: Harbourside – non-asbestos containing mastic sealant to the external metal cladding

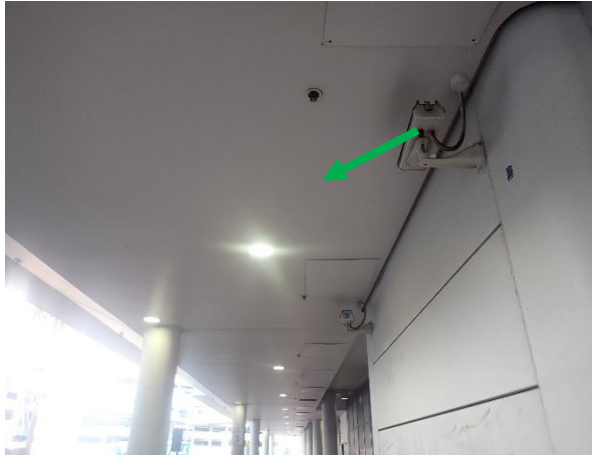
Photo 7: Harbourside – non-asbestos containing fibre cement sheeting to the external soffit linings

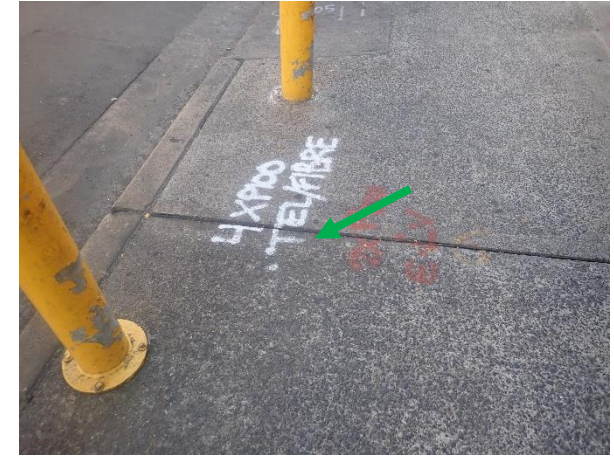
Photo 9: Harbourside – non-asbestos containing bituminous floor external expansion joints

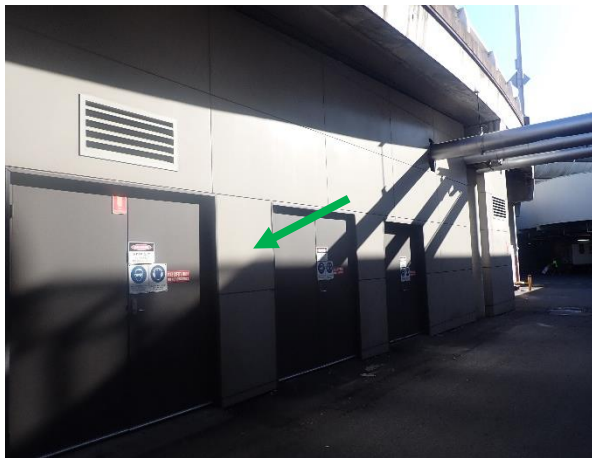
Photo 10: Harbourside – non-asbestos containing compressed fibre cement sheeting to the chiller plant room/Ausgrid Substation external cladding

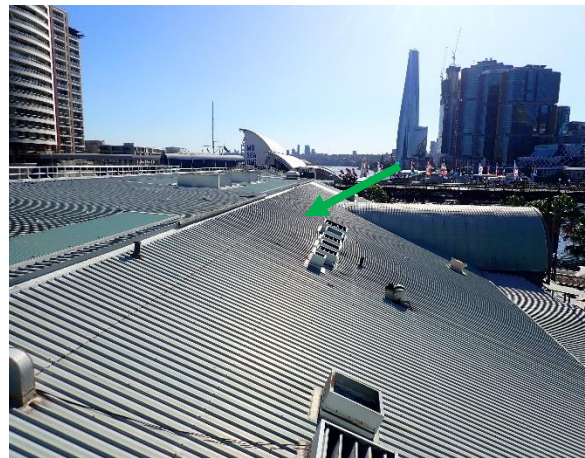
Photo 11: Harbourside – non-lead based green paint to the corrugated metal roof

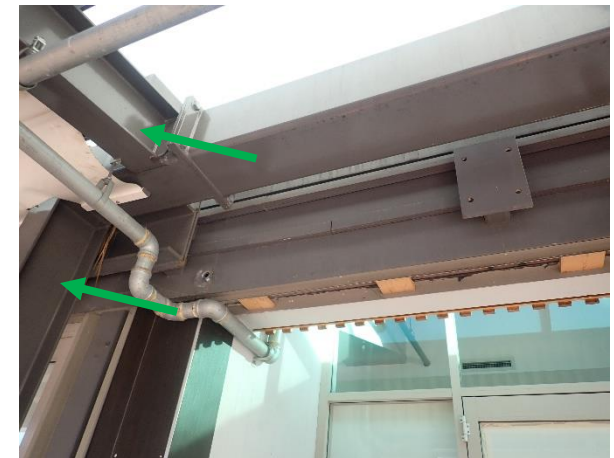
Photo 12: Harbourside – non-lead based grey paint to the external steel framework

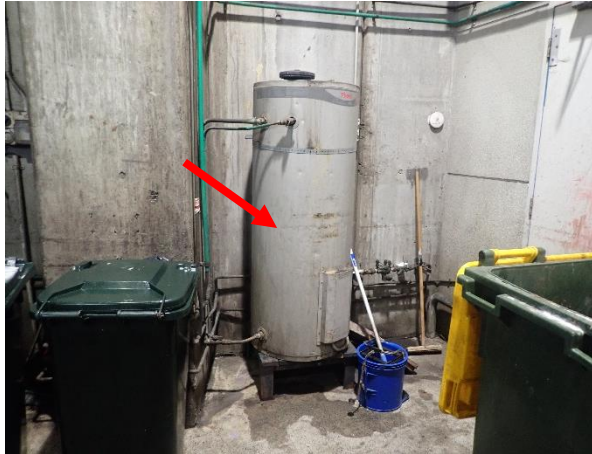
Photo 13: Harbourside – assumed SMF internal insulation to hot water systems within the loading dock

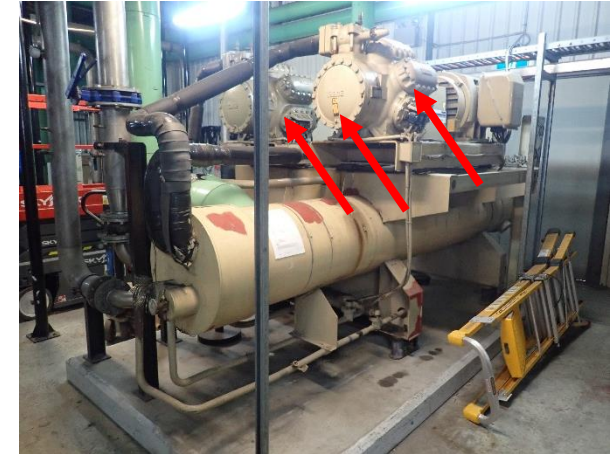
Photo 15: Harbourside – assumed asbestos containing gaskets to Chiller #2 in the chiller plant room on Level 1

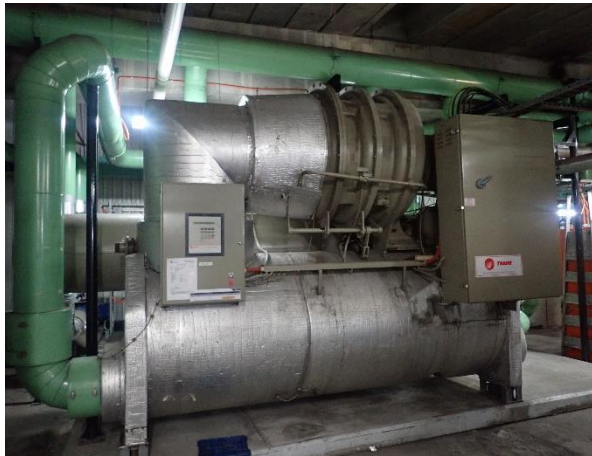
Photo 16: Harbourside – assumed asbestos containing gaskets to Chiller #5 in the chiller plant room on Level 1

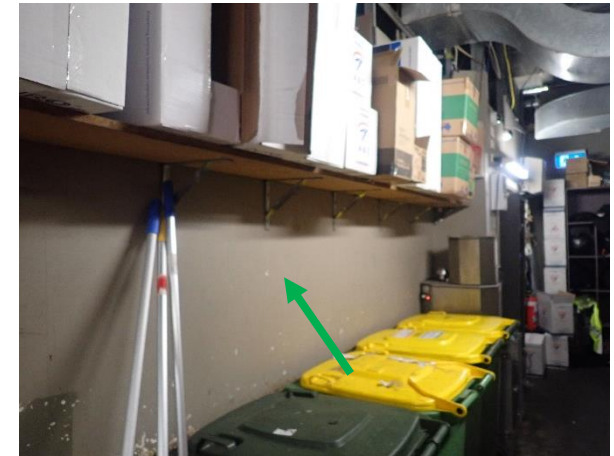
Photo 18: Harbourside – non-asbestos containing fibre cement sheeting to the back of house/kitchen wall linings in Shop 198 (The Watershed) on Level 1

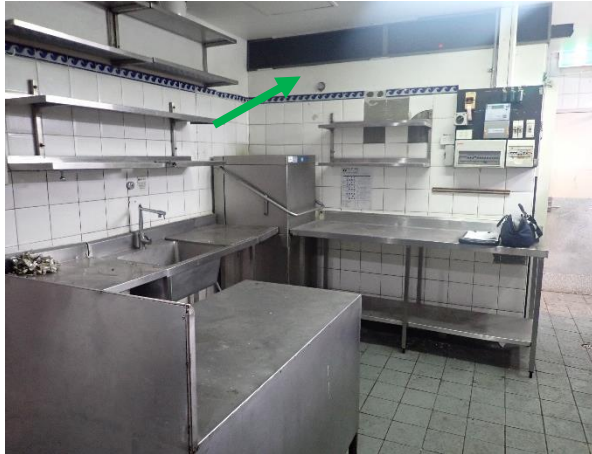
Photo 19: Harbourside – non-asbestos containing fibre cement sheeting to the kitchen/back of house wall linings in Shop 293 (formerly Toro) on Level 1

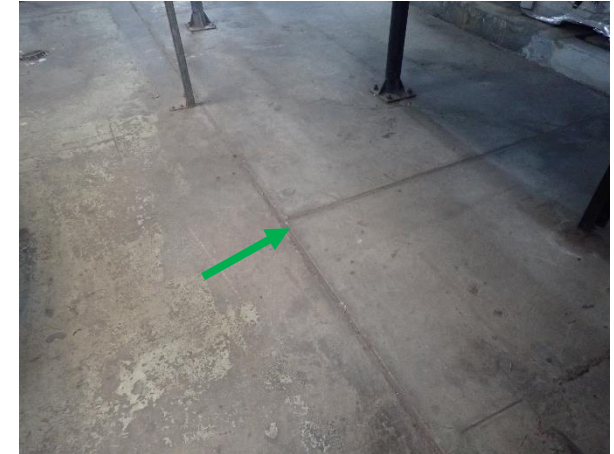
Photo 21: Harbourside – non-asbestos containing bituminous floor expansion joints within the chiller plant room on Level 1

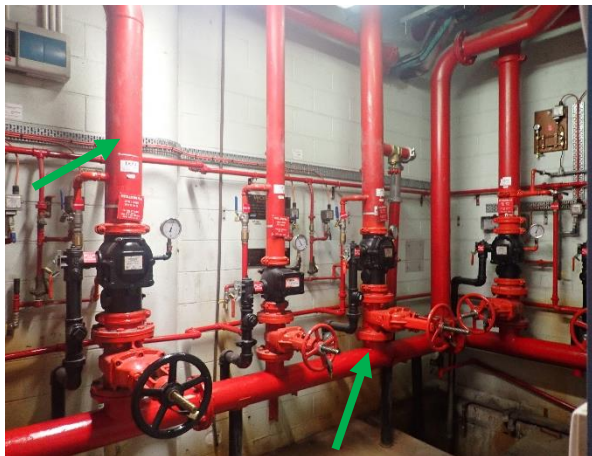
Photo 22: Harbourside – non-lead based red paint to the pipework within the sprinkler valve/pump room on Level 1

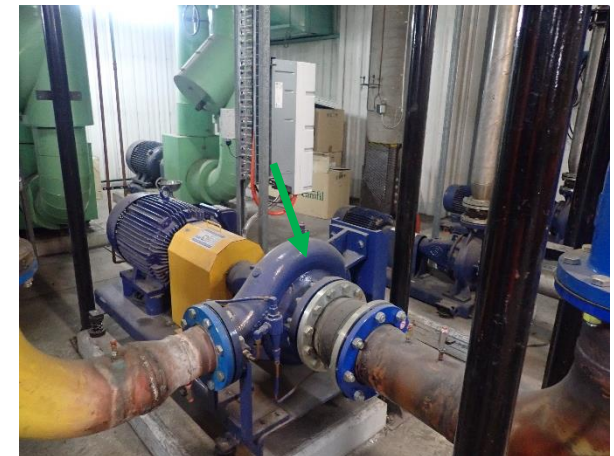
Photo 24: Harbourside – non-lead based blue paint to the pumps in the chiller plant room on Level 1

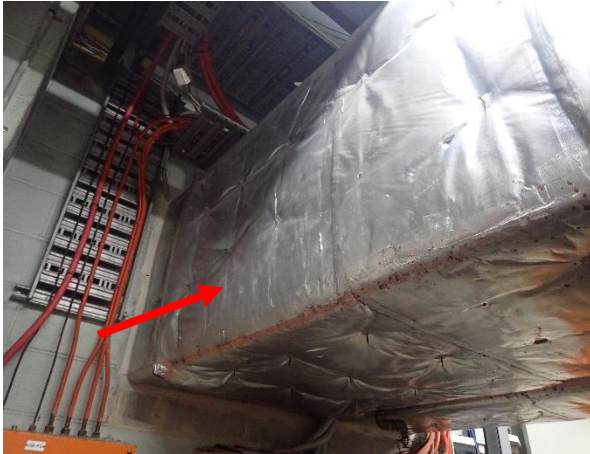
Photo 25: Harbourside – assumed SMF insulation to the HVAC ducting throughout the ceiling cavities/plant rooms on Level 1

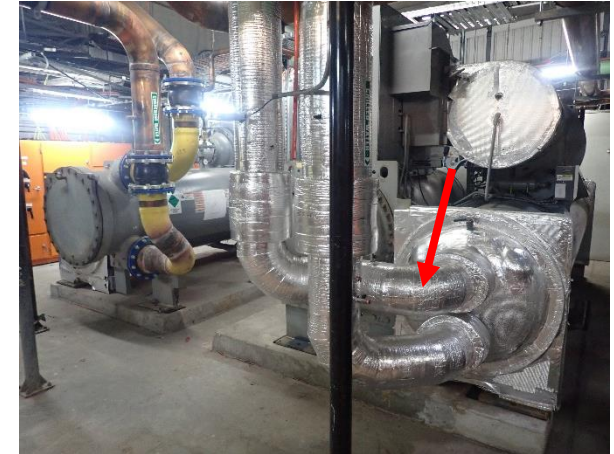
Photo 27: Harbourside – assumed SMF insulation to Chillers #3, #4 and #5 in the chiller plant room on Level 1

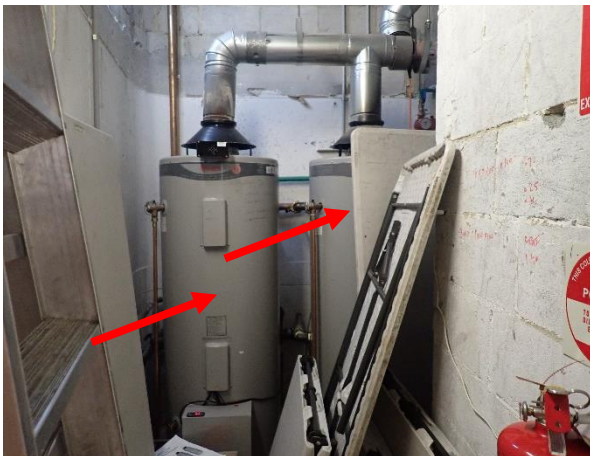
Photo 28: Harbourside – assumed SMF insulation to the hot water systems within the tenancies on Level 1

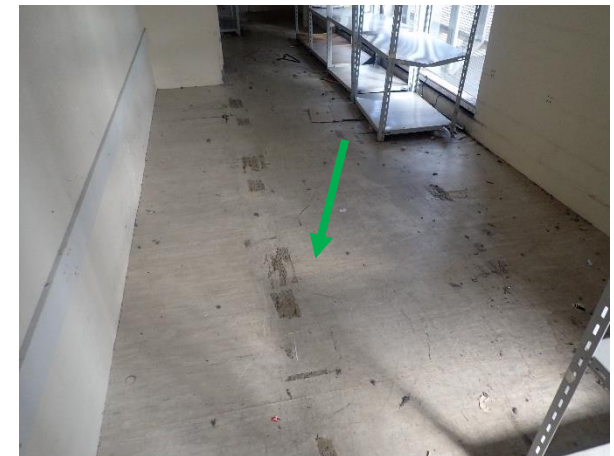
Photo 30: Harbourside – non-asbestos containing cream vinyl flooring to the rear store rooms of Shop 419 (formerly Glue) on Level 2

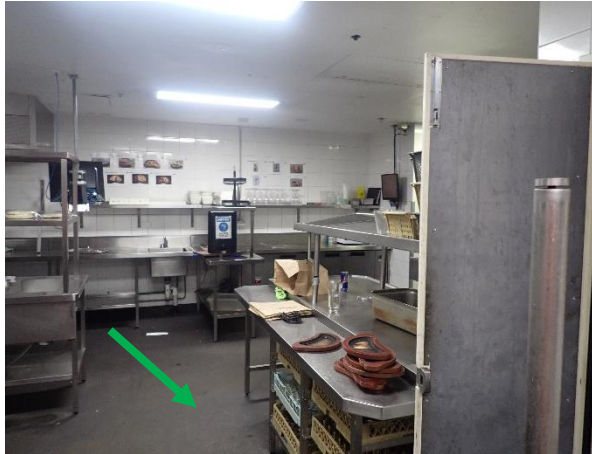
Photo 31: Harbourside – non-asbestos containing black membrane to the kitchen floor of Shop 321/357 (formerly Hard Rock Café) on Level 2

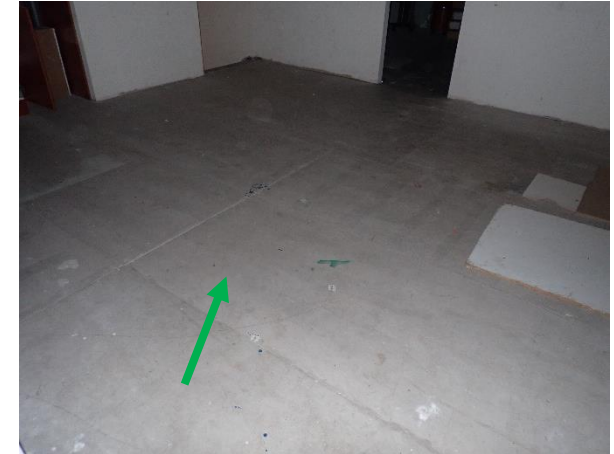
Photo 33: Harbourside – non-asbestos containing compressed fibre cement sheeting to the mezzanine floor of Shop 402 (formerly World Newsagency) on Level 2

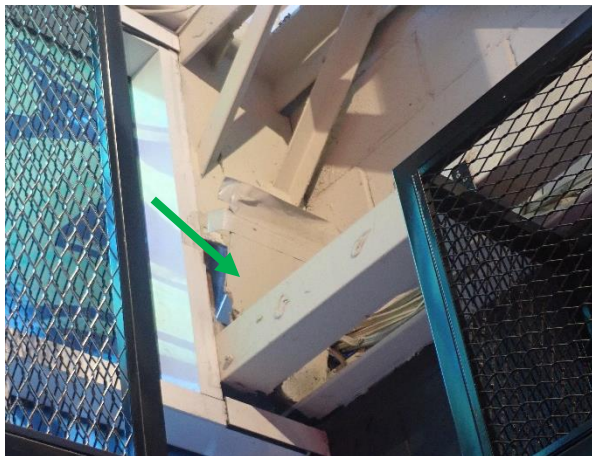
Photo 34: Harbourside – non-asbestos containing fibre cement sheeting to the infill panel between the steel framework and arched window frame in the NW corner of Shop409 (Stateside Sports) on Level 2

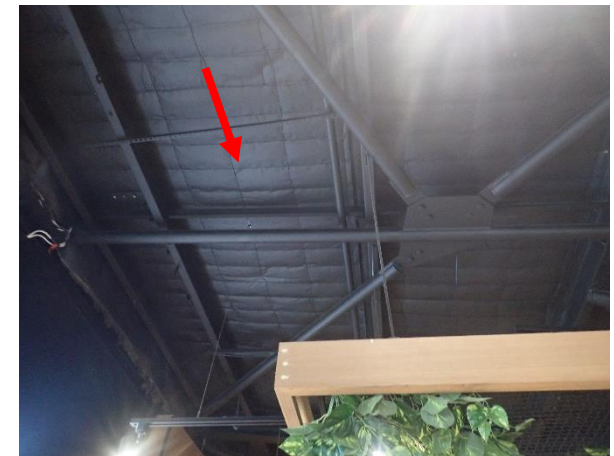
Photo 36: Harbourside – assumed SMF insulation to the roof sarking within the ceiling cavities/plant rooms on Level 2

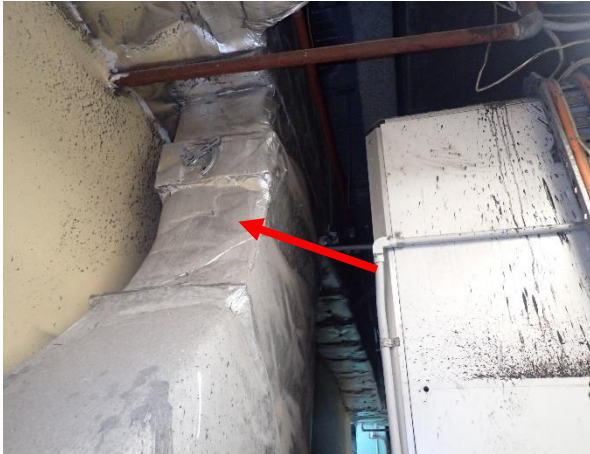
Photo 37: Harbourside – assumed SMF insulation to the HVAC ducting within the plant room on Level 2

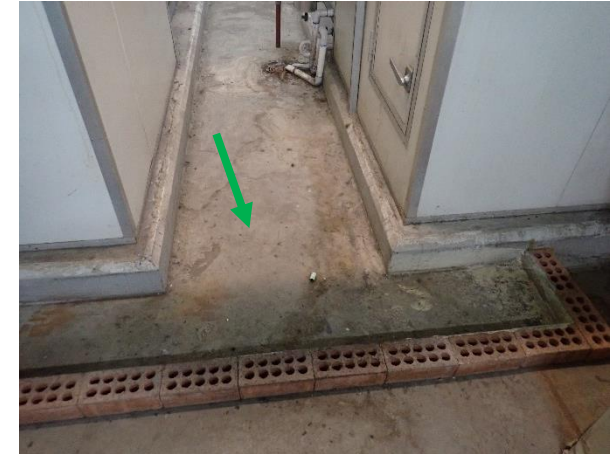
Photo 39: Harbourside – non-asbestos containing cream fibrous membrane between AHU 3.1 & 3.2 in the plant room on Level 3

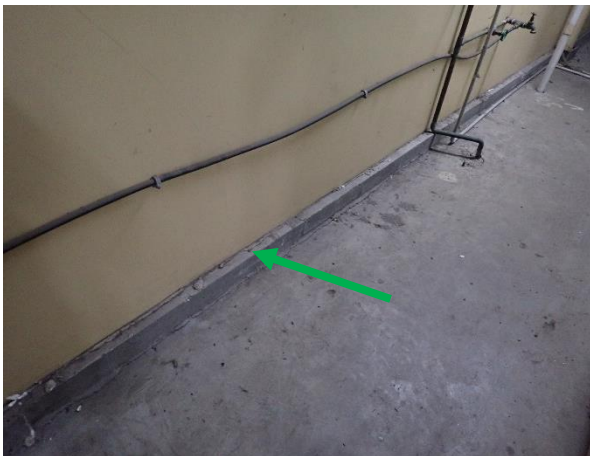
Photo 40: Harbourside – non-asbestos containing white caulking to the base of the south wall in the plant room on Level 3

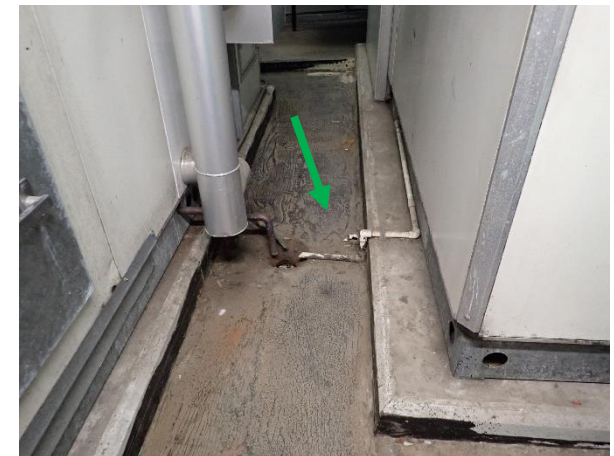
Photo 42: Harbourside – non-asbestos containing black membrane between AHU 3.3 & 3.4 in the plant room on Level 3

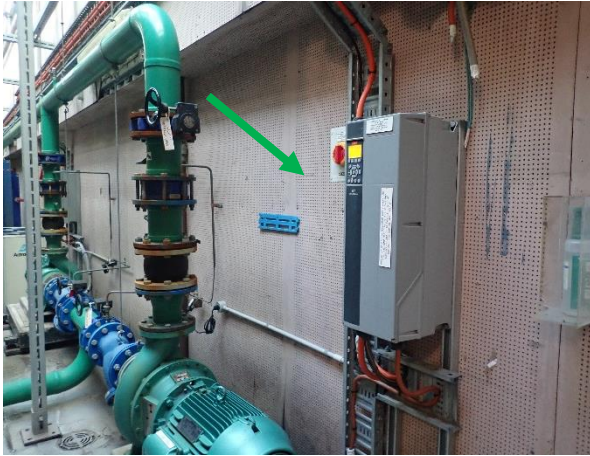
Photo 43: Harbourside – non-asbestos containing fibre cement sheeting to the walls of the cooling tower area on Level 3

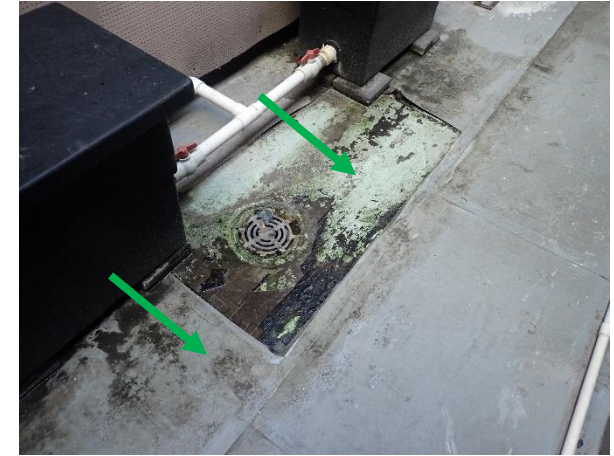
Photo 45: Harbourside – non-asbestos containing upper and lower waterproofing membranes to the cooling tower area on Level 3

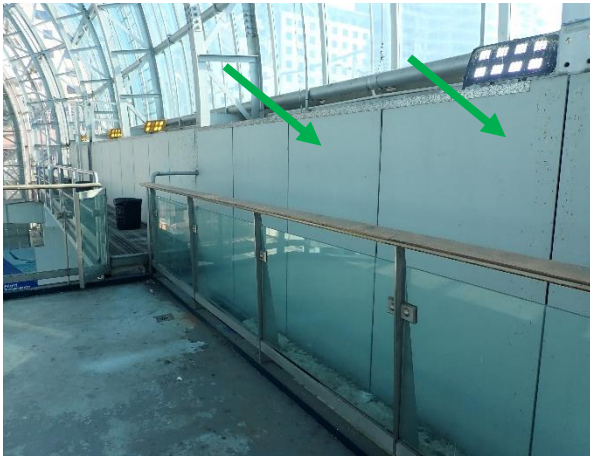
Photo 46: Harbourside – non-asbestos containing compressed fibre cement sheeting to the north and south wall panels on Level 3 mezzanine

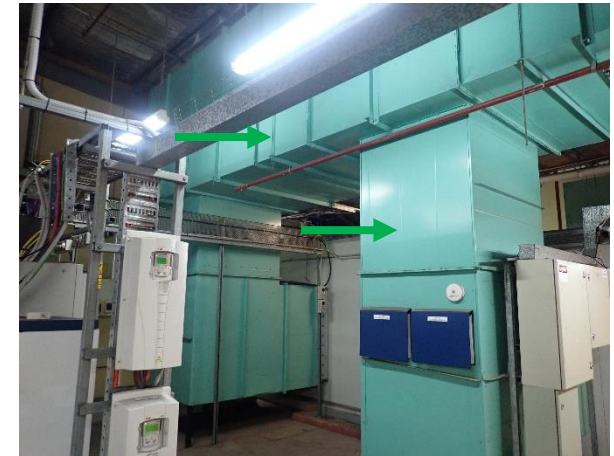
Photo 48: Harbourside – non-lead based aqua paint to the HVAC ducting in the plant room on Level 3

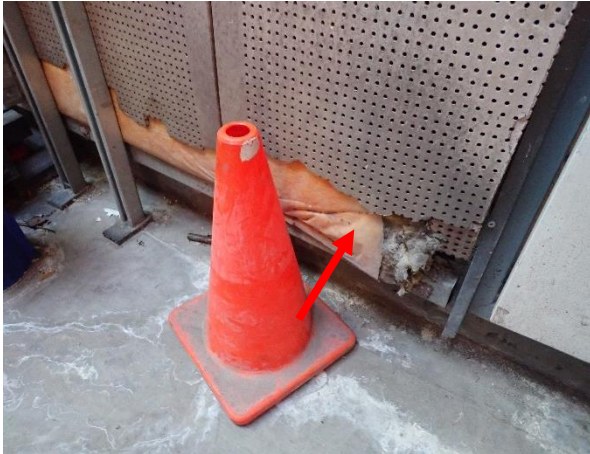
Photo 49: Harbourside – assumed SMF insulation to the walls of the cooling tower area on Level 3

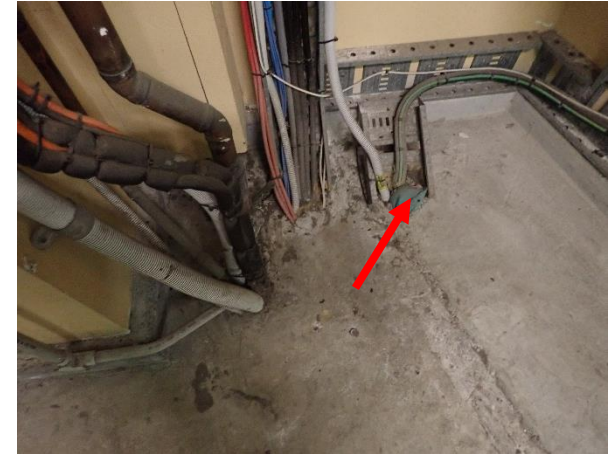
Photo 51: Harbourside – assumed SMF insulation to packing pillows

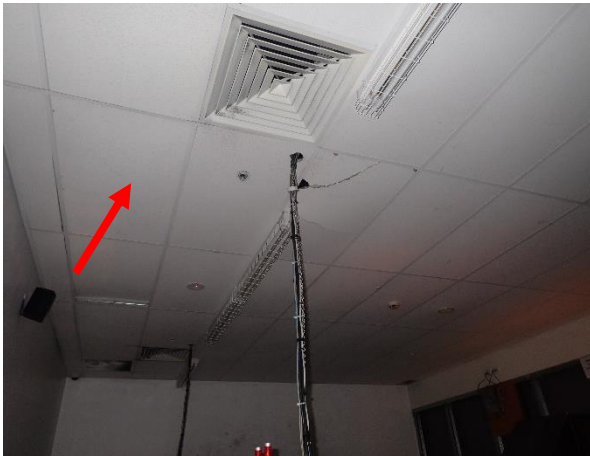
Photo 52: Harbourside – assumed SMF suspended ceiling tiles to the bowling machine rooms in Shop 501 & 502 (Kingpin) on Level 3

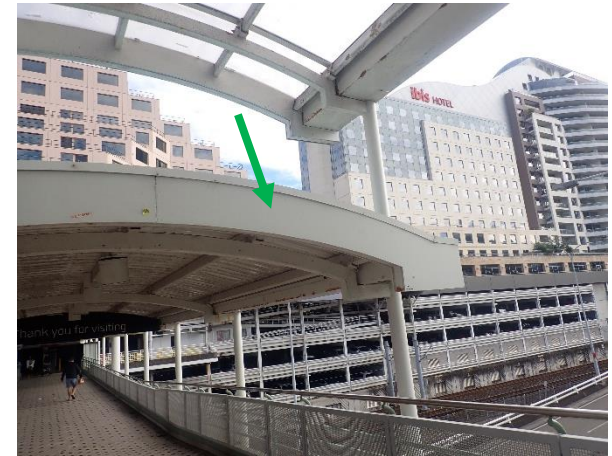
Photo 54: Pedestrian Link Bridge – non-asbestos containing compressed fibre cement sheeting to the east and west fascia cladding

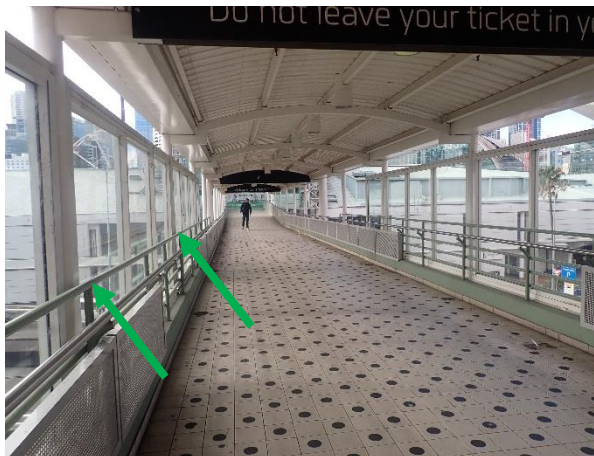
Photo 55: Pedestrian Link Bridge – non-lead based green paint to the handrails and balustrades

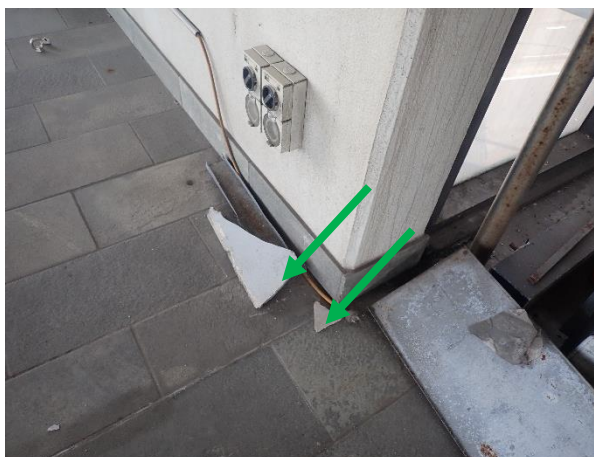
Photo 58: Former Monorail Station – non-asbestos containing compressed fibre cement debris to the station platform

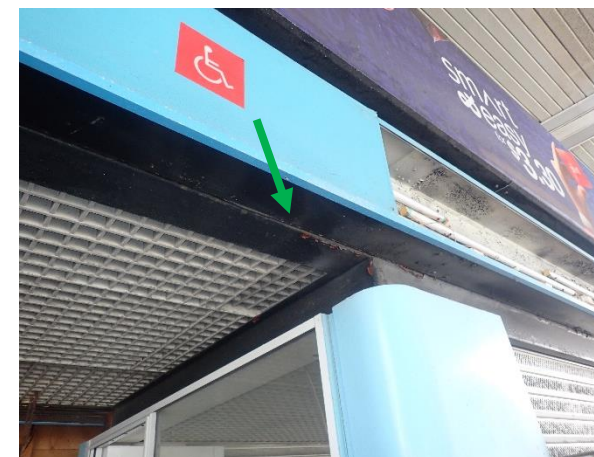
Photo 60: Former Monorail Station – non-lead based black paint to the ticket booth structure
