6 November 2025

Addendum Archaeological Technical Report – SYD086 2 Glendenning Road, Glendenning (SSD 73761707) Response to Submission to Heritage NSW

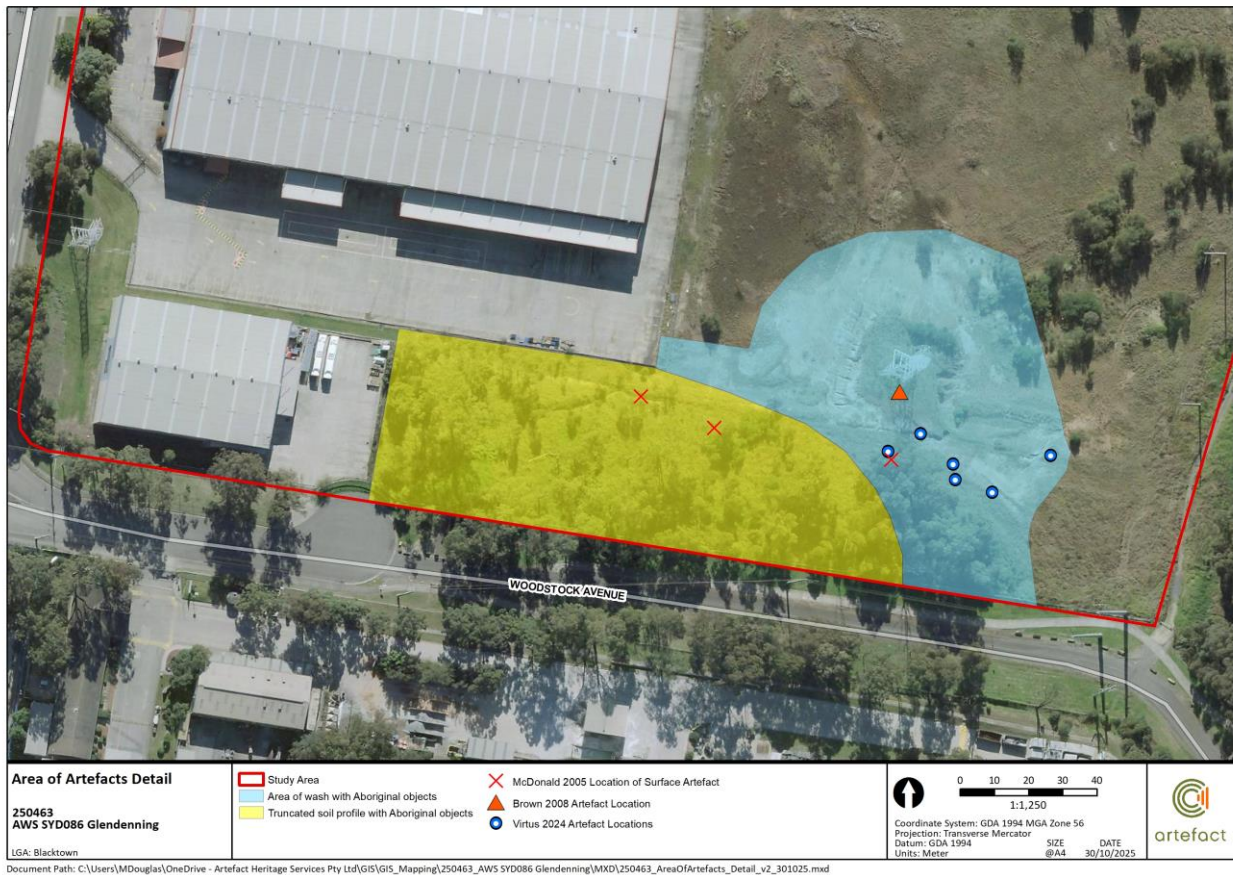
Figure 64: Updated artefact locations and archaeological potential mapping within the study area

The additional site visit and interpretation of historical aerials indicated the level of disturbance within the study area has removed the potential for archaeological deposits to be present within the study area except in the area of truncated soil profile shaded yellow in Figure 64. This area is located outside of the area of proposed works.

Aboriginal objects are still present within the study area in the area shaded blue in Figure 64. The artefacts are isolated surface finds within a disturbed context and are believed to have washed out of the truncated deposit located just up slope.

45-5-0456	Partial harm– assumed partial destroyed	Partial direct harm	<ul style="list-style-type: none"> • The site has been logged as destroyed under AHIP 941 in the 2001 Kohen and Knight salvage report and under Permit 0461 in the initial AHIMS entry which most likely refers to the collection of the original 60 artefacts identified as part of the AHIMS site. • The site was originally described in the AHIMS site card as being located on the road, and the 60 identified artefacts were collected. • Subsequent artefact potential has been established to the west of the site extents in 1999 and 2001 which has also since been impacted by warehouse development. • The additional artefacts located by McDonald 2005 and Brown 2008 attributed to 45-5-0456 in the report but not updated in the site card are partially located in an area of potential community collection and direct harm. • The McDonald 2005, Brown 2008 artefacts, although attributed to AHIMS ID 0456, are within disturbed contexts and not within the original recovered boundaries. The majority of the potential site located on the ridge slope is not included in the pathway of current works plans (Figure 63 and Figure 66). The only remaining context for this site is located on the Southern ridgeline which is not included in the proposed works areas. • Updated mapping establishes an area of potential including location of isolated artefacts which have washed down the hillslope (Figure 64) the buffer area of artefact.

- Community collection is recommended to be conducted in the area of wash, shaded blue in Figure 64, prior to the commencement of the proposed works.
- No further archaeological investigation, management or mitigation measures are required in the remainder of the study area
- The 'truncated soil profile with aboriginal objects' shaded yellow in Figure 64 above, will not be impacted by the proposed works.
