PHOTOGRAPHIC RECORD SHEET  
DESCRIPTION OF PHOTOGRAPHIC  
MONITORING POINT

| Site | Littoral Rainforest No# 116 Revegetation Buffer |

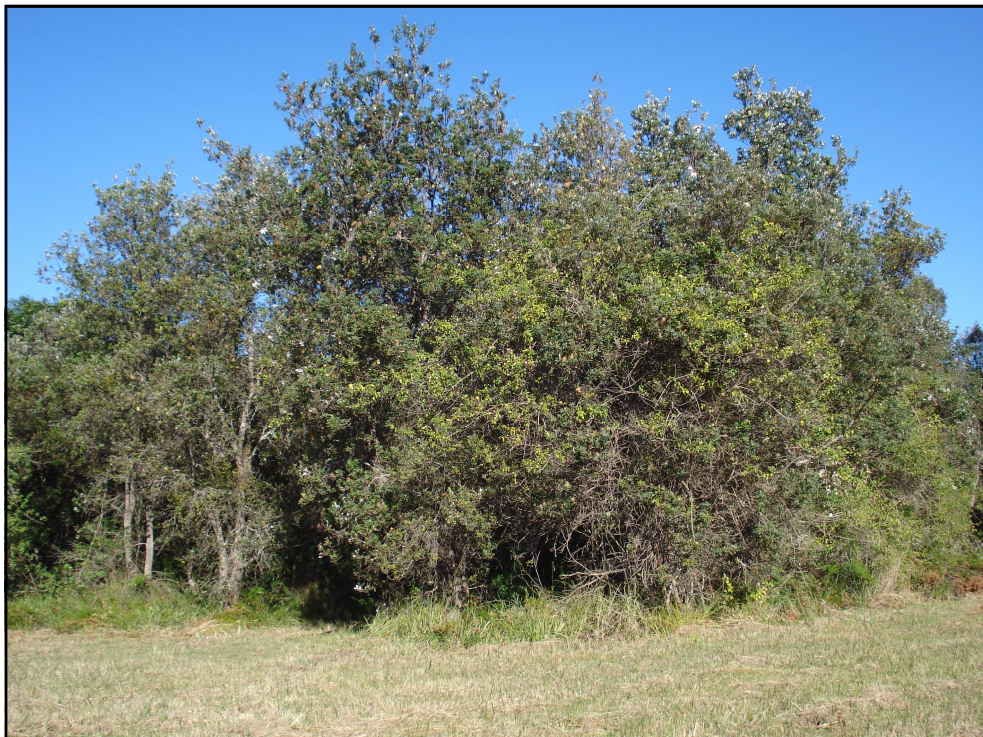
| Photographic monitoring point # | 1 |

| Description of area photographed including reference points, landmarks etc | Showing mature <i>Banksia integrifolia</i> which are forage trees for the common blossom bat. Lantana is currently growing around these trees. |

| Caption to accompany photo (if any) | Photo shows paddock recently slashed & <i>lantana camara</i> growing around the <i>Banksia integrifolia</i> forage trees. |

| Likely site changes to observe during project / Comments | <p>Woody weed control including removal of the <i>Lantana camara</i> and the young <i>Senna pendula</i> which are growing around the mature <i>Banksia integrifolia</i> trees.</p> <p>Revegetation of the currently slashed area, including Littoral Rainforest species and more <i>Banksia integrifolia</i> forage trees for the common blossom bat.</p> |

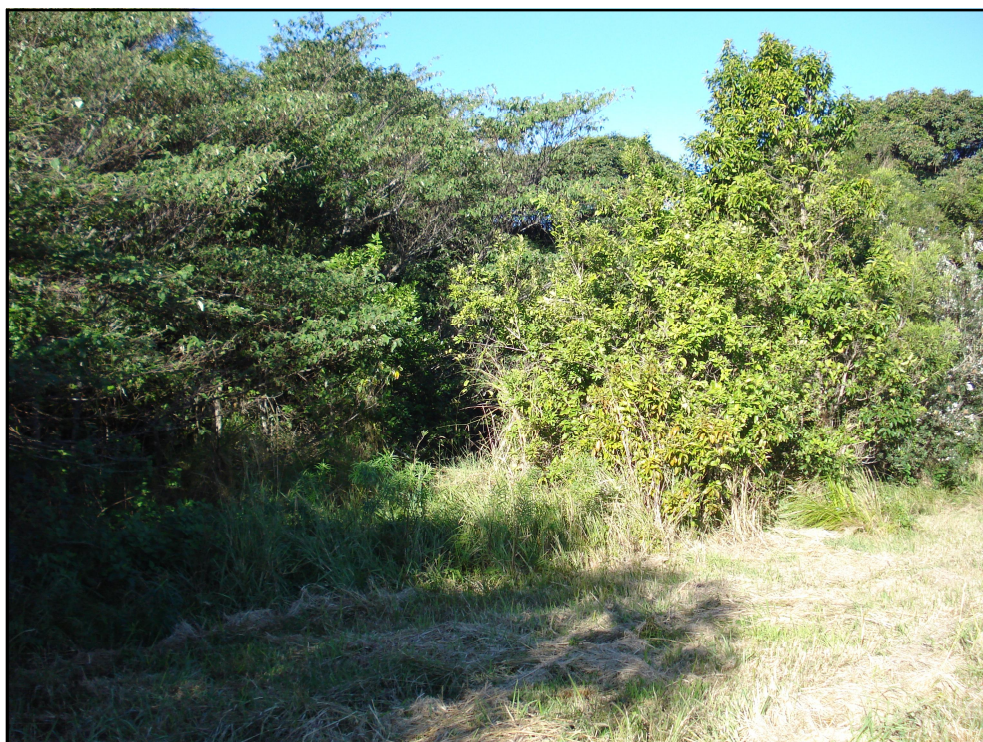
| Photographic monitoring point # | 2A |

| Description of area photographed including reference points, landmarks etc | 2A= LHS of photo shows <i>Commersonia bartramia</i> (Brown Kurrajong)<br><br>2B= photo shows (Crofton weed) & young <i>Senna pendula</i> |

| Likely site changes to observe during project / Comments | Hand removal/ Spraying of <i>Ageratina adenophora</i> (Crofton weed)<br><br>Treatment of woody weeds including <i>Senna pendula</i> (Winter Cassia), <i>Lantana camara</i> & <i>Chrysanthemoides monulifera</i> (Bitou Bush)<br><br>Revegetation of slashed area in photo 2A with Littoral Rainforest species |

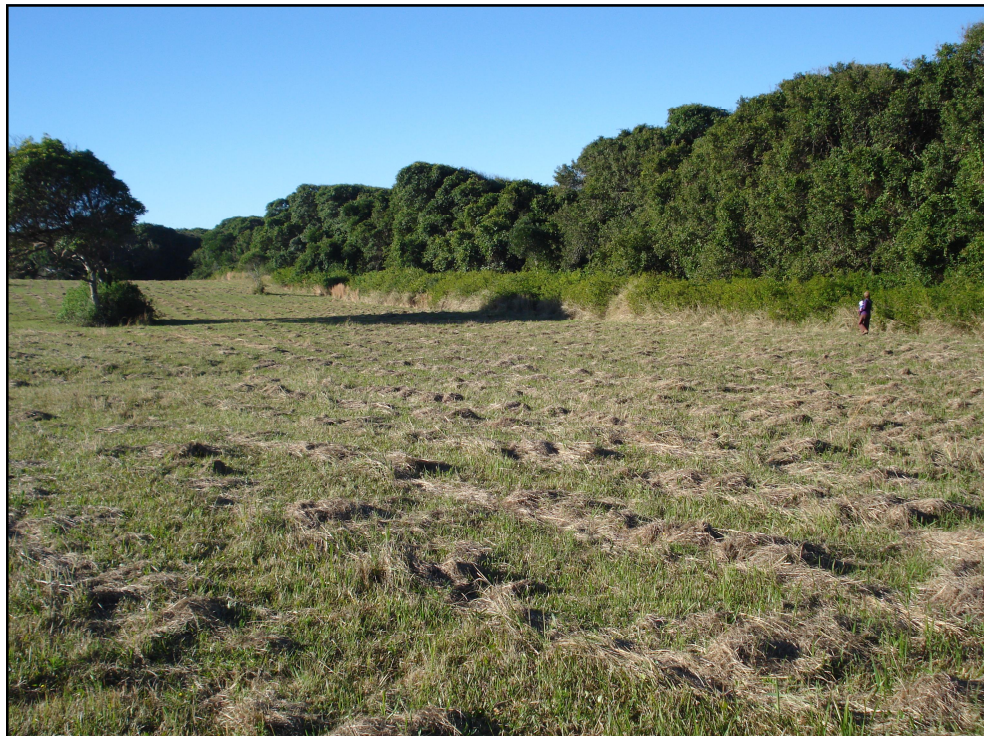
| Photographic monitoring point # | 4A |

| Description of area photographed including reference points, landmarks etc | <p>4A= LHS of photo shows a mature <i>Banksia integrifolia</i> tree &amp; <i>Senna pendula</i> (Winter Cassia) thicket on edge of rainforest in the centre of photo</p> <p>4A &amp; 4B= photos show the canopy of Littoral Rainforest no# 116 in the background and the proposed revegetation buffer area in the foreground</p> |

| Caption to accompany photo (if any) | Bio filtration basin will be in this area |

| Likely site changes to observe during project / Comments | <p>Treatment of woody weeds including <i>Senna pendula</i> (Winter Cassia), <i>Lantana camara</i> &amp; <i>Chrysanthemoides monulifera</i> (Bitou Bush) on edge of Rainforest.</p> <p>Revegetation of the currently slashed area, including Littoral Rainforest species and more <i>Banksia integrifolia</i> forage trees for the common blossom bat.</p> <p>Bio filtration basin proposed for this area</p> |

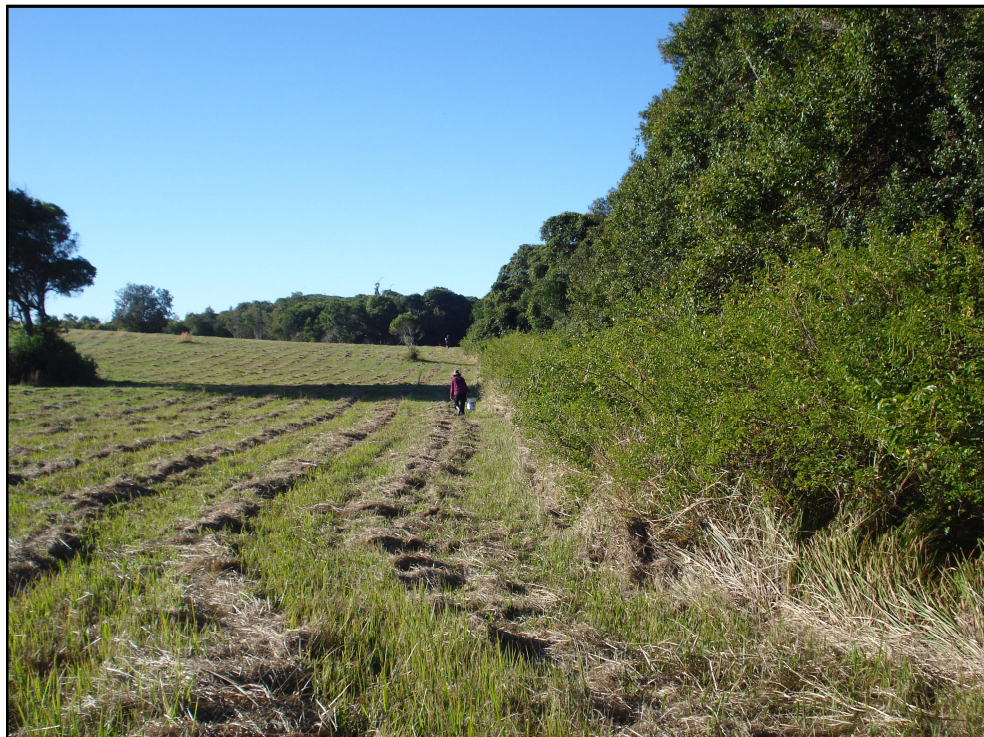
| Photographic monitoring point # | 5 |

| Description of area photographed including reference points, landmarks etc | LHS of photo shows a mature <i>Banksia integrifolia</i> tree & RHS of photo shows <i>Senna pendula</i> (Winter Cassia) thicket on edge of rainforest. The proposed revegetation buffer area is in the middle |

| Caption to accompany photo (if any) | <i>Senna pendula</i> (Winter Cassia) thicket |

| Likely site changes to observe during project / Comments | <p>Treatment of woody weeds including <i>Senna pendula</i> (Winter Cassia), <i>Lantana camara</i> &amp; <i>Chrysanthemoides monulifera</i> (Bitou Bush) on edge of Rainforest.</p> <p>Revegetation of the currently slashed area, including Littoral Rainforest species and more <i>Banksia integrifolia</i> forage trees for the common blossom bat.</p> <p>Bio filtration basin proposed for this area</p> |

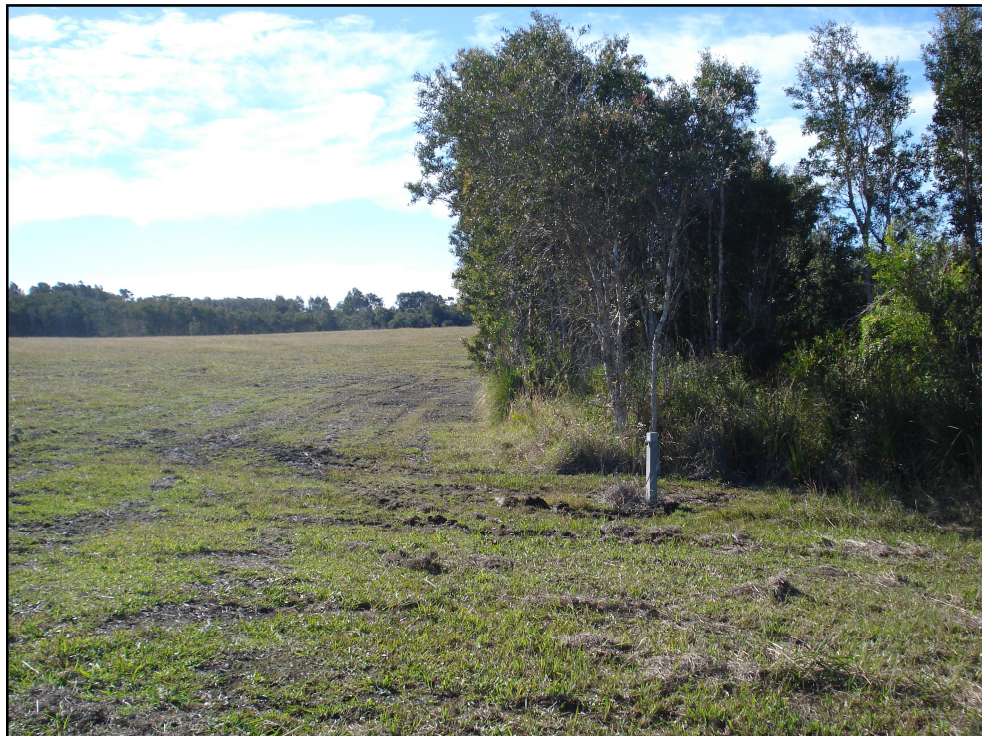
| Photographic monitoring point # | 6 |

| Description of area photographed including reference points, landmarks etc | Centre of photo shows the edge of existing Swamp Sclerophyll Forest and edge of slashed paddock where a bio filtration basin and ground water recharge systems are proposed. |

| Caption to accompany photo (if any) | Bio filtration basin site will be outside the existing vegetation shown in this photo |

| Likely site changes to observe during project / Comments | Bio filtration basin and ground water recharge systems are proposed. |

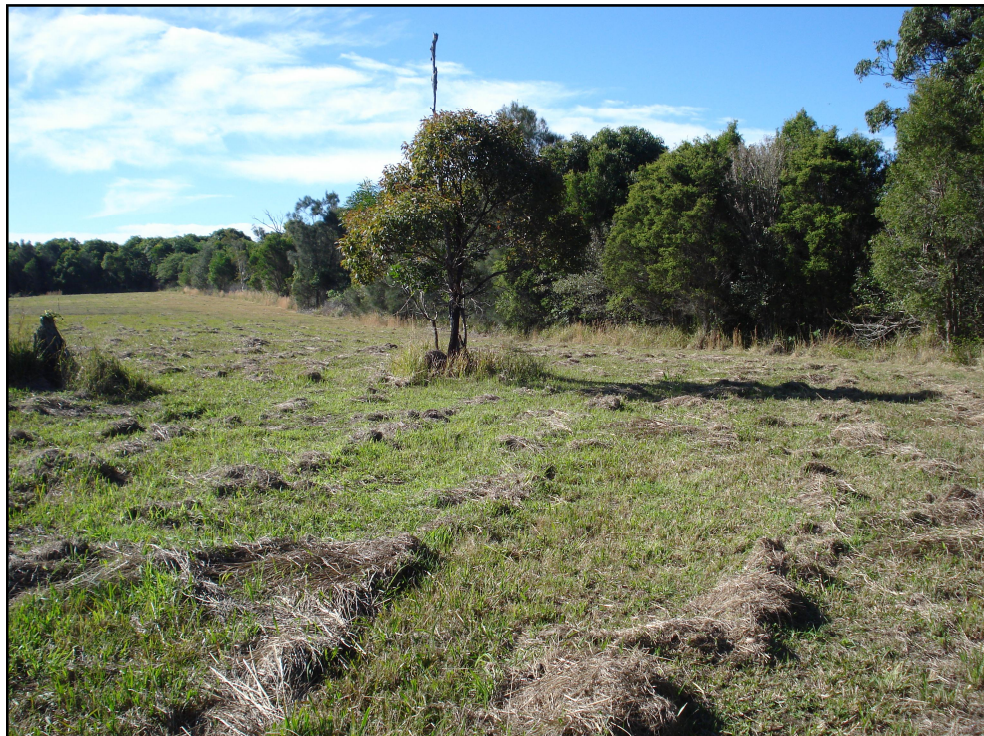
| Photographic monitoring point # | 7 |

| Description of area photographed including reference points, landmarks etc | Young <i>Eucalyptus siderphloia</i> (Grey Iron-bark) in centre of the photo. Stump on LHS of photo & existing vegetation on RHS of photo. Slashed area will be revegetated with Littoral Rainforest species. |

| Likely site changes to observe during project / Comments | Revegetation of the currently slashed area, including Littoral Rainforest species and a few <i>Banksia integrifolia</i> forage trees for the common blossom bat. |
