## Arborist Report

Commissioned By:	Root Projects Australia Level 5, 23-31 Macquarie Place SYDNEY NSW 2000
Site:	MCA Redevelopment Project
Date:	25 / 11 / 08
Prepared By:	Meredith Gibbs (Dip Hort Arb) MISA MISAAC MAIH

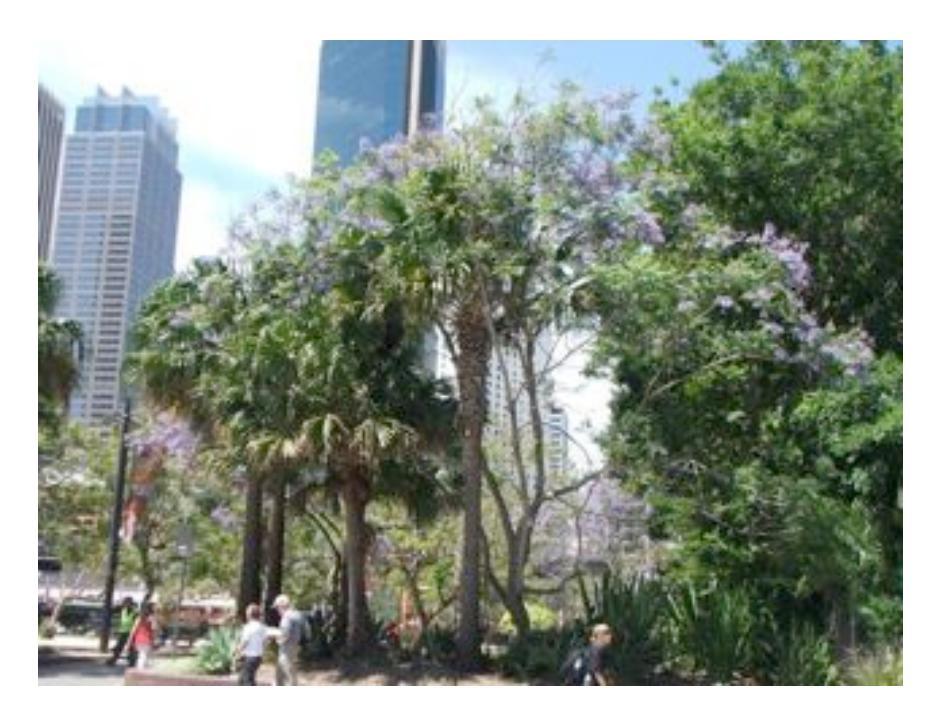
Figure 3. Trees no. 1 to 8.

- 5.2.1 Jacaranda mimosifolia (Jacaranda) Trees no. 1, 8 13 are all located within the proposed new landscaping area and are in poor form, stunted growth and twig dieback from salt winds. Salt spray damage is generally confined to the portion of the canopy exposed to wind-driven spray. Along the coast, for instance, the greatest damage would be on the windward side of the plant... Foliage of broadleaf plants may show marginal necrosis, defoliation, premature fall colouration, and delayed spring leafout (Costello and others, 2003). The root zones of Jacarandas 8 11 are in heavily compacted soil. Compaction of soils is a major cause of tree problems. After the top layer of the soil is compacted, roots begin to die. Death of roots in compacted soils is due to lack of oxygen as well as to lack of water. Roots do require oxygen to respire or to function properly. Non woody and woody roots may not grow into dense soils (Shigo, 1986).

- 5.2.2 *Livistona australis* (Cabbage Palm) Trees no. 2 7 are young palm trees generally in adequate health and condition. The tallest palm is approximately 8m in height. These trees are located within the proposed new landscaping and are proposed to be removed.

6.1 *Jacaranda mimosifolia* (Jacaranda) Trees no. 1, 8 - 13 are small, stunted and have poor form caused by salt winds and compacted soils. This species is not suited to this environment.

6.2 *Livistona australis* (Cabbage Palm) Trees no. 2-7 are in adequate health and condition, though young and small. These trees can be can be relocated if required but may be too costly.

Recommendation – The trees are not worthy of retention and should be removed.

Recommendation – The palms should be removed.

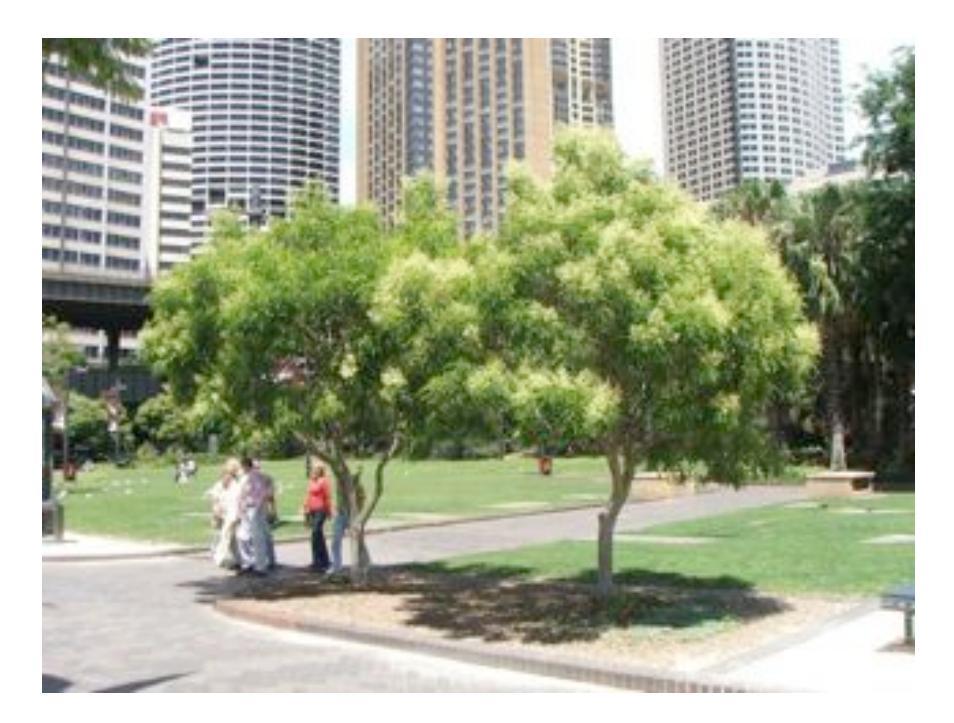
Figure 7. Trees no. 15 & 16.

- 5.2.3 *Fraxinus griffithii* (Evergreen Ash) Trees no. 14 16 are all young and small trees that are also located within heavily compacted soils. These trees are proposed for removal due to their location within the re-landscaping.

6.3 *Fraxinus griffithii* (Evergreen Ash) Trees no. 14 – 16 are also all young and small trees of no significance.

Recommendation - The trees should be removed.

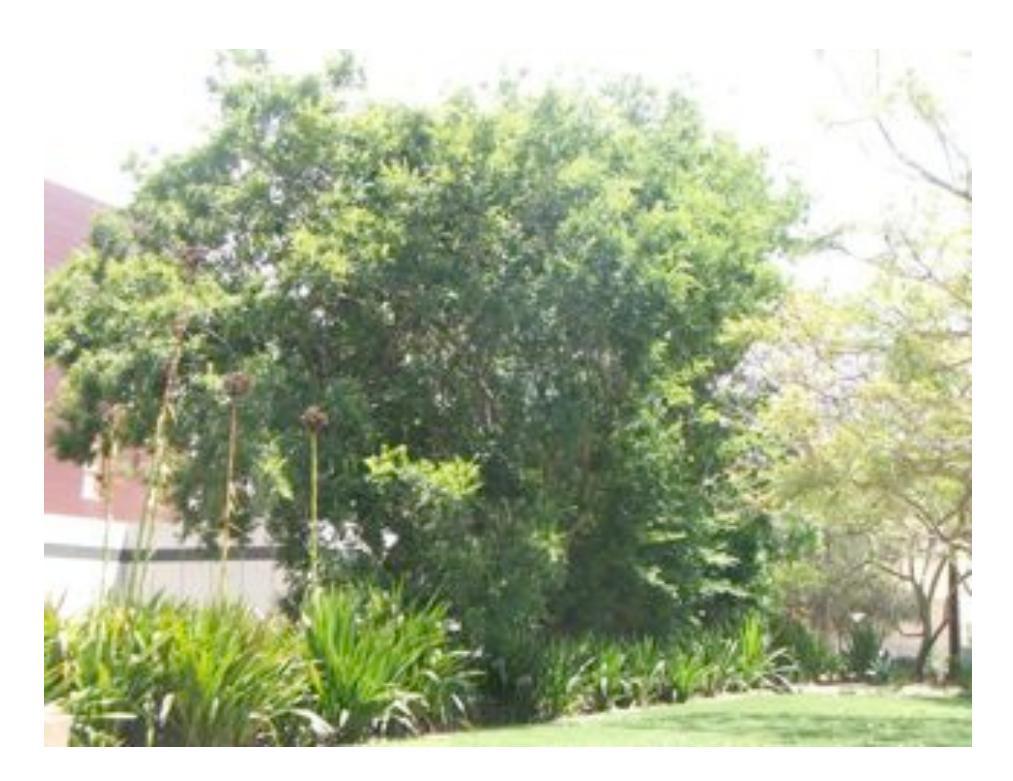
Figure 8. Trees no. 17 – 24.

- 5.2.4 *Phoenix canariensis* (Canary Island Date Palm) Tree no. 17 is located north of the row of Chinese Nettle Trees. The palm is young, small in adequate health.

- 5.2.5 *Celtis sinensis* (Chinese Nettle Tree) Trees no. 18 24 are a row of trees is located at the edge of the existing car parking facility and West Circular Quay. These trees are highly visible and the most dominant part of the landscape. The species is vigorous in growth and known to easily self-seed. The trees are in adequate health though some have pruning wounds with areas of potential decay. The lawn area adjacent to the tree is raised by 50cm to 1m, though the trees do not appear to be suffering from root suffocation. Some bark inclusions were sited

within the trees. Included bark means inner and outer bark that forms between the expanding cylinder of the branch and the trunk. The vascular cambium "turns" inward within the branch-trunk crotch. The branch bark ridge also turns inward to form an invaginated structure. The expanding wedge greatly weakens the branch and may cause it to break off under very slight loading (Shigo, 1986).

6.5 *Celtis sinensis* (Chinese Nettle Tree) Trees no. 18 – 24 are vigorous in growth and known to easily self-seed. The trees are in adequate health but with numerous pruning wounds and defective branch attachments.

Recommendation – The palm should be removed.

Recommendation – The trees are not worthy of retention or causing redesign the development and should be removed.

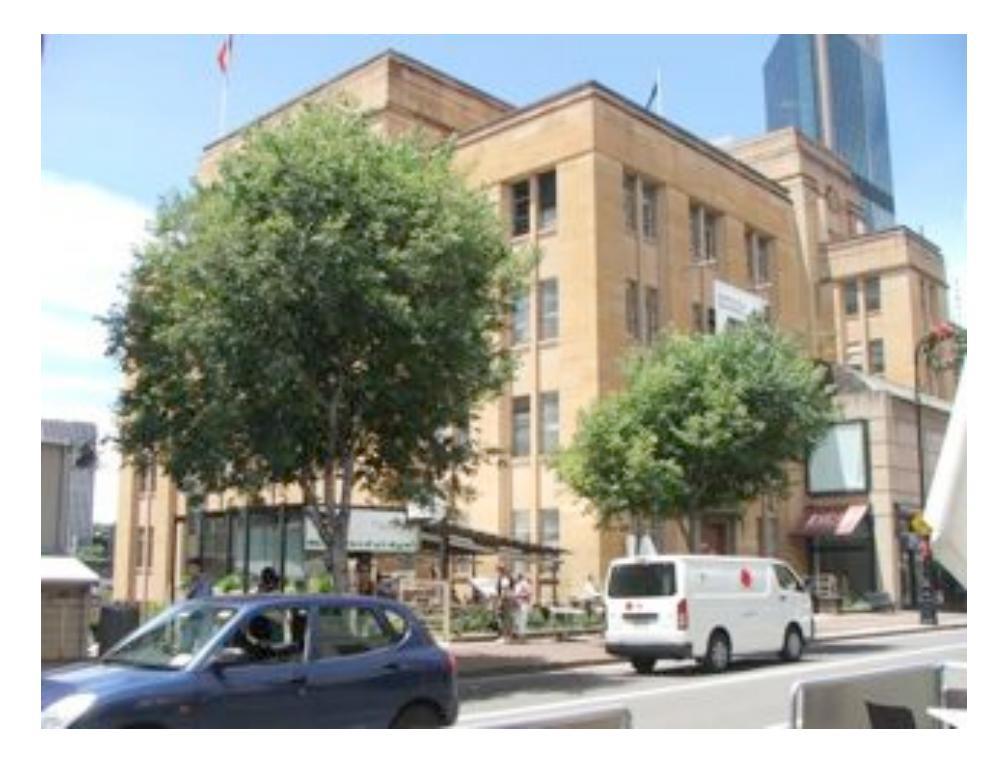
Figure 10. Trees no. 26 & 27.

5.2.6 *Celtis australis* (European Nettle Tree) 26 & 27 are semi mature trees growing on the George St foot path and will require removal for the proposed works. They are in adequate health though a limb has been torn out of the trunk of tree no. 26 leaving an extensive wound. Both trees are planted close to the curb and likely to cause damage to the foot path and road surface in the future. Tree no 25 is causing cracking to the existing pebbled soil cover. Given the vigorous growth root systems this species is not recommended for the particular location.

6.6 *Celtis australis* (European Nettle Tree) 26 & 27 are in adequate health tree no. 26 has a wound on the trunk. The species is not suited to long term retention in this situation due to their vigorous growth and root systems.

Recommendation – The trees are not worthy of retention or causing redesign the development and should be removed.

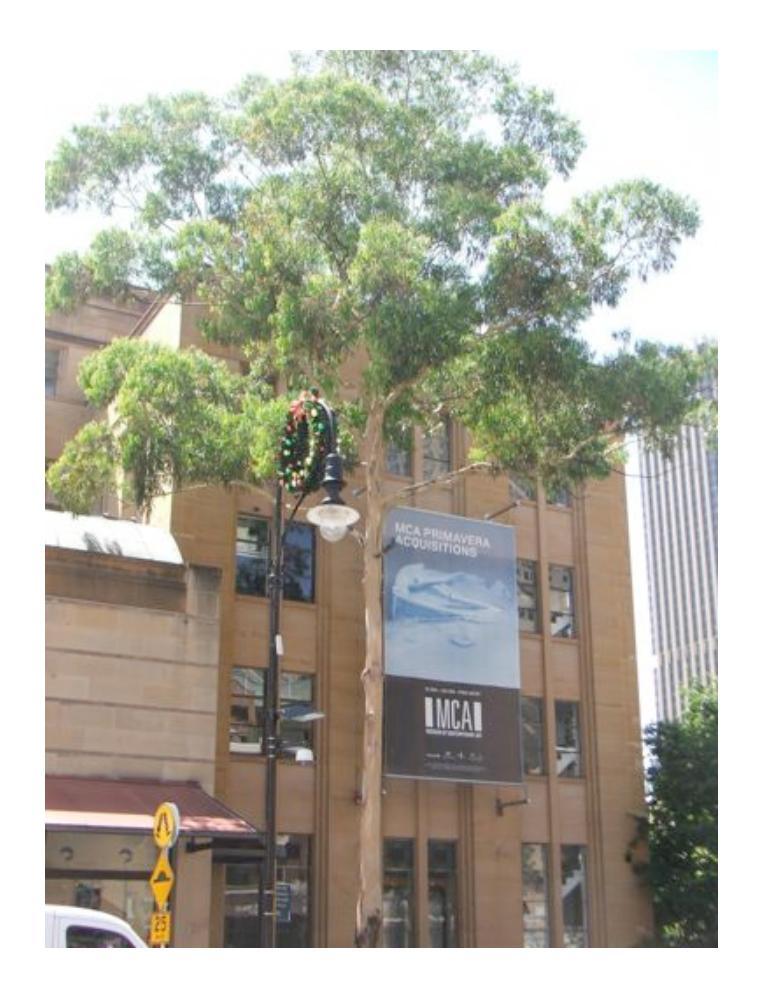
Figure 11. Tree no. 28.

- 5.1.1 Tree no. 25 *Populus deltoides* (American Black Poplar) is located on Argyle St and proposed for retention. It is in good health but exhibiting poor canopy form.
- 5.1.2 Tree no. 28 *Eucalyptus saligna* (Sydney Blue Gum) is located within the foot path towards the southern end of the MCA building and is exhibiting adequate health and condition. The tree is likely to require pruning to provide adequate clearance for the proposed works. This pruning must be in accordance with Australian Standards for Pruning of Amenity Trees AS-4373-2007. All pruning must be made as close as possible to the branch collar or branch bark ridge, without cutting the collar.

6.7 *Eucalyptus saligna* (Sydney Blue Gum) tree no. 28 is in adequate health and may be pruned to allow construction work clearance.

Recommendation – Pruning be in accordance with AS4373- 2007 by a suitably qualified arborist.
