Site Audit Report Delineation and Characterisation Sampling and Review of Remedial Options Former Gasworks Site, Burren Street, Erskineville NSW

14 September 2007

HLA Ref: S4015604_SAR_14Sept07

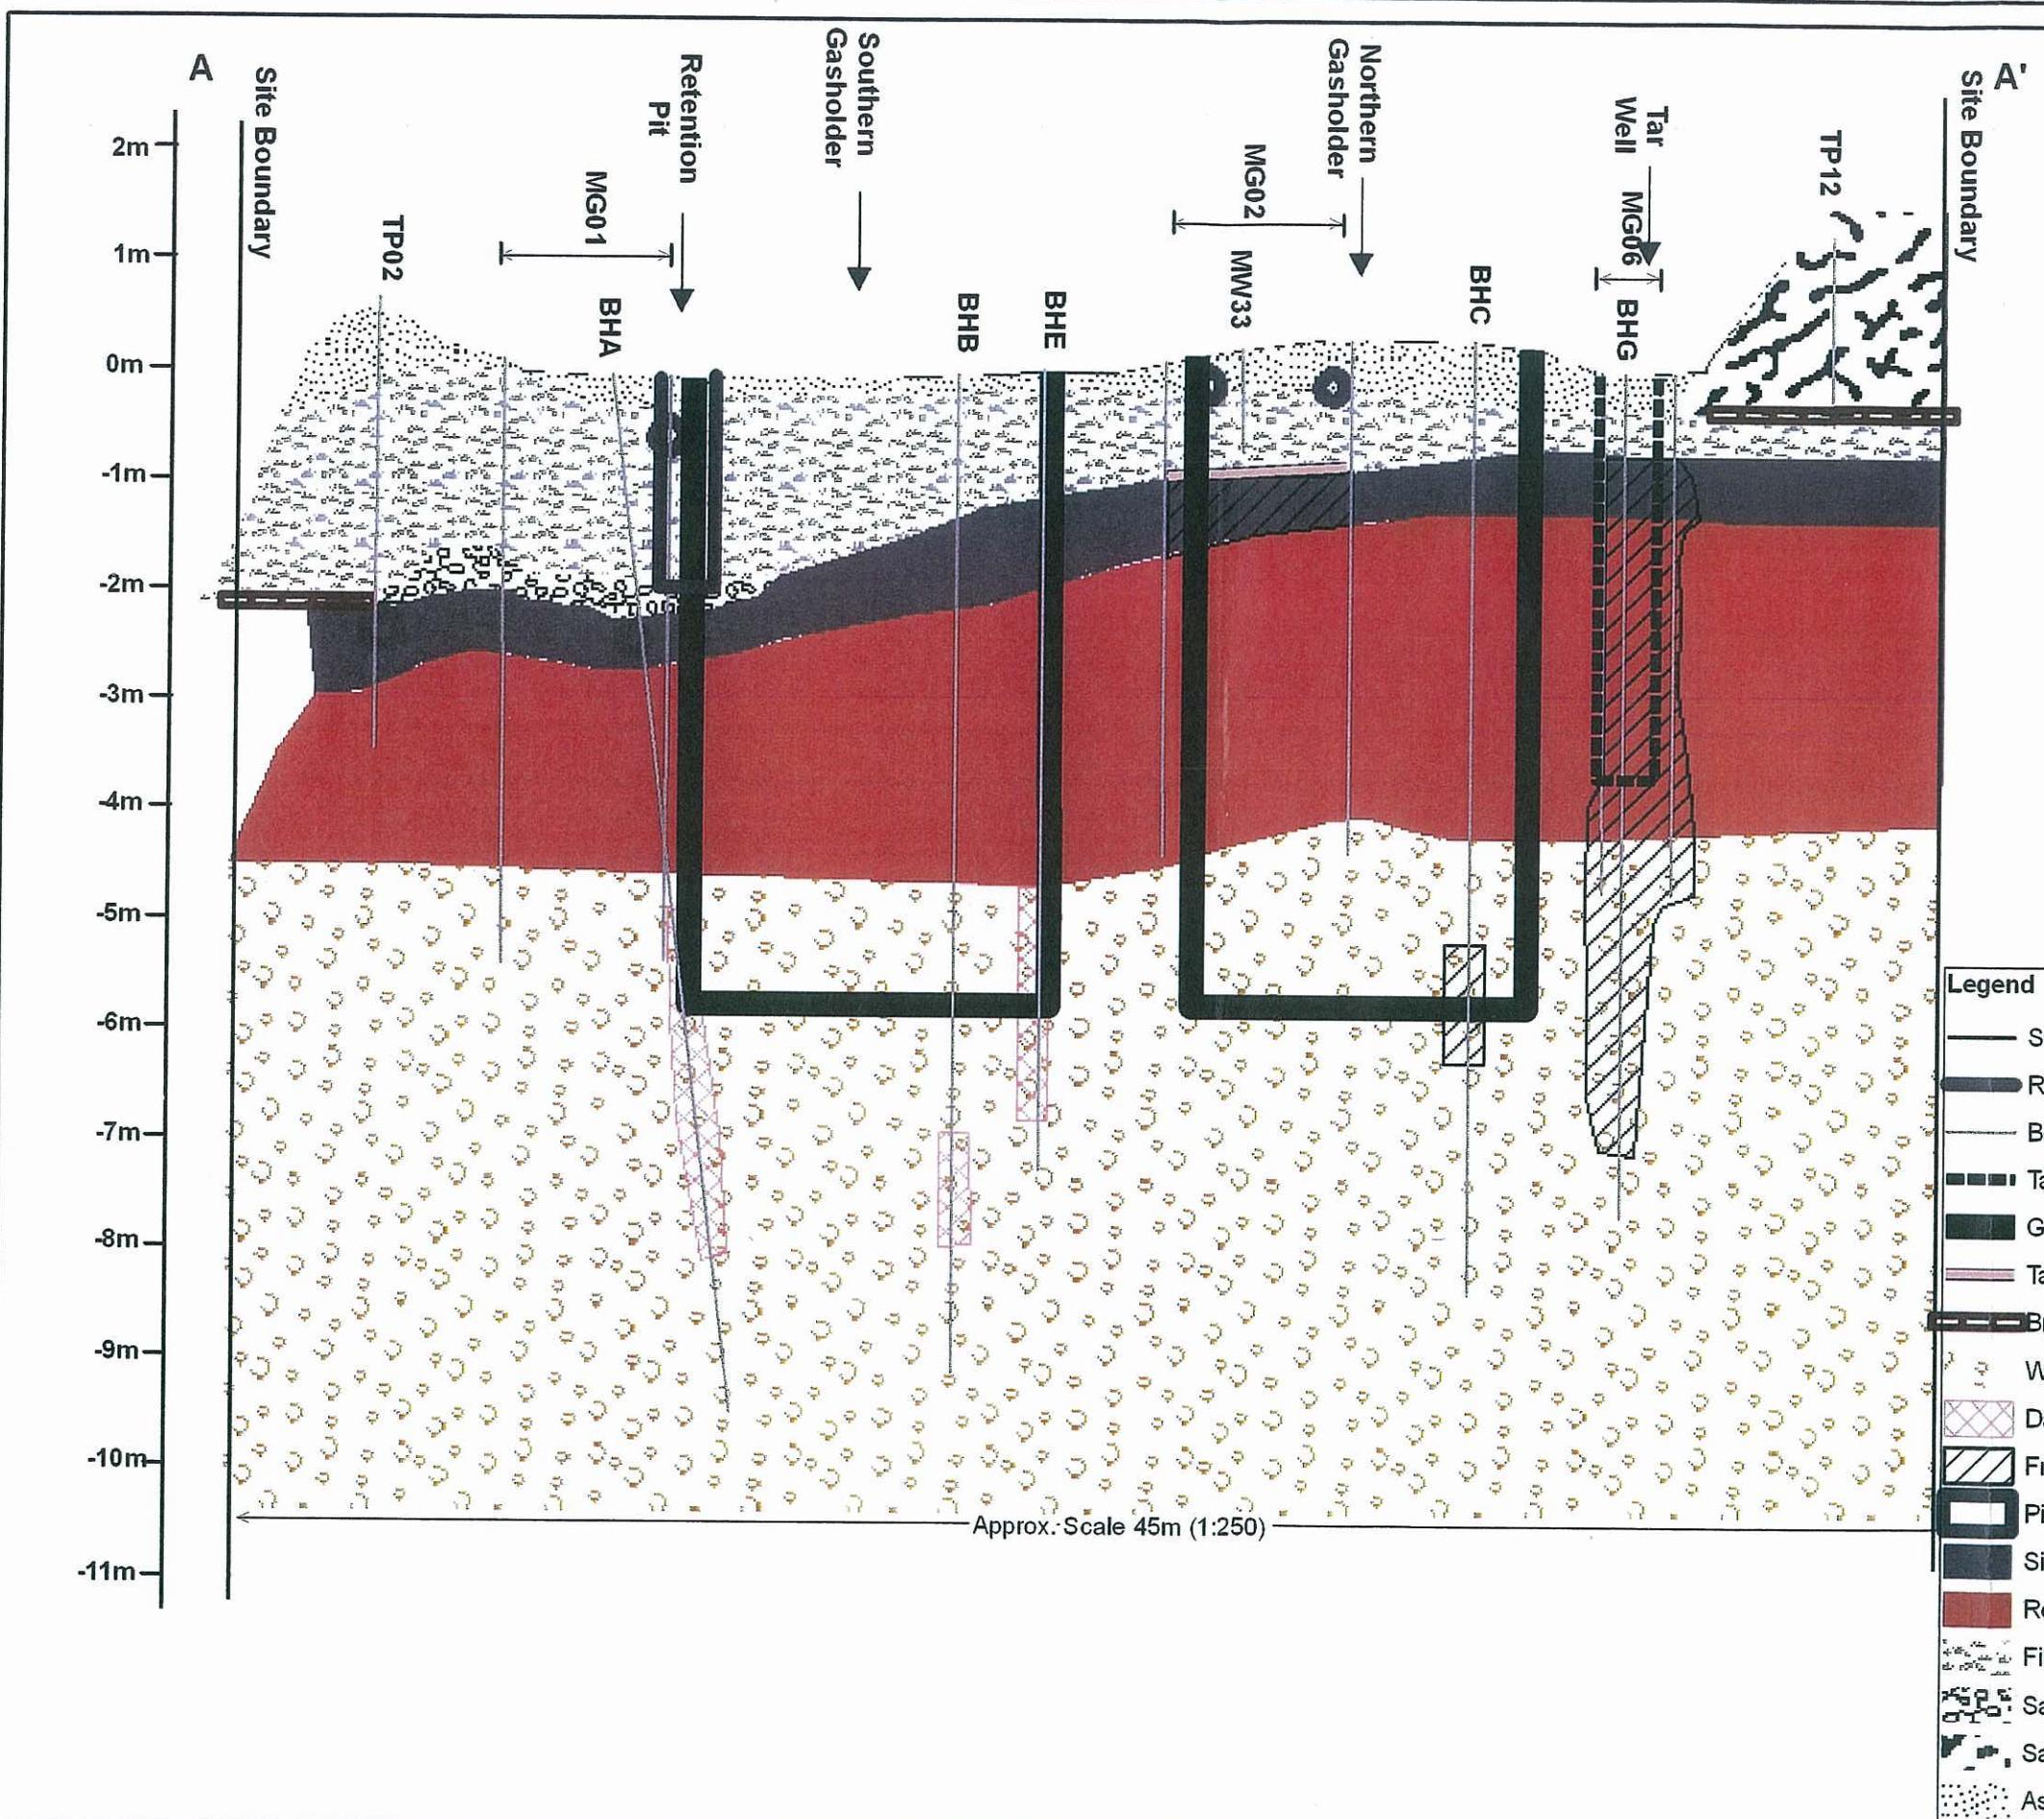
Figure 5 Cross Section Plan No. 1

- Free tar was observed at the base of the Northern Gasholder and was observed to be seeping from the brick annulus wall during the excavation of trenches adjacent to the annulus wall. No free tar was observed beneath the Southern Gasholder. The vertical extent of contamination beneath the Northern and Southern Gasholder was stated to be between 8 to10 mbgs. The lateral extent was estimated to up to 5 m laterally from the annuli and the depth of contamination outside of the annuli was estimated between 4 to 15 mbgs;
