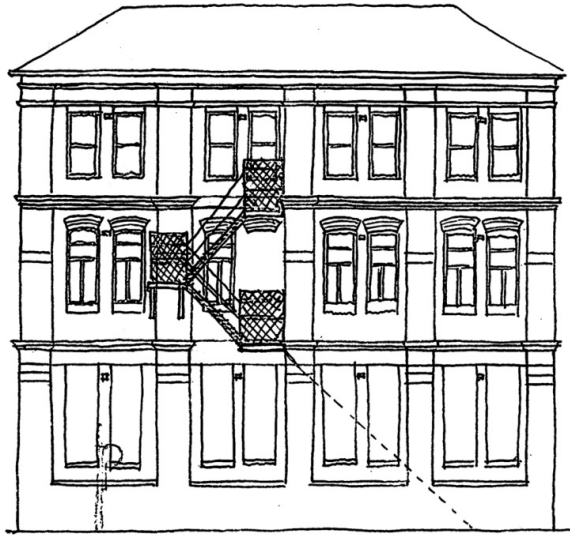
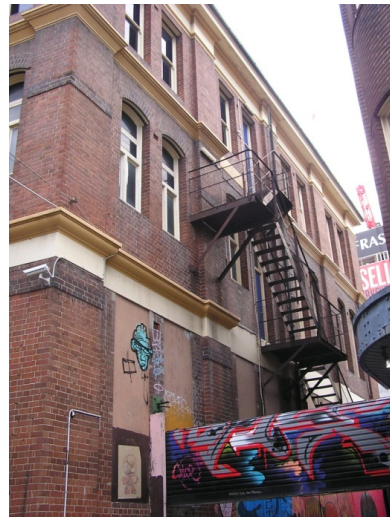
Figure 6. The northern elevation of the Administration Building is largely hidden in views from Broadway by the adjacent County Clare Hotel due to the narrow driveway and the bulk of the County Clare Hotel. The facade is dominated by the external fire escape.

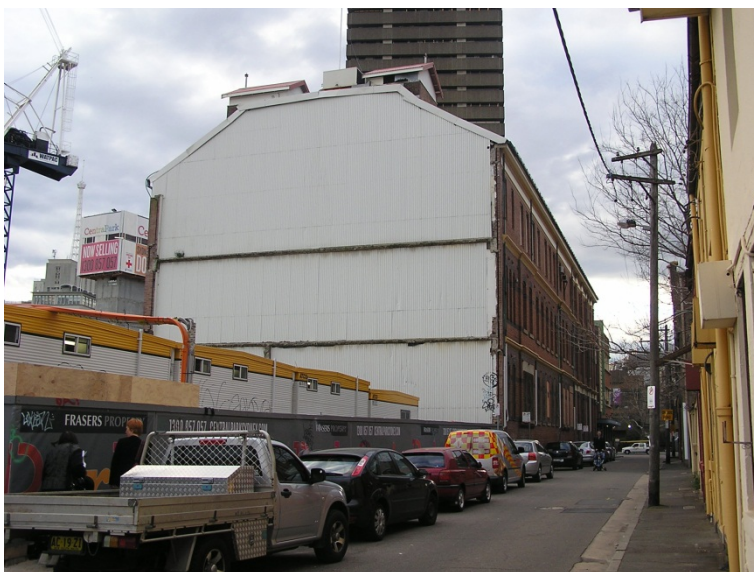
Figure 8.

Southern elevation of the Administration Building showing the temporary wall erected to protect the Administration Building following the demolition of the earlier addition.

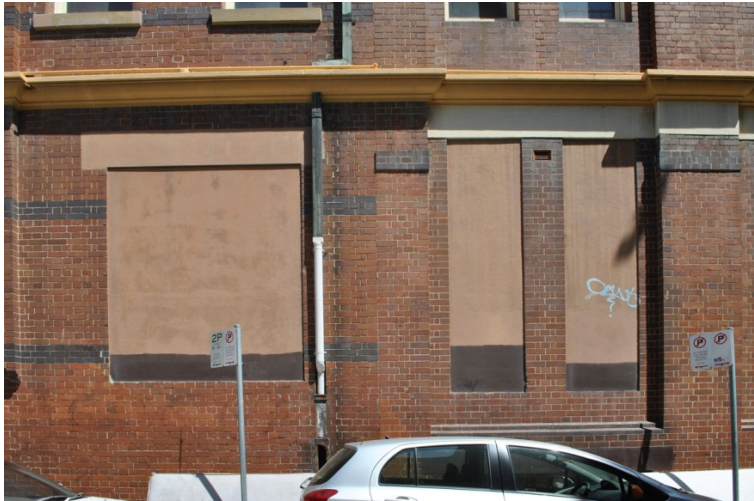
Figure 9.

The 1930 addition was designed to blend comfortably with the earlier part of the building, and this has been so successfully achieved that the two parts are only readily discerned on close inspection. Indicators include the clearly defined joint (no attempt was made to key the brickwork) and the subtle differences in the modelling and fenestration of the two sections.

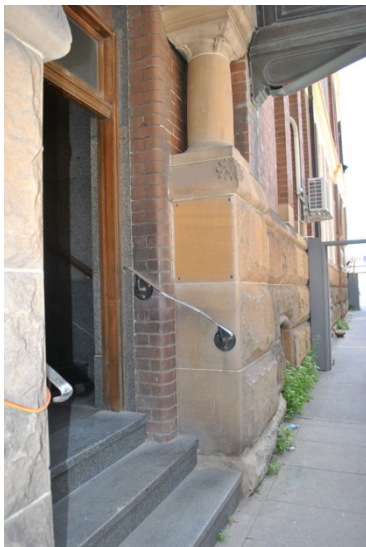
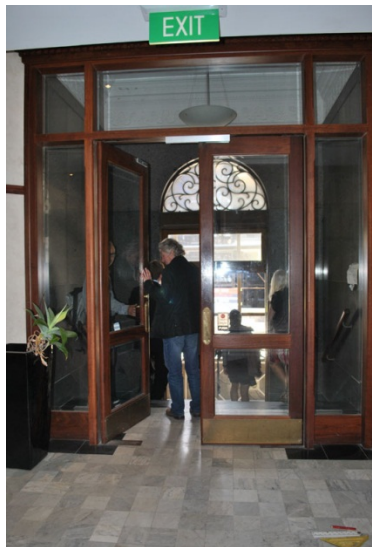
Figure 11.

(left) The entrance to Carlton Street, and (right) main door to the building. The joinery to the main door is simple, with a pair of glazed leaves framed in varnished timber. The decorative ironwork grill that has been added to protect the glazed arch above the front door. The vestibule area was stripped and the marble floor and new doors installed as part of the 1930s alterations.

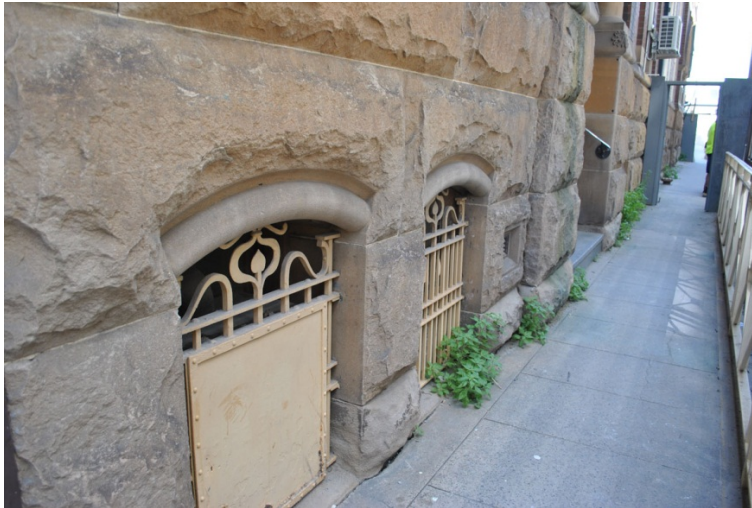
Figure 12.

The Carlton Street elevation is set on a rusticated stone base into which the basement windows are set, the openings finished neatly with a dressed roll. The basement windows are protected by worked iron grilles in the Art Nouveau style.

The sandstone base to the building on the western elevation appears to be in good condition and free of damage which is notable given the industrial environment within which it was located.

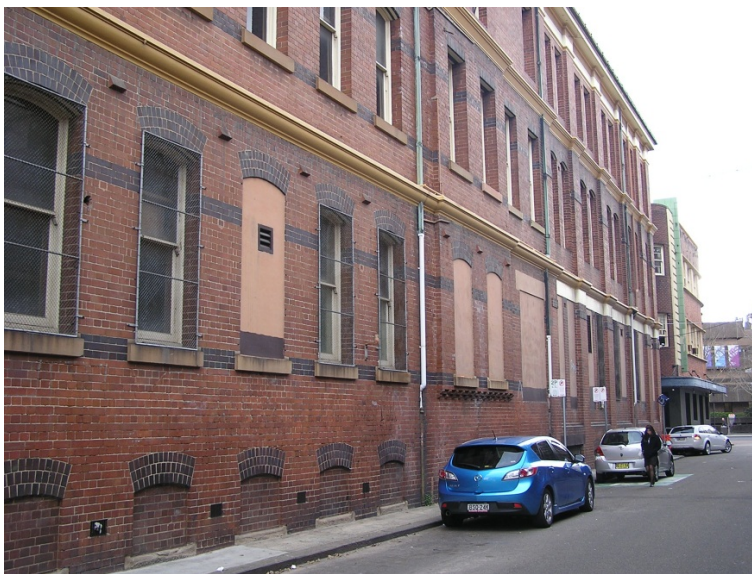
Figure 21.

The building turns its back on the adjacent Kensington Street, with no door openings and groups of windows set high above the footpath level to allow light. The windows to the basement have been infilled with brickwork at the southern (1910) section and protected by utilitarian heavy grilles to the northern (below).

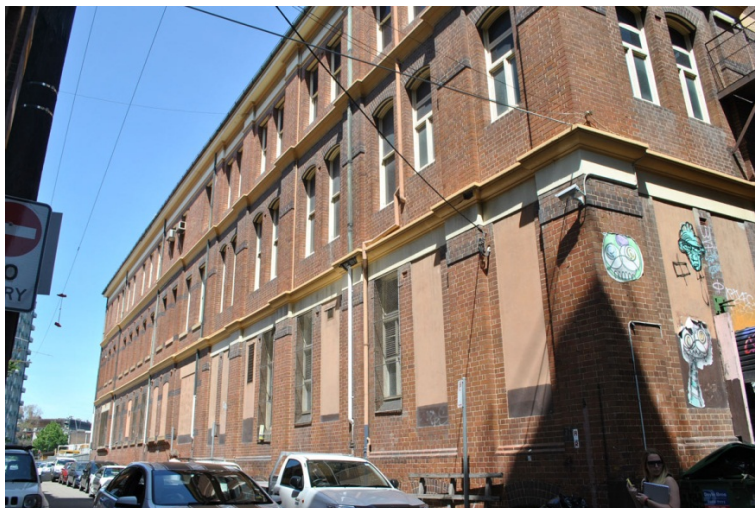
Figure 14.

The condition of the external fabric appears to be generally sound, with the main areas of damage noted being limited to the PVC downpipes used to the lower levels of the building, and which have now cracked and broken allowing water penetration and some deterioration of brick jointing.

The building has remained relatively free of vandalism such as graffiti or malicious damage. The 'graffiti' seen here was applied on a film base as part of a community art project.

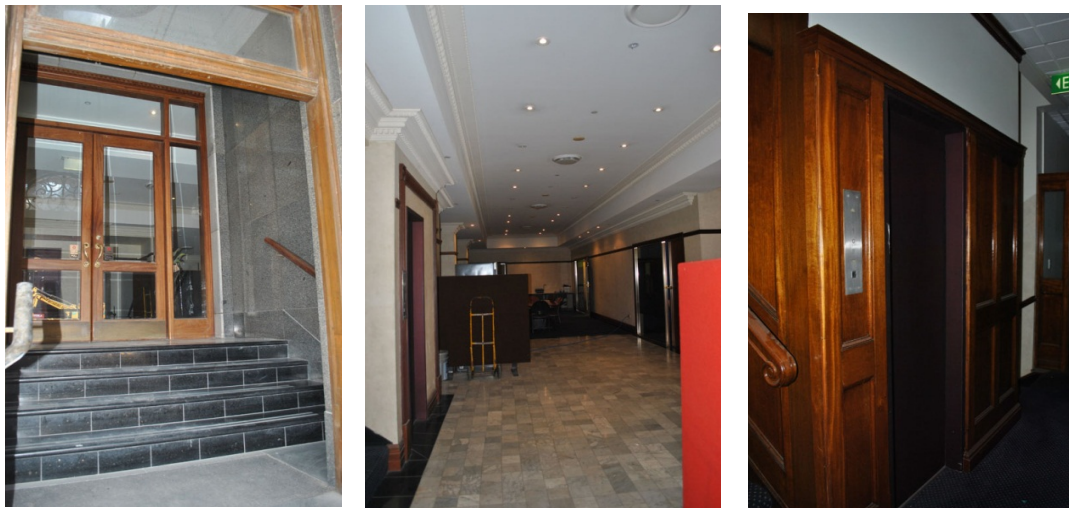
Figure 15.

The main entrance has been lined in granite to walls and treads, and the door and its frame is not the original, the works being done as part of the 1930s refurbishment. It is spatially significant, being the original entrance to the Administration Building, and will be incorporated as a feature within the Vestibule Suite. The lower area leads to Carlton Street, which is the main avenue through the

precinct, and could be used as a small seating area. The management of the public/private interface needs to be detailed carefully to retain the three-dimensional qualities of the entrance space.

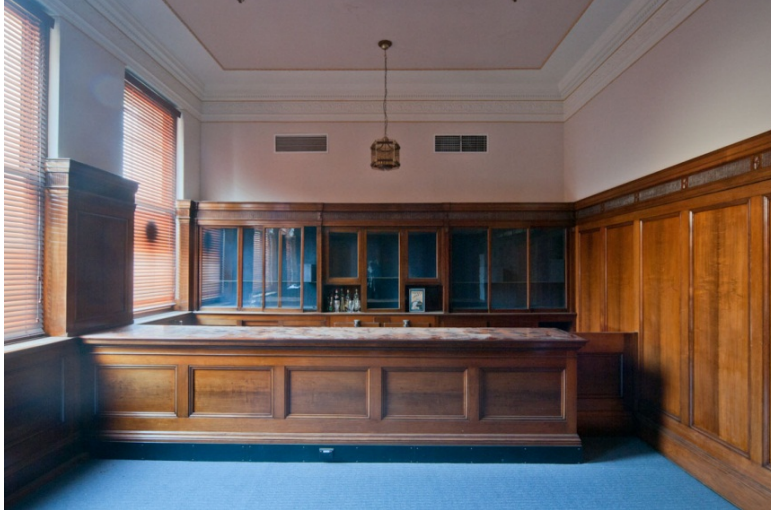
Figure 18.

The Show Bar is an impressively presented room used for the tasting and promotion of the company's products. The room is fully lined in Queensland Maple and features a large parquetry bar in front of a display cabinet and built-in refrigerator facilities.

This room will be carefully dismantled during the building process and then reconstructed in the same position to existing quality and detail. It will then be used as one of the unique suites within the hotel.

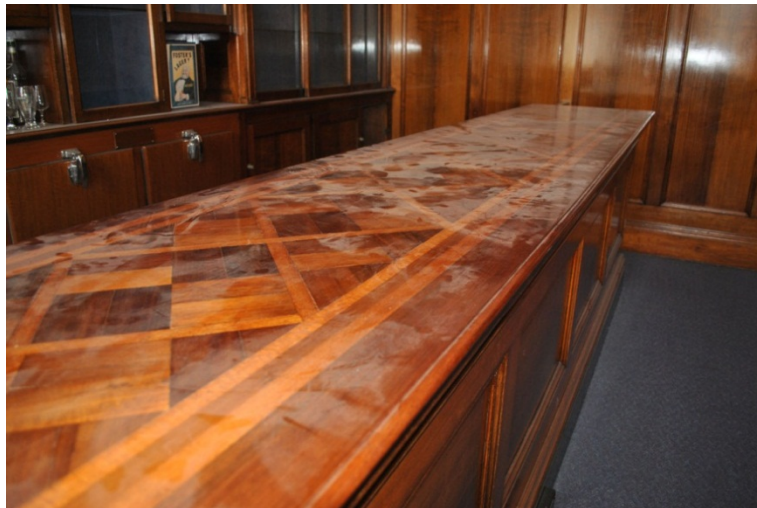
Figure 19.

Parquetry bar in the Show Bar. Early photographs reveal that the floor was also parquetry laid in the same pattern. It is not known if it survives under the carpet. If uncovered during dismantling of the room it will be removed in numbered sections and reinstated in the reconstructed room.

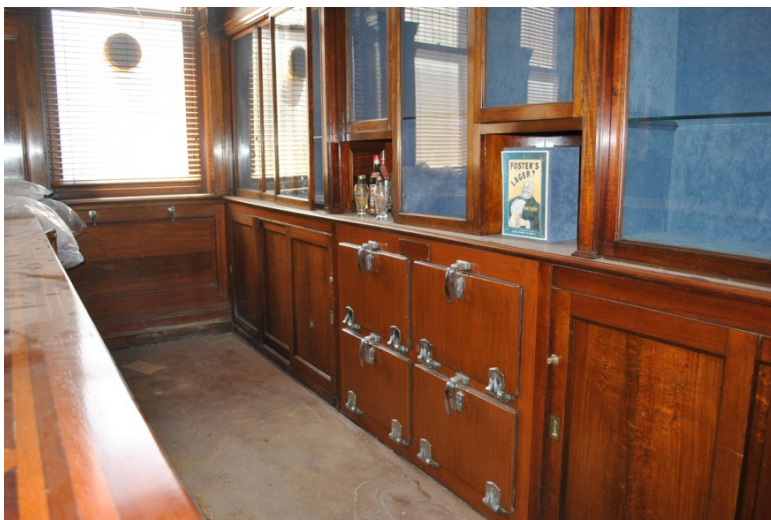
Figure 20.

Fitted bar fridges and display cabinet in the Show Bar. These will all be stored and reinstated.

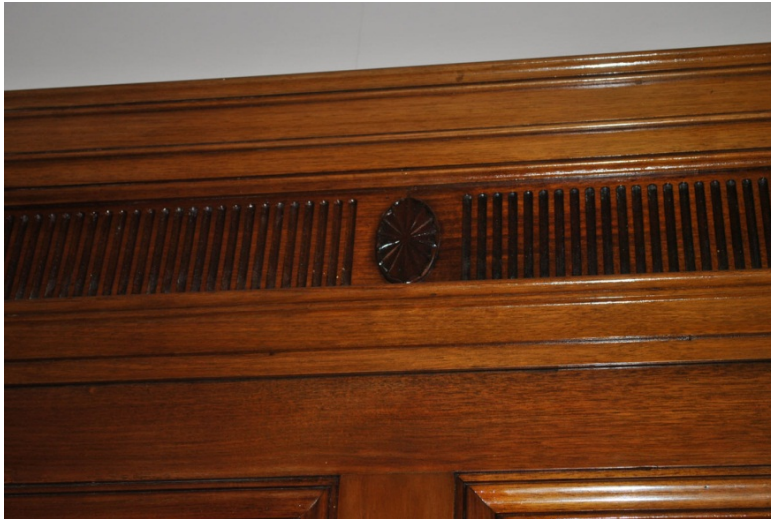
Figure 30.

Detail of carved panel frieze. All panelling will be removed, numbered and re-fixed to the reinstated room.

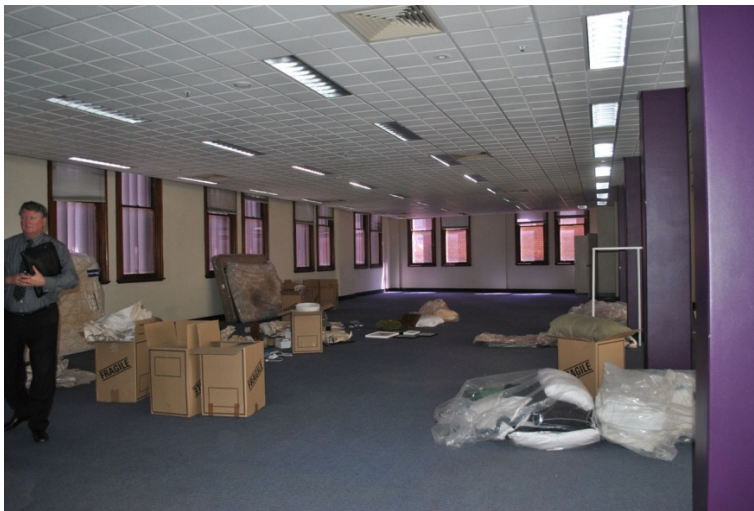
Figure 31.

The building, with the exception of the nominated significant spaces, has been gutted and used for general office space. Note the low ceilings created by the suspension of services under the timber ceilings which give the space a claustrophobic character.

The proposed removal of the existing timber floors and office-style fitout will allow each level to once again align with the original windows.

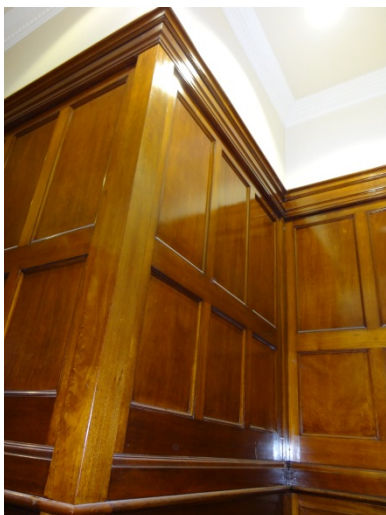
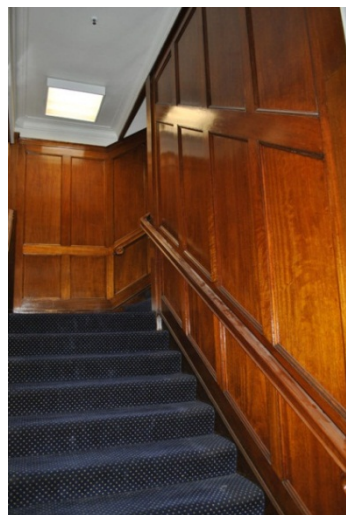
Figure 21.

The timber lined stair between Levels 1 and 2 is an important part of the heritage significance of the Administration Building and forms part of the visual differentiation of the 'Executive Route' to the boardroom. It has been archivally recorded and will be dismantled and re-used within the hotel to provide an analogous 'privileged' route to the wine store on the lower level. As noted the lining only remains between levels 1 and 2.

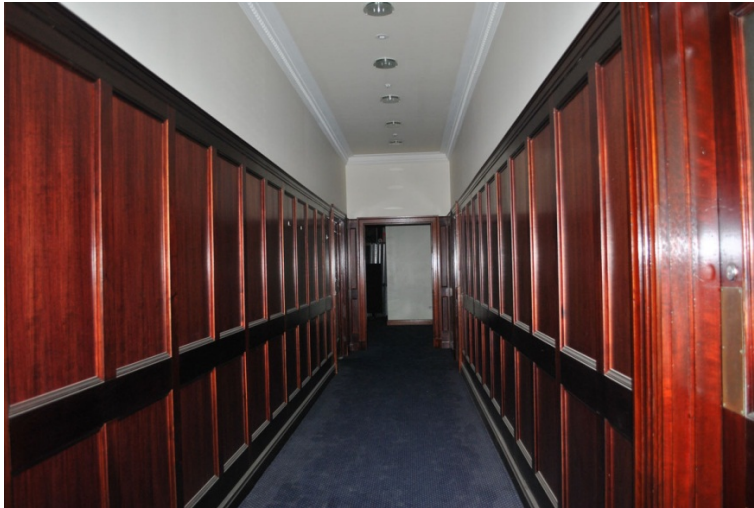
Figure 22.

The panelling continues along the corridor to the Boardroom. Although not nominated as significant in the earlier CMPs (it is of later construction), this panelling will also be removed carefully and used in the public areas of the hotel.

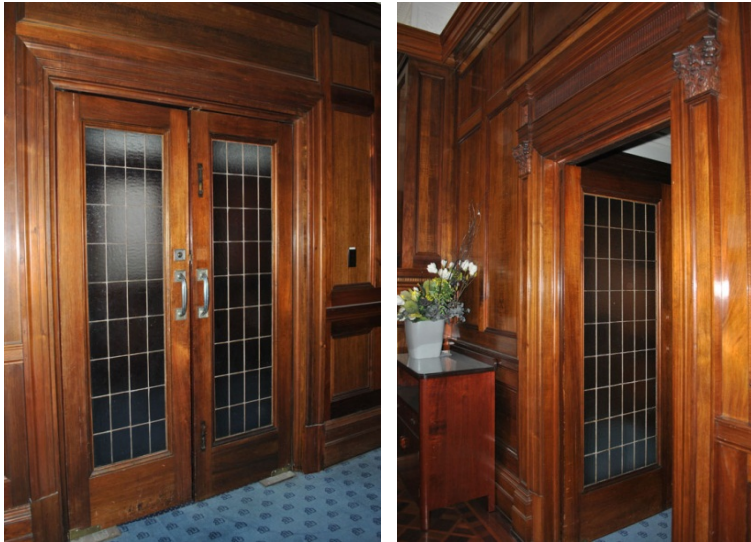
Figure 25.

Doors to the Ante-room. These doors currently separate the executive area from the remainder of the building, but are glazed and will not be capable of providing the fire separation rating necessary for a hotel room without significant intervention to the space. They will be re-used within the suite or (depending on the final fitout of the suite) elsewhere in the public areas of the hotel.

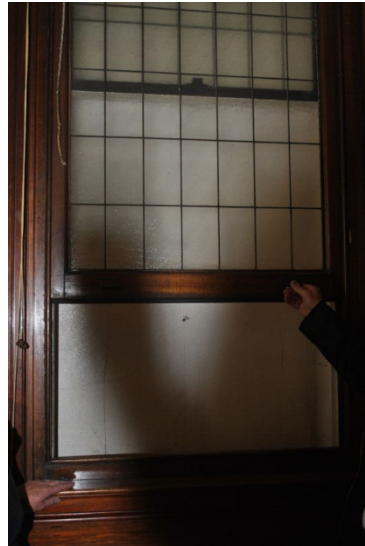
Figure 40.

(right) This window originally opened to a light well, but became a blind opening when the extension was added to the south in the 1950s. The contemporary bathroom to the Executive Suite will be located in the space behind this window (accessed through the original bathroom area) and this opening will be retained as a blind window.

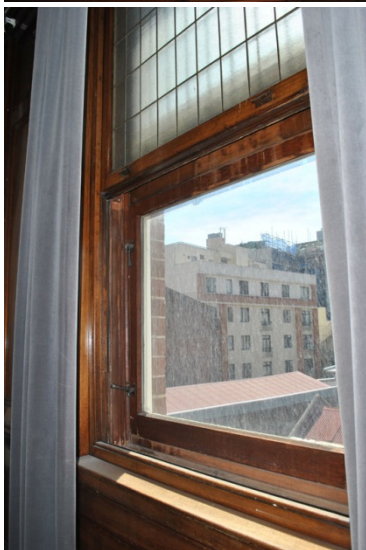
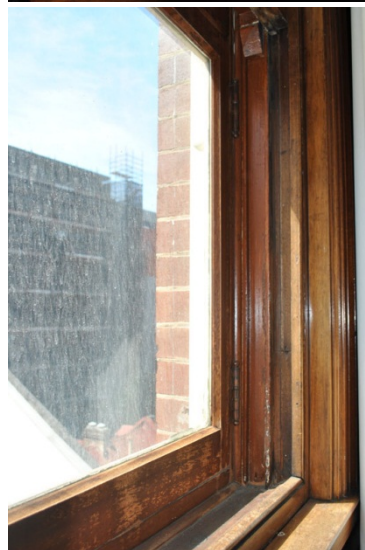
Figure 41.

The windows to the boardroom are double-glazed sash windows set into separately operable tracks. They provide good sound insulation and will be retained.

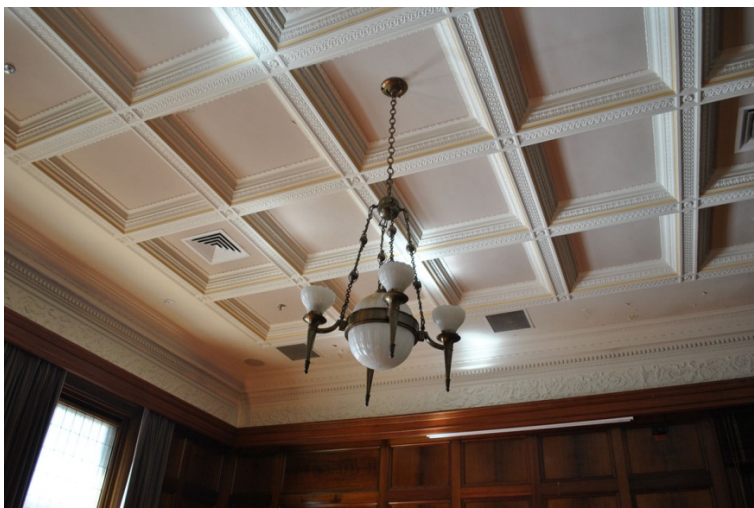
Figure 42.

Detail of the ceiling. New temporary penetrations will be kept to a minimum and will be located within the panel areas.
