Our ref: HMS ID 2221

**Sandstone Precinct Mod 18 - Lands Building Ceilings (SSD-7484-Mod-18) – Lands Building Ceilings**

## Attachment 2 – Analysis of SSD 7484 Modification 18

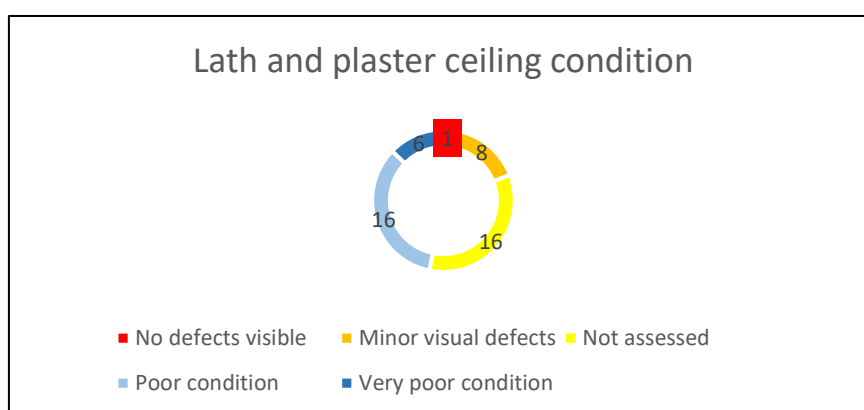
Table 3: Condition of Lath &Plaster ceilings proposed for demolition by Mod 18.

From the documentation provided, the condition of the lath and plaster ceilings has deteriorated from generally good and fair in 2015 to poor and very poor in 2022.

| <b>2022</b><br><br>Condition assessment (2022) prepared by Northrop for Mod 18 | Found considerable deterioration in ceiling condition with 47% now being of poor or very poor condition.<br><br>Approximately 34% were not given a condition rating as ceiling protection is installed and there are floorboards above the ceiling. |

The decline in the ceilings over this short period of time is likely to be reflective of the lack of ongoing maintenance and the continued ingress of water before the roof was made watertight. It is also possible that vibrations from the construction may have contributed to the deterioration of their condition.

The Northrop report recommended that any collapsed ceilings should be demolished and new lath and plaster reinstated.

Northrop have also recommended that where lath and plaster ceilings have collapsed this portion of the ceiling should be removed and the lath and plaster ceiling reconstructed. This is also supported.
