# Attachment F: Supplementary Information in support of the Hunter Transmission Project Aviation Impact Assessment

## Aviation Impact Assessment

### Peer review (November 2025)

### Warkworth Airfield risk assessment (May 2026)

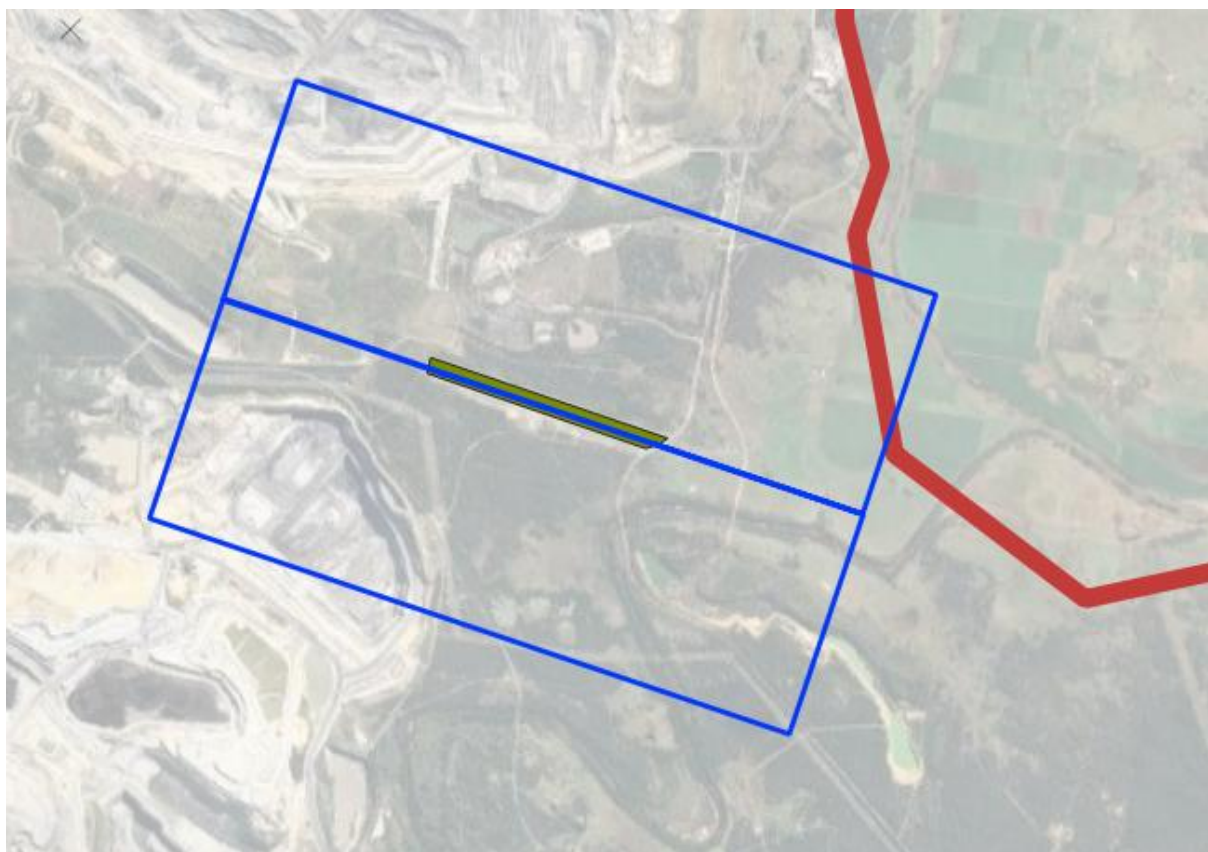
- **Circuit height variability (p. 31):** The AIA states that when joining the circuit from the east, aircraft would be at a minimum height of 1,000 ft above the runway when over the HTP corridor. This assumption requires clarification on how it was derived. Aircraft in the circuit typically turn on to their final approach at least 500 ft above aerodrome elevation (CASA AC 91-10 v1.6). If the 1,000 ft figure is based on specific data, such as flight tracking, consultation with the flight school, or other documented sources, the report should explicitly state this. Without clear attribution, the validity of this assumption remains uncertain.

A short assessment carried out by To70 below shows a typical circuit pattern based on a one-nautical-mile final approach, as determined by experience with other projects and analysis of publicly available flight tracks. While it is important to consider that circuits can vary significantly depending on aircraft performance, pilot decisions, and weather conditions, this shows that a base-to-final turn, the aircraft is descending, and may be conducted over and in proximity to the transmission line. Figure 1 illustrates a representative left-hand circuit pattern based on a one-nautical-mile approach, informed by To70's experience on comparable projects and review of publicly available flight tracks. As shown in the diagram below, a base-to-final turn may be conducted over, or in close proximity to, the transmission line alignment.

Figure 1: Indicative circuit pattern at Warkworth Aerodrome showing a one-nautical-mile final approach and the relative position of the HTP corridor

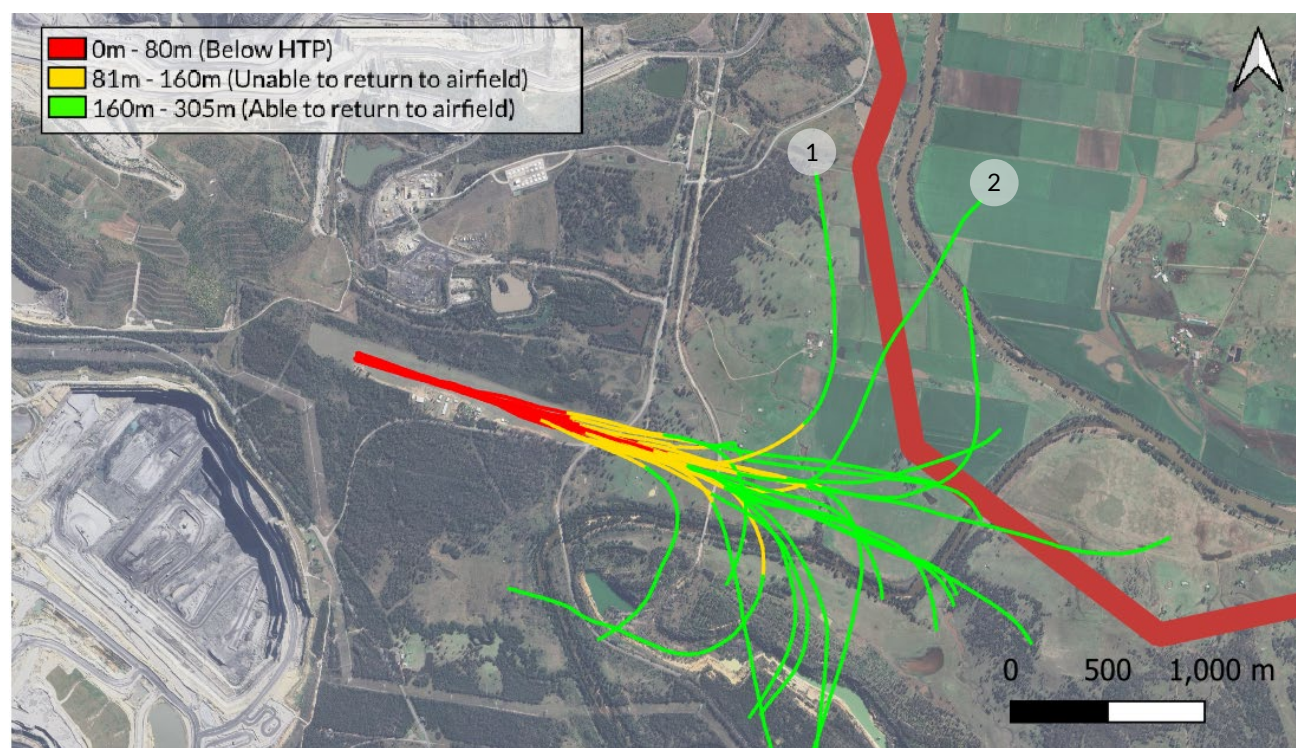
Figure 2 shows that, based on this sample of flights, most flights would have sufficient altitude for the glider to make a safe return to the airfield following a launch failure in the vicinity of the HTP. However, for some flights (for example, those marked as 1 and 2), a launch failure during a short period may leave them in a situation where the safest landing option is in areas that could be obstructed by the HTP infrastructure. Due to poorer glide performance, a powered aircraft or towplane

would be less likely to have sufficient height to return to the airfield, and it would be more likely to conflict with the HTP infrastructure following an engine failure.

Figure 2 - Examples of aerotow departures from runway 10

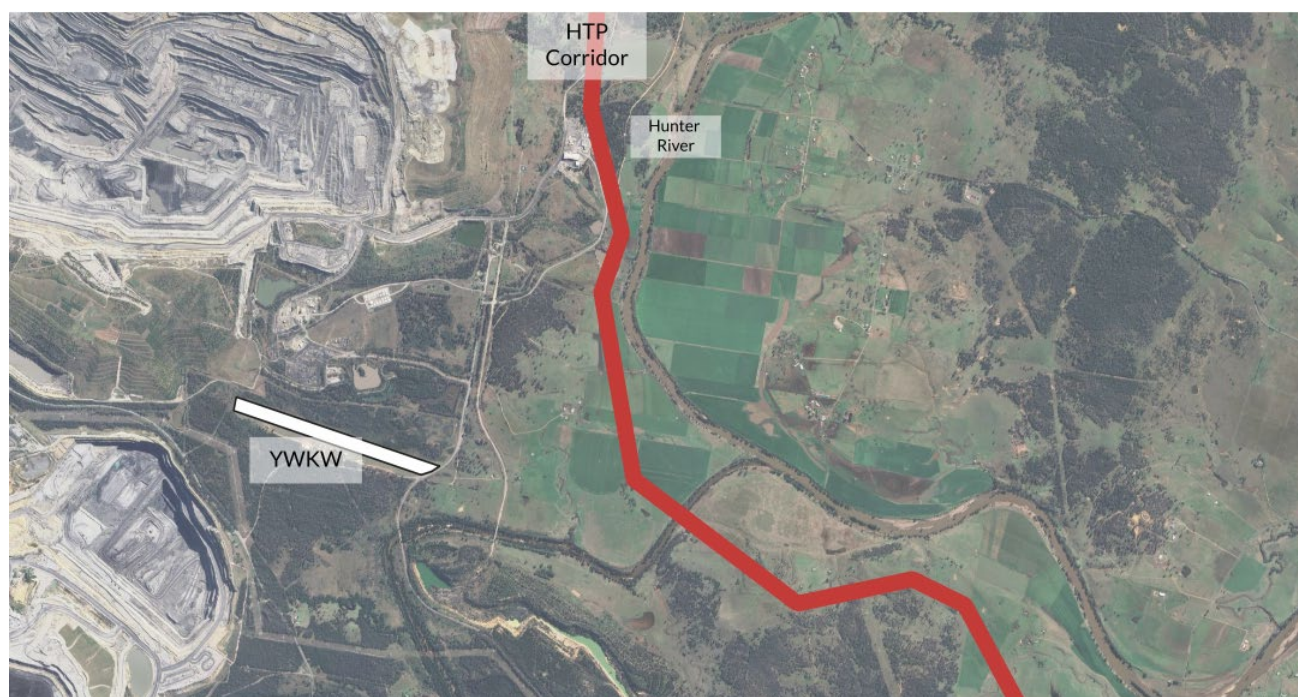
This risk is defined as a forced outlanding in inferior terrain due to HTP infrastructure that constrains access to preferred paddocks for outlanding. This increases the risk of landing in rough or small fields and of colliding with obstacles, such as fences or irrigation systems.

An outlanding is an unplanned landing that occurs when a glider pilot must make an unscheduled landing at an airfield or in a field due to an unexpected change in weather conditions or other operational need. In this situation, the pilot is trained to select a field based on multiple criteria, including size, orientation, surface, slope, obstacles (such as power poles and wires), and surroundings. When flying east and north of Warkworth Aerodrome, areas where a safe outlanding could be carried out are restricted by mining sites, forested areas, the Hunter River, and terrain. In Figure 3 the aerial view shows this area, and while options will change depending on stock or crop, the area through which the HTP corridor is currently deemed by HVGC to be suitable for outlandings, if required. These are also privately owned and may be subject to changes in use or development that may impact their suitability for outlandings. The area east of the Hunter River may offer similar options, less affected by the HTP corridor; these are farther from the airfield.

Figure 3 - Aerial view of the area to the east of Warkworth Aerodrome showing approximate HTP corridor

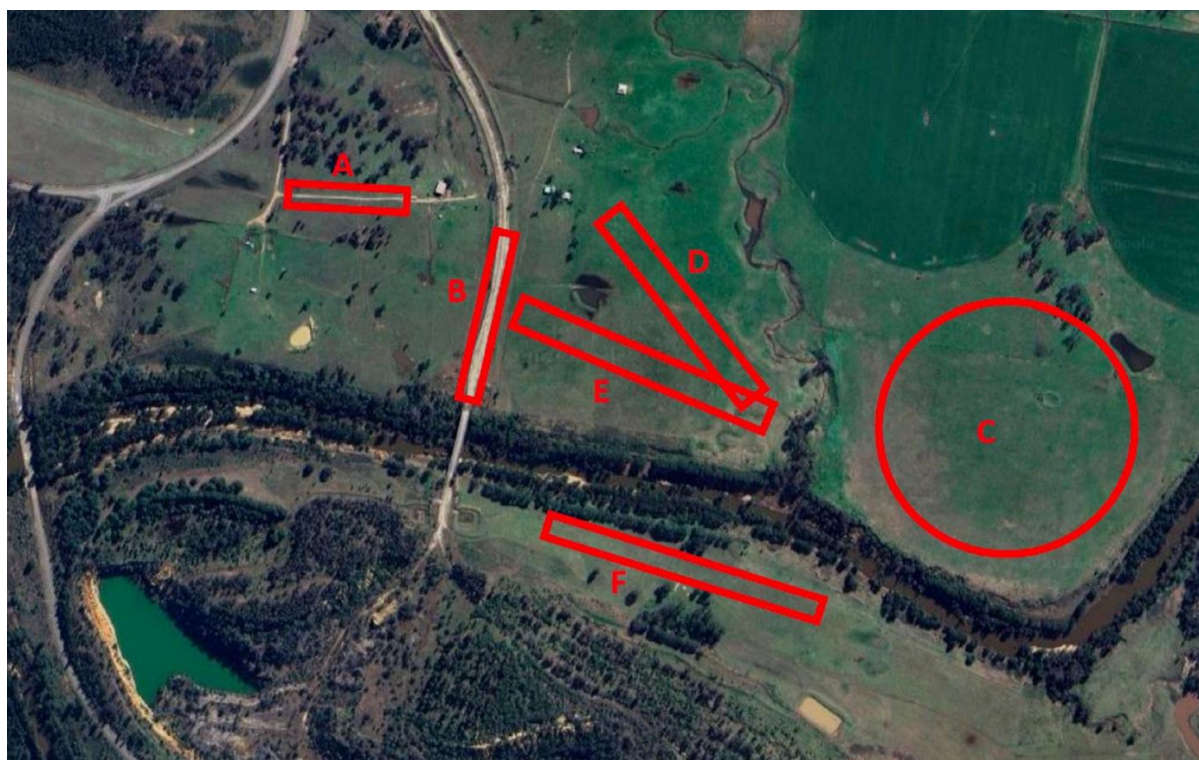
Control 3, establishment of new emergency landing area(s) east of the aerodrome to offset reduced outlanding options (subject to agreement with HVO), **is seen by GAus to be the most effective and most important risk control measure**, particularly in the absence of elimination (relocation) options. GAus welcomes HVGC efforts to explore one or several of the emergency landing options presented and agrees with HVGC on their viability.

Cascade risks from using these alternate landing areas can be appropriately managed by HVGC through training and operational safeguards.

If Control 3 alternate landing area measures are not adopted, then the residual risk for HVGC operations is considerably higher, even if other proposed risk controls are adopted.
