AUSTRALIAN TREE CONSULTANTS Pty Ltd
ABN 38 104 636 535
P.O. Box 417 Glenbrook NSW 2773
Mobile: Hugh 0418 474796
E-mail:
hugh@australiantreeconsultants.com.au
www.australiantreeconsultants.com.au

Re – DA Arborist Report

I refer to your request to update the information in regards to trees being removed and retained within St John of God Richmond Hospital.

St John of God Richmond Hospital Trees for Removal

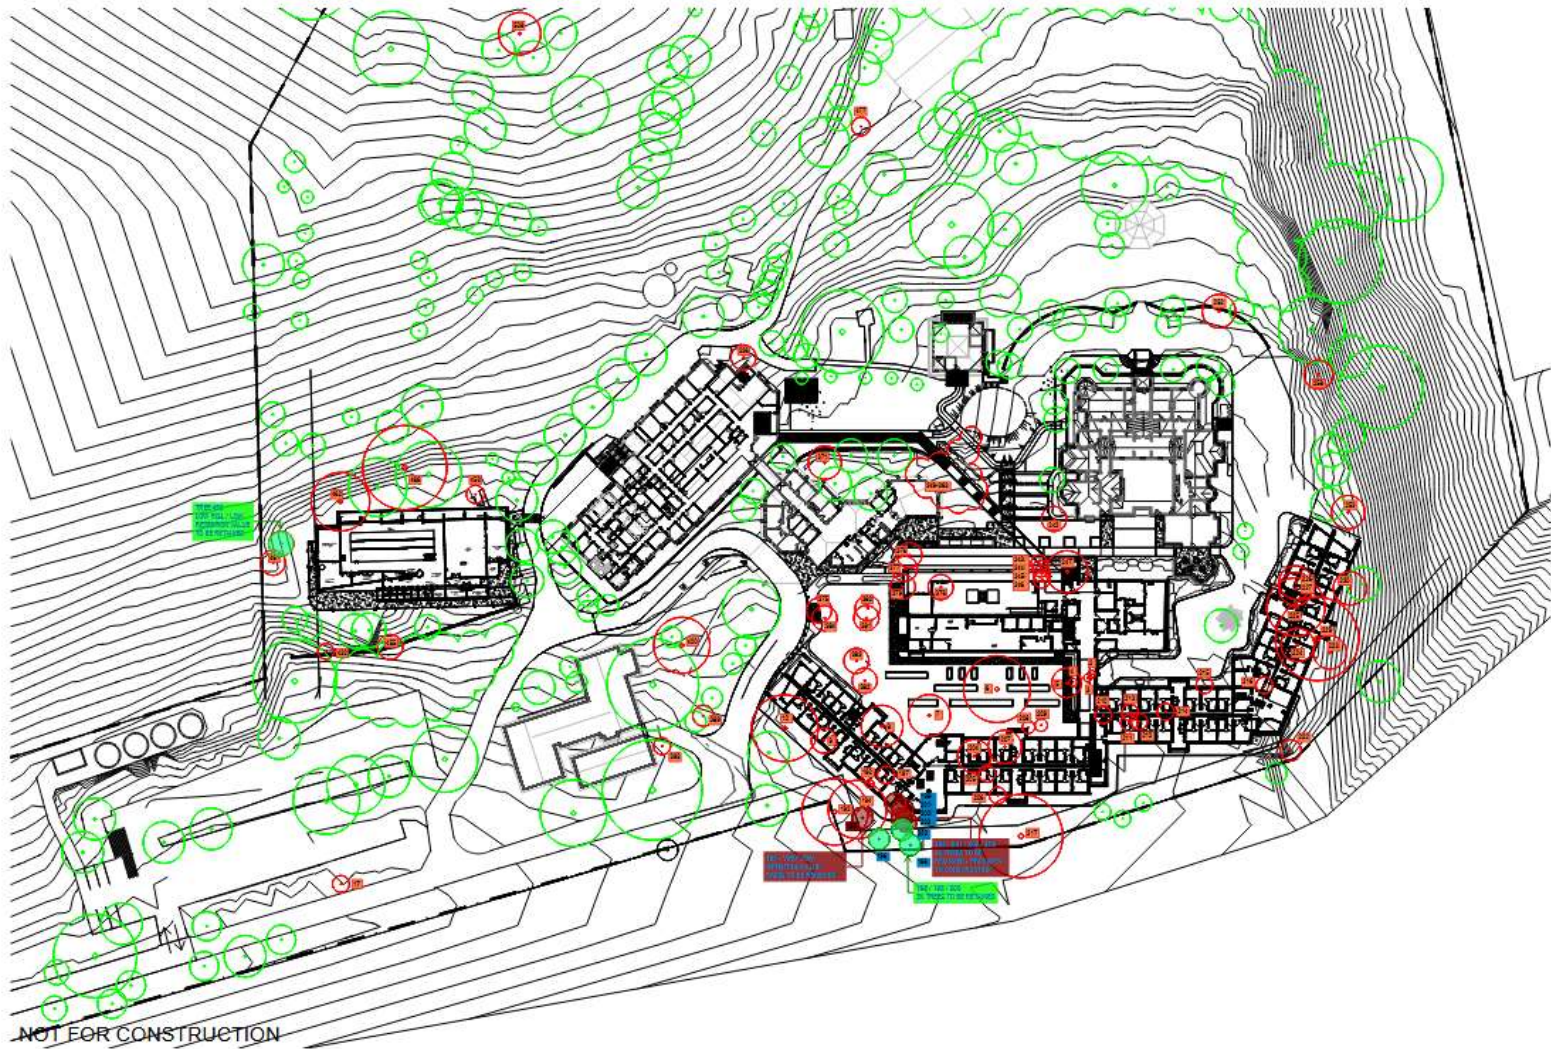
Drawing Name: Tree Removal Plan

The total count of trees to be removed is 97. Trees for removal have been highlighted in Tree Removal Markup_STH_220208.

Tree removal plan.
