ADDENDUM TO THE HERITAGE IMPACT STATEMENT

SAC REMOTE SITE

48 VICTORIA ROAD & 2B GORDON STREET

JUNE 2022

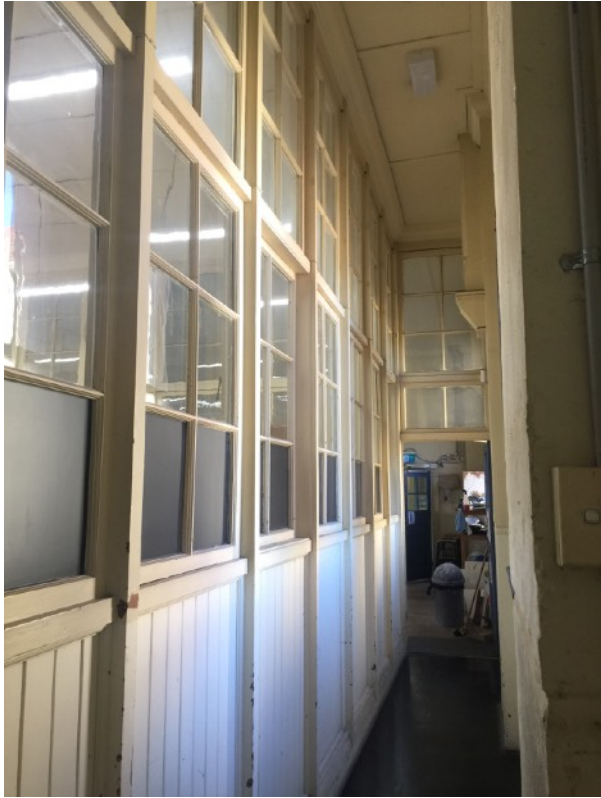
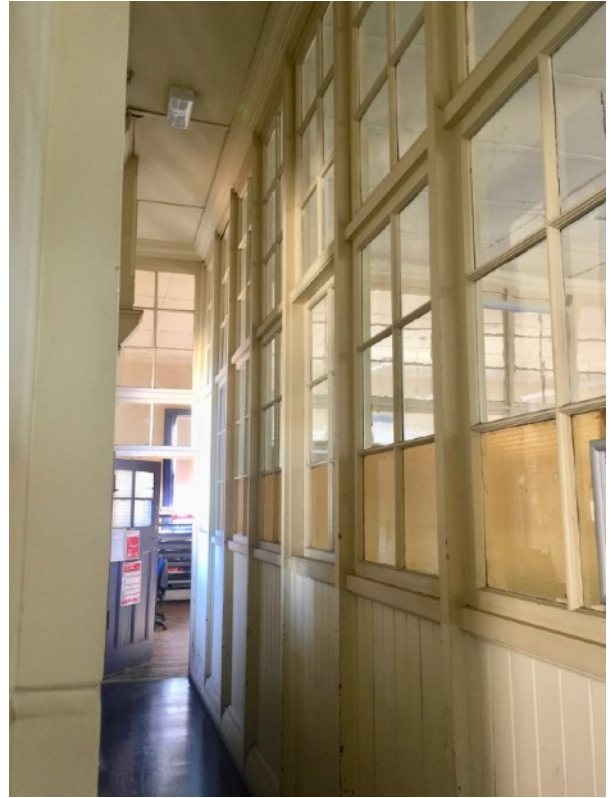
- Frosted film on the lower panes of corridor windows
- Vinyl flooring

1 & 2. Left and Right. View of the corridor on the western side of the classrooms. The frosted film on the lower panes of corridor windows and vinyl flooring are not original. The vinyl on the floor is not an original finish.

- Remove frosted film from existing windows
- Remove vinyl sheeting and make good the timber floor

The removal of the frosted film from existing windows and the vinyl sheeting will not impact on the significant building fabric.

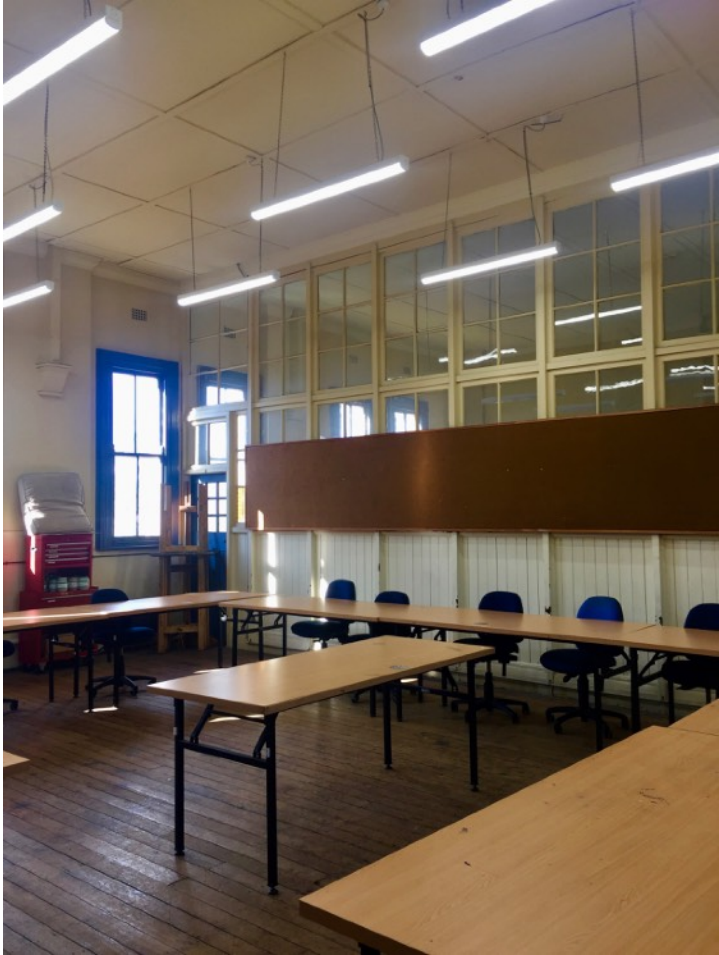
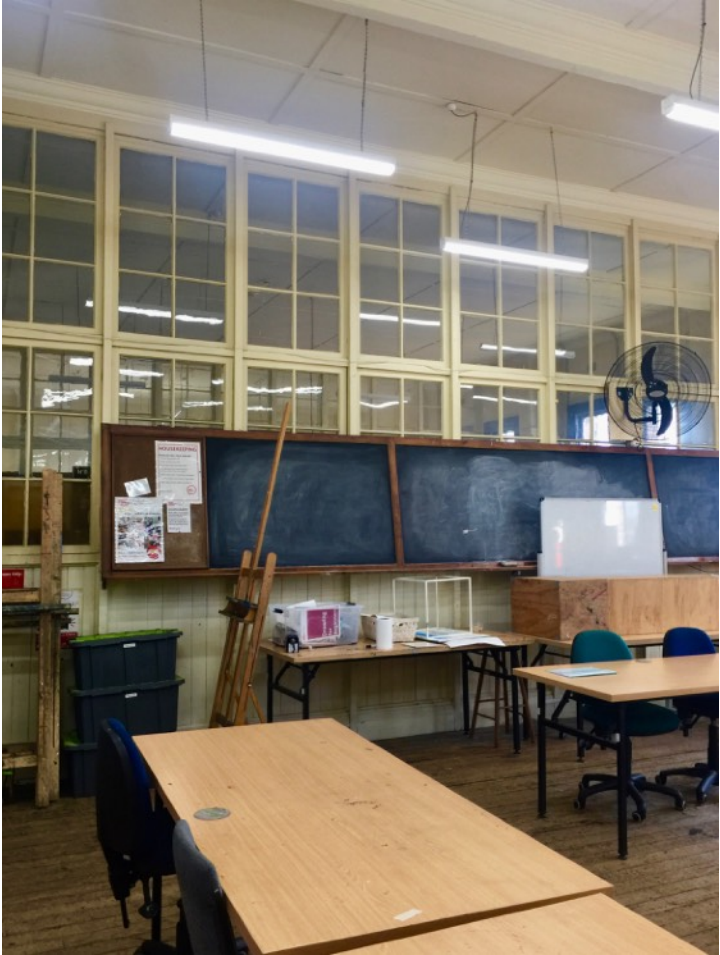
The existing pin boards in these classrooms are not original items in these classrooms. Their removal will not affect significant building fabric.

3 & 4. Left and right.View of the interior of the classrooms. These photographs show the location of pin boards.

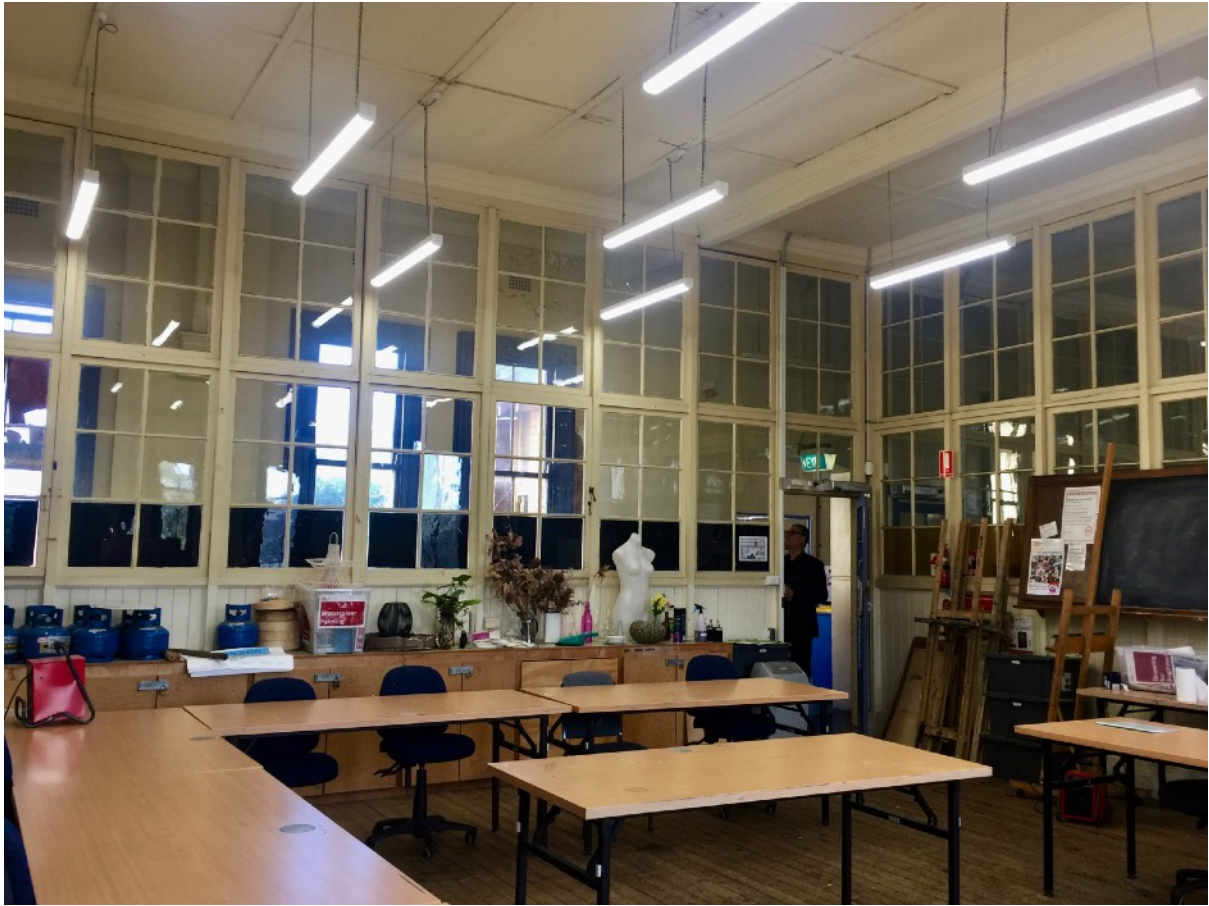
The joinery unit on the corridor wall is a later addition and the proposed removal will not impact on significant building fabric.

5 View of classroom 3 interior looking towards the corridor on the western side. The joinery unit under the corridor wall is not part of the original building fabric but a later addition.

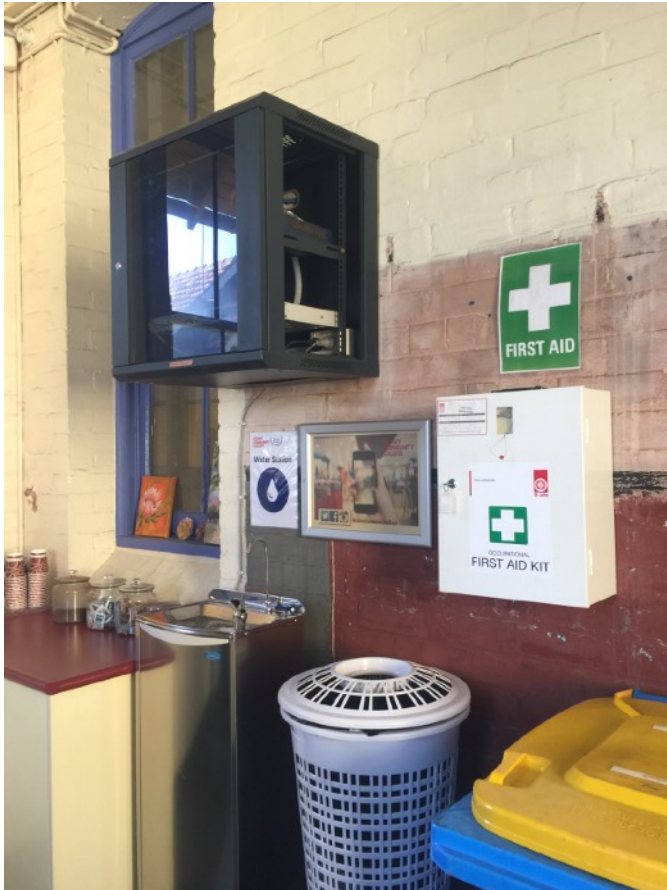
5. View of the existing tearoom in the lobby space. The fitout is later and not part of the original building fabric.

- Removal of the existing kitchen and making good to the existing wall and floor finishes.
- Replace the existing handrail to comply with BCA

The removal of removal of the existing kitchen and making good, and the replacement of the existing handrail with a metal balustrade and handrail to comply with BCA requirements will not impact on significant building fabric.

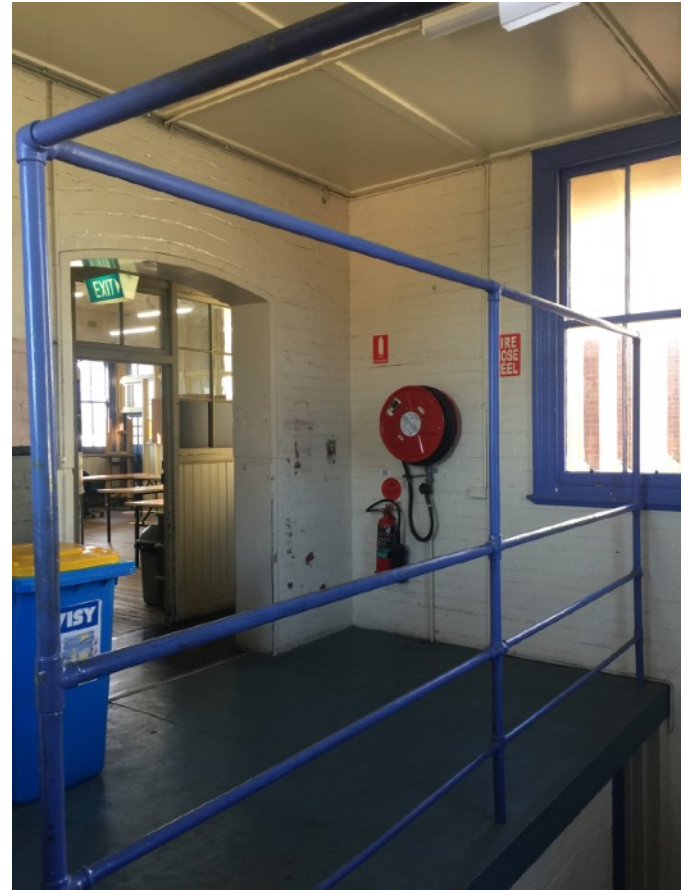
6. View of the non compliant and later pipe hand rail in the lobby. It is proposed to replace the non compliant handrail with a compliant metal handrail.
