## REMEDIATION ACTION PLAN

### 97-123 WALLGROVE ROAD, CECIL PARK NSW

CECIL PARK BUSINESS HUB DEVELOPMENT

| | Brisbane, QLD 4000 | <b>Reference</b> | 81971-2 |

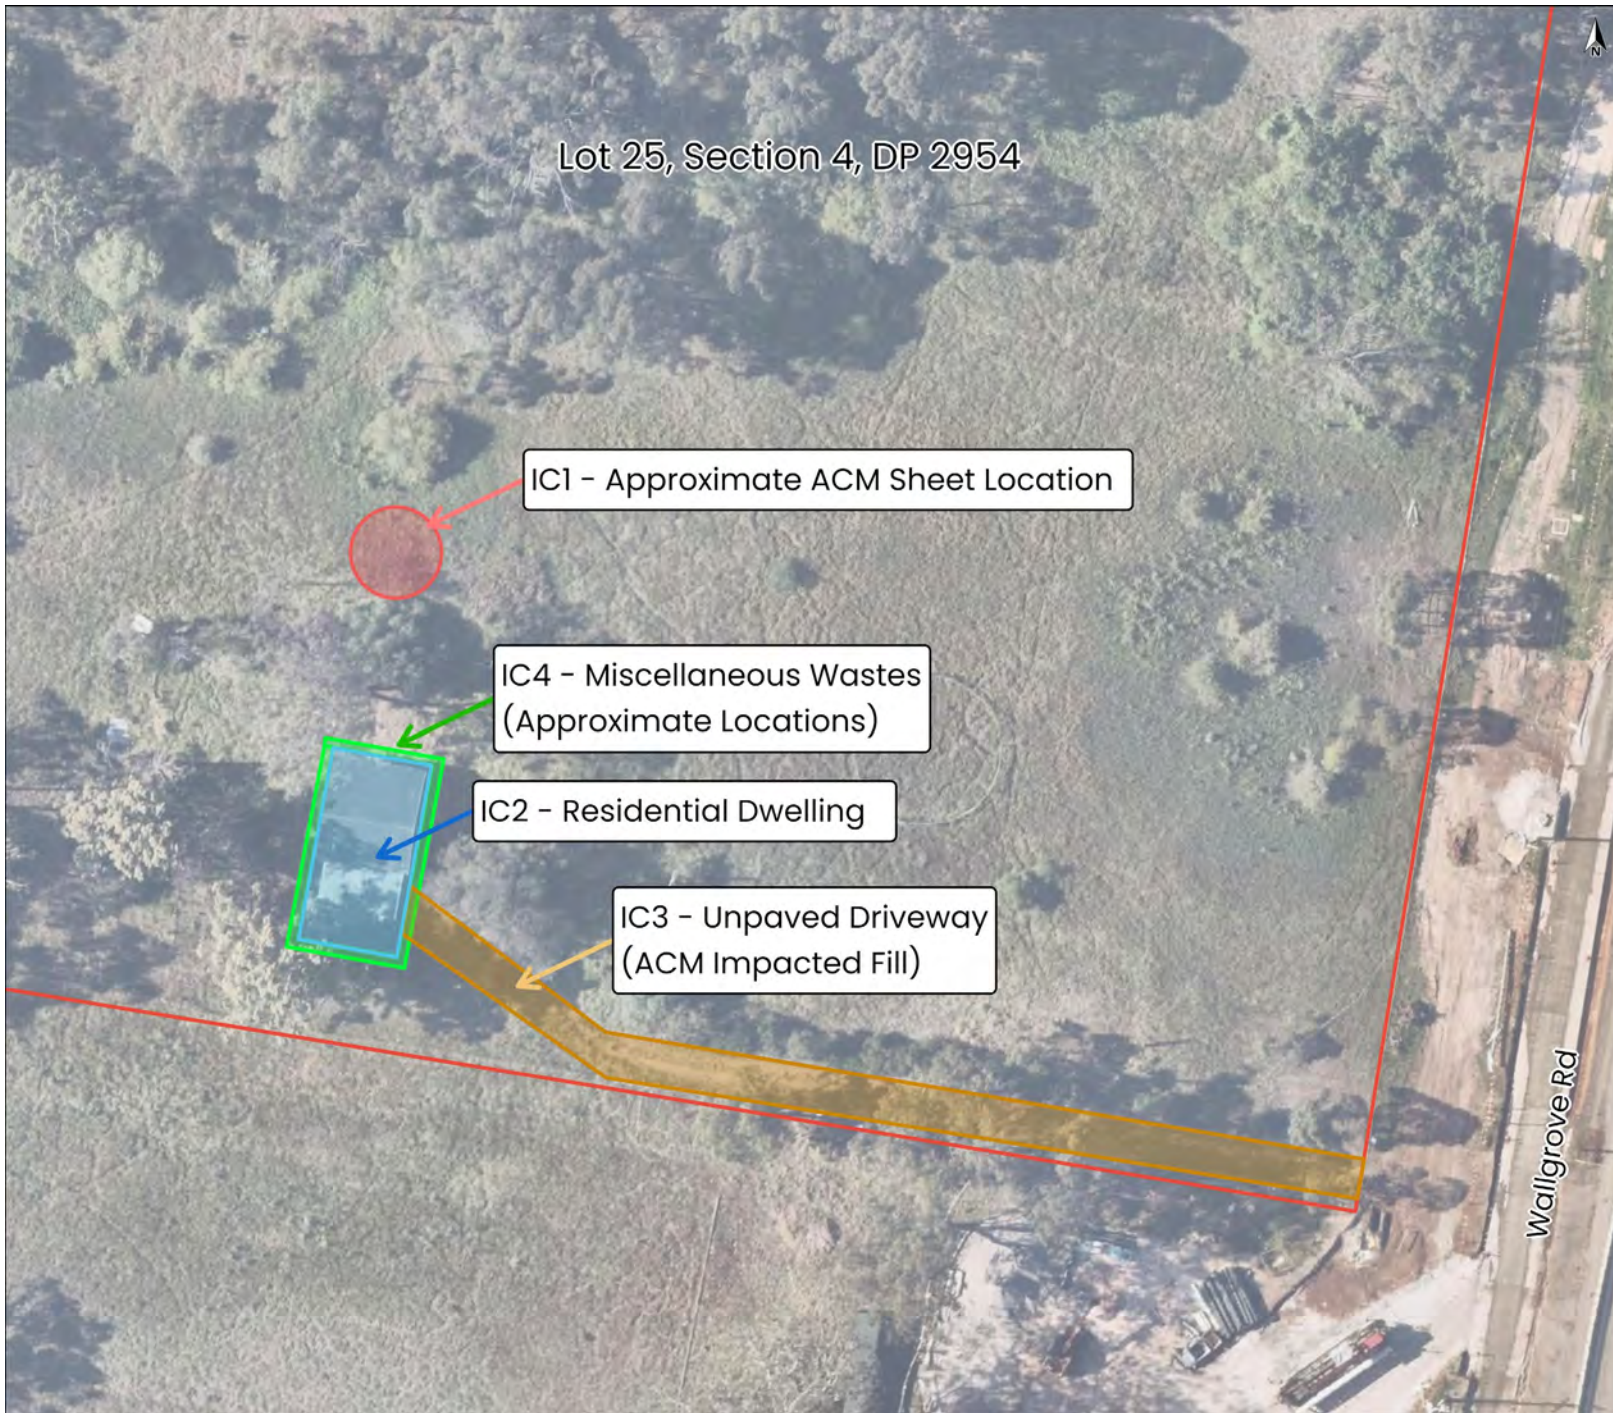
Title: Remediation Area Plan

Contamination at the site has been identified in the form of a discarded piece of ACM sheeting. This sheeting was likely derived from sheeting that had been used elsewhere on the site. ACM contamination was also found in the fill material used to construct the unsealed driveway into the property. A loose fibre bundle was detected in one of the samples from the unsealed driveway.

The ACM sheeting is present in a bonded form within the matrix of the building material and so does not present a risk to human health in its current undisturbed condition, whilst the site remains vacant. However, the presence of a loose fibre bundle indicates that the unsealed driveway fill material may present a potential risk to human health if disturbed. The fibre bundle has almost certainly been generated from the movement of vehicles over the bulk ACM fragments present in the fill material used to construct the driveway.

IC1 - Approximate ACM Sheet Location

IC4 - Miscellaneous Wastes  
(Approximate Locations)

IC2 - Residential Dwelling

IC3 - Unpaved Driveway  
(ACM Impacted Fill)

To remove all ACM contamination from the site, the residential dwelling (refer IC2 in Figure 1 attached) will require a pre-demolition audit by a suitably qualified person to identify and confirm the presence of any ACM within existing on-site structures. All bonded asbestos in quantities greater than 10 m<sup>2</sup> and/or all friable asbestos, will require removal by a licensed asbestos removal contractor in accordance with applicable legislation and codes of practice. The ACM must be transported in accordance with SafeWork NSW code of practice requirements and disposed to a suitably licensed landfill. If the pre-demolition audit recommends air monitoring, it should be undertaken in accordance with *SafeWork Australia 2024 Workplace Exposure Standards for Airborne Contaminants*.

The identified loose ACM sheeting (refer IC1 in Figure 1 attached) will also require removal by the licensed asbestos removal contractor in accordance with all relevant legislation. A survey of the ground surface in the vicinity of the loose ACM sheeting will be required to ensure no other ACM is present. Once the ACM sheeting has been removed, the licenced asbestos assessor will undertake a clearance inspection and issue an asbestos clearance certificate.

The unsealed driveway (refer IC3 in Figure 1 attached) which is made up of shallow fill soils that contain bonded asbestos, and an asbestos fibre bundle (refer Fyfe 2024), will require removal by a Class A licensed asbestos removal contractor in accordance with all relevant legislation.

Upon the complete removal of shallow fill soils within the unsealed driveway, the licenced asbestos assessor will undertake a clearance inspection and issue an asbestos clearance certificate.

Additional miscellaneous wastes identified on-site (refer IC4 in Figure 1 attached) requiring removal as part of the site remediation works. These wastes include domestic oil and chemical containers, a car engine, tyre, vehicle batteries, scrap metal and concrete fragments.
