Arboricultural Impact Assessment and Management Plan

2-4 Hale Street, Botany.

Dated: **July 2025.**

Report Reference: **2025/0450.**

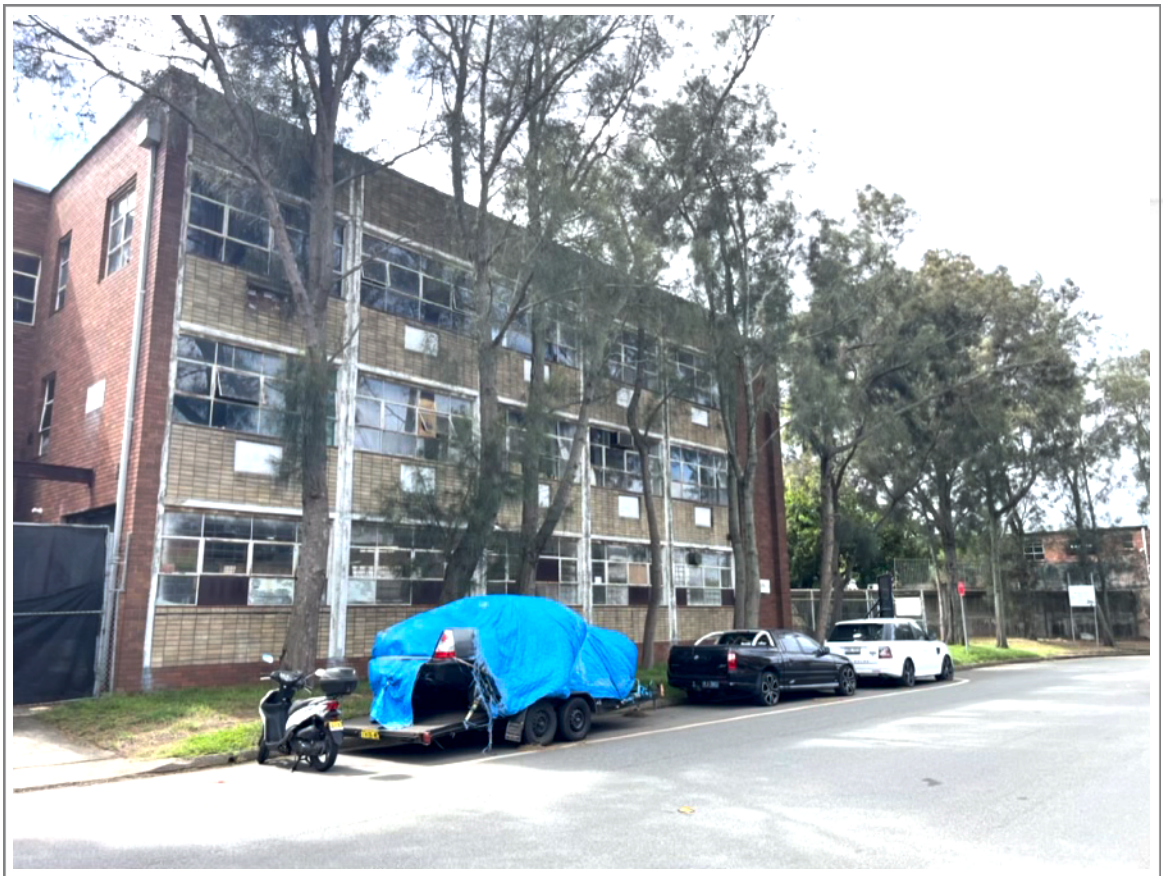
Figure 2 shows the extent of the stand of She Oaks documented.
