Two Conway Pty Ltd

**Prepared by Capability Green Consulting**

# ARBORICULTURAL IMPACT ASSESSMENT REPORT

**Site Address:** 2-6 Conway, 2A Conway, 38 Carlisle, 15, 15A Fernleigh and 40 Carlisle Street, Rose Bay,  
NSW 2029. (DIAN)

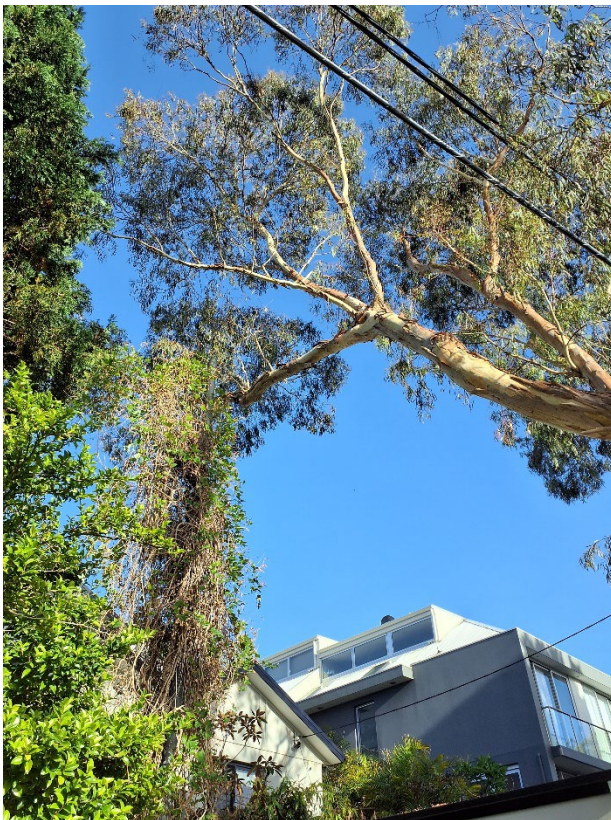
Trees 39 *Eucalyptus scoparia* (Wallangarra White Gum) has an overextended third order branch extending west into the front setback of 38 Carlisle Street which will interfere with machinery required for the excavation for the basement, and the erection of the scaffolding and built form. Due to the form of the junction where the overextended branch dissects into fourth order branches, it is recommended that the final cut be made at the branch collar between the third and second order branches (refer Figure 2 below). Based on observations of other previous pruning sites on this tree it is likely that if the cut were made between third and fourth order branches, the wound may fail to occlude and dieback or additional epicormic growth may result.

Figure 1 – Overextend branch  
Site Photos (Source: Capability Green Co) 27.11.25

The following pruning works are recommended for Tree 39:

- Prune the overextended third order branch extending south back to the collar on the southern second order stem.

All pruning is to be carried out prior to the commencement of demolition works on site and in accordance with AS4373-2007 *Pruning of Amenity Trees* by an AQF Level 3 Arborist.

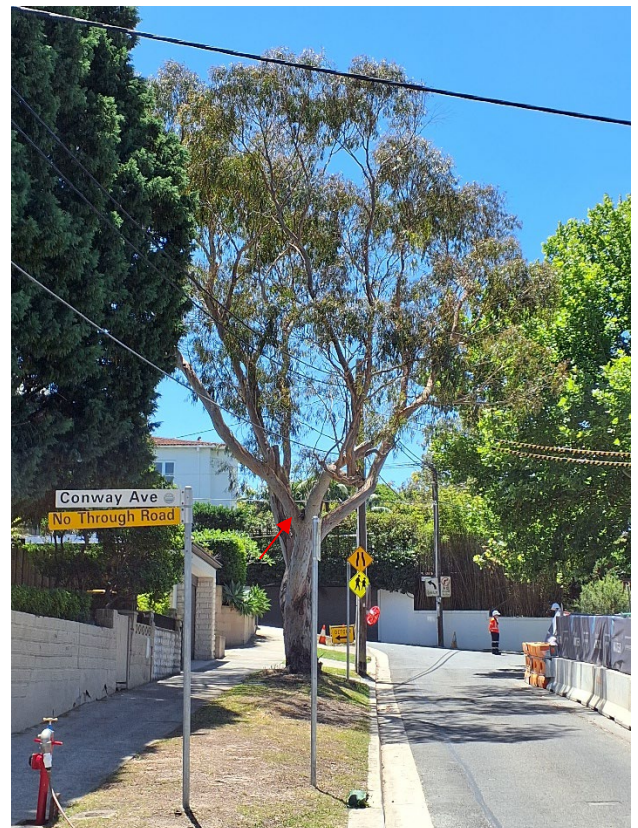
Figure 2 – Recommended location of final cut
