Tree Impact Assessment Report

**211 Pacific Highway,
St Leonard's NSW 2069**

Prepared by Mark Bury Consulting

10th May 2019

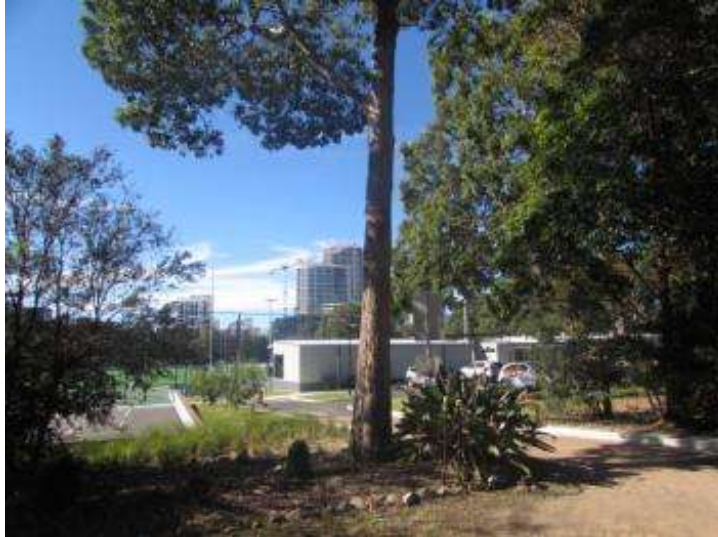
Tree 1 *Lophostemon confertus*
Brushbox

- 5.1 **Tree 1** (*Lophostemon confertus* Brushbox) is a tree in good condition Appendix 1 gives a description of the tree as per AS-4970-2009 Section 2. Appendix 2 shows a photograph of the tree; Appendix 4 indicates the location of the tree on a survey plan of the site.
- 5.2 The tree will not be severely affected by the proposed driveway and roadwork's (See Appendix 1). The hydrological and soil environments of the tree will be not be impacted as there is only a very small incursion into the TPZ of the tree. Furthermore there is an existing kerb and gutter between proposed roadwork's and the tree and provided the tree is protected by the treatments and works specified in appendix 6 the tree management plan for the site the existing tree site will not be impacted..
- 5.3 It would be considered appropriate tree management that the tree be

Tree Number	1
Species	<i>Lophostemon confertus</i>
Common Name	Brushbox
Vigour	Normal Vigour- Ability of a tree to maintain and sustain its life processes. This may be evident by the typical growth of leaves, crown cover and crown density, branches, roots and trunk and resistance to predation. This is independent of the condition of a tree but may impact upon it , and especially the ability of a tree but may impact upon it , and especially the ability of a tree to sustain itself against predation
Structure	Fair Condition - tree is of good habit or misshapen, a form not severely restricted for space and light has some physical indication of decline due to the early effects of predation by pests and diseases, fungal, bacterial, or insect infestation, or has suffered physical injury to itself that may be contributing to instability or structural weaknesses, or its basic survival. Such a tree may recover with remedial works where appropriate, or without intervention may stabilise or improve over time where appropriate, or without intervention may stabilise or improve over time, or in response to the implementation of beneficial changes to its local environment. This may be independent from, or contributed to by vigour.

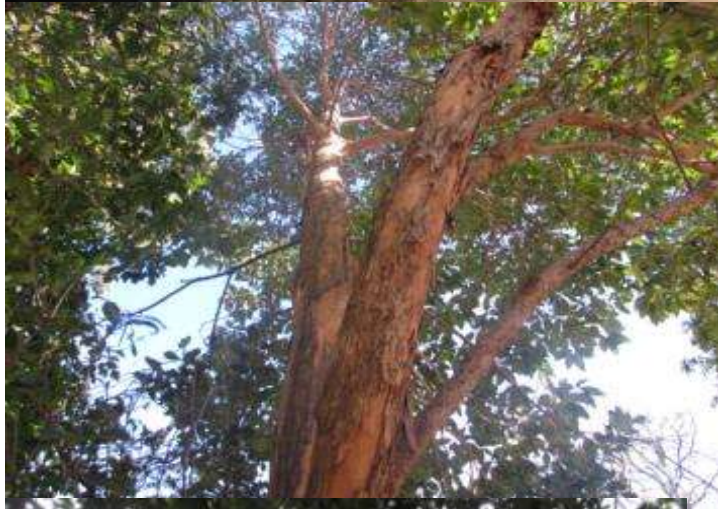
Tree 2 *Lophostemon confertus*
Brushbox

- 5.6 **Tree 2** (*Lophostemon confertus* Brushbox) is a tree in good condition Appendix 1 gives a description of the tree as per AS-4970-2009 Section 2. Appendix 2 shows a photograph of the tree; Appendix 4 indicates the location of the tree on a survey plan of the site.

Tree Number	2
Species	<i>Lophostemon confertus</i>
Common Name	Brushbox
Vigour	Normal Vigour- Ability of a tree to maintain and sustain its life processes. This may be evident by the typical growth of leaves, crown cover and crown density, branches, roots and trunk and resistance to predation. This is independent of the condition of a tree but may impact upon it , and especially the ability of a tree to sustain itself against predation
Structure	Fair Condition - tree is of good habit or misshapen, a form not severely restricted for space and light has some physical indication of decline due to the early effects of predation by pests and diseases, fungal, bacterial, or insect infestation, or has suffered physical injury to itself that may be contributing to instability or structural weaknesses, or its basic survival. Such a tree may recover with remedial works where appropriate, or without intervention may stabilise or improve over time where appropriate, or without intervention may stabilise or improve over time, or in response to the implementation of beneficial changes to its local environment. This may be independent from, or contributed to by vigour.

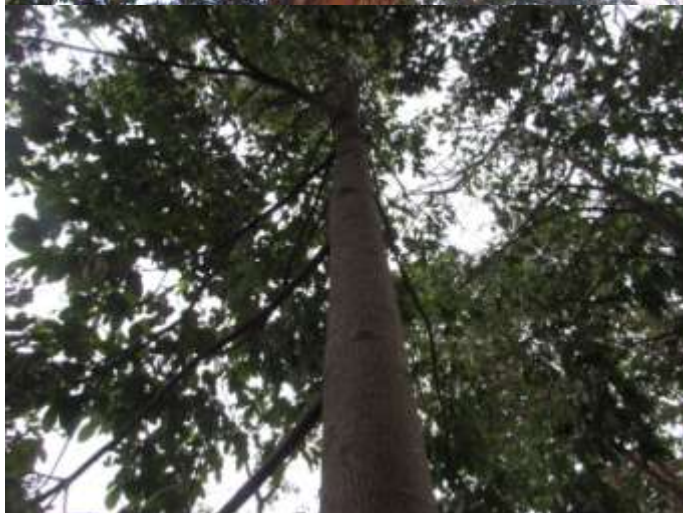
Tree 3 *Erythrina x sykesii*.
Coral Tree

- 5.11 **Tree 3** (*Erythrina x sykesii* Coral Tree) is a tree in good condition Appendix 1 gives a description of the tree as per AS-4970-2009 Section 2. Appendix 2 shows a photograph of the tree; Appendix 4 indicates the location of the tree on a survey plan of the site.

Tree Number	3
Species	<i>Erythrina x sykesii.</i>
Common Name	Coral Tree
Vigour	Normal Vigour- Ability of a tree to maintain and sustain its life processes. This may be evident by the typical growth of leaves, crown cover and crown density, branches, roots and trunk and resistance to predation. This is independent of the condition of a tree but may impact upon it , and especially the ability of a tree but may impact upon it , and especially the ability of a tree to sustain itself against predation
Structure	Fair Condition - tree is of good habit or misshapen, a form not severely restricted for space and light has some physical indication of decline due to the early effects of predation by pests and diseases, fungal, bacterial, or insect infestation, or has suffered physical injury to itself that may be contributing to instability or structural weaknesses, or its basic survival. Such a tree may recover with remedial works where appropriate, or without intervention may stabilise or improve over time where appropriate, or without intervention may stabilise or improve over time, or in response to the implementation of beneficial changes to its local environment. This may be independent from, or contributed to by vigour.

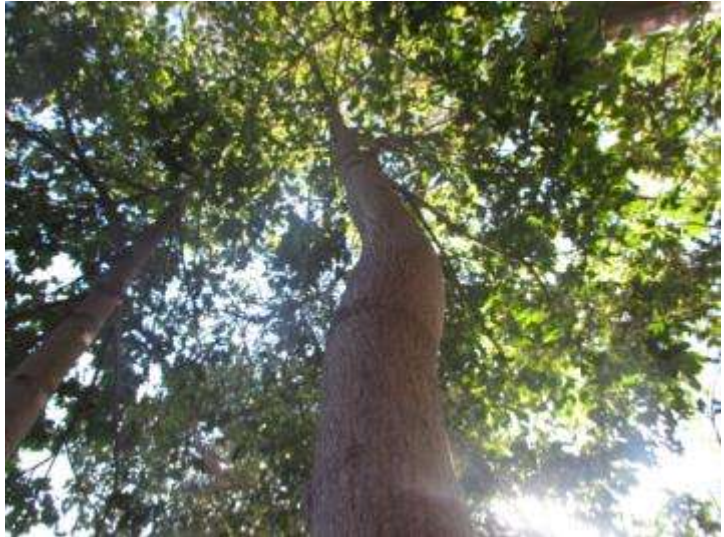
Tree 4 *Brachychiton acerifolius*
Illawarra Flame Tree

Tree Number	4
Species	<i>Brachychiton acerifolius</i>
Common Name	Illawarra Flame Tree
Vigour	Normal Vigour- Ability of a tree to maintain and sustain its life processes. This may be evident by the typical growth of leaves, crown cover and crown density, branches, roots and trunk and resistance to predation. This is independent of the condition of a tree but may impact upon it , and especially the ability of a tree but may impact upon it , and especially the ability of a tree to sustain itself against predation
Structure	Fair Condition - tree is of good habit or misshapen, a form not severely restricted for space and light has some physical indication of decline due to the early effects of predation by pests and diseases, fungal, bacterial, or insect infestation, or has suffered physical injury to itself that may be contributing to instability or structural weaknesses, or its basic survival. Such a tree may recover with remedial works where appropriate, or without intervention may stabilise or improve over time where appropriate, or without intervention may stabilise or improve over time, or in response to the implementation of beneficial changes to its local environment. This may be independent from, or contributed to by vigour.

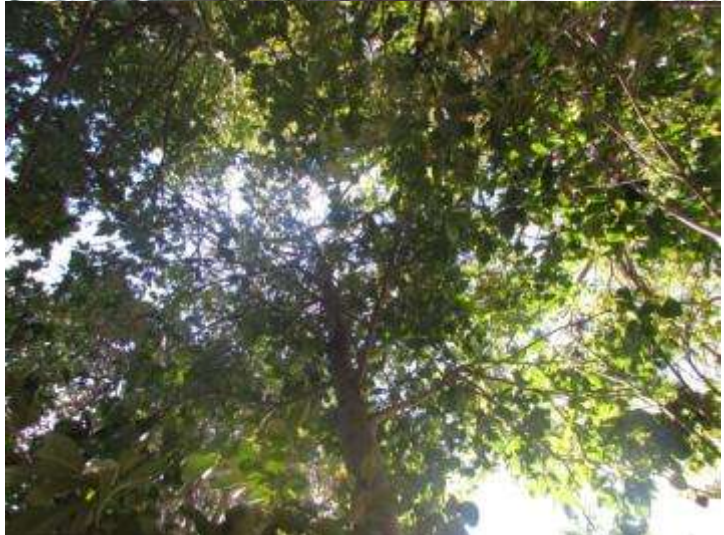
Tree 5 *Brachychiton acerifolius*
Illawarra Flame Tree

Tree Number	5
Species	<i>Brachychiton acerifolius</i>
Common Name	Illawarra Flame Tree
Vigour	Normal Vigour- Ability of a tree to maintain and sustain its life processes. This may be evident by the typical growth of leaves, crown cover and crown density, branches, roots and trunk and resistance to predation. This is independent of the condition of a tree but may impact upon it , and especially the ability of a tree but may impact upon it , and especially the ability of a tree to sustain itself against predation
Structure	Fair Condition - tree is of good habit or misshapen, a form not severely restricted for space and light has some physical indication of decline due to the early effects of predation by pests and diseases, fungal, bacterial, or insect infestation, or has suffered physical injury to itself that may be contributing to instability or structural weaknesses, or its basic survival. Such a tree may recover with remedial works where appropriate, or without intervention may stabilise or improve over time where appropriate, or without intervention may stabilise or improve over time, or in response to the implementation of beneficial changes to its local environment. This may be independent from, or contributed to by vigour.

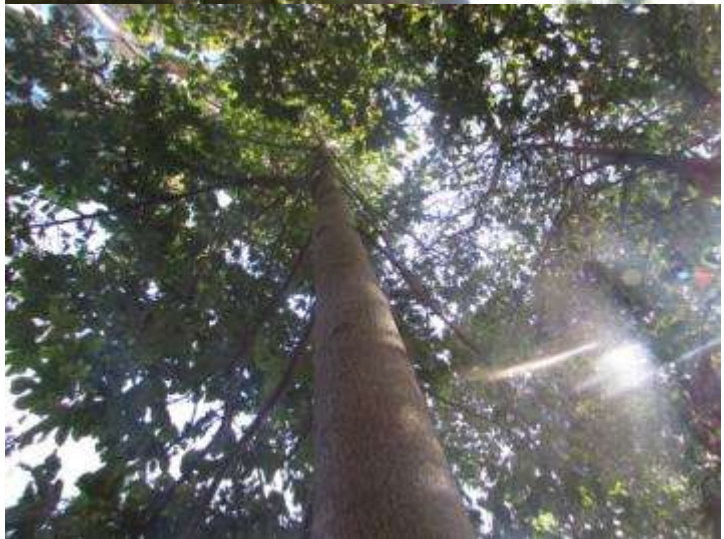
Tree 6 *Brachychiton acerifolius*
Illawarra Flame Tree

Tree Number	6
Species	<i>Brachychiton acerifolius</i>
Common Name	Illawarra Flame Tree
Vigour	Normal Vigour- Ability of a tree to maintain and sustain its life processes. This may be evident by the typical growth of leaves, crown cover and crown density, branches, roots and trunk and resistance to predation. This is independent of the condition of a tree but may impact upon it , and especially the ability of a tree but may impact upon it , and especially the ability of a tree to sustain itself against predation
Structure	Fair Condition - tree is of good habit or misshapen, a form not severely restricted for space and light has some physical indication of decline due to the early effects of predation by pests and diseases, fungal, bacterial, or insect infestation, or has suffered physical injury to itself that may be contributing to instability or structural weaknesses, or its basic survival. Such a tree may recover with remedial works where appropriate, or without intervention may stabilise or improve over time where appropriate, or without intervention may stabilise or improve over time, or in response to the implementation of beneficial changes to its local environment. This may be independent from, or contributed to by vigour.

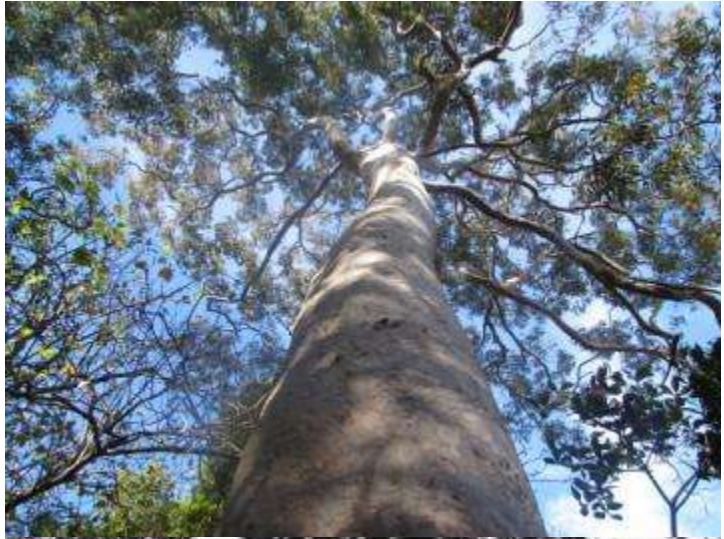
Tree 7 *Angophora costata*
Sydney Red Gum

- 5.30 **Tree 7** (*Angophora costata* Sydney Red Gum) is a tree in good condition Appendix 1 gives a description of the tree as per AS-4970-2009 Section 2. Appendix 2 shows a photograph of the tree; Appendix 4 indicates the location of the tree on a survey plan of the site.

Tree Number	7
Species	<i>Angophora costata</i>
Common Name	Sydney Red Gum
Vigour	Normal Vigour- Ability of a tree to maintain and sustain its life processes. This may be evident by the typical growth of leaves, crown cover and crown density, branches, roots and trunk and resistance to predation. This is independent of the condition of a tree but may impact upon it , and especially the ability of a tree but may impact upon it , and especially the ability of a tree to sustain itself against predation
Structure	Fair Condition - tree is of good habit or misshapen, a form not severely restricted for space and light has some physical indication of decline due to the early effects of predation by pests and diseases, fungal, bacterial, or insect infestation, or has suffered physical injury to itself that may be contributing to instability or structural weaknesses, or its basic survival. Such a tree may recover with remedial works where appropriate, or without intervention may stabilise or improve over time where appropriate, or without intervention may stabilise or improve over time, or in response to the implementation of beneficial changes to its local environment. This may be independent from, or contributed to by vigour.

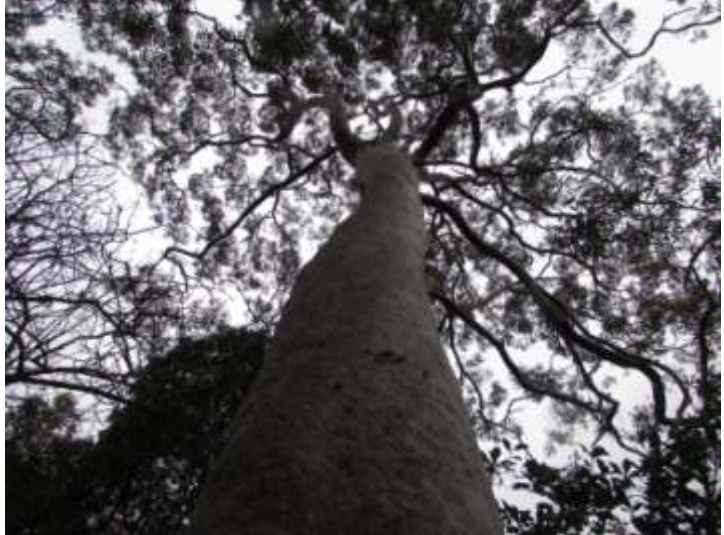
Tree 8 *Angophora costata*
Sydney Red Gum

- 5.34 The tree has normal vigour and provides visual and environmental amenity to the vicinity it is located.
- 5.35 **Tree 8** (*Angophora costata* Sydney Red Gum) is a tree in good condition Appendix 1 gives a description of the tree as per AS-4970-2009 Section 2. Appendix 2 shows a photograph of the tree; Appendix 4 indicates the location of the tree on a survey plan of the site.

Tree Number	8
Species	<i>Angophora costata</i>
Common Name	Sydney Red Gum
Vigour	Normal Vigour- Ability of a tree to maintain and sustain its life processes. This may be evident by the typical growth of leaves, crown cover and crown density, branches, roots and trunk and resistance to predation. This is independent of the condition of a tree but may impact upon it , and especially the ability of a tree but may impact upon it , and especially the ability of a tree to sustain itself against predation
Structure	Fair Condition - tree is of good habit or misshapen, a form not severely restricted for space and light has some physical indication of decline due to the early effects of predation by pests and diseases, fungal, bacterial, or insect infestation, or has suffered physical injury to itself that may be contributing to instability or structural weaknesses, or its basic survival. Such a tree may recover with remedial works where appropriate, or without intervention may stabilise or improve over time where appropriate, or without intervention may stabilise or improve over time, or in response to the implementation of beneficial changes to its local environment. This may be independent from, or contributed to by vigour.

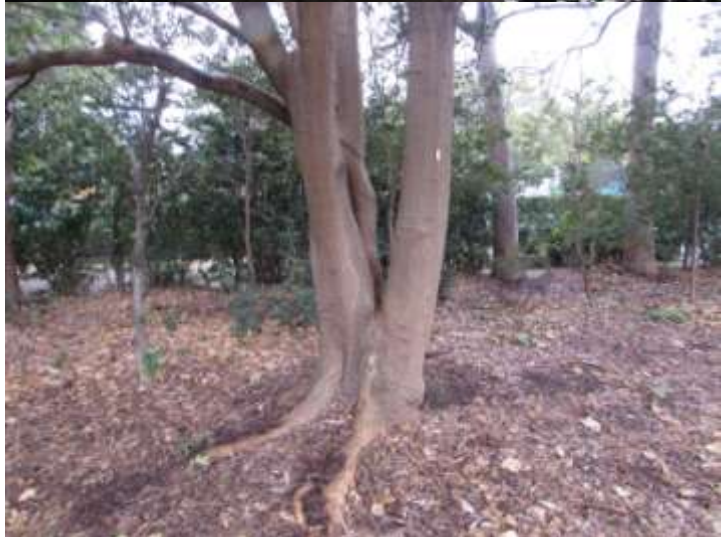
Tree 9 *Castanospermum australe*
Blackbean Tree

- 5.39 The tree has normal vigour and provides visual and environmental amenity to the vicinity it is located.
- 5.40 **Tree 9** (*Erythrina x sykesii* Coral Tree) is a tree in good condition Appendix 1 gives a description of the tree as per AS-4970-2009 Section 2. Appendix 2 shows a photograph of the tree; Appendix 4 indicates the location of the tree on a survey plan of the site.

Tree Number	9
Species	<i>Erythrina x sykesii.</i>
Common Name	Coral Tree
Vigour	Normal Vigour- Ability of a tree to maintain and sustain its life processes. This may be evident by the typical growth of leaves, crown cover and crown density, branches, roots and trunk and resistance to predation. This is independent of the condition of a tree but may impact upon it , and especially the ability of a tree but may impact upon it , and especially the ability of a tree to sustain itself against predation
Structure	Fair Condition - tree is of good habit or misshapen, a form not severely restricted for space and light has some physical indication of decline due to the early effects of predation by pests and diseases, fungal, bacterial, or insect infestation, or has suffered physical injury to itself that may be contributing to instability or structural weaknesses, or its basic survival. Such a tree may recover with remedial works where appropriate, or without intervention may stabilise or improve over time where appropriate, or without intervention may stabilise or improve over time, or in response to the implementation of beneficial changes to its local environment. This may be independent from, or contributed to by vigour.

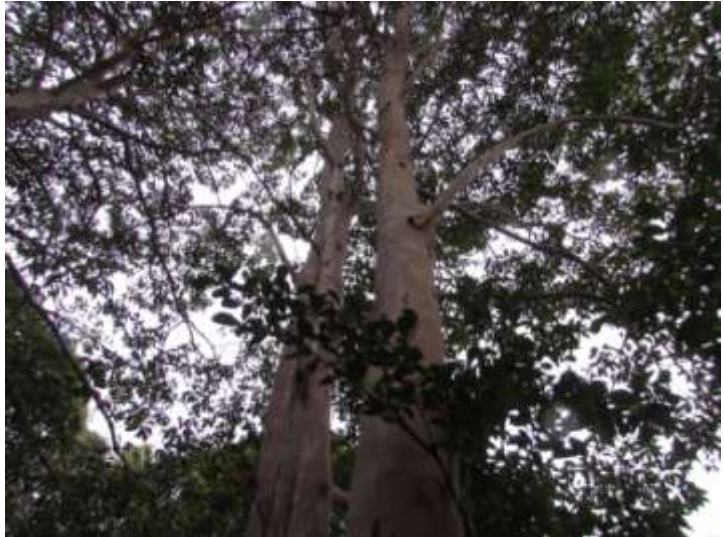
Tree 10 *Lophostemon confertus*
Brushbox

- 5.44 The tree has normal vigour and provides visual and environmental amenity to the vicinity it is located.
- 5.45 **Tree 10** (*Lophostemon confertus* Brushbox) is a tree in good condition Appendix 1 gives a description of the tree as per AS-4970-2009 Section 2. Appendix 2 shows a photograph of the tree; Appendix 4 indicates the location of the tree on a survey plan of the site.

Tree Number	10
Species	<i>Lophostemon confertus</i>
Common Name	Brushbox
Vigour	Normal Vigour- Ability of a tree to maintain and sustain its life processes. This may be evident by the typical growth of leaves, crown cover and crown density, branches, roots and trunk and resistance to predation. This is independent of the condition of a tree but may impact upon it , and especially the ability of a tree but may impact upon it , and especially the ability of a tree to sustain itself against predation
Structure	Fair Condition - tree is of good habit or misshapen, a form not severely restricted for space and light has some physical indication of decline due to the early effects of predation by pests and diseases, fungal, bacterial, or insect infestation, or has suffered physical injury to itself that may be contributing to instability or structural weaknesses, or its basic survival. Such a tree may recover with remedial works where appropriate, or without intervention may stabilise or improve over time where appropriate, or without intervention may stabilise or improve over time, or in response to the implementation of beneficial changes to its local environment. This may be independent from, or contributed to by vigour.

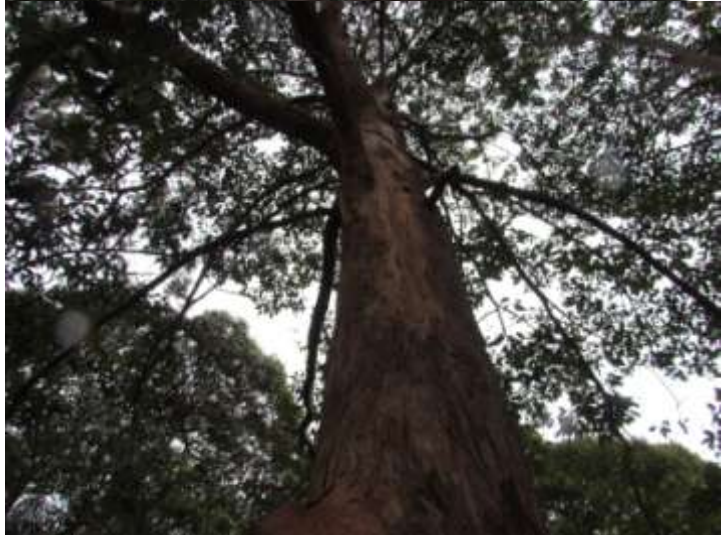
Tree 11 *Lophostemon confertus*
Brushbox

- 5.49 The tree has normal vigour and provides visual and environmental amenity to the vicinity it is located.
- 5.50 **Tree 11** (*Lophostemon confertus* Brushbox) is a tree in good condition Appendix 1 gives a description of the tree as per AS-4970-2009 Section 2. Appendix 2 shows a photograph of the tree; Appendix 4 indicates the location of the tree on a survey plan of the site.

Tree Number	11
Species	<i>Lophostemon confertus</i>
Common Name	Brushbox
Vigour	Normal Vigour- Ability of a tree to maintain and sustain its life processes. This may be evident by the typical growth of leaves, crown cover and crown density, branches, roots and trunk and resistance to predation. This is independent of the condition of a tree but may impact upon it , and especially the ability of a tree but may impact upon it , and especially the ability of a tree to sustain itself against predation
Structure	Fair Condition - tree is of good habit or misshapen, a form not severely restricted for space and light has some physical indication of decline due to the early effects of predation by pests and diseases, fungal, bacterial, or insect infestation, or has suffered physical injury to itself that may be contributing to instability or structural weaknesses, or its basic survival. Such a tree may recover with remedial works where appropriate, or without intervention may stabilise or improve over time where appropriate, or without intervention may stabilise or improve over time, or in response to the implementation of beneficial changes to its local environment. This may be independent from, or contributed to by vigour.

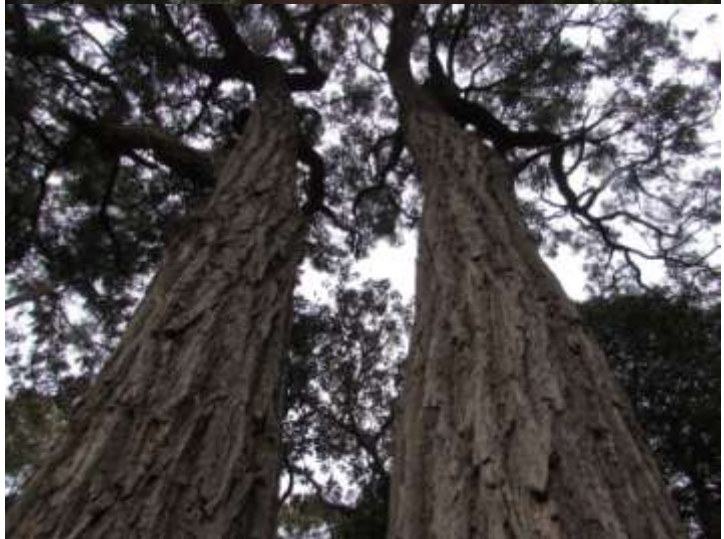
Tree 12 *Eucalyptus resinifera*
Red Mahogany

- 5.54 The tree has normal vigour and provides visual and environmental amenity to the vicinity it is located.
- 5.55 **Tree 12** (*Eucalyptus resinifera* Red Mahogany) is a tree in good condition Appendix 1 gives a description of the tree as per AS-4970-2009 Section 2. Appendix 2 shows a photograph of the tree; Appendix 4 indicates the location of the tree on a survey plan of the site.

Tree Number	12
Species	<i>Eucalyptus resinifera</i>
Common Name	Red Mahogany
Vigour	Normal Vigour- Ability of a tree to maintain and sustain its life processes. This may be evident by the typical growth of leaves, crown cover and crown density, branches, roots and trunk and resistance to predation. This is independent of the condition of a tree but may impact upon it , and especially the ability of a tree but may impact upon it , and especially the ability of a tree to sustain itself against predation
Structure	Fair Condition - tree is of good habit or misshapen, a form not severely restricted for space and light has some physical indication of decline due to the early effects of predation by pests and diseases, fungal, bacterial, or insect infestation, or has suffered physical injury to itself that may be contributing to instability or structural weaknesses, or its basic survival. Such a tree may recover with remedial works where appropriate, or without intervention may stabilise or improve over time where appropriate, or without intervention may stabilise or improve over time, or in response to the implementation of beneficial changes to its local environment. This may be independent from, or contributed to by vigour.

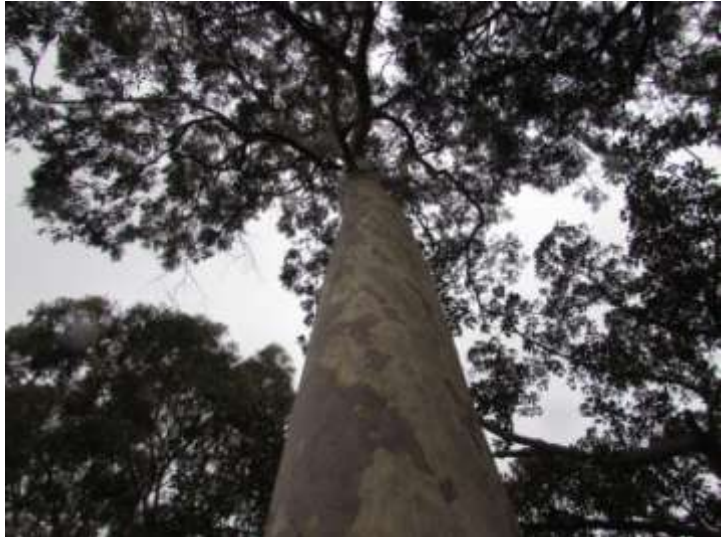
Tree 13 *Corimbya maculata*
Spotted Gum

- 5.59 The tree has normal vigour and provides visual and environmental amenity to the vicinity it is located.
- 5.60 **Tree 13** (*Corimbya maculata* Spotted Gum) is a tree in good condition Appendix 1 gives a description of the tree as per AS-4970-2009 Section 2. Appendix 2 shows a photograph of the tree; Appendix 4 indicates the location of the tree on a survey plan of the site.

Tree Number	13
Species	<i>Corimbya maculata</i>
Common Name	Spotted Gum
Vigour	Normal Vigour- Ability of a tree to maintain and sustain its life processes. This may be evident by the typical growth of leaves, crown cover and crown density, branches, roots and trunk and resistance to predation. This is independent of the condition of a tree but may impact upon it , and especially the ability of a tree to sustain itself against predation
Structure	Fair Condition - tree is of good habit or misshapen, a form not severely restricted for space and light has some physical indication of decline due to the early effects of predation by pests and diseases, fungal, bacterial, or insect infestation, or has suffered physical injury to itself that may be contributing to instability or structural weaknesses, or its basic survival. Such a tree may recover with remedial works where appropriate, or without intervention may stabilise or improve over time where appropriate, or without intervention may stabilise or improve over time, or in response to the implementation of beneficial changes to its local environment. This may be independent from, or contributed to by vigour.
