## **Arborist Report**

# **Arboricultural Impact Assessment**

*For the property*  
**369 381 President Avenue Kirrawee, NSW**

30/11/20 (V2)

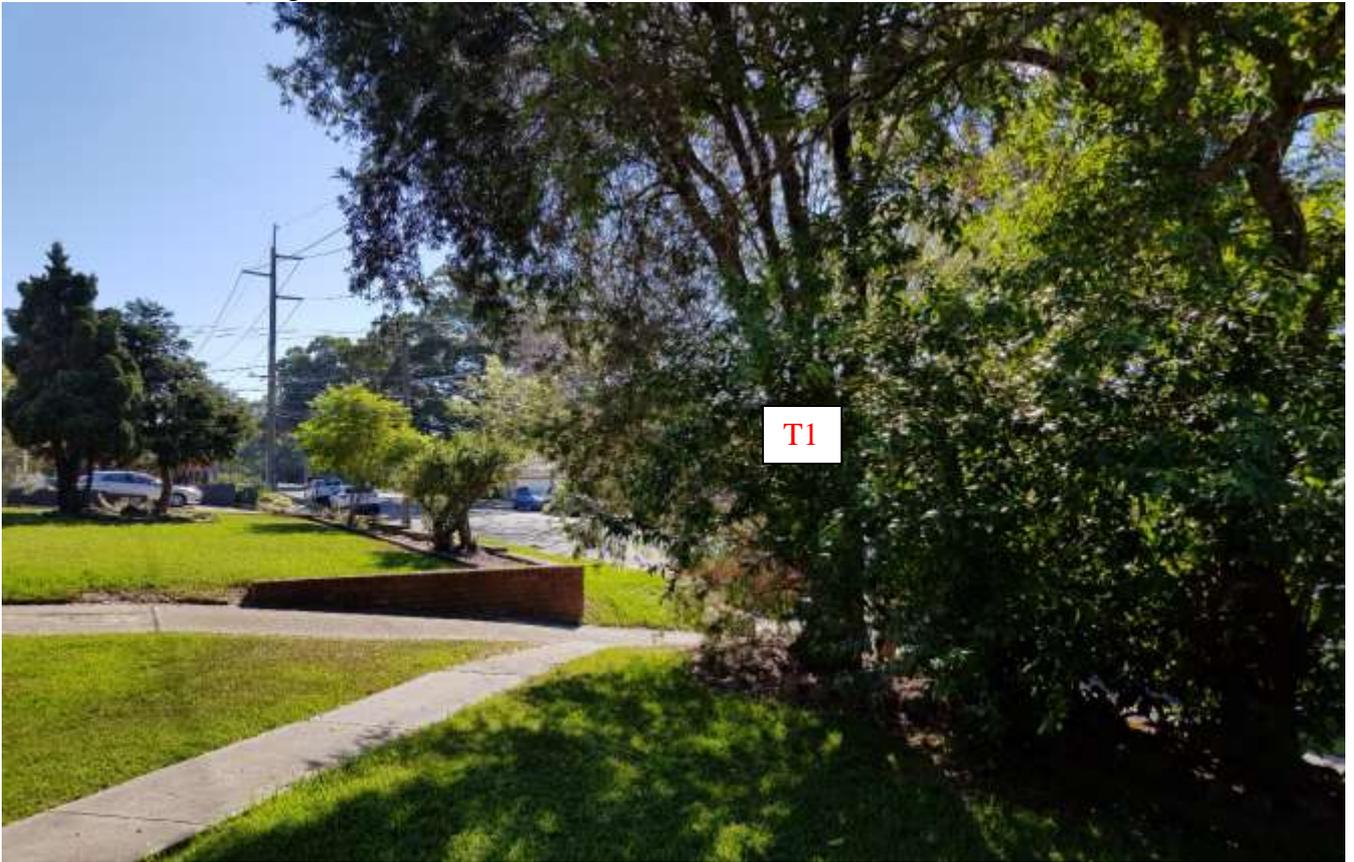
Photo 1 below, looking north at Tree 1, *Callistemon viminalis* to be RETAINED/ PROTECTED.

**Tree 1 – *Callistemon viminalis* – RETAIN** – This tree is growing within the front yard of 61 Hotham Rd Kirrawee. Tree Protection measures shall be recommended

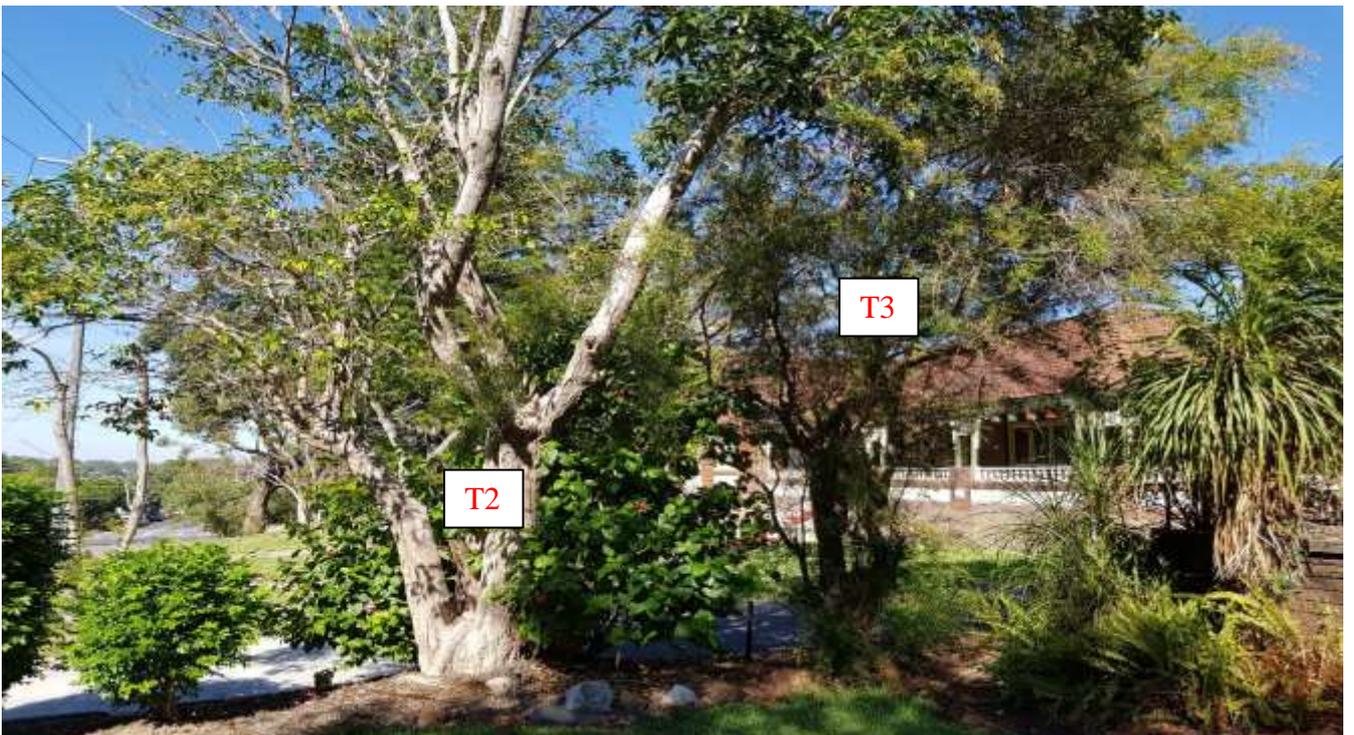
Photo 2, below, looking south to Tree 2 and Tree 3 to be REMOVED.

**Tree 2 – *Ligustrum lucidum* – EXEMPT/ REMOVE** - This tree is growing within 61 Hotham Rd Kirrawee, South Boundary front fence. This tree/ shrub species is upon the NSW Weeds list - <http://weeds.dpi.nsw.gov.au/>

**Tree 3 – *Leptospermum petersonii* – REMOVE** - This tree is growing within 61 Hotham Rd and growing within the footprint of proposed development.

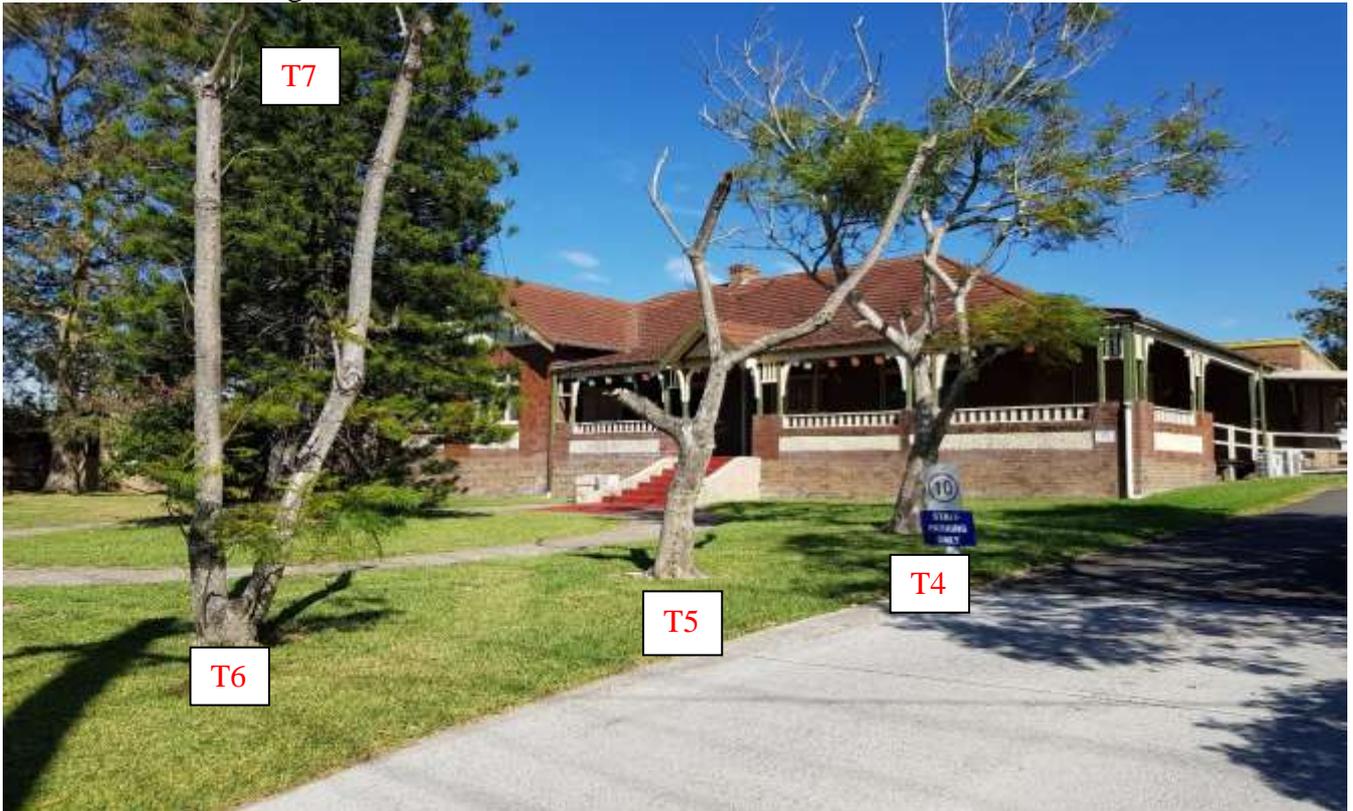
Photo 3, below looking at Trees 4, 5, 6 to be REMOVED. Tree 7 shall be RETAINED/ PROTECTED

**Tree 4, 5 & 6 – *Jacaranda mimosifolia* (X3) – REMOVE** – These three trees are dying, in decline or suppressed and not worthy of retention

**Tree 7 – *Araucaria columnaris* – RETAIN** –

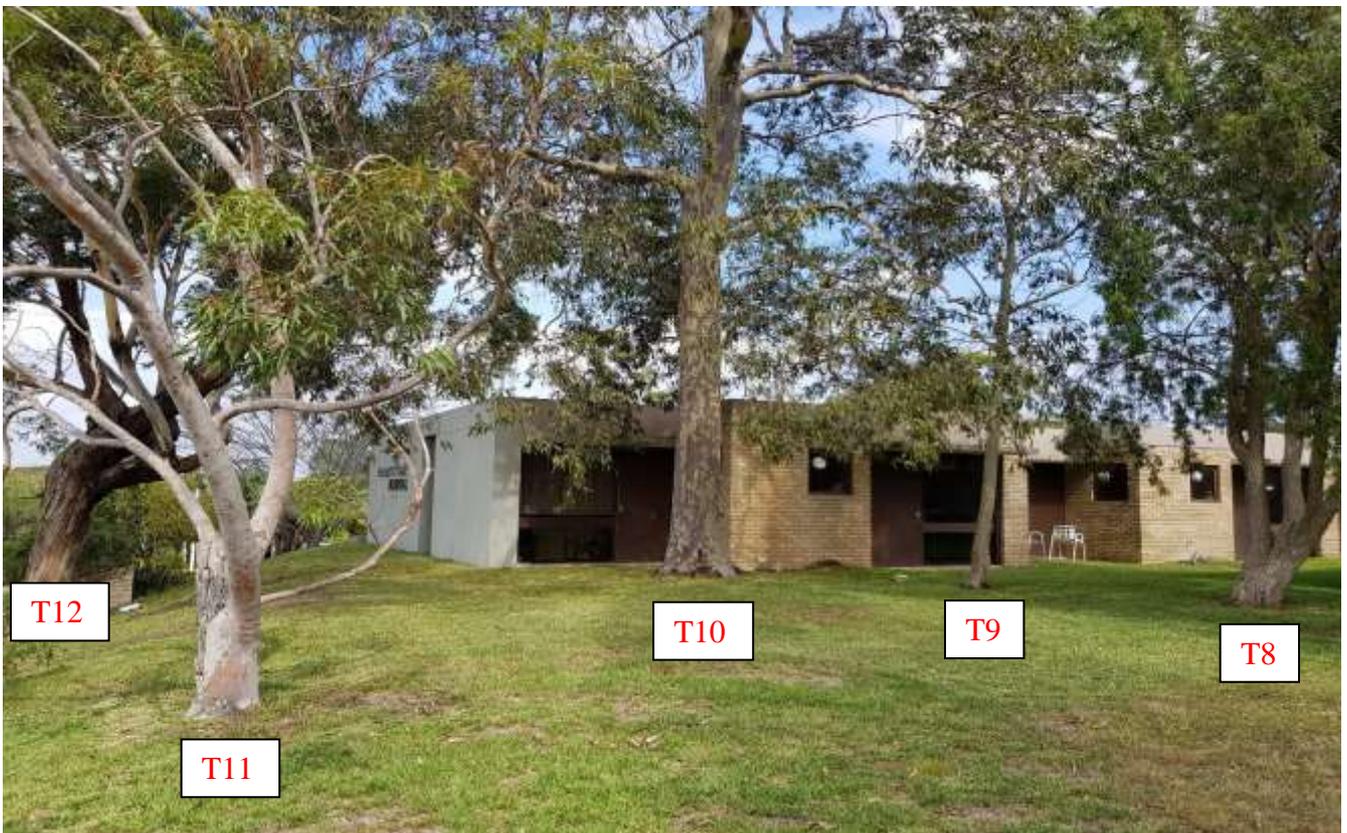
Photo 4, below looking south at trees 8, 9, 10, 11, to be REMOVED and 12 for RETENTION, with the canopy removed and the trunk retained for fauna habitation.

**Tree 12 – *Eucalyptus pilularis* – RETAIN TRUNK**– This tree is growing upon an embankment with the proposed basement several metres west of this tree. The canopy of this tree extends predominately north to north west with the proposal conflicting with this tree. Recommendations for canopy removal only and retention of the trunk as this possesses a potential fauna habitat.

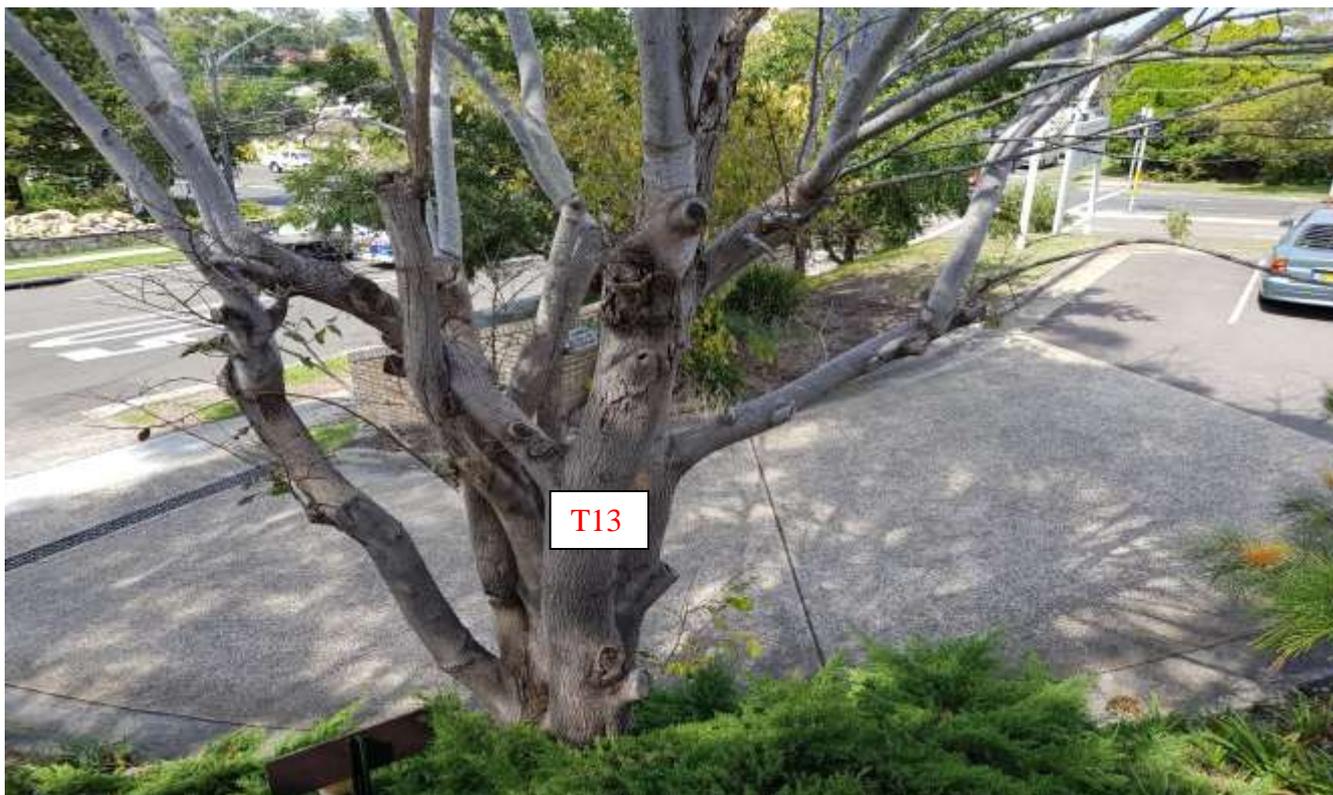
Photo 5, below looking at entrance to carpark, with tree 13, to be REMOVED

**Tree 13 – *Ulmus rubra* – REMOVE** – Poor condition, decay, compensatory planting for this removal recommended.

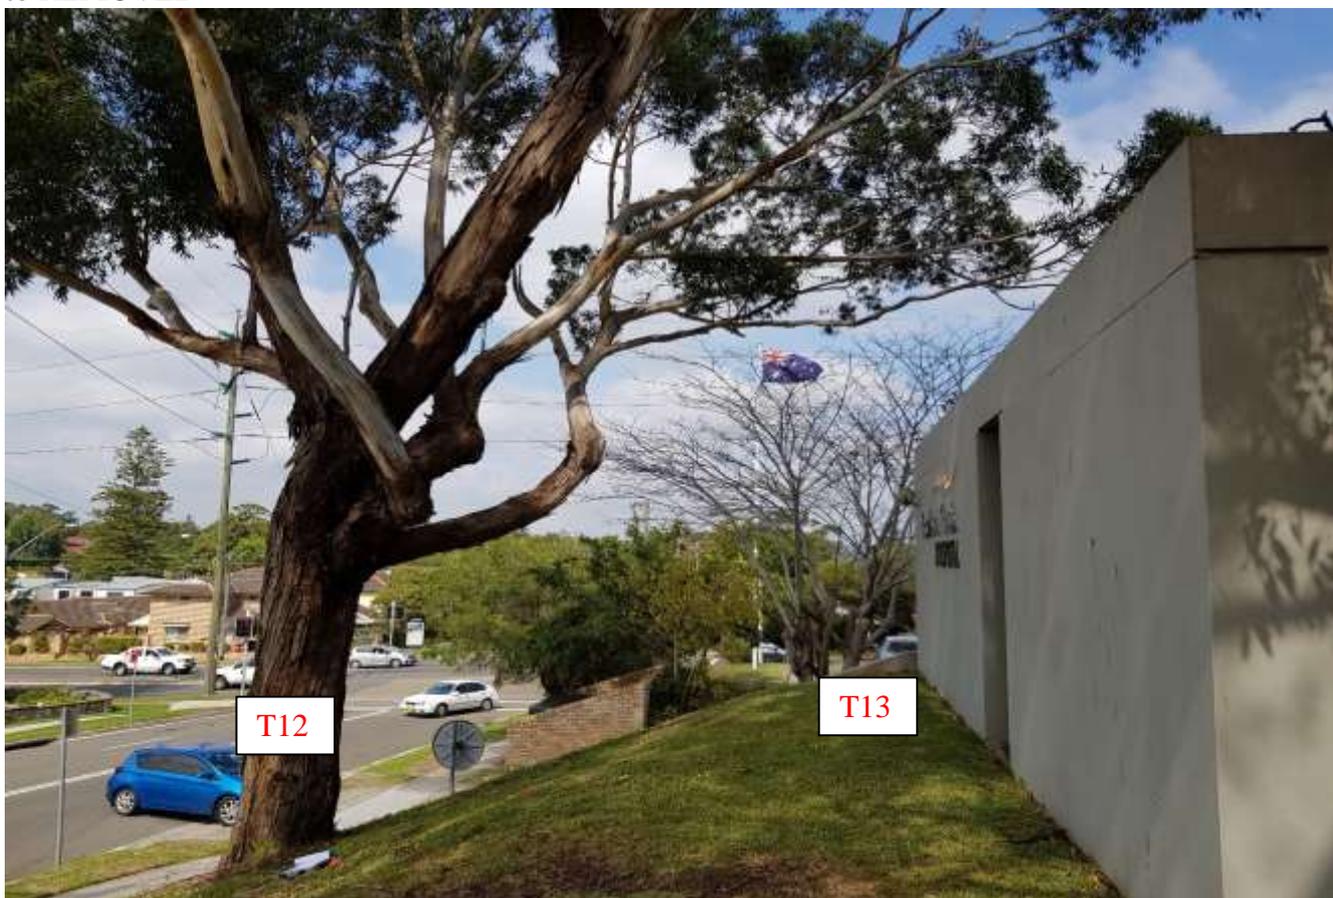
Photo 6, below, looking south with trees 12 to be RETAINED / PROTECTED (trunk only) and Tree 13 to REMOVED

5. Tree Protection Zone (TPZ) is the area surrounding the tree required to maintain tree vigour.
6. Formative / Target pruning is recommended for Tree 12, by a minimum AQF Level 3 climbing Arborist to retain the fauna habitat for this tree.

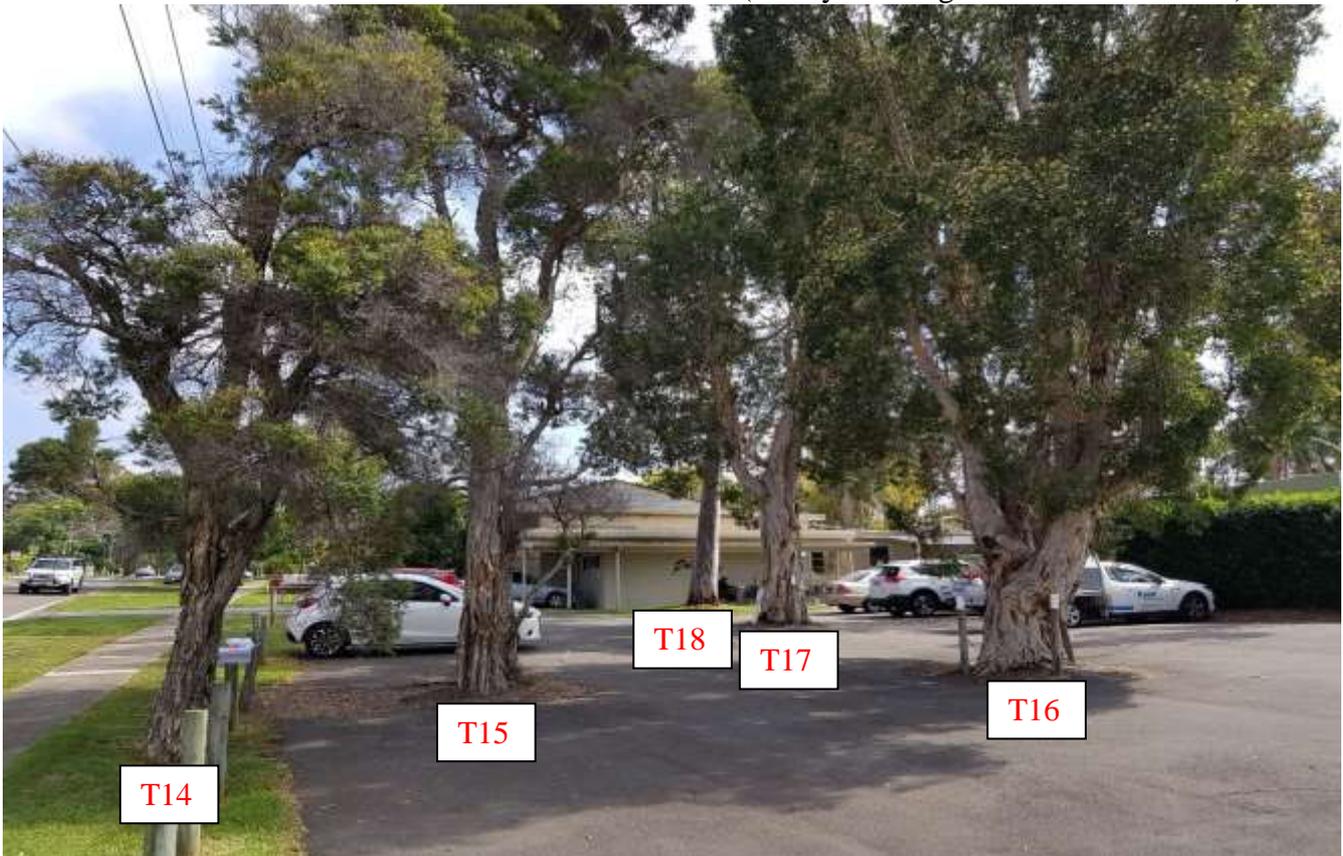
**Tree 17 – *Melaleuca quinquenervia* – REMOVE** - This tree is growing within existing carpark, middle of asphalt, Tree too large for location and dangerous for clients/ patients with roots lifting asphalt.

Photo 7, below looking south west into carpark showing Tree 14, 15, 16 and 17 to be REMOVED, whilst Tree 18 shall be RETAINED / PROTECTED (survey showing T14 is within the site)

**Tree 18 – *Corymbia maculata* – RETAIN** – Growing within grassed section next to Café, at the carpark. Proposed works have demonstrated elevated stairs and ramp with isolated piers within the TPZ of this

tree. Hand excavations and root mapping may alleviate potential issues if structural elements of the proposal conflict with major structural roots of this tree. Tree Protection measures recommended.

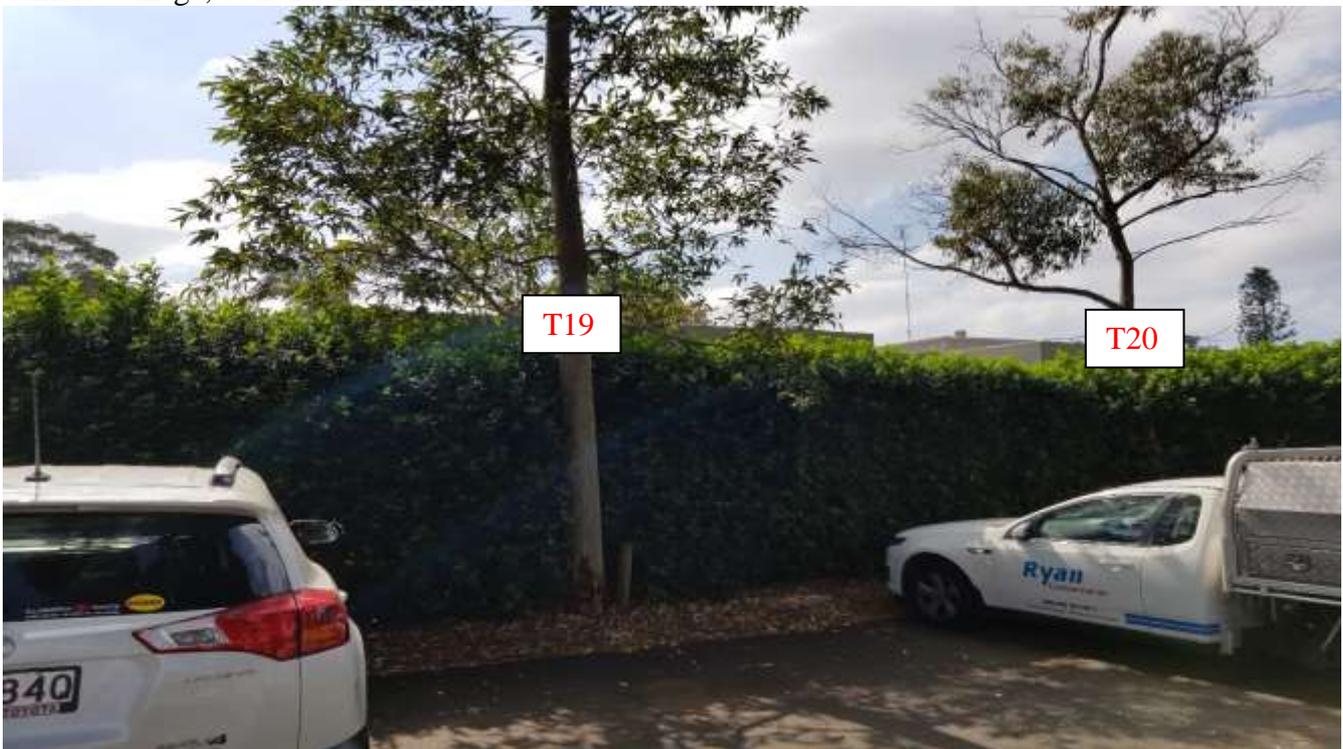
**Tree 19/20 – *Corymbia maculata* - REMOVE** – Both trees are dying, insect borer damage and in path of vehicle parking.

Photo 8, below, looking north at Tree 19 and Tree 20, both in decline and suffering borer damage/ vehicle damage, both TO BE REMOVED

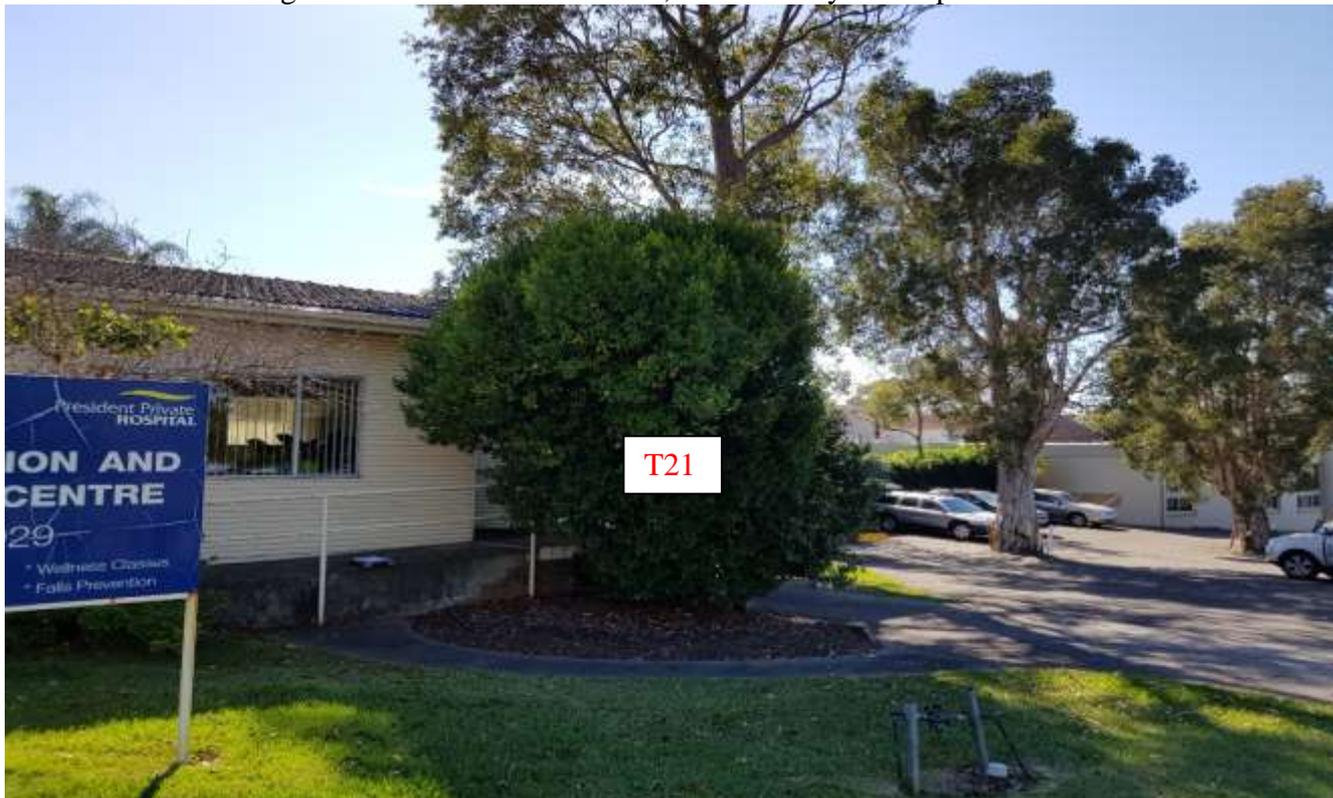
Photo 9 below looking at tree 21 to be REMOVED, to make way for carpark

**Tree 21 – *Michelia figo* – REMOVE** – Aged and growing within proposed parking allotment

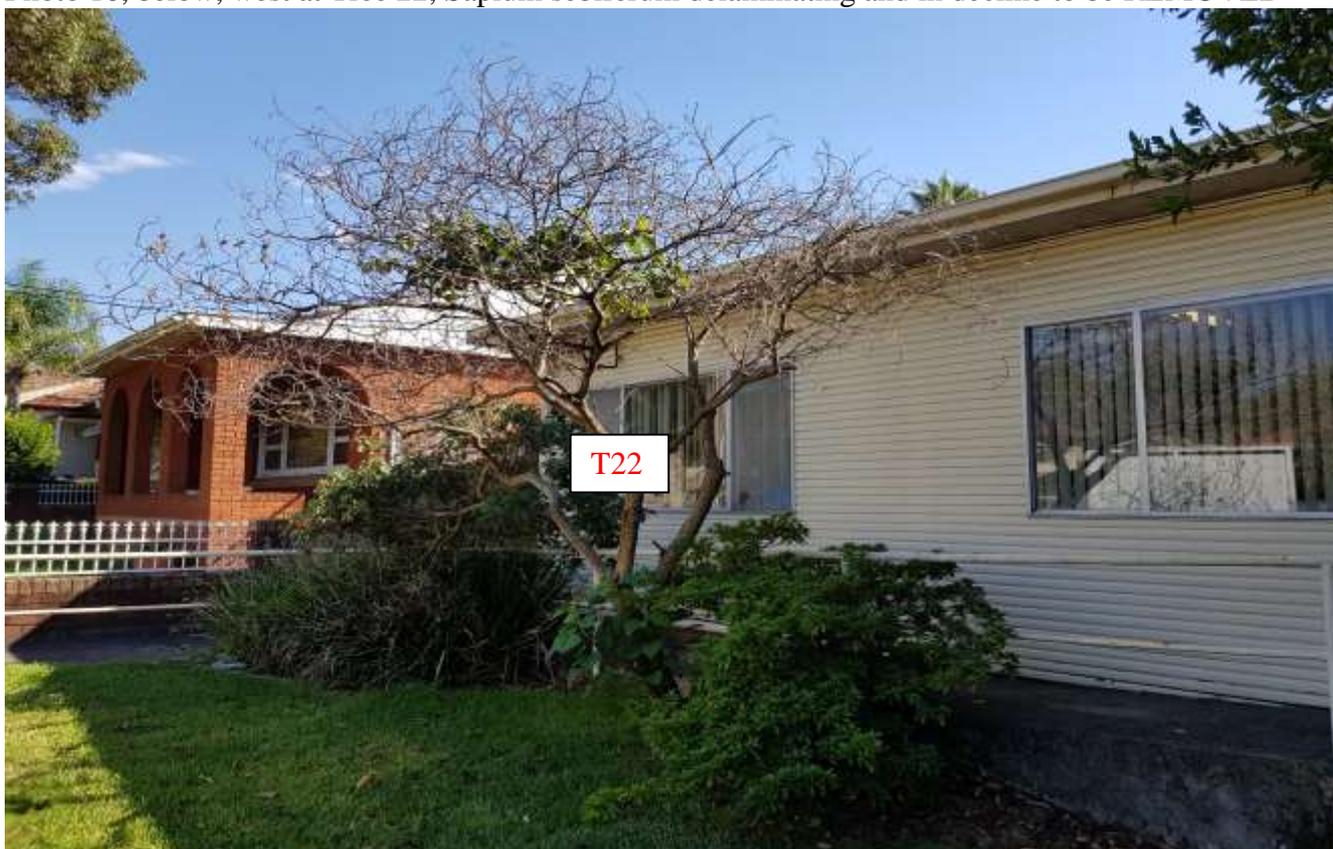
**Tree 22 – *Sapium sebiferum* – REMOVE** – Dead/ dying small tree

Photo 10, below, west at Tree 22, *Sapium sebiferum* delaminating and in decline to be REMOVED

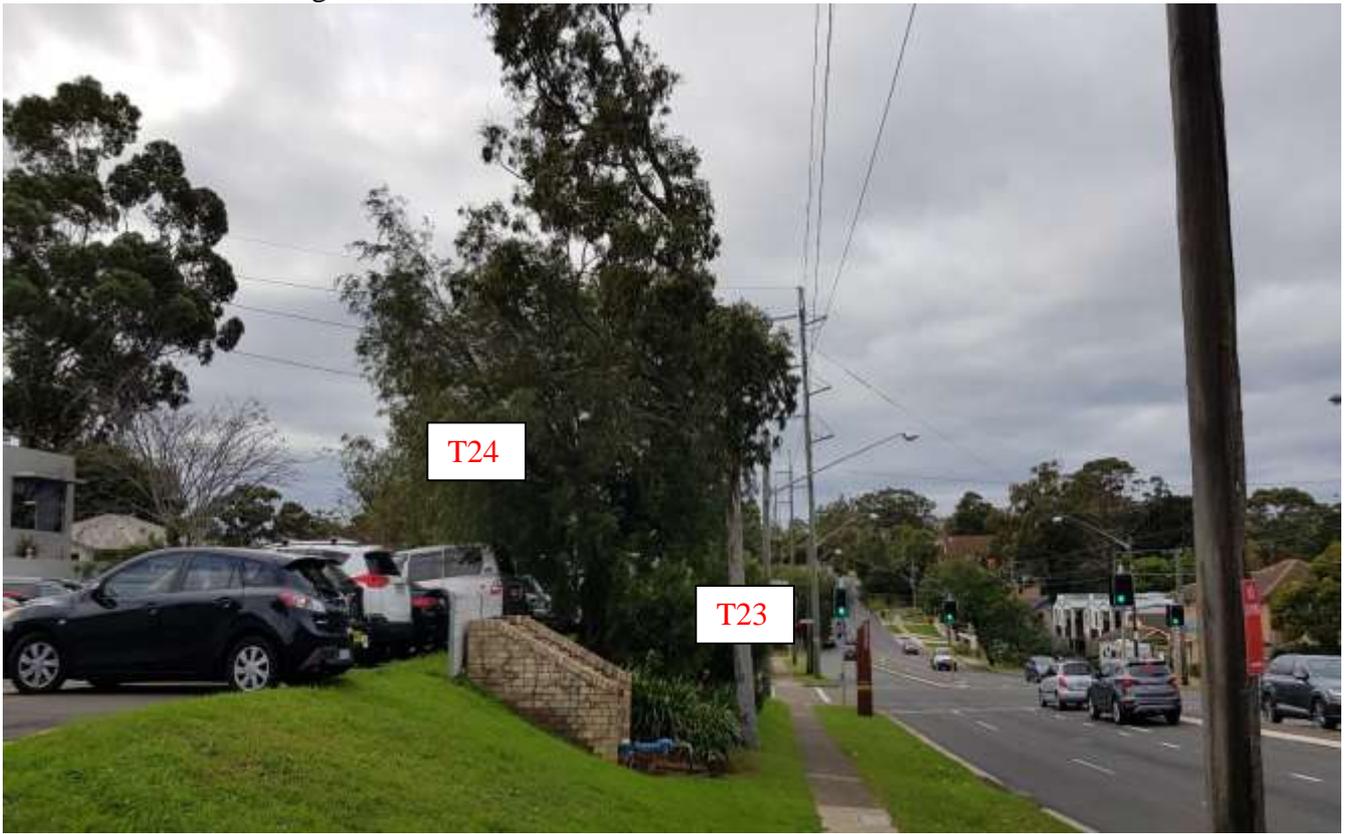
Photo 11, below, looking east Tree 23 and 24 with tree 23 to be retained and tree 24 to be removed.

**Tree 23 – *Corymbia maculata* - RETAIN** – Basement carpark is approximately 5.0 metres north of tree and TPZ is 4.2. Tree protection measures implemented.

**Tree 24 – *Leptospermum petersonii* – REMOVE** – Total loss from basement carpark, south of site

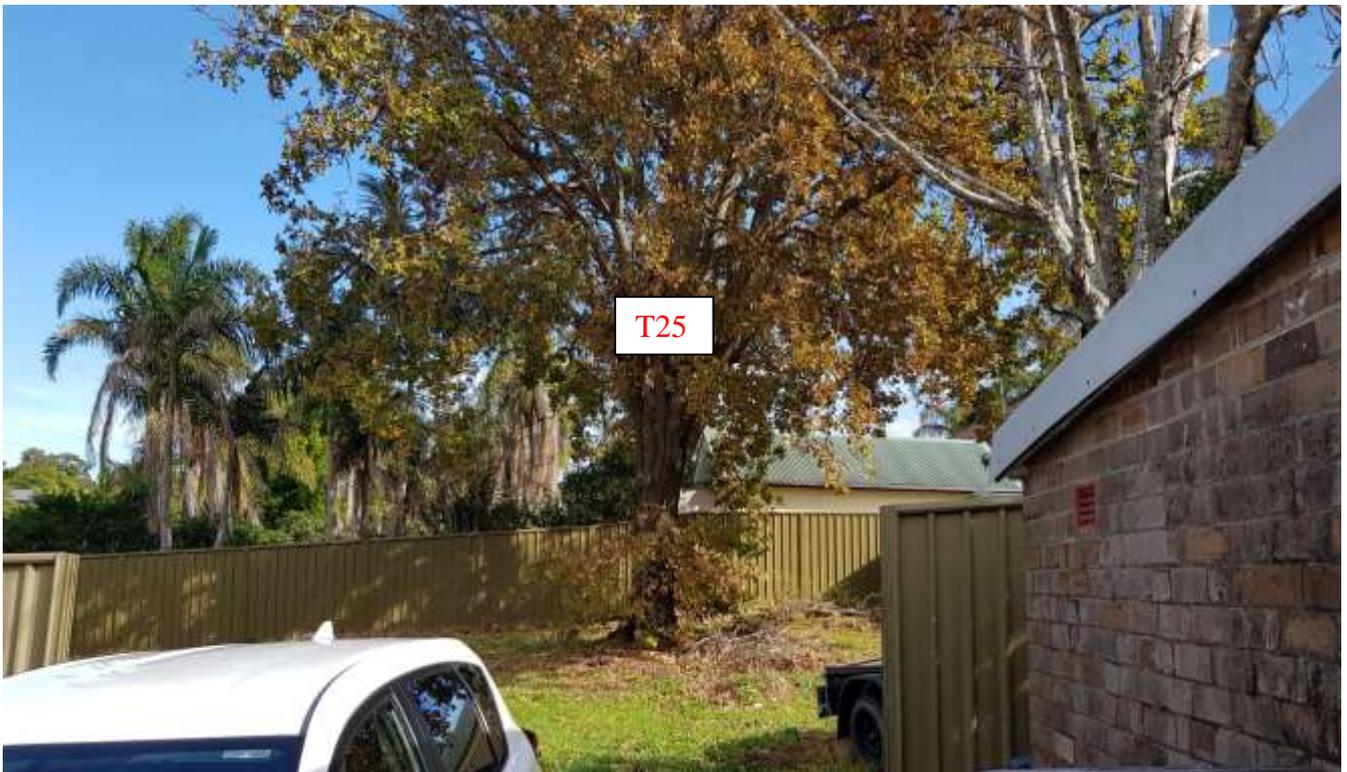
Photo 12, below, looking west to tree 25 to be removed. Aged mature tree with proposal conflicting with tree 25.

**Tree 25 – *Quercus robur* – REMOVE** – Conflicts with proposal, total loss due to basement carpark

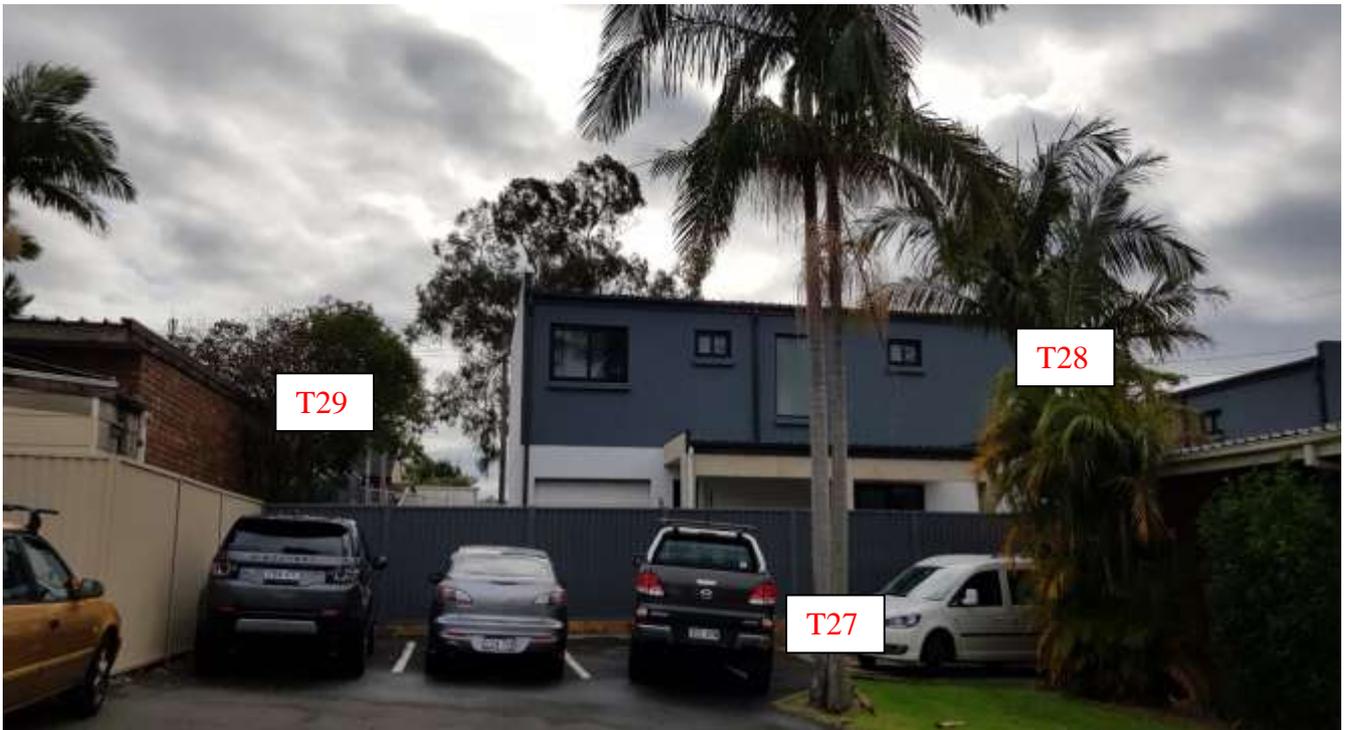
Photo 13, below, looking north to trees 27/28 on site to be removed and tree 29 (neighbours tree) to be retained

**Tree 27 / 28 – *Archontophoenix cunninghamiana* – REMOVE** – Conflicts with proposal, total loss

**Tree 29 – *Ligustrum lucidum* – RETAIN** – Neighbours tree against fence

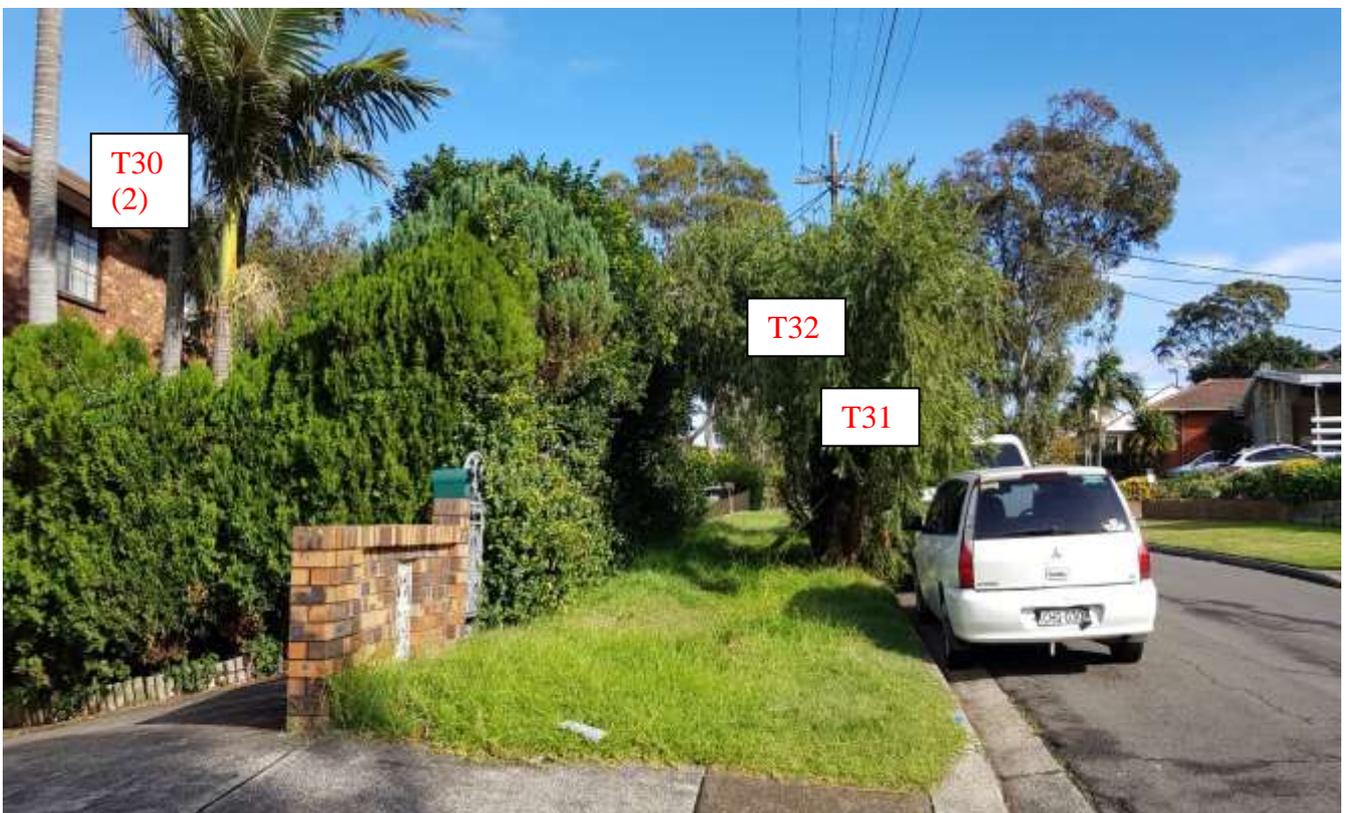
Photo 14, below, looking west to trees 30, 32 and 32, with 30 being removed and trees 31 and 32 being retained and protected

**Tree 30 (2) – *Archontophoenix cunninghamiana* – REMOVE** – Conflicts with proposal, total loss

**Tree 31 – *Callistemon viminalis* – RETAIN** – Councils asset

**Tree 32 – *Callistemon viminalis* – RETAIN** – Councils asset
