for Alterations and Additions to
St Philip's Christian College,
Cessnock

Arboricultural Impact Assessment

Site Address: 10 Lomas Lane Nulkaba, NSW

Date: October 2021

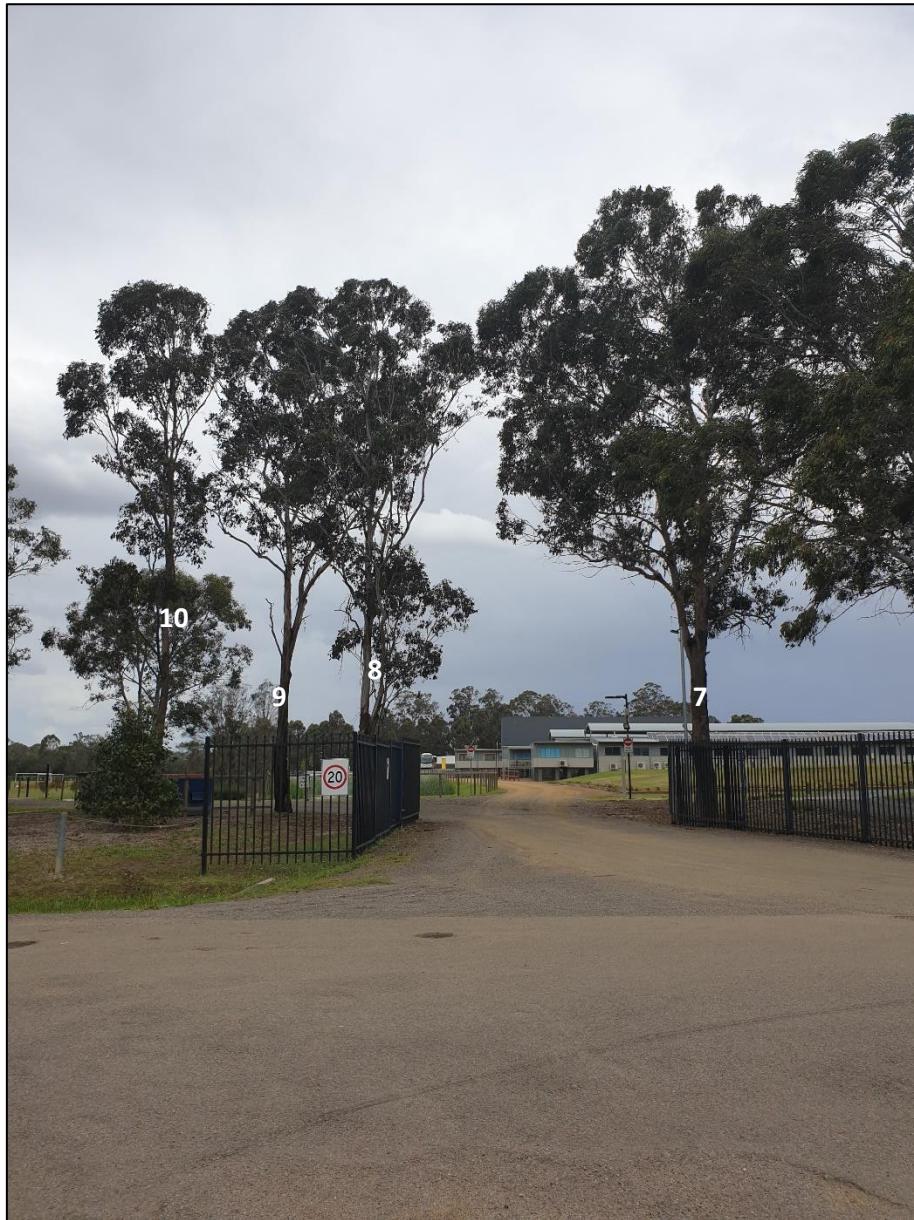
Figure 1 Trees 7 – 10 *Eucalyptus moluccana* adjacent to the site entry

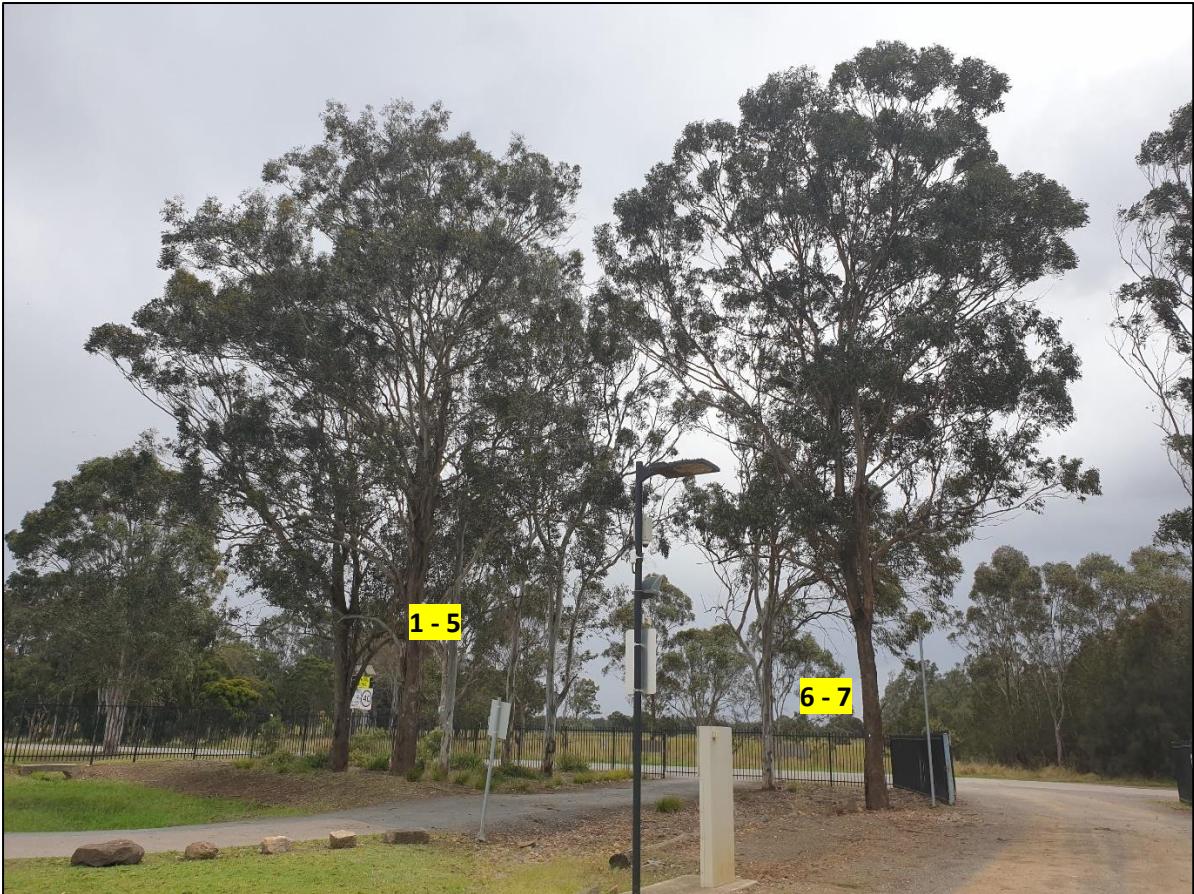
The proposed bus turning area will support frequent use by heavy vehicles and therefore will be constructed to a high standard requiring a deep and highly compacted subgrade which will impact trees 6 to 14.

Trees 6, 13 and 14 *Eucalyptus tereticornis* are located to the East and West of the proposed road works and will be subject to encroachments ranging from 19% to 40% of the TPZ's and 11% to 22% of the SRZ's. This is considered to be a major and unsustainable level of encroachment and the trees are therefore proposed to be removed in favour of the proposed development.

Figure 3 Trees 6 – 7 will be subject to encroachment from construction of the proposed roadway

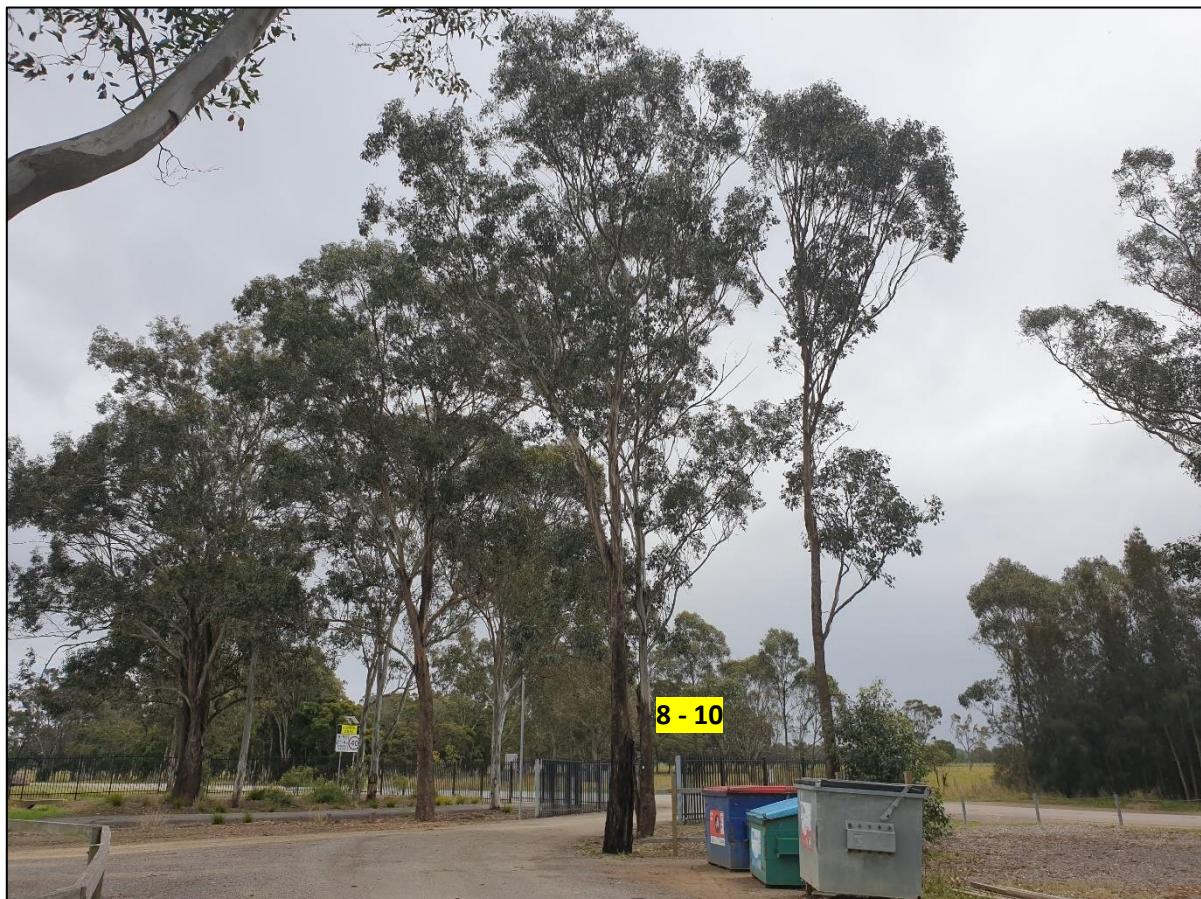
Trees 7, 8, 9, 10, 11 *Eucalyptus moluccana* and 12 *Eucalyptus tereticornis* are located within the plan area of the proposed roadway and cannot be retained in conjunction with the current design which takes advantage of existing gates and compacted gravel roadways. These trees are also proposed for removal to allow the development to proceed as planned.

Figure 4 Trees 8- 10 will be subject to encroachment from construction of the proposed roadway

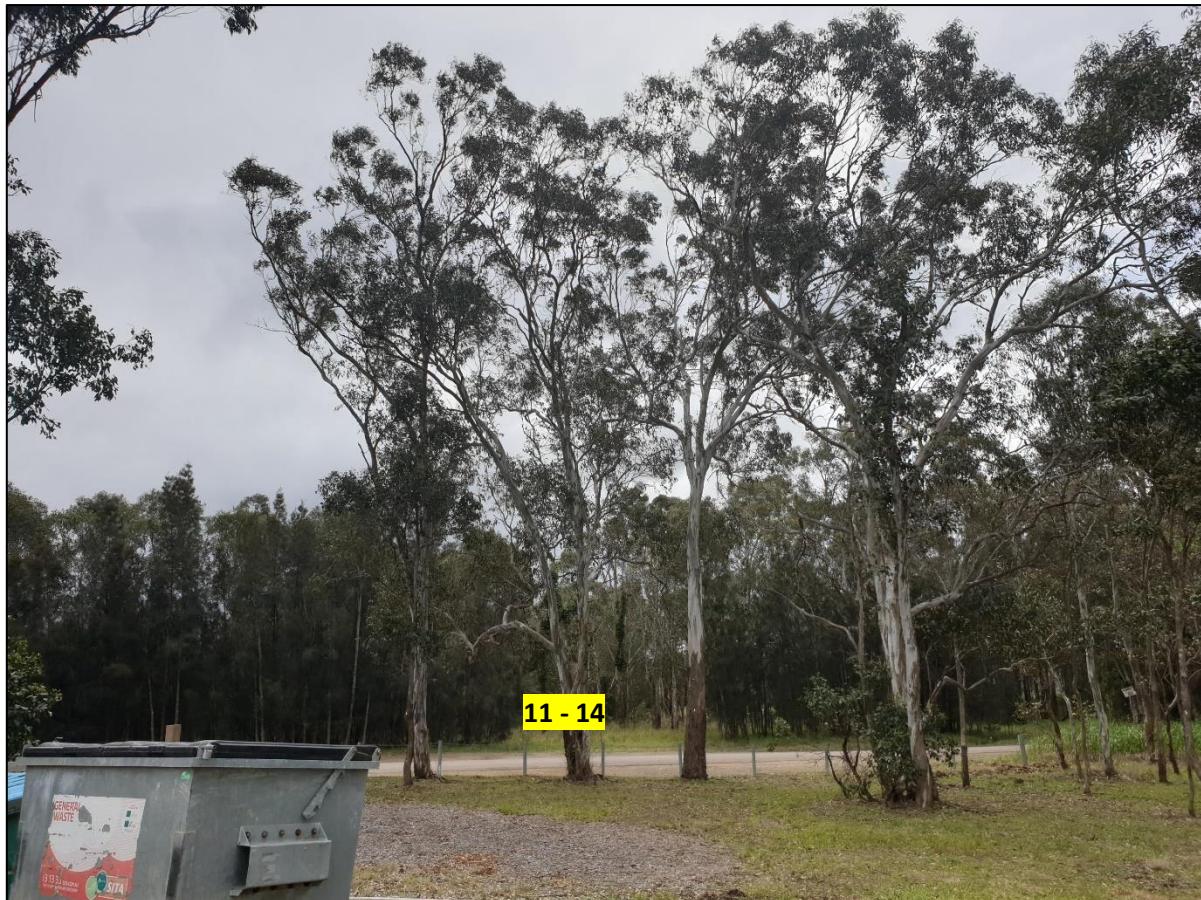
Figure 5 Trees 11 - 14 will be subject to encroachment from construction of the proposed roadway

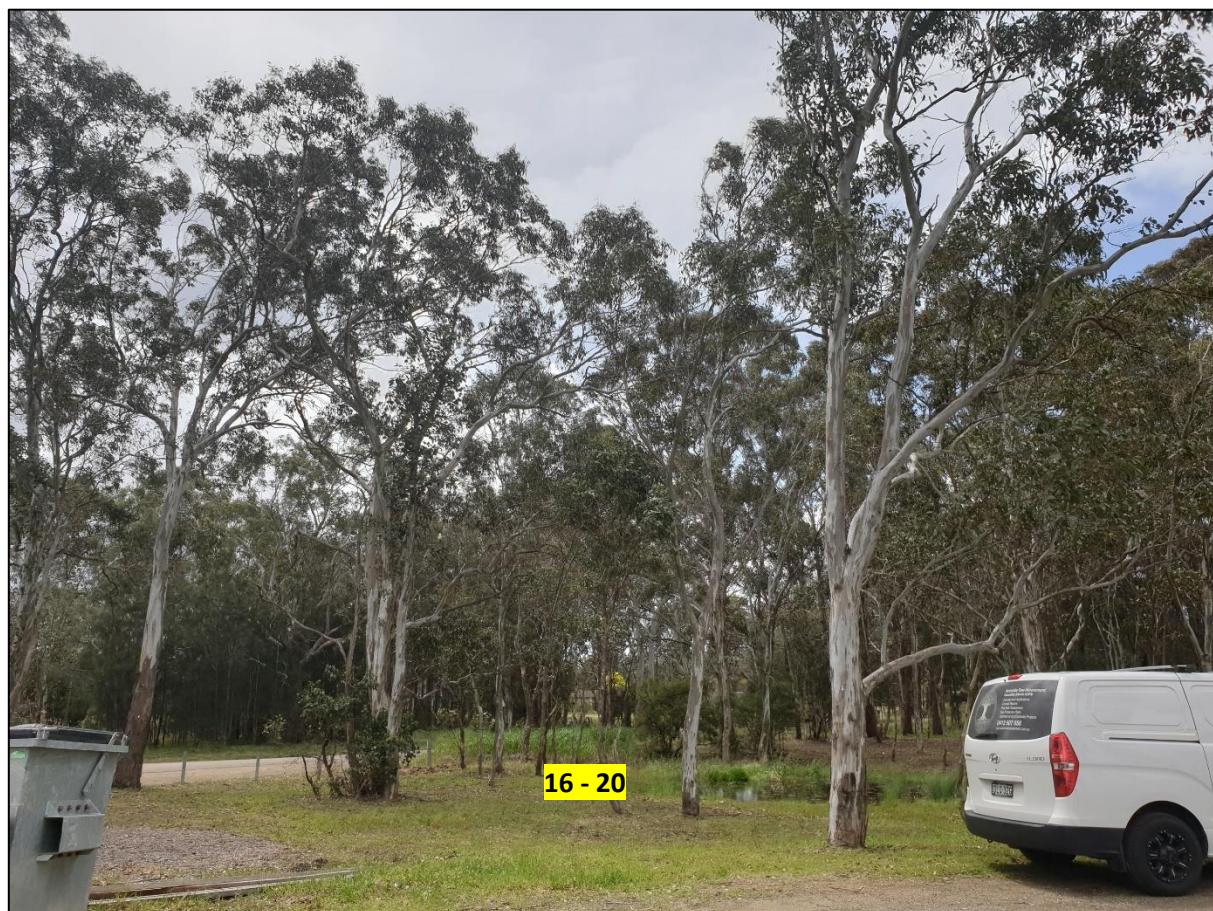
Trees 15 to 20 are set back from the edge of the proposed roadway, only the larger Trees 15 and 16 *Eucalyptus tereticornis* are subject to encroachment which is calculated at 11% and 18% respectively and can be managed by the implementation of protection measures meeting the requirements of AS4970.

Figure 6 Trees 16 – 20 will be retained in conjunction with the proposed development

As with the retained trees noted above protective fencing will be installed to create an exclusion zone round the whole group to restrict access and provide a buffer between the trees and the work area.

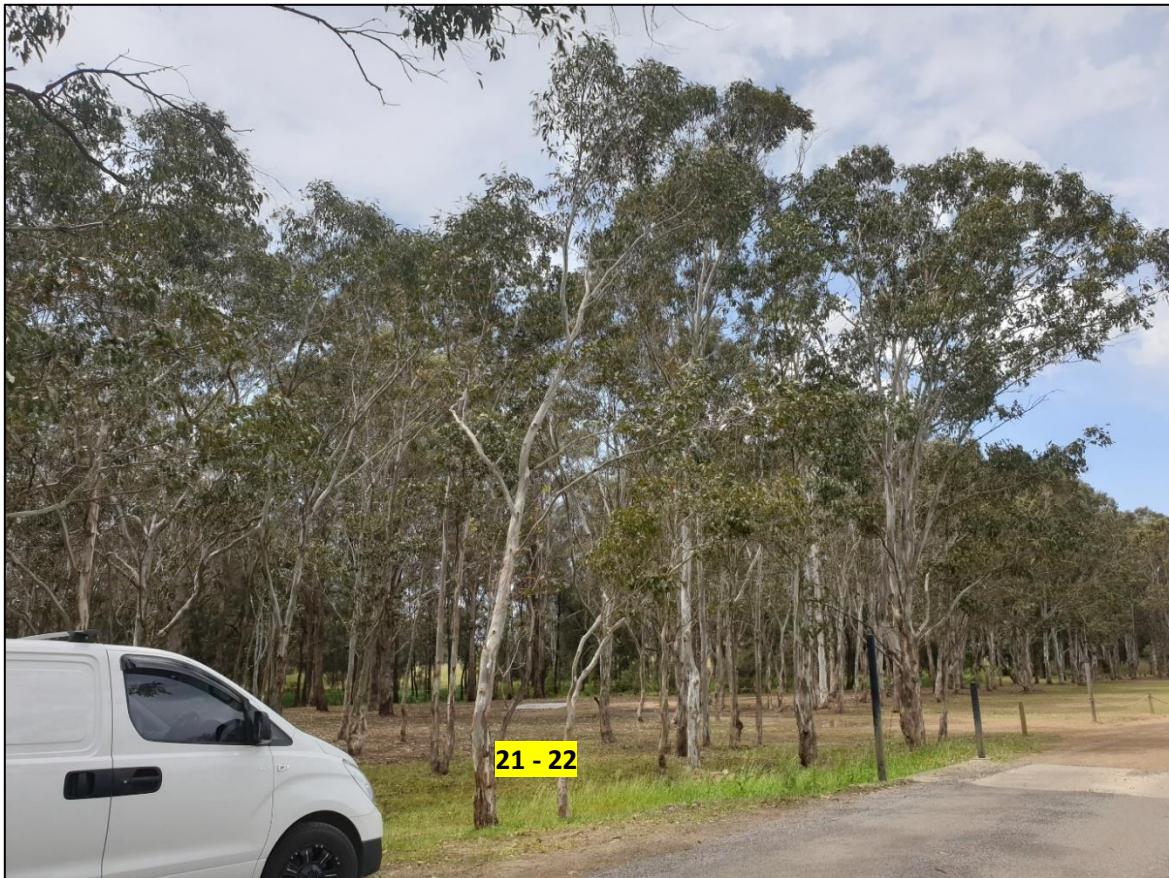
Trees 21 to 23 *Eucalyptus tereticornis* are located close to the edge of the existing roadway which will be retained, so no increase in the level of encroachment is expected. The trunks of the trees are to be protected by armouring as detailed above and at appendix 12.3.b.

Figure 7 Trees 21-22 *Eucalyptus tereticornis* are proposed for retention

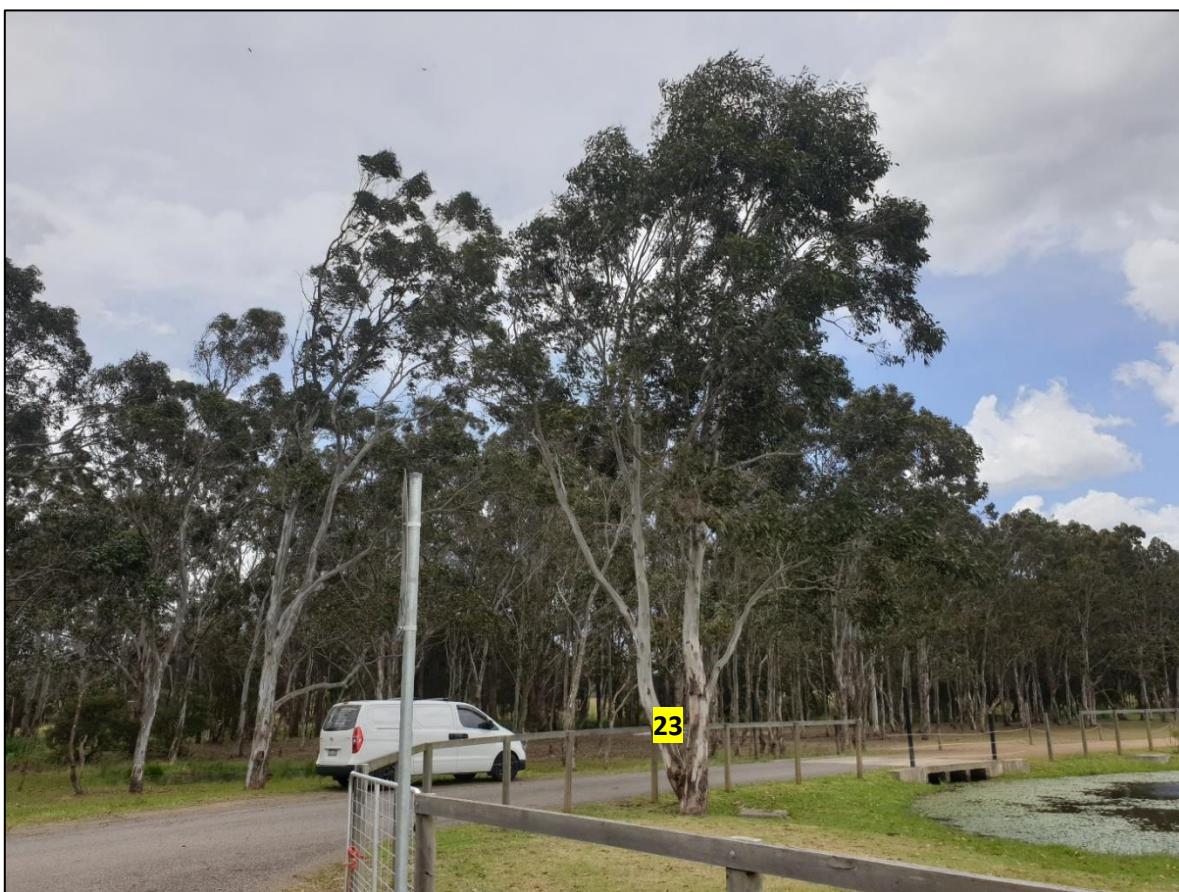
Figure 8 Tree 23 *Eucalyptus tereticornis* is proposed for retention
