# Geomorphology Report

## Proposed New Berrima Brickworks Facility at 416-524 Berrima Road, Moss Vale

For Brickworks Limited

16 April 2020

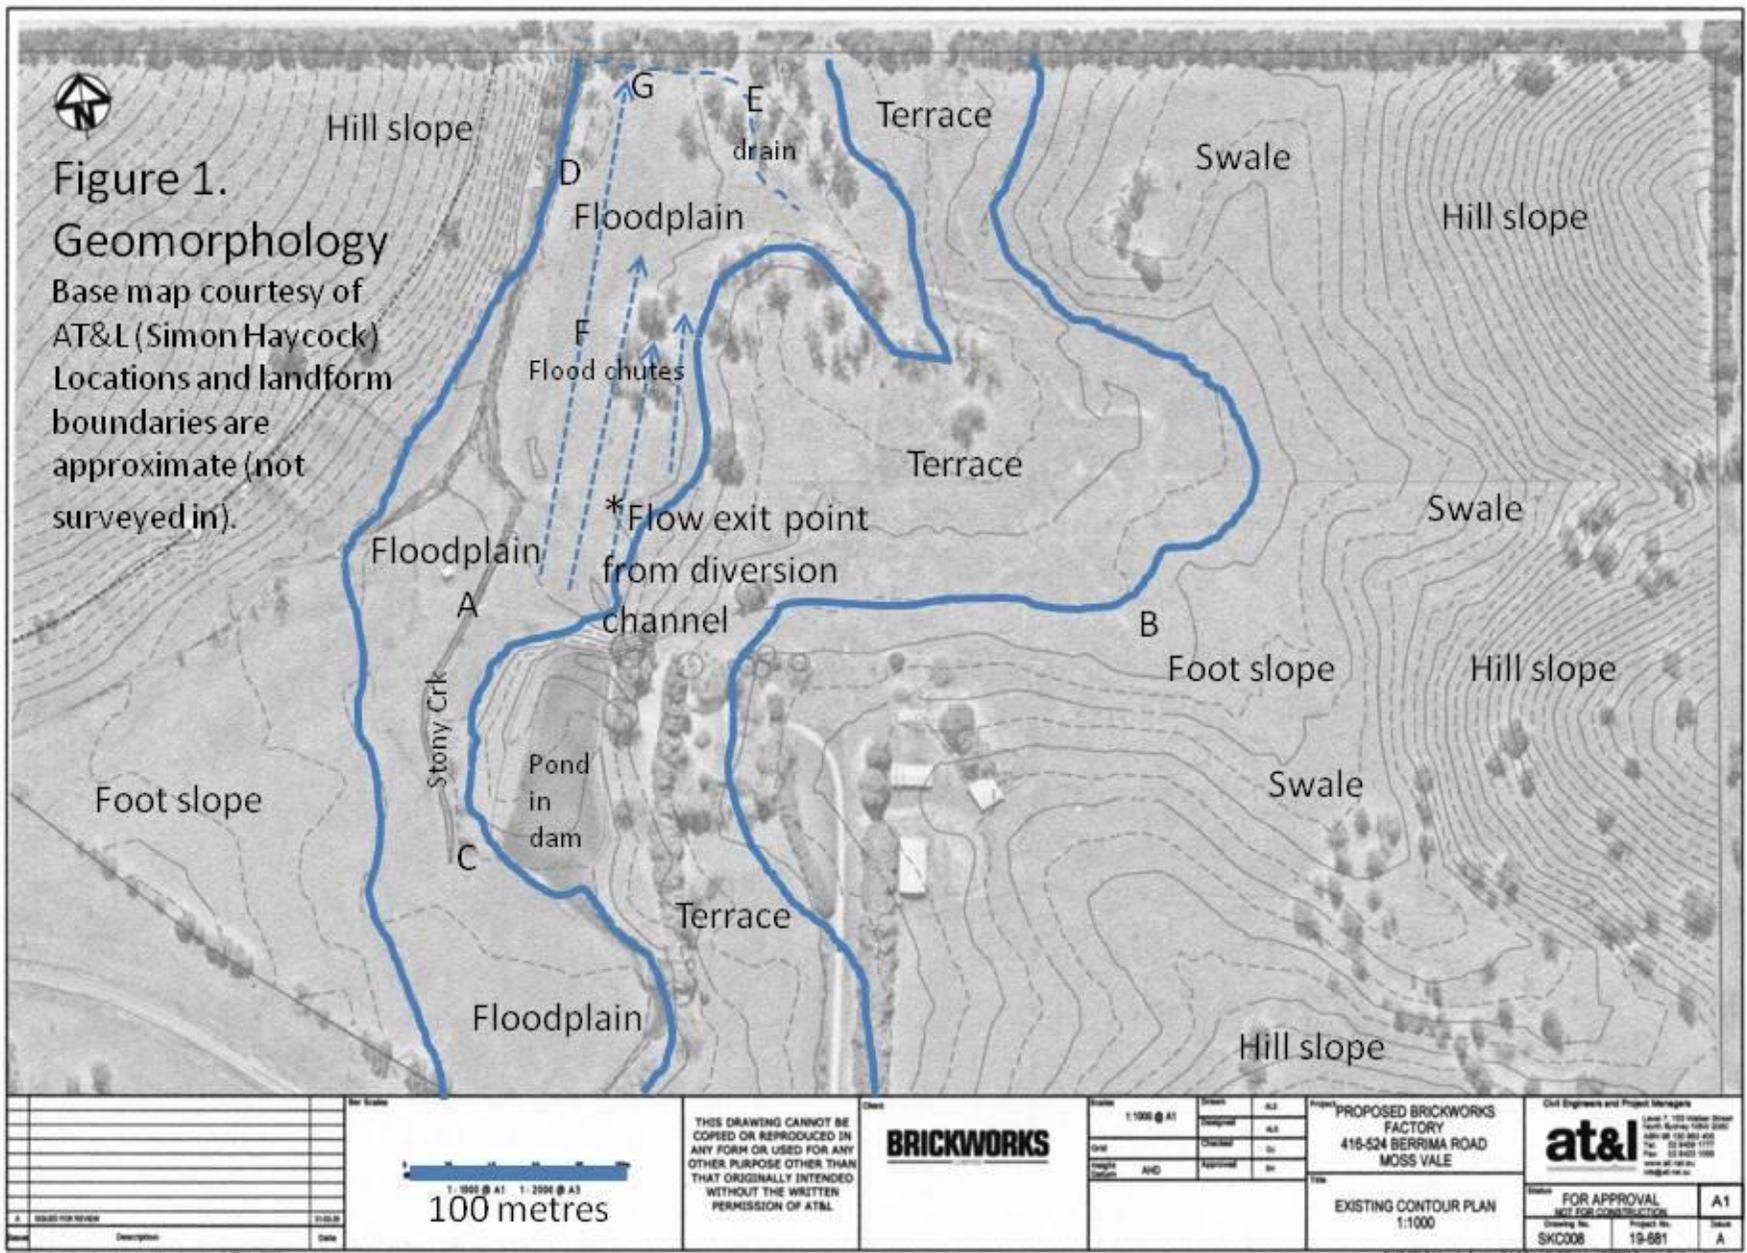
I have produced a geomorphology map (Figure 1) from my inspection observations and from the site flood report (SMEC, 2020).

All landforms shown on my map (Figure 1) are presently “stable” in terms of the human time scale. That is, a person would not notice any significant changes in their lifetime. All landforms have a dense cover of grasses, including Stony Creek. There is no sign of any significant recent erosion or deposition. All hill slopes and soils are stable. Apart from Stony Creek, runoff is by way of shallow overland flow. One short section of Stony Creek has stock trampling damage to the banks.

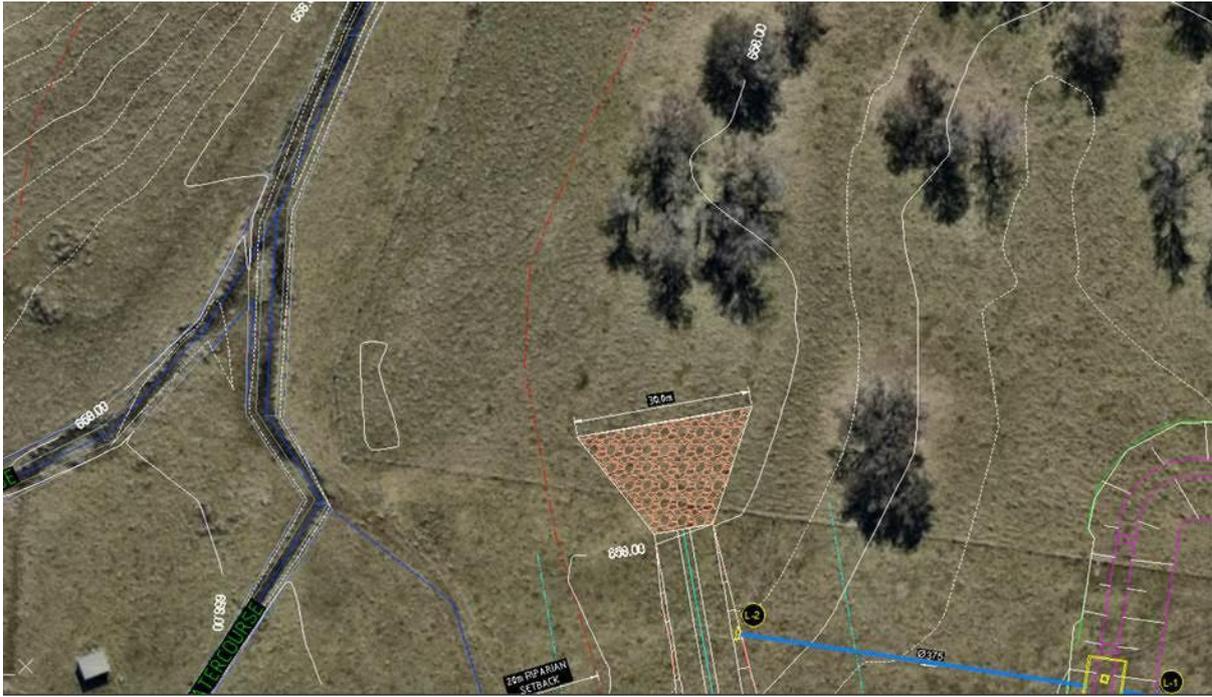
If the flow exiting the proposed diversion channel travels down just one of the flood chutes, the flow may be concentrated enough to cause significant erosion. This could be prevented by spreading out the exiting flow to at least 20m in width so that it flows down at least 2 of the flood chutes. Figure 2 is a concept drawing of a flow spreader at the downstream end of the proposed diversion channel. A dense growth

Figure 2. Concept drawing of a flow spreader at the downstream end of the proposed diversion channel (courtesy of Simon Haycock, AT&L).

1. A flow spreading structure at least 20m wide should be constructed at the downstream end of the proposed diversion channel. This should be designed to reduce the exiting flow concentration, making the flow wide and shallow so that it flows overland down the slope of the flood plain and down at least 2 of the existing flood chutes.
2. The east bank flood plain overland flow area downstream from the diversion channel exit should be planted with closely-spaced low-growing native plants such as *Lomandra longifolia* (spiny-head mat-rush).
3. The diversion channel and the area downstream from its end should be monitored by inspection for erosion and sedimentation after each high flow event. Any problems should be rectified immediately.

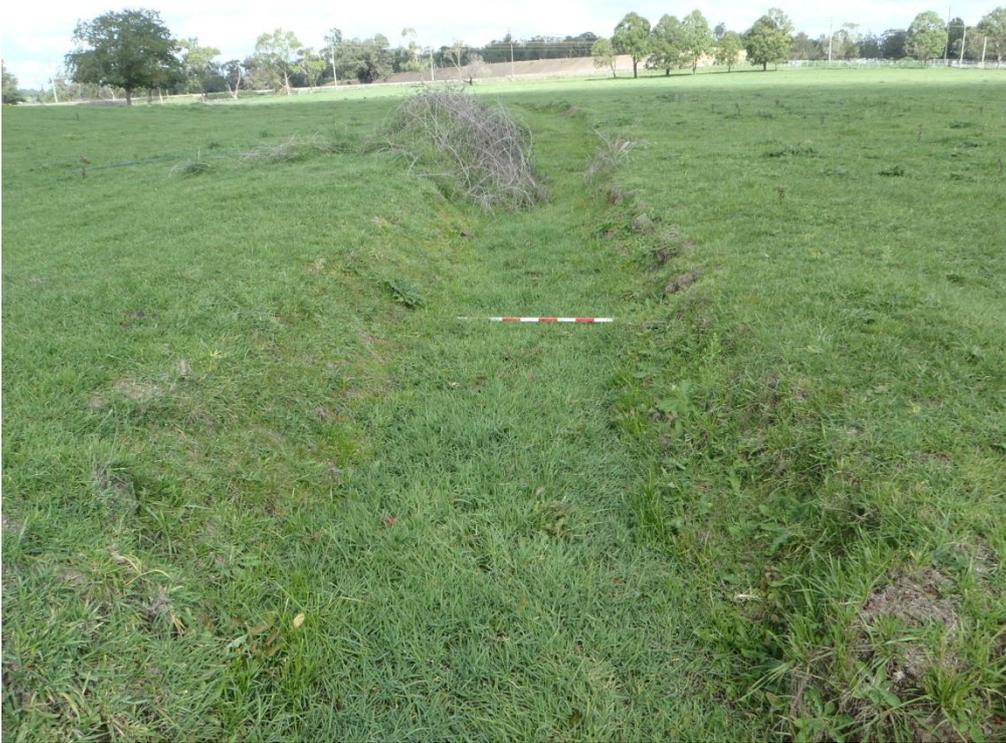
The only natural “defined” (definite bed and banks) stream I found on the site is Stony Creek. This 5<sup>th</sup> order stream (AT&L, 2020) flows from south to north along the west side of the site. It is quite small considering its order. Bed width is less than 2m and bank height is less than 0.5m high (Photo 1, Site A Figure 1). It flows into the Wingecarribee River 1 km north of the area. I found no “stones” in the creek bed where it flows through the site, only silt and sand. There was no flow at the time of my inspection. The farm dam contained a large pond of water and there are two small ponds of water in Stony Creek upstream of the northern property boundary. The River Style® (Brierley and Fryirs, 2005) is “Low Sinuosity Fine Grained”.

- The former 1<sup>st</sup> and 2<sup>nd</sup> order streams flowing out from the hills to the east of the site have been filled to form broad swales (Photo 2, Site B Figure 1).
- Remnants of spoil heaps beside the channel indicate that Stony Creek has been straightened and the banks have been battered (Photo 1). It is possible that the channel was dug to drain a swamp when the property was first settled.

Photo 1. Stony Creek looking upstream. Site A on Figure 1. The scale pole is 1.5m long with 15cm divisions.

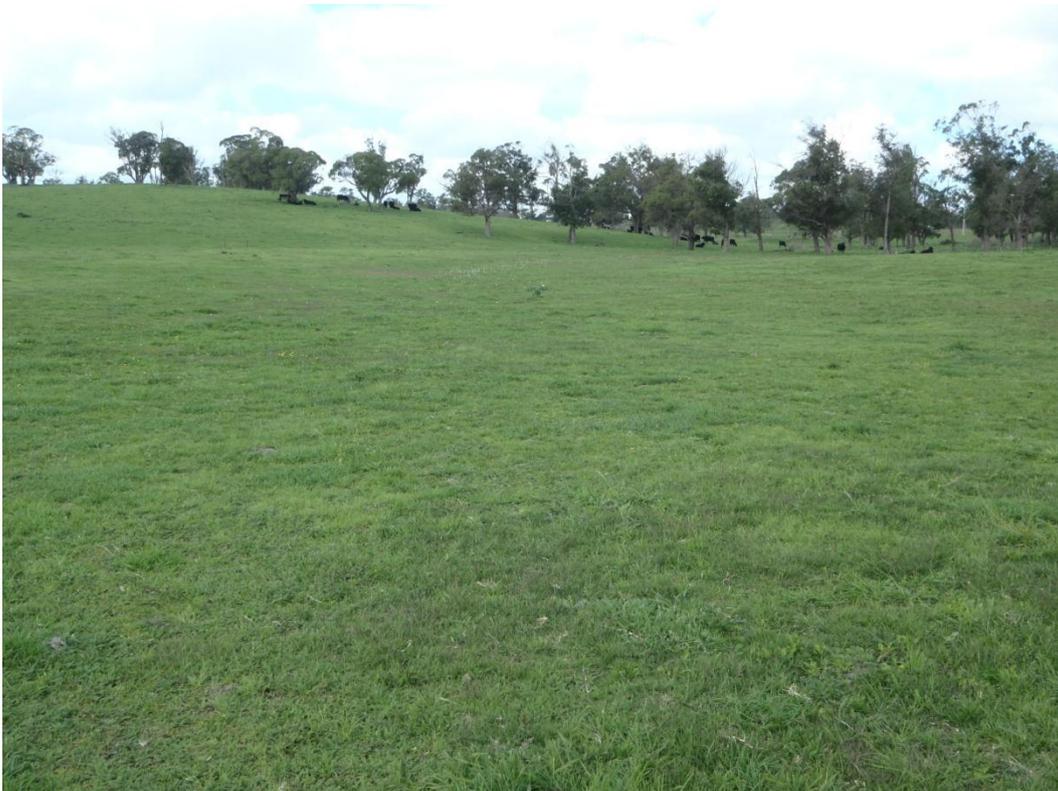
Photo 2. Looking upslope at the swale at site B on Figure 1.

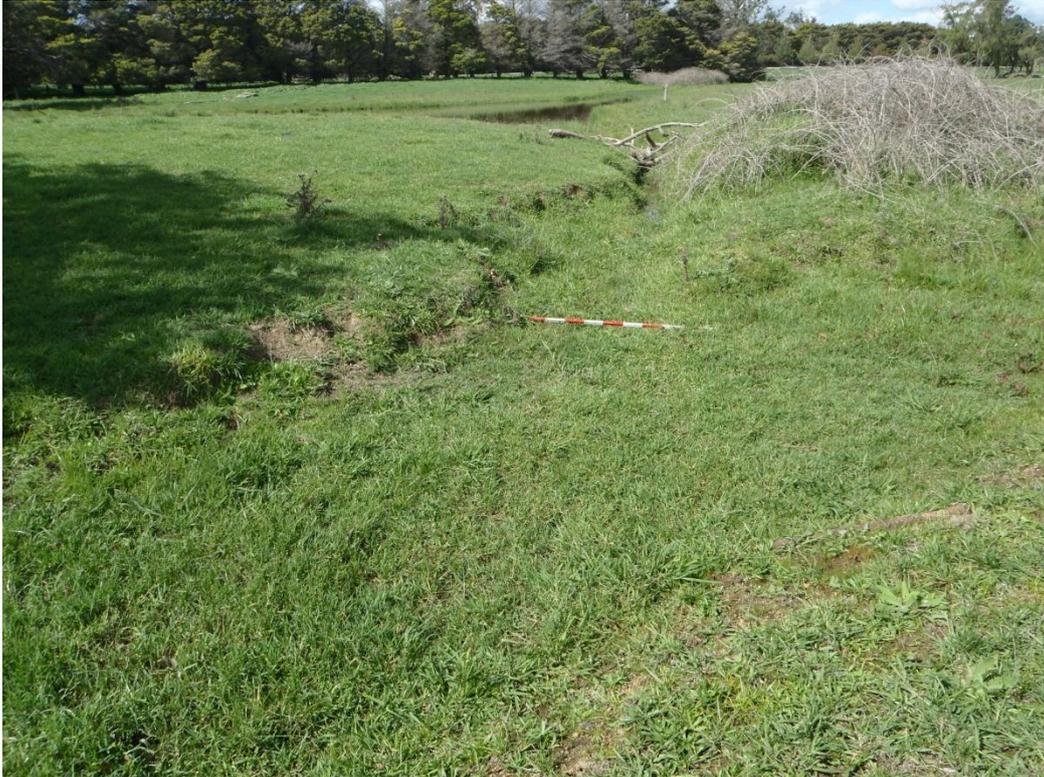
- Stony Creek has been diverted into a large farm dam with flow exiting the dam by way of breach in its south west corner (Photo 3, Site C Figure 1). The dam backwater reduces flood velocities upstream.
- A small earth-and-culvert weir has been built on Stony Creek near the northern property boundary (Photo 4, Site D Figure 1). Although it is partially breached, the weir is still backing up a small pond and reducing flood flow velocities upstream.

Photo 3. The breach at the upstream end of the farm dam where Stony Creek flows out of the dam pond. Site C on Figure 1. The scale pole is 1.5m long with 15cm divisions.

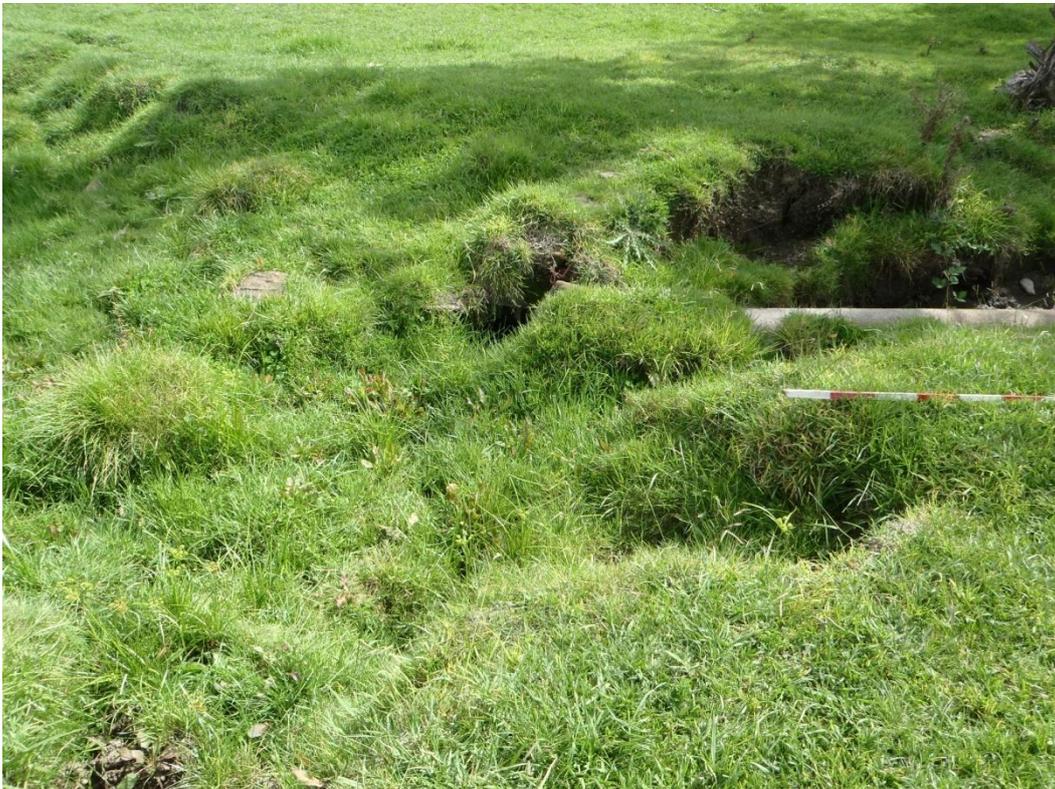
Photo 4. Partially breached soil-and-culvert weir on Stony Creek at site D on Figure 1. The scale pole is 1.5m long with 15cm divisions.

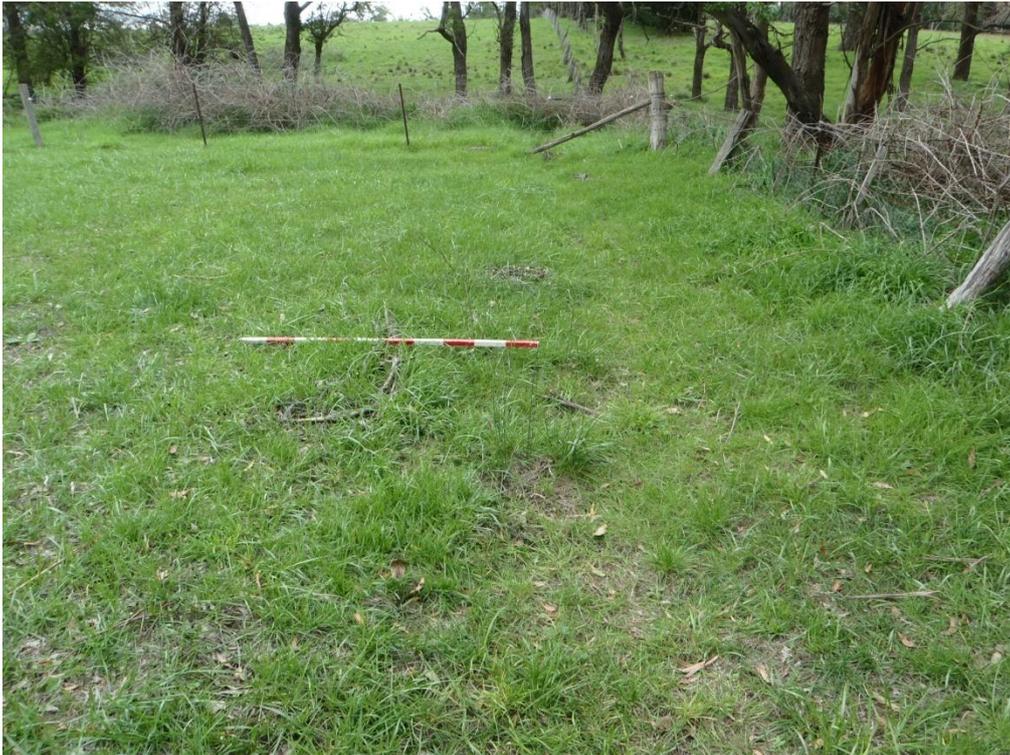
There is a short constructed drainage channel at site E on Figure 1 in the north west corner of the site. This appears to be intercepting the overland flow and diverting it into a very small pond. The overflow from the pond goes down another small artificial channel (Photo 5) along the northern property boundary and into Stony Creek. These artificial channels are stable with a good cover of grasses. They will not be affected by the proposed construction except for a reduction in flow when the fill for the pad is put in place, cutting off the overland flow. This will make the channels more stable.

Photo 5. A drainage channel dug parallel to the fence, looking downstream toward Stony Creek (just beyond the blackberry bush). The western-most flood chute ends at the scale pole. Under the pole is flood debris that has been floated down the flood chute. Site G on Figure 1. The scale pole is 1.5m long with 15cm divisions

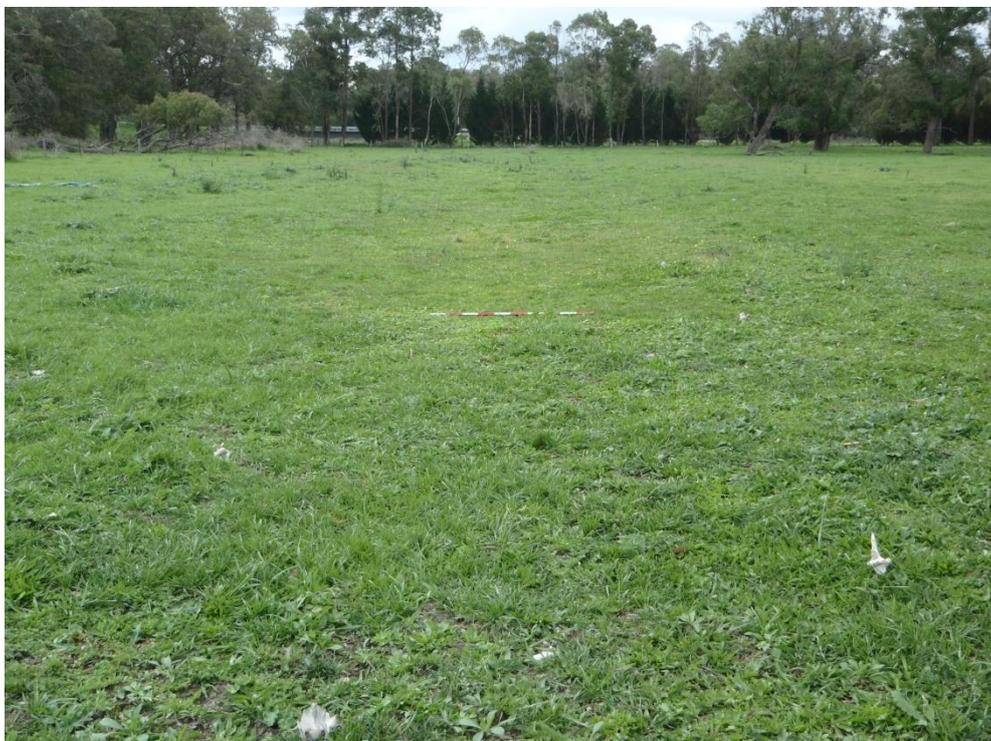
The drawings for the proposed diversion channel show that its downstream end is approximately 60m from Stony Creek and located on the creek's flood plain. I inspected this site and found the presence of 4 flood chutes (Figure 1). They are very shallow (less than 30cm deep), up to 1.5m wide at the bed and up to 3m wide at the top of the banks. Photo 6 is taken looking downstream along one such chute from site F on Figure 1. Flood chutes are linear depressions in a flood plain that run parallel to the stream channel and convey flood flow. They can be formed by scour or they may be prior stream channels that have been partially filled with sediment (Brierley and Fryirs, 2005).

Photo 6. Looking north and downstream along a flood chute from site F on Figure 1. The scale pole is 1.5m long with 15cm divisions
