# REMEDIATION ACTION PLAN

Aspect Industrial Estate, Mamre Road, Kemps Creek, NSW  
2178 – Rev 3 Final

Prepared for Mirvac Projects Pty Ltd

15 OCTOBER 2020

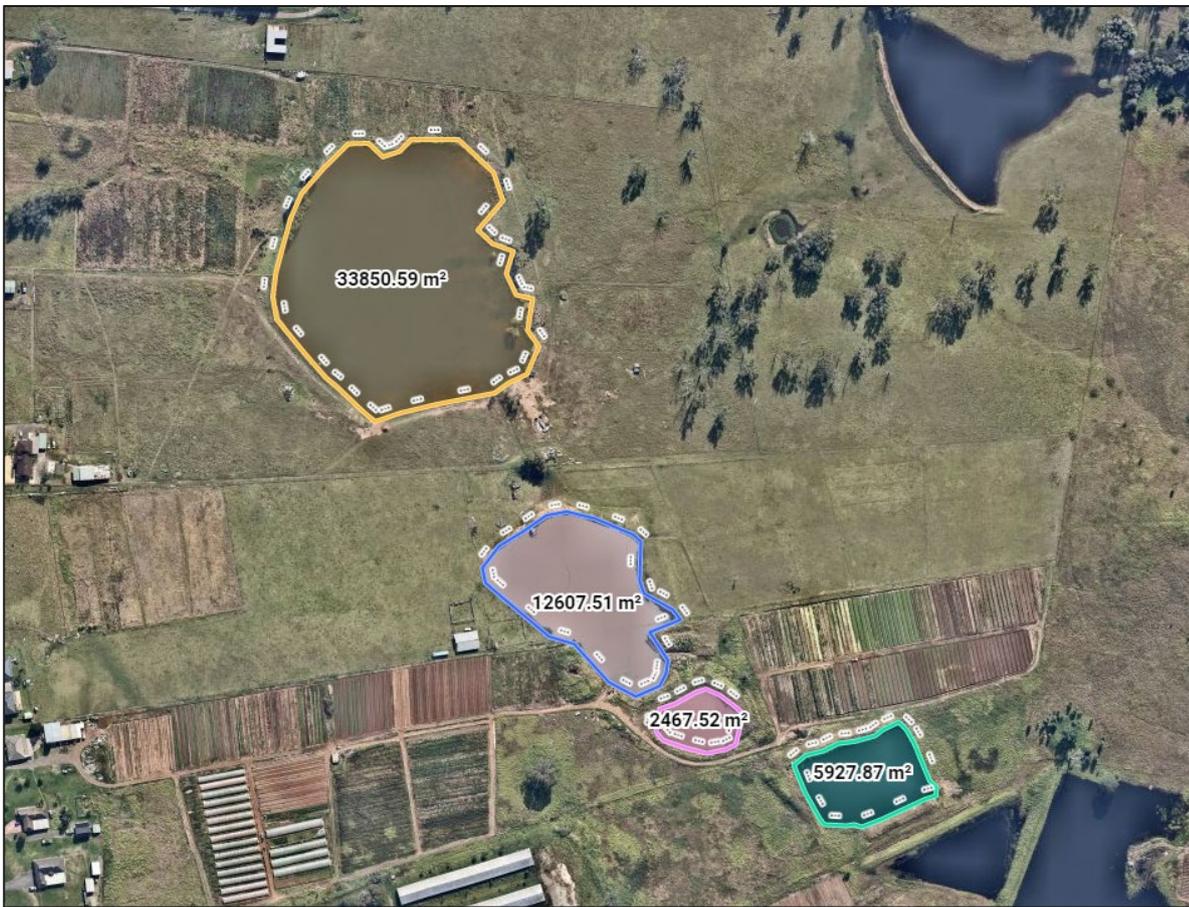
Plate 1: Aerial photograph obtained from Nearmap (2020) used to estimate excavation volumes.

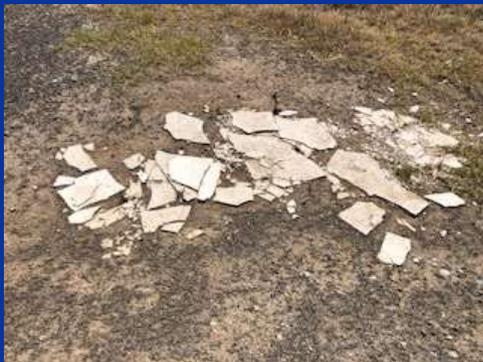
Photo No.  
2

Lot 54  
Fragments and broken sheeting at rear of property

**Asbestos**
