Arborist's Report

Arboricultural Impact Assessment

UNSW Health Translation Hub
Wallace Wurth Building
Botany Street
Randwick

18th March 2021

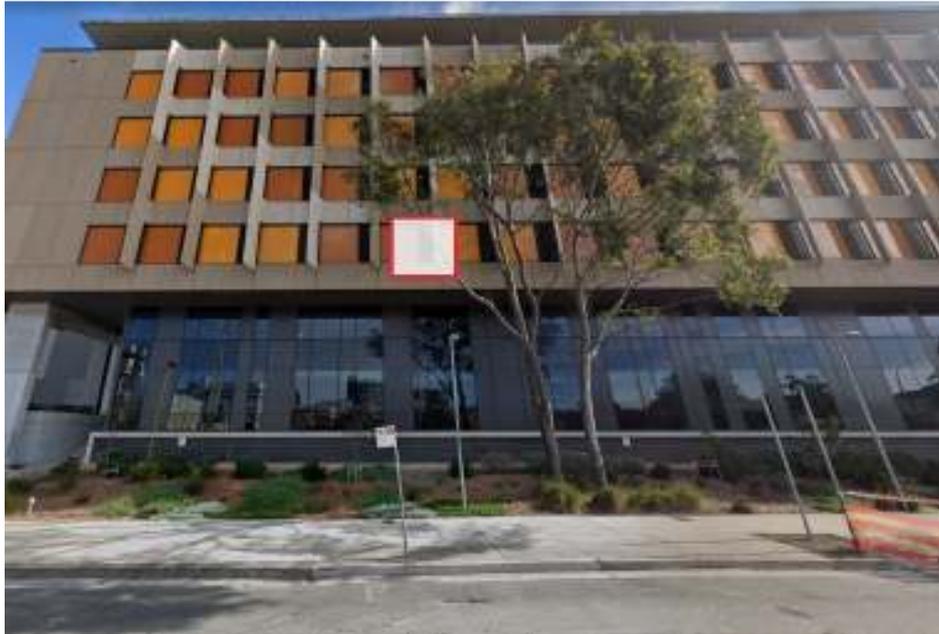
Remote assessment is based on architectural drawings and current Google Streetview maps (photograph) as illustrated on the front cover of this report.

The two trees are identified as trees number 267 and 268 from the university Tree Inventory data provided by UNSW. Both are semi-mature *Corymbia maculata* (Spotted Gum) with DBH's of 450mm and 350mm respectively. Each has been assigned a low risk rating in the inventory.

The form of the trees is co-dominant, that is to say they have restricted canopy growth due to competition with each other.

The larger (southern) tree (267) has a secondary leader at approx. 2m in height which branches to the South parallel to the face of the building.

The illustration on the front cover of this report indicates the approximate location of a proposed pedestrian bridge.

As indicated by the red square this structure will require removal of the lower limb from tree 267. It may also be desirable to minimise future branch conflict by pruning the higher limb seen in the photograph. Two pruning cuts will be made, each to the branch collar in accordance with the guidelines of AS4373 - pruning of amenity trees.

Such pruning will comprise approximately 15% of the current canopy and is within the tree's anticipated tolerance, particularly if soil conditions are maintained in a favourable condition through supplementary irrigation. Future growth of new foliage will be managed in accordance with existing tree management practices.

In this case it is not recommended that additional pruning be carried out, but rather that tree 267 be removed entirely.

Such work would be carried out ensuring no damage to the adjacent tree (268) which would be retained and would benefit from reduced canopy competition.
