Tree Pruning Specification

Hammondcare Greenwich Hospital

Prepared by Mark Bury Consulting

21st October 2021

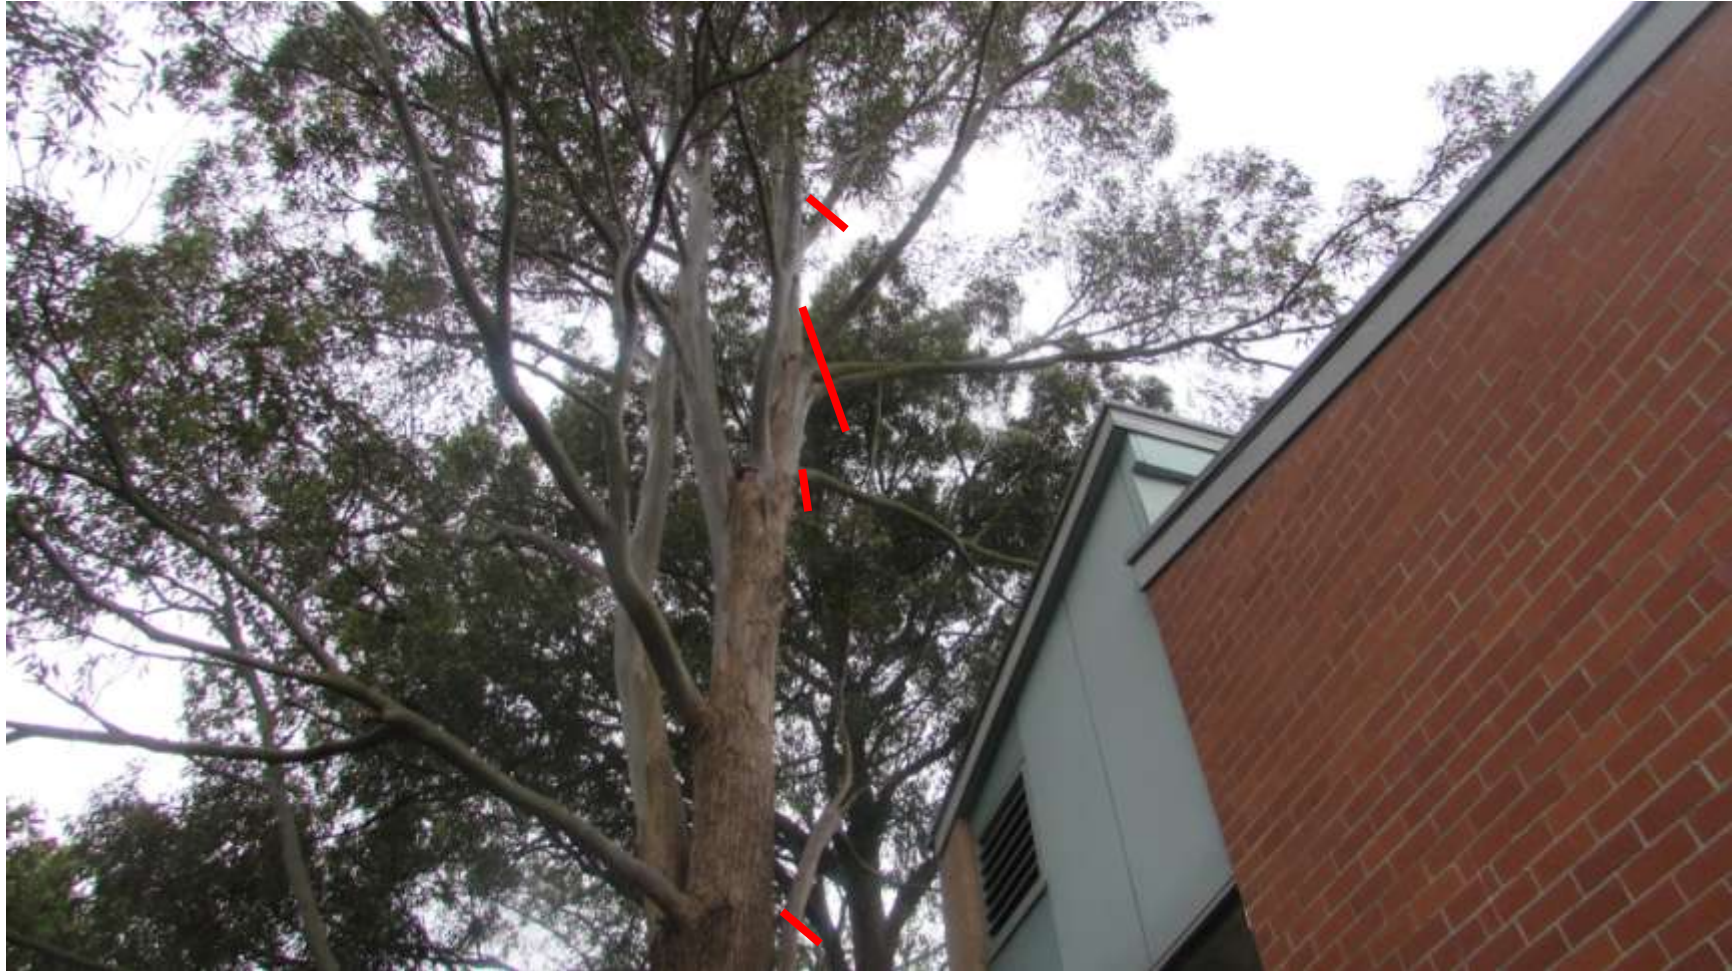
Tree 147 *Eucalyptus saligna*
Sydney Blue Gum
Pruning Cuts and Branches to
be pruned in red

Tree #147 is a mature *Eucalyptus salignus* Sydney Blue Gum, included within the previous tree impact assessment. The tree has branches which will conflict with the proposed building line and would require the following tree works:

All eastern limbs and branches- Prune Braches back to building line where required

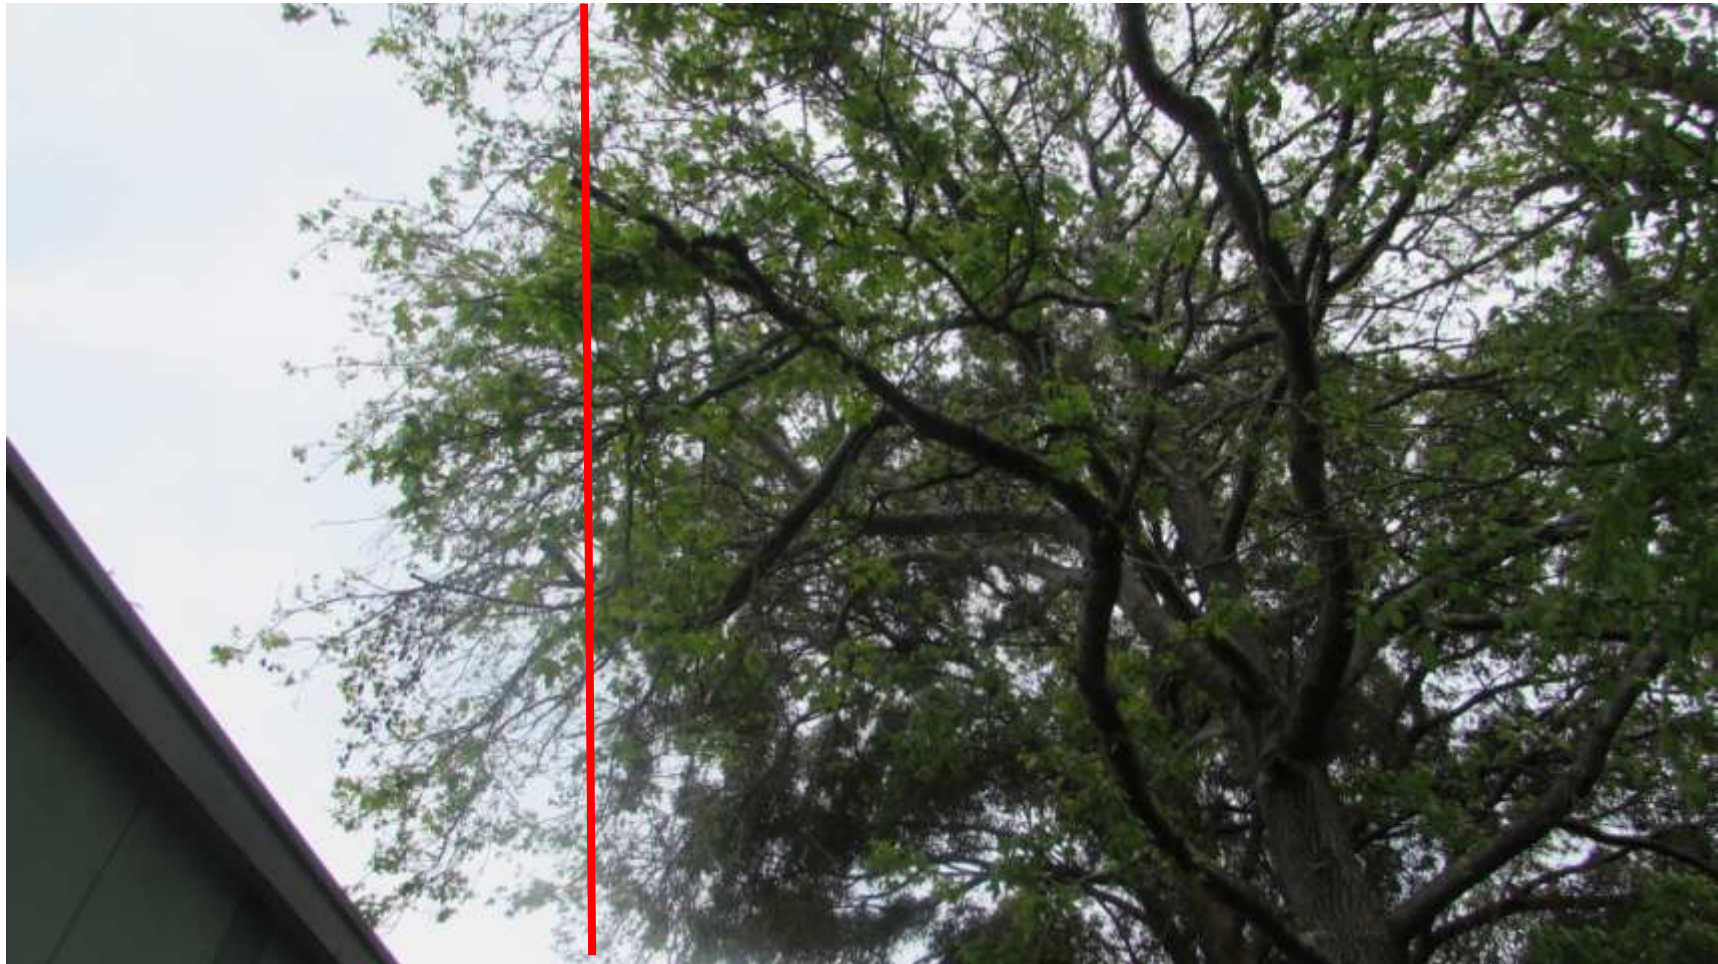
Tree 149
Eucalyptus microcorys
Tallowood
Tree to be correctionally pruned
to red line

Tree #149 is a mature *Eucalyptus microcorys* Tallowood, included within the previous tree impact assessment. The tree has branches which will conflict with the proposed building line and would require the following tree works:

All eastern limbs and branches- Prune Braches back to building line where required

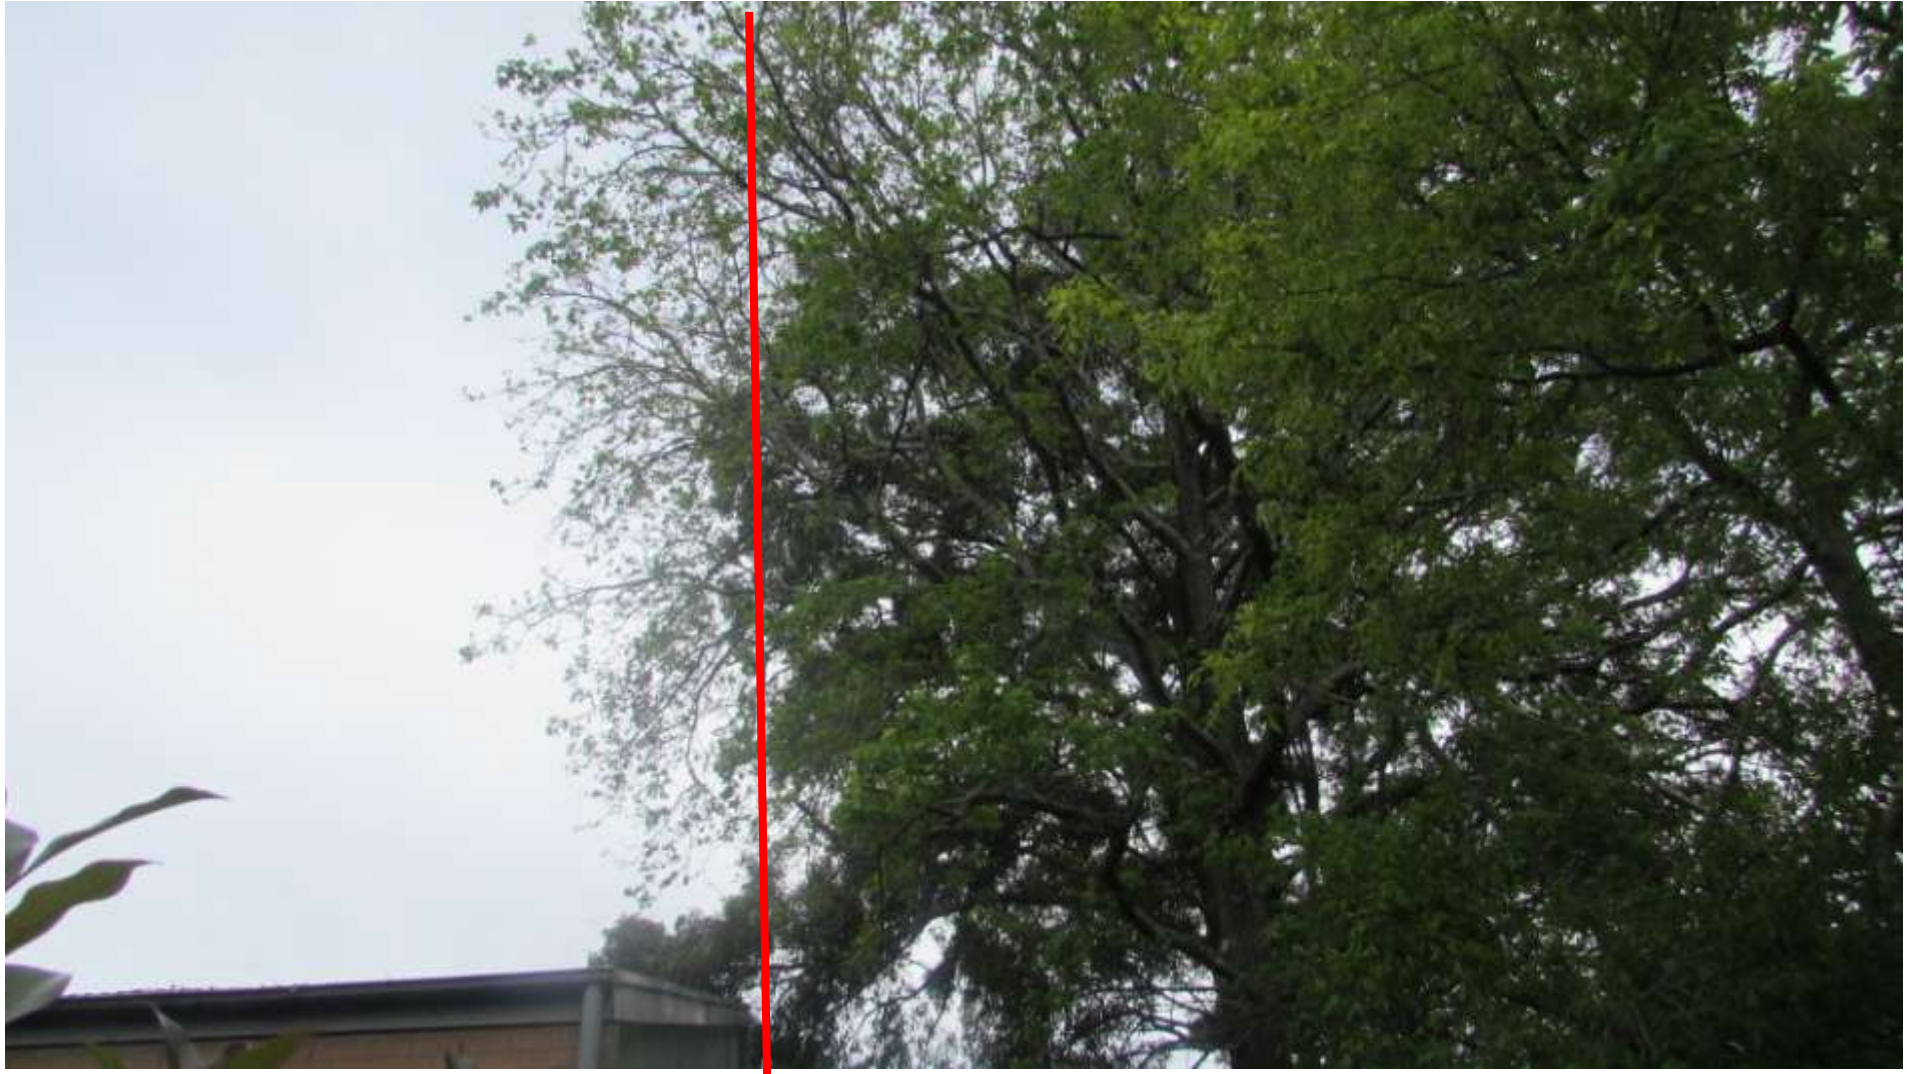
Tree 150
Liquidambar styraciflua
Liquidamber
Tree to be correctionally pruned
to red line

Tree #150 is a mature *Liquidamber styraciflua* Liquidamber, included within the previous tree impact assessment. The tree has branches which will conflict with the proposed building line and would require the following tree works:

All eastern limbs and branches- Prune Braches back to building line where required

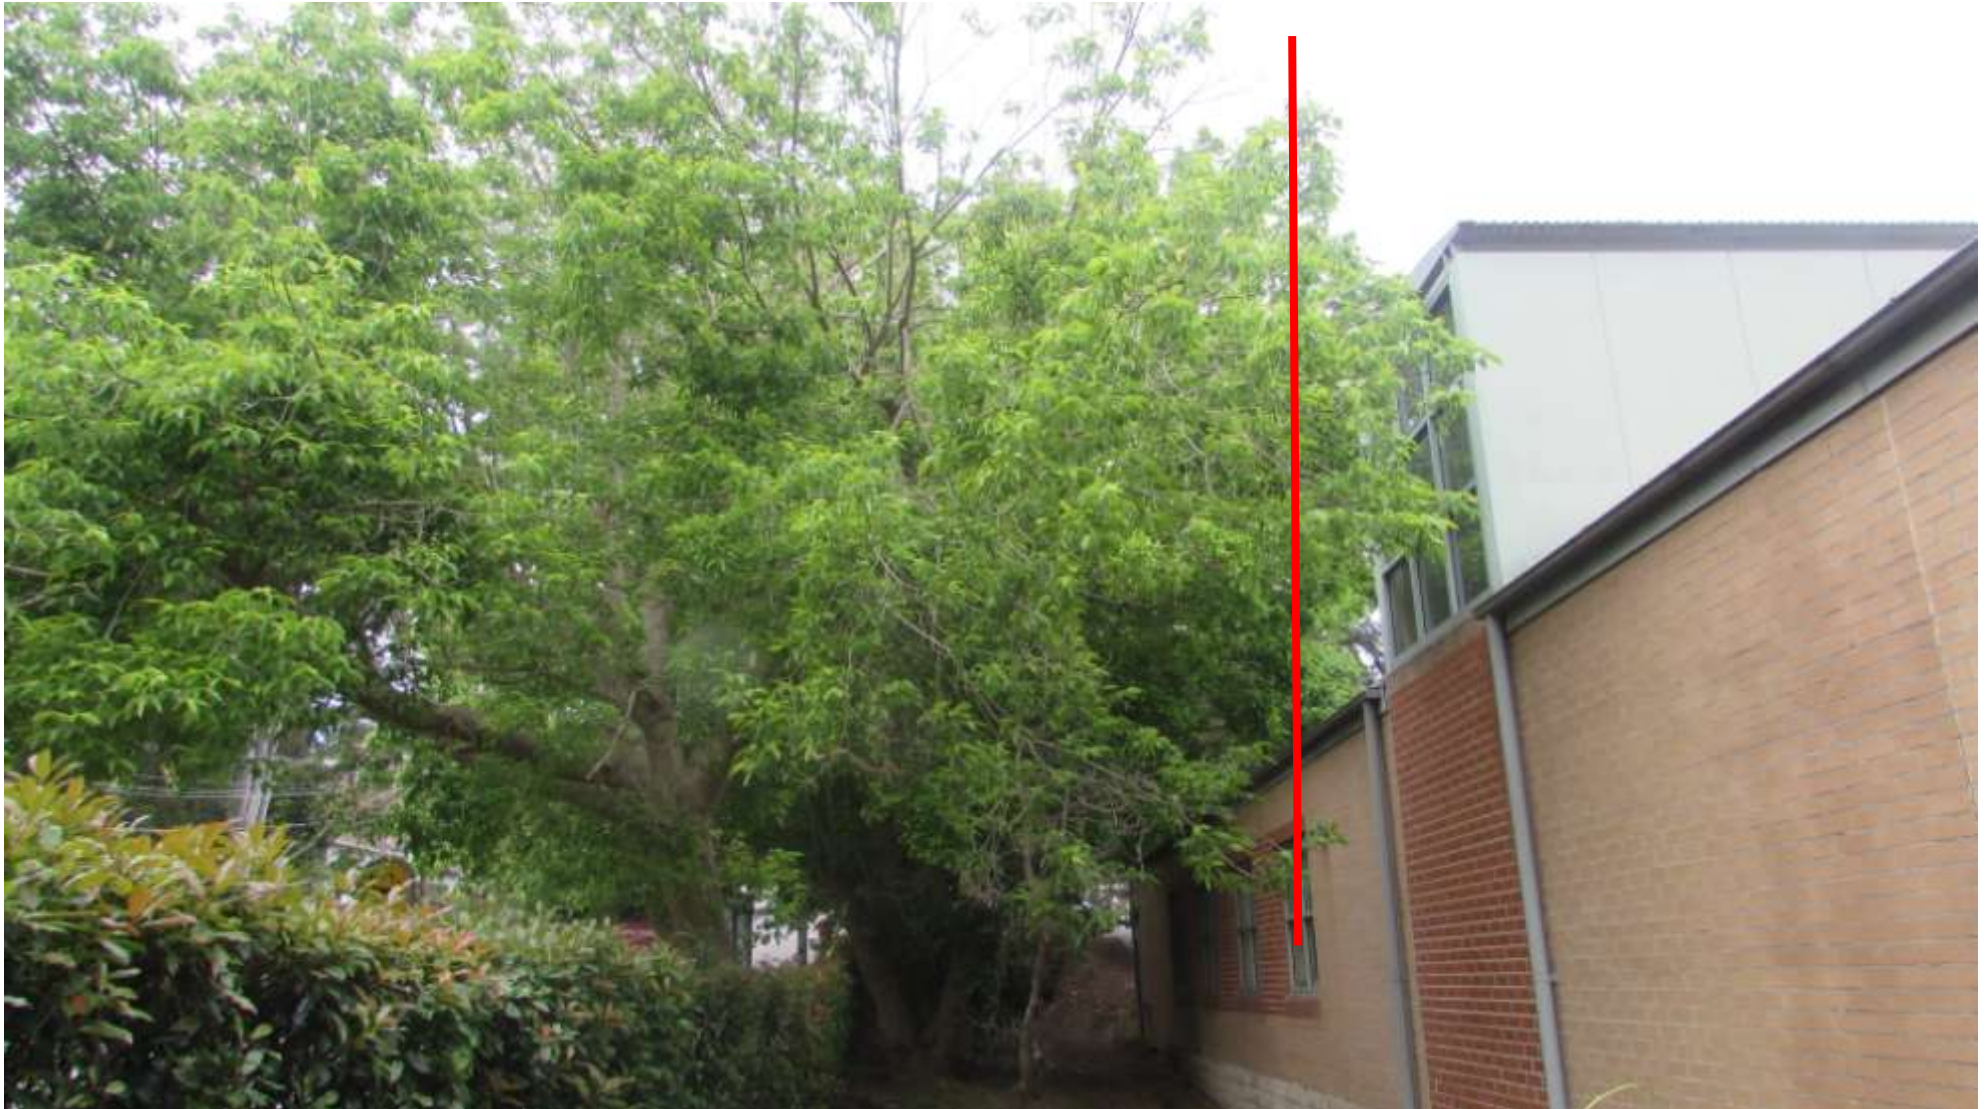
Tree 152
Acer negundo
Box Elder
Tree to be correctionally pruned
to red line

Tree #152 is a mature *Acer negundo* Box Elder, included within the previous tree impact assessment. The tree has branches which will conflict with the proposed building line and would require the following tree works:

All southern limbs and branches- Prune Braches back to building line where required

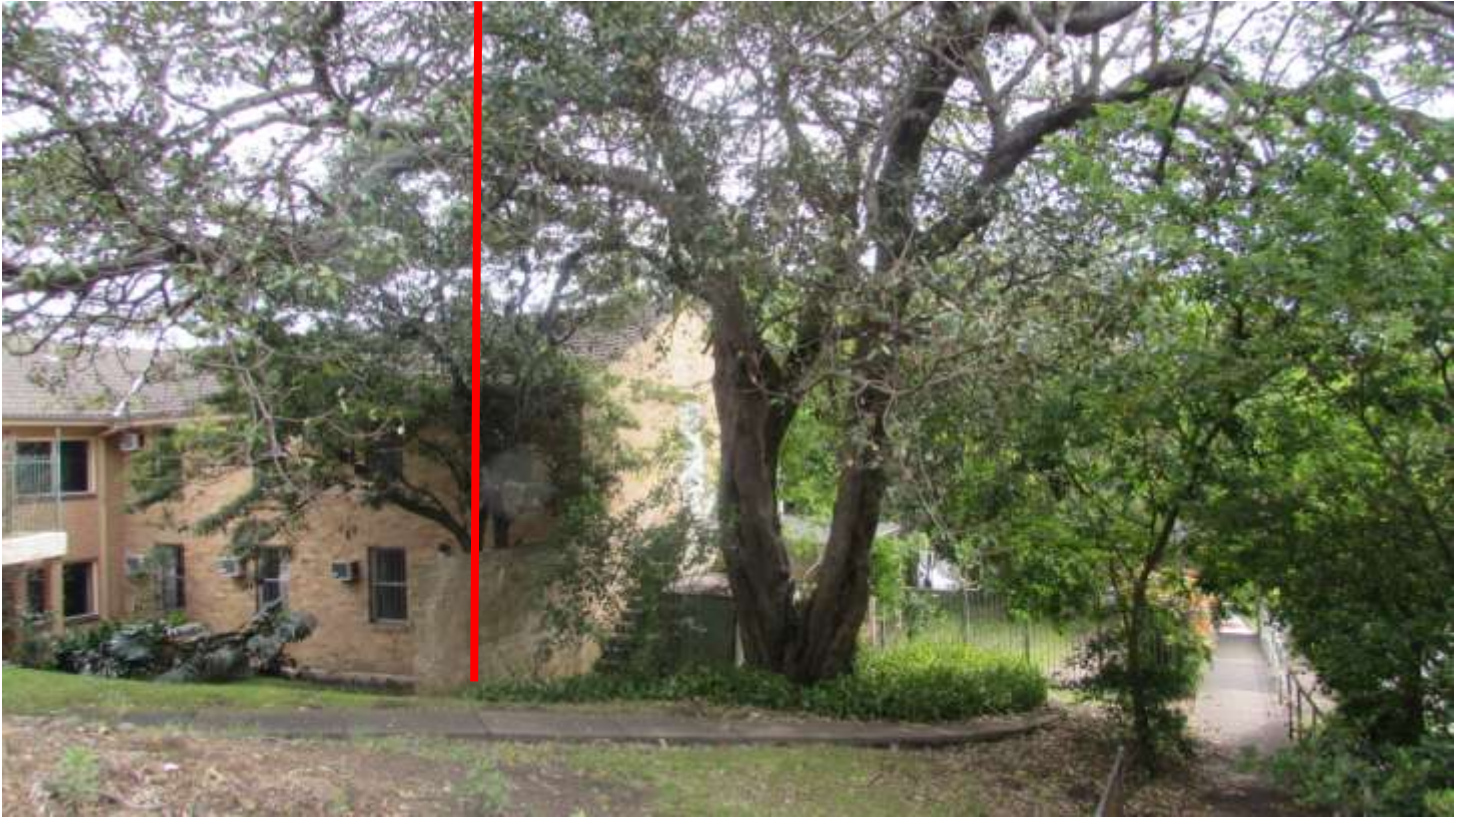
Tree 152
Acer negundo
Box Elder
Tree to be correctionally pruned
to red line

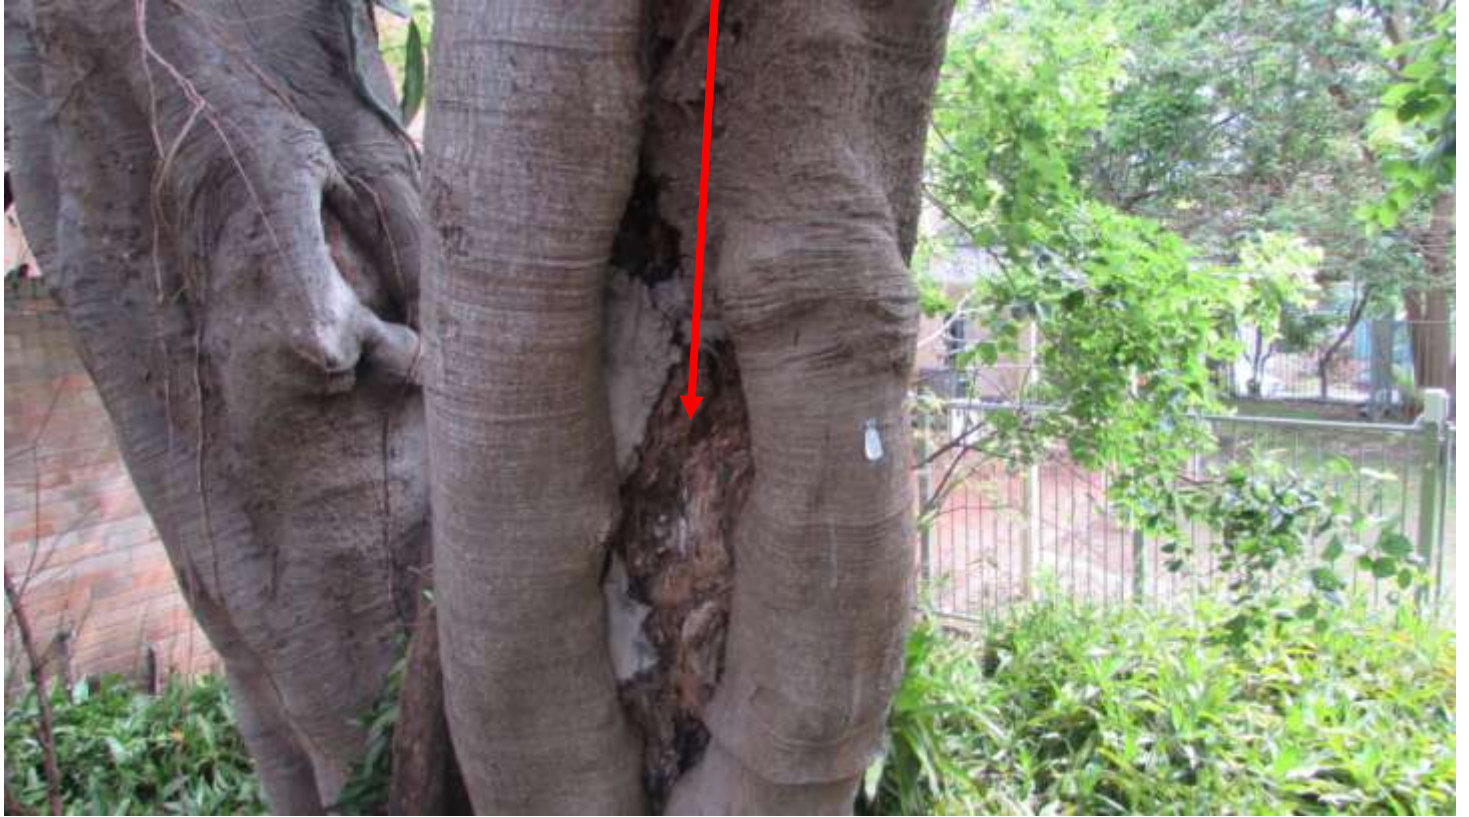
Tree 152
Acer negundo
Box Elder
Extensive decay structural issues
