Tree Impact Assessment Report and Tree Management Plan

**HammondCare
Greenwich Hospital
River Road,
Greenwich NSW**

Prepared by Mark Bury Consulting

27th September 2021

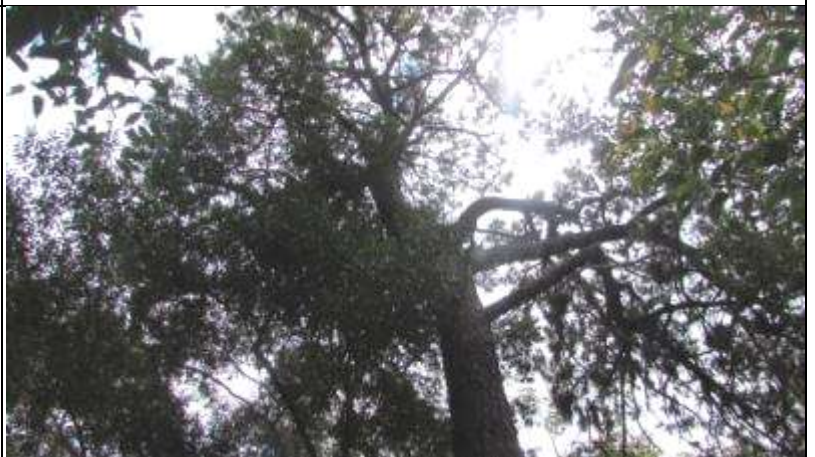
Tree 2
Pinus radiata
Monterey Pine

- 5.4 **Tree 2** (*Pinus radiata* Monterey Pine) is a tree in fair condition Appendix 1 gives a description of the tree as per AS-4970-2009 Section 2. Appendix 2 shows a photograph of the tree; Appendix 4 indicates the location of the tree on a survey plan of the site.
