REPORT TO HEALTH INFRASTRUCTURE C/-CBRE

ON PRELIMINARY SITE INVESTIGATION (PSI)

FOR PROPOSED NEPEAN HOSPITAL STAGE 2 DEVELOPMENT

AT NEPEAN HOSPITAL, DERBY STREET, KINGSWOOD, NSW

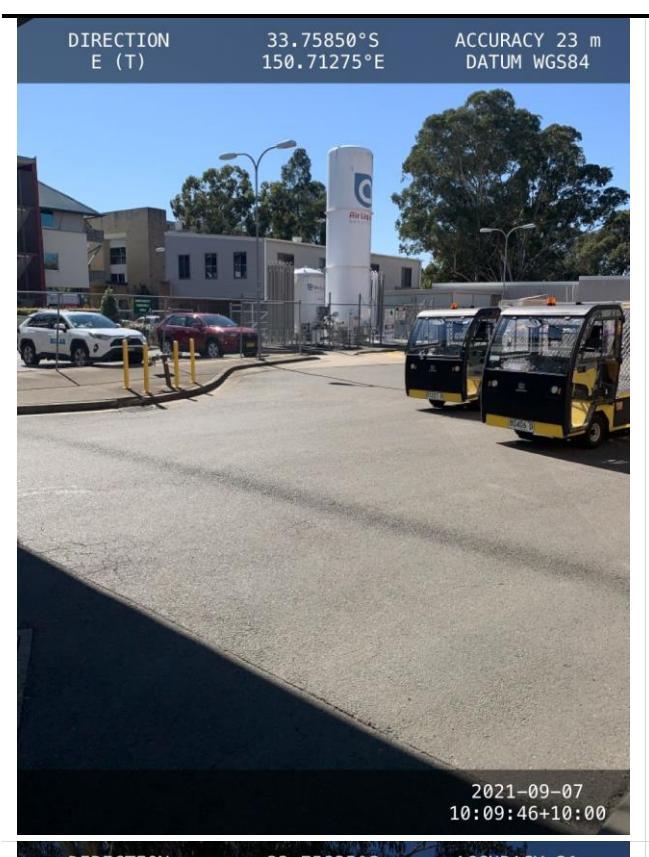
Photograph 1: Taken showing the central portion of the site, facing east.

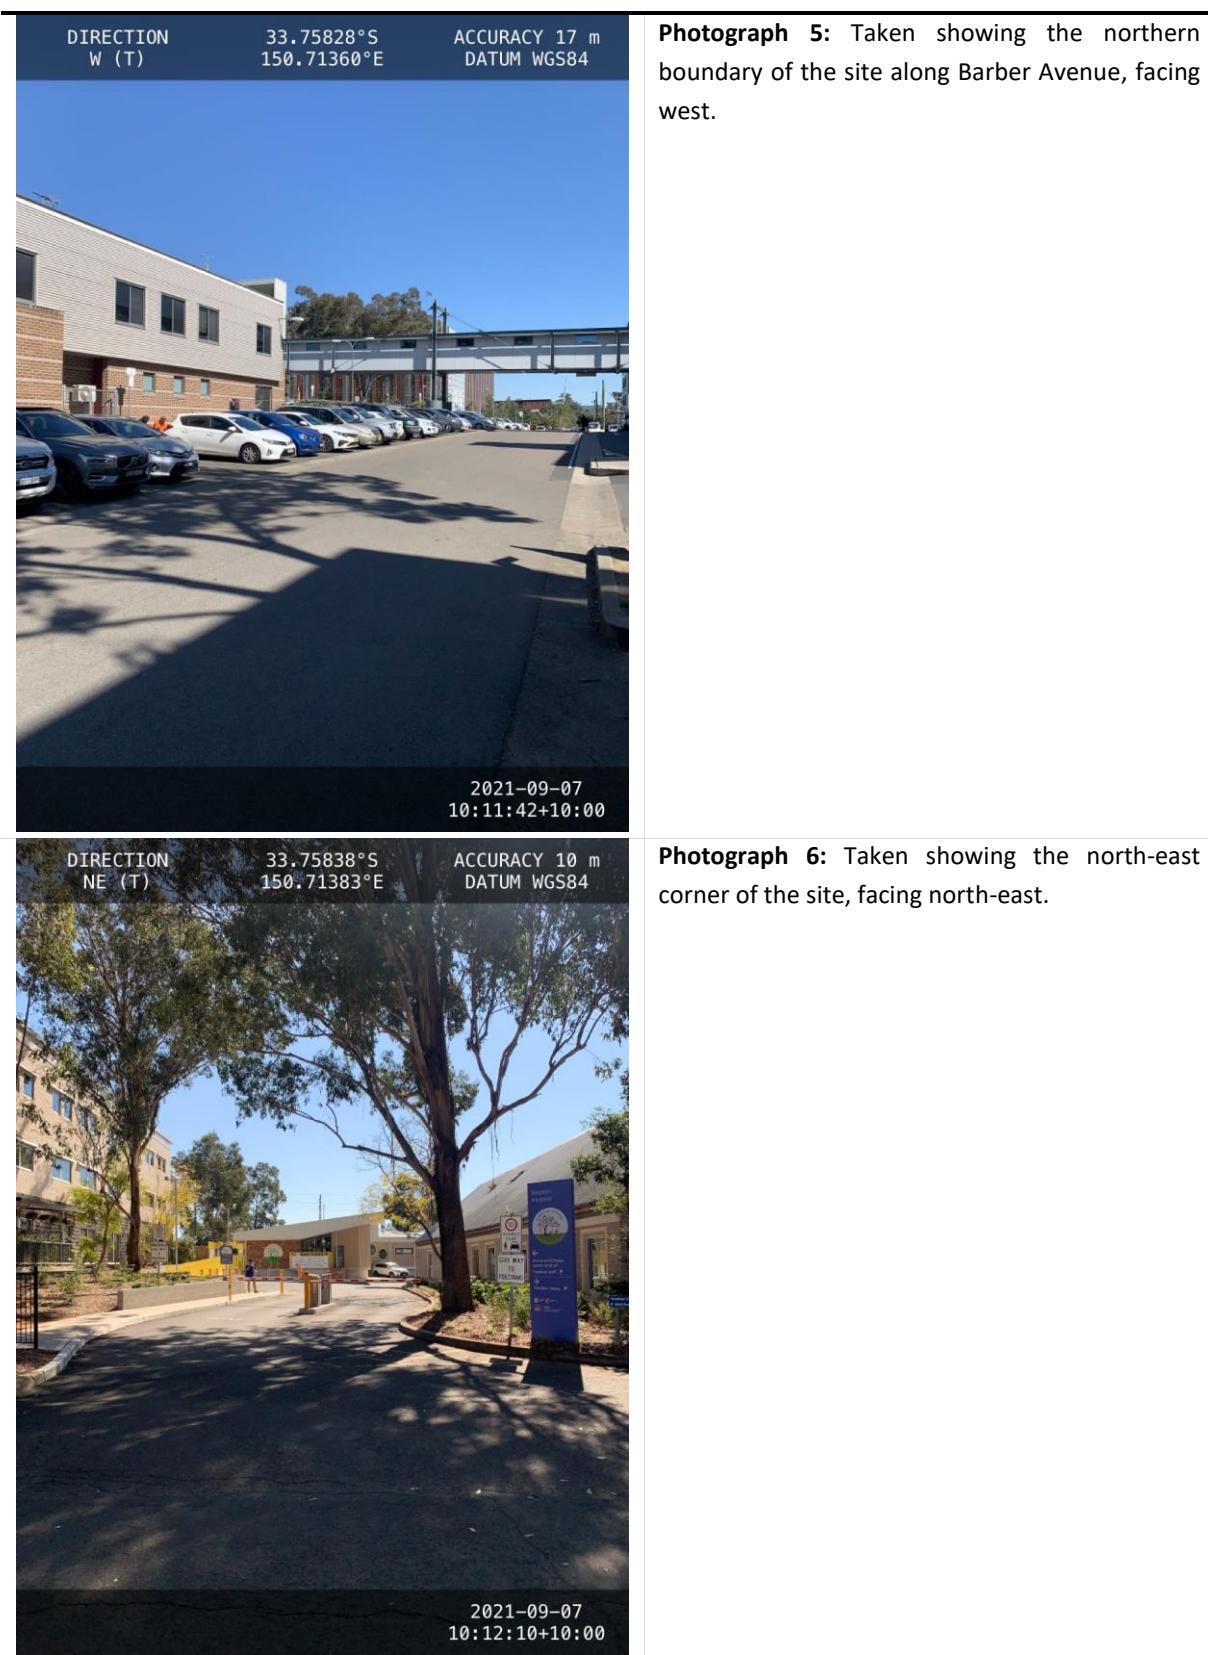
Photograph 5: Taken showing the northern boundary of the site along Barber Avenue, facing
