CIVICA

3 November 2021

Arboricultural Impact Assessment Report regarding twenty-three (23) trees located within the vicinity of the proposed development at St Aloysius College, 48 Victoria Road, Rozelle

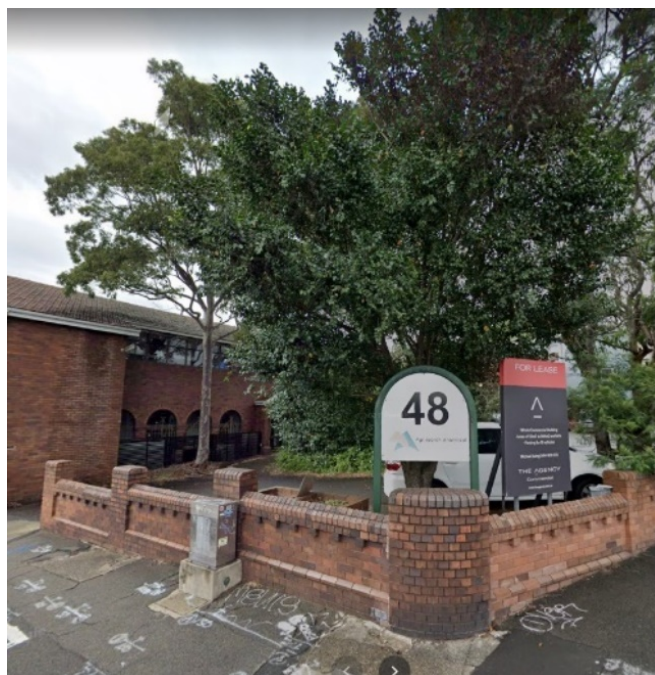
6.3.8 The structural condition of the tree was rated as good as a result of its overall defect free crown form. Co-dominance, the nature of several crossing limbs and damage to infrastructure were noted.

6.3.9 Due to the current age, health and structural condition of the tree it was allocated a useful life expectancy (ULE) of 15–25 years (estimated), during which time its physical size was not expected to increase significantly. The tree was subsequently (despite its position in a landscape and good condition) allocated a Low retention value.

Figure 5. View to north of Tree 11 *Glochidion ferdinandi* (Cheese Tree) in its growing environment. (Street view, June 2021).

6.3.10 Tree 11 will require specific protection measures during the construction (see section 7.3 for guidance).

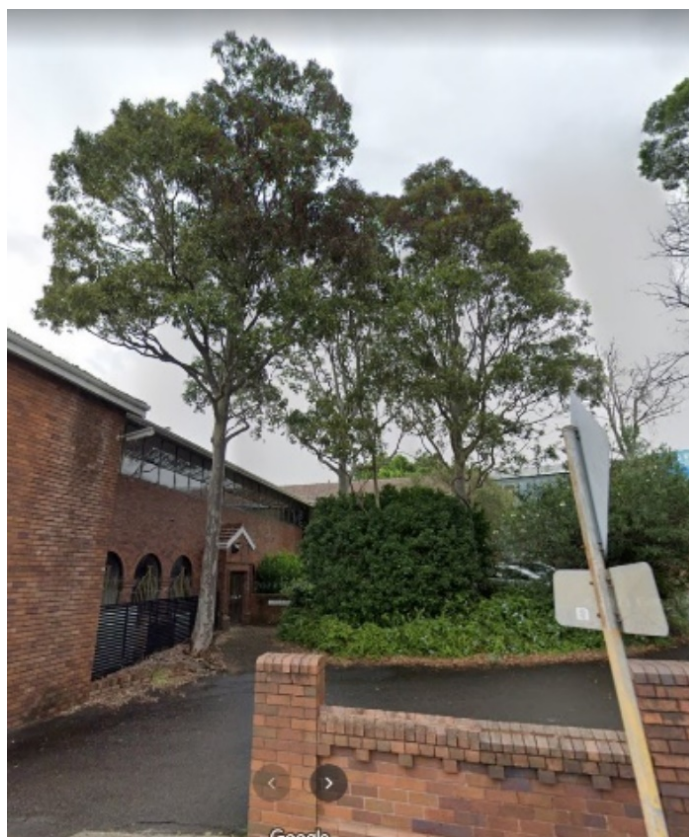
6.3.11 Tree 12

- 6.3.12 Tree 12 was identified as mature example of *Corymbia maculata* (Spotted Gum). This tree is a stand-alone specimen growing in the border garden adjacent to the east facing facade of the main building. Tree 12 displayed medium to large dimensions for this species in an urban setting and had a noticeable presence within the surrounding landscape. It was deemed to provide important visual amenity outside of the immediate landscape (see Figure 6).
- 6.3.13 The health of Tree 12 was considered good with evidence of now tip growth and good crown foliage cover.
- 6.3.14 Due to the current age, health and structural condition of Tree 12 it was allocated a ULE of 25–50 years (estimated) and a High retention value.
- 6.3.15 The roots of this tree were noted to have damaged the kerbing and adjacent brick paving.

Figure 6. View to north of Tree 12 *Corymbia maculata* (Spotted Gum) in its growing environment. (Street view June 2021).

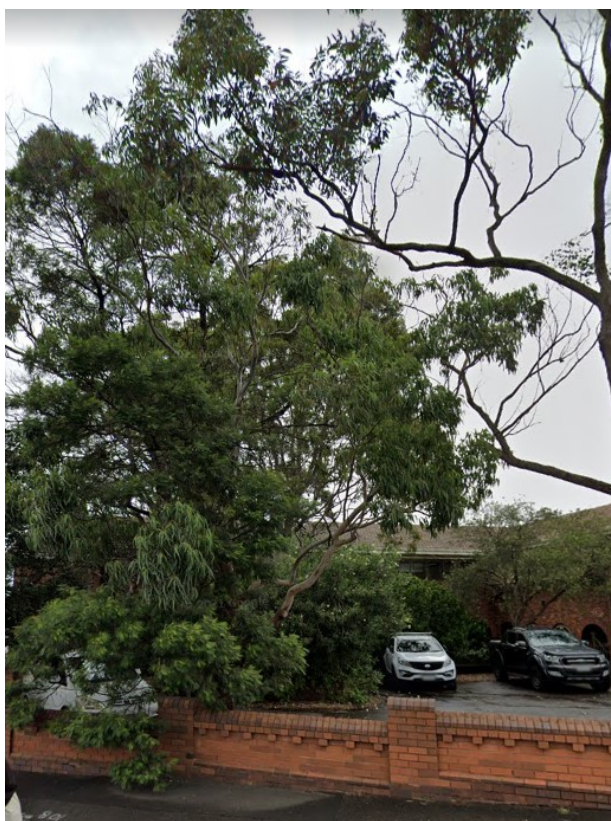
6.3.16 Trees 14, 15 and 16

- 6.3.18 The health of the trees was considered good with evidence of new tip growth and good crown foliage cover.
- 6.3.19 Due to the current age, health and structural condition of Tree 14 and 16 they are allocated a ULE of 25–50 years (estimated). These two (2) trees have been allocated a High retention value. Tree 15 being a juvenile suppressed specimen has been allocated a ULE of 15–25 years (estimated). Tree 15 has been allocated a Low retention value.

Figure 7. View to west of Tree 14, 15 and 16 *Corymbia maculata* (Spotted Gum) in their growing environment. (Street view, June 2021).

- 6.3.20 These trees will require specific protection measures as the surrounding surfacing will be disturbed and upgraded. For the viable retention of these trees care must be taken to retain any structural roots. Excavation of the site is to be under arborist supervision. Grade changes and excavation causing root severance must be avoided to ensure the structural integrity of these trees (see section 7.3 for guidance).

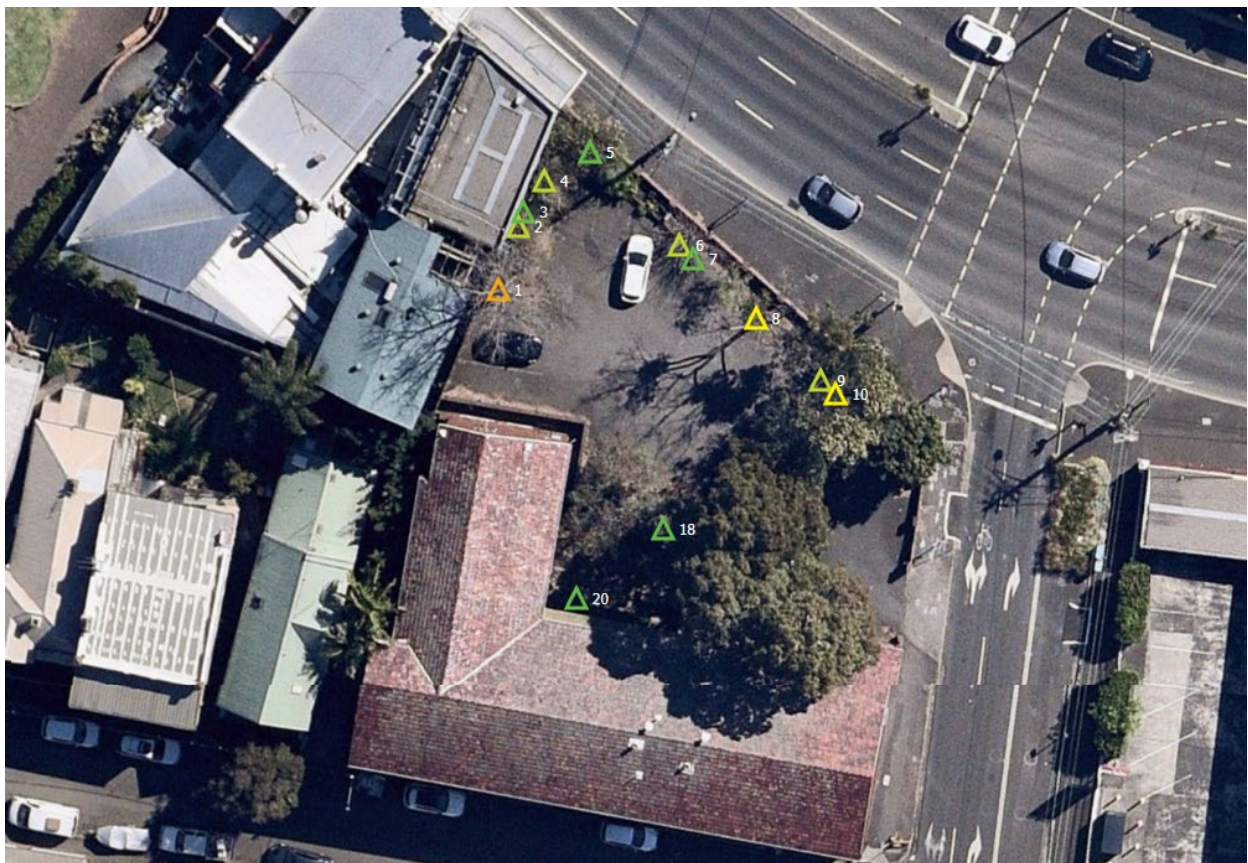
Figure 8. Site map showing tree requiring removal. (ArborPlan, June 2021).

7.1.1 Twelve (12) trees would require removal as follows, based on the supplied design proposal. These trees would require removal to allow the proposed development:

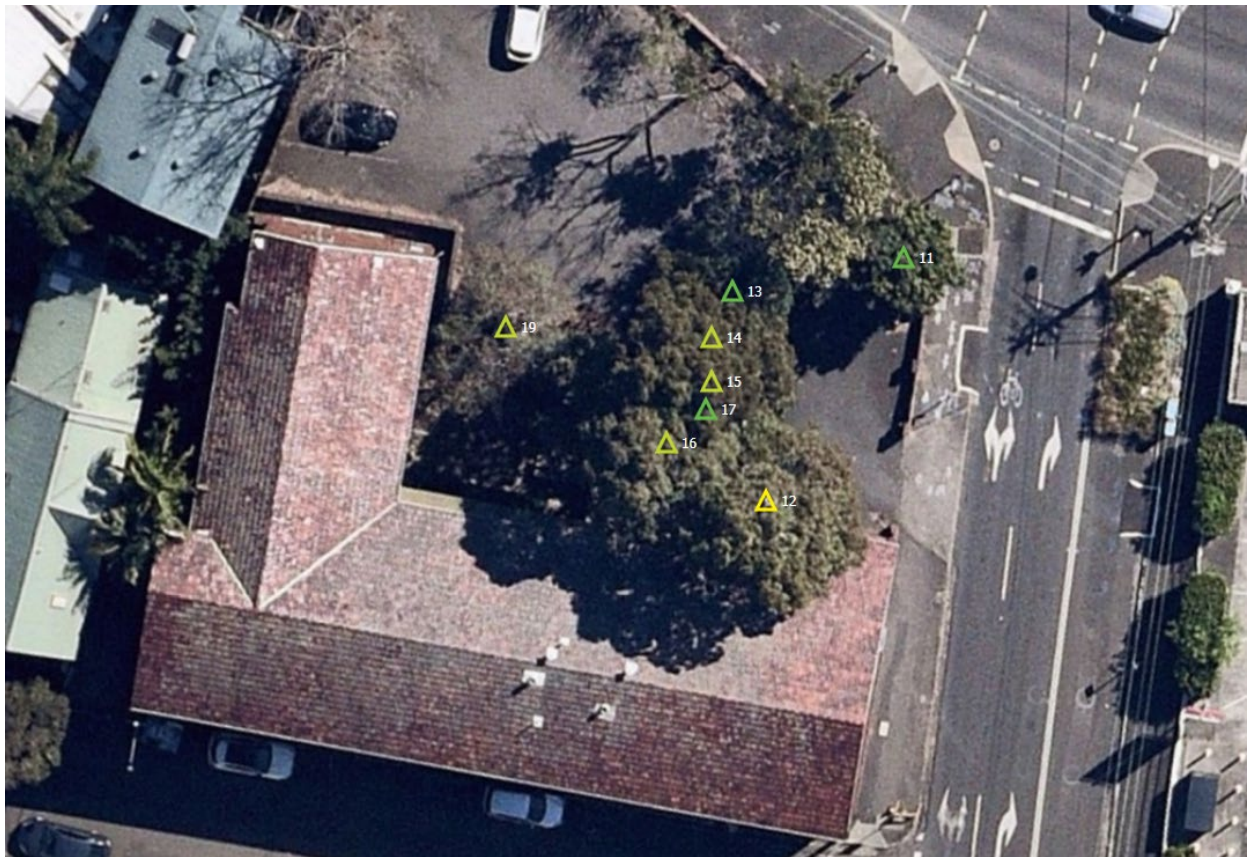
Figure 9. Site map showing tree requiring specific protection measures. (ArborPlan, June 2021).

7.3.2 Excavation is to be carried out only under arborist supervision. No excavation should occur within the SRZ of this tree. It was recommended that the proposed excavation commence at the outer extent of the TPZ and move inwards to minimise root damage to the trees.

7.3.6 Other proposed surfacing within the TPZ is to be installed above the existing grade and be of a permeable nature to allow the passage of air and moisture. If the surfacing is to be load bearing, then it is suggested that a geogrid/web or similar is incorporated to ensure the rooting area below does not become compacted.
