HAZARDOUS MATERIALS REGISTER

Barker College – 91 Pacific Highway

Project No. 21401 [Rev 1.]

Date: 10/09/20

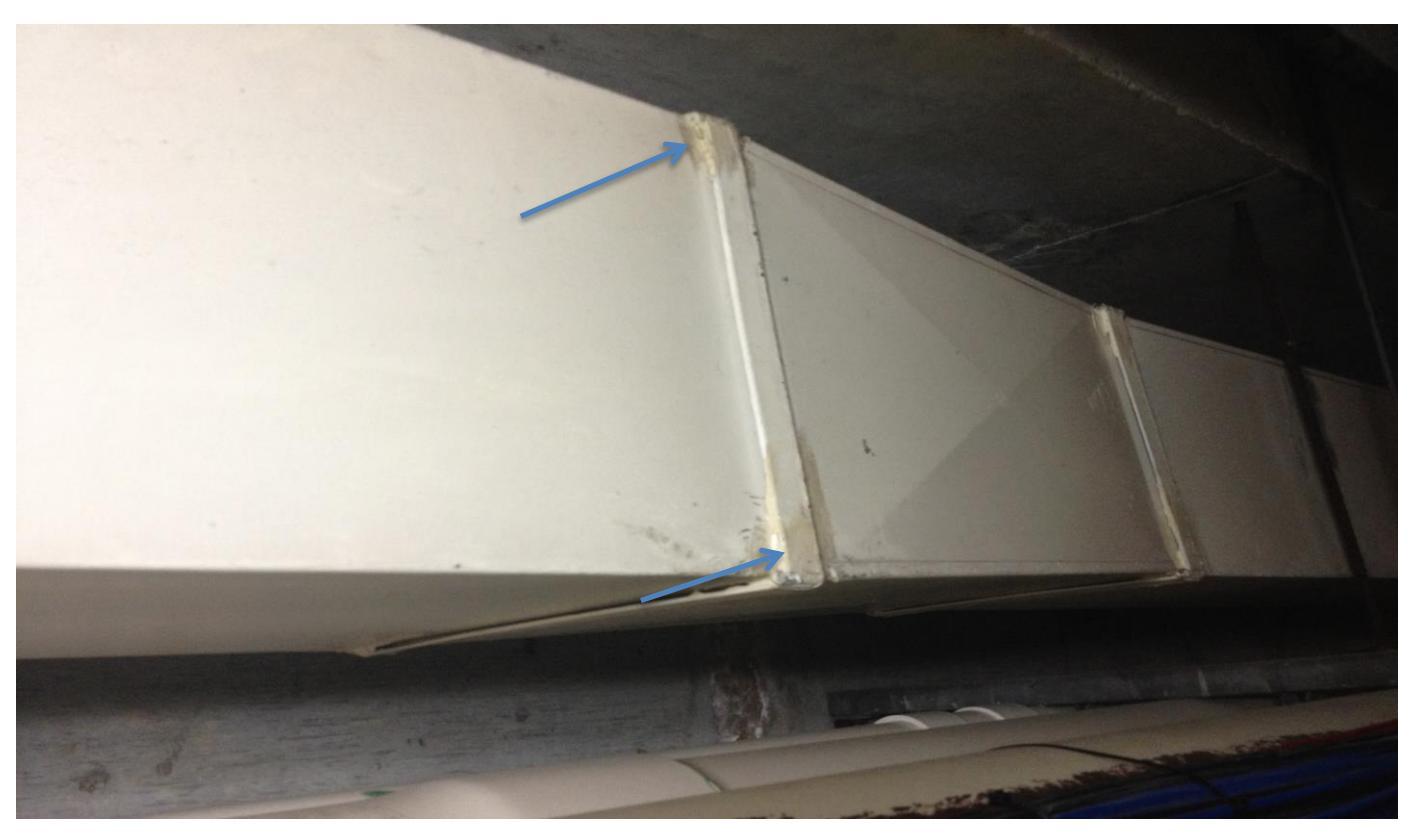
**Photo 1:** Mastic containing asbestos on the joins on the white air conditioning duct work in the cavity in the sub-floor of the Aquatic Centre.

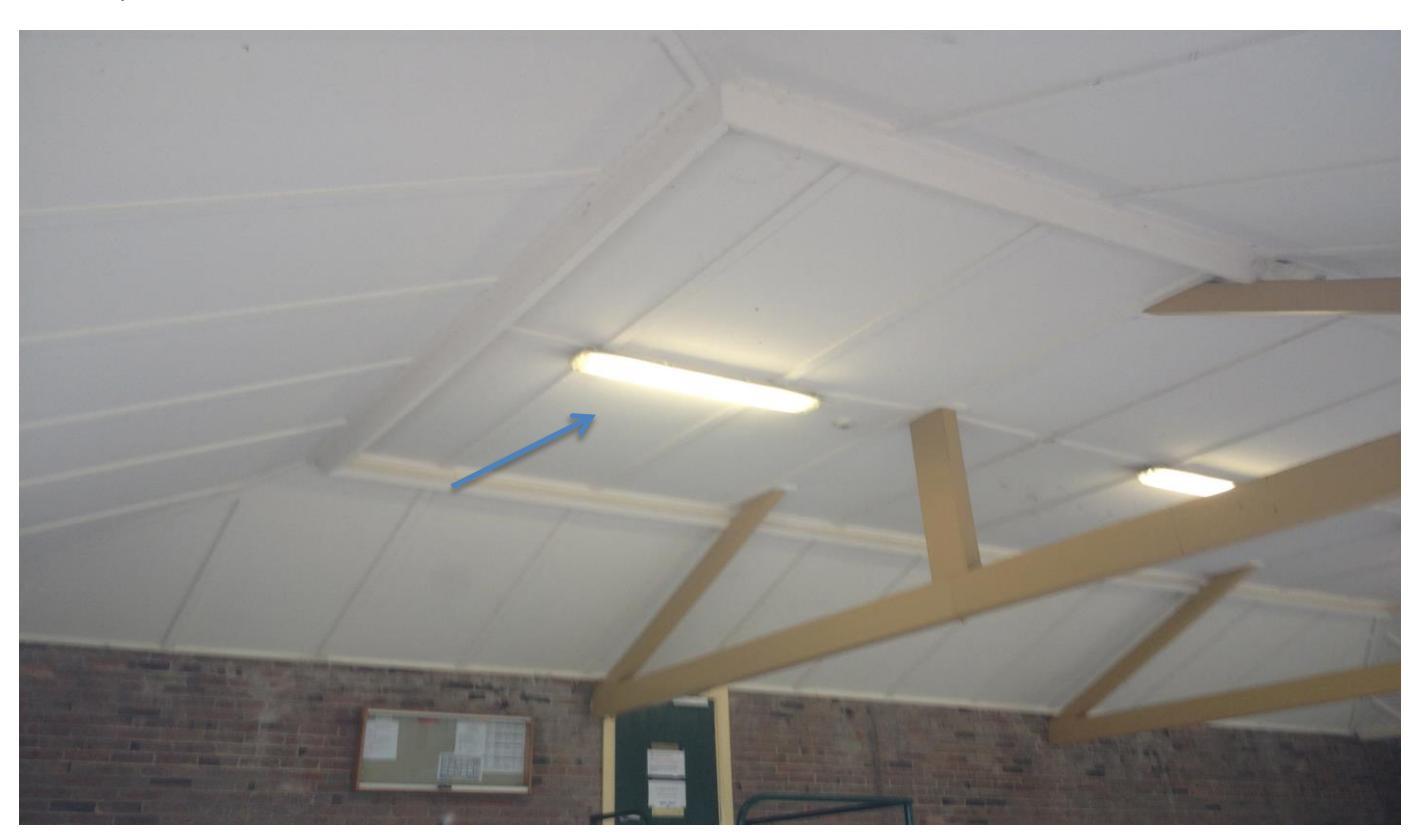
Photo 2: Asbestos cement sheeting on the ceiling lining of the Cadets Office/Grandstand.

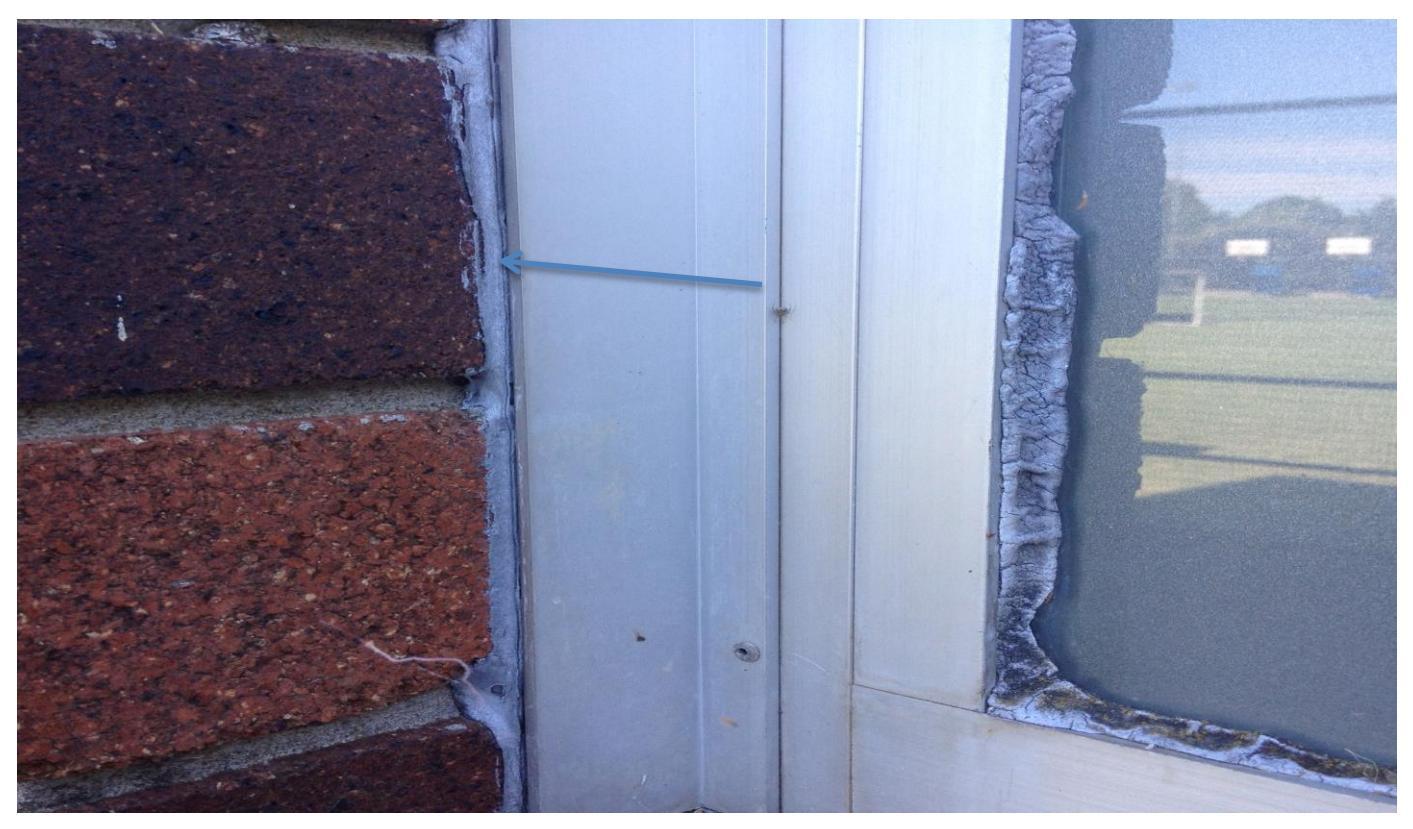
**Photo 3:** Mastic containing asbestos on in between the window frames and the brickwork on the southern perimeter of Level 1, Level2 and Level 3 of C Block.

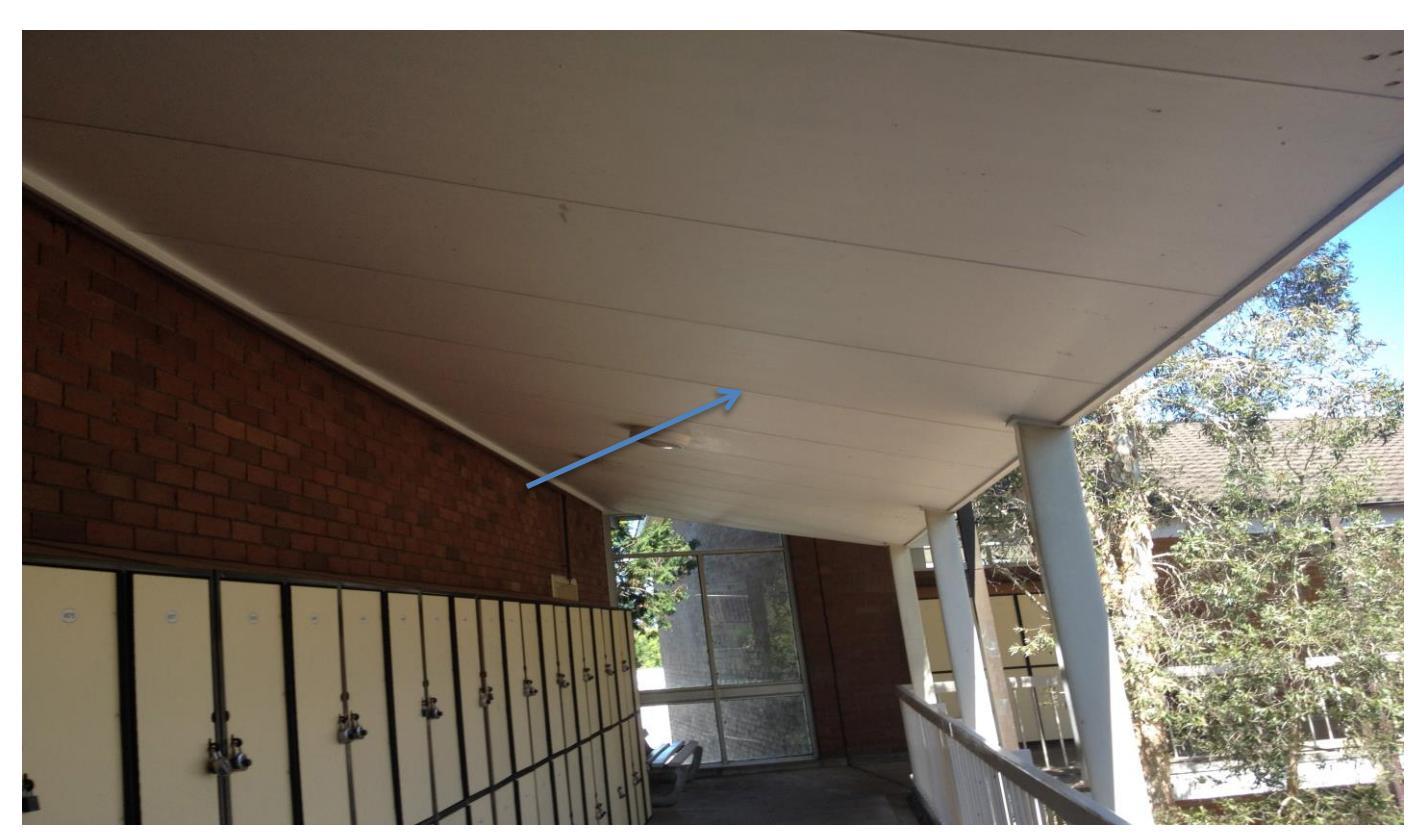
Photo 4: Asbestos cement sheeting on the awning lining on the western perimeter of level 2 of C Block.

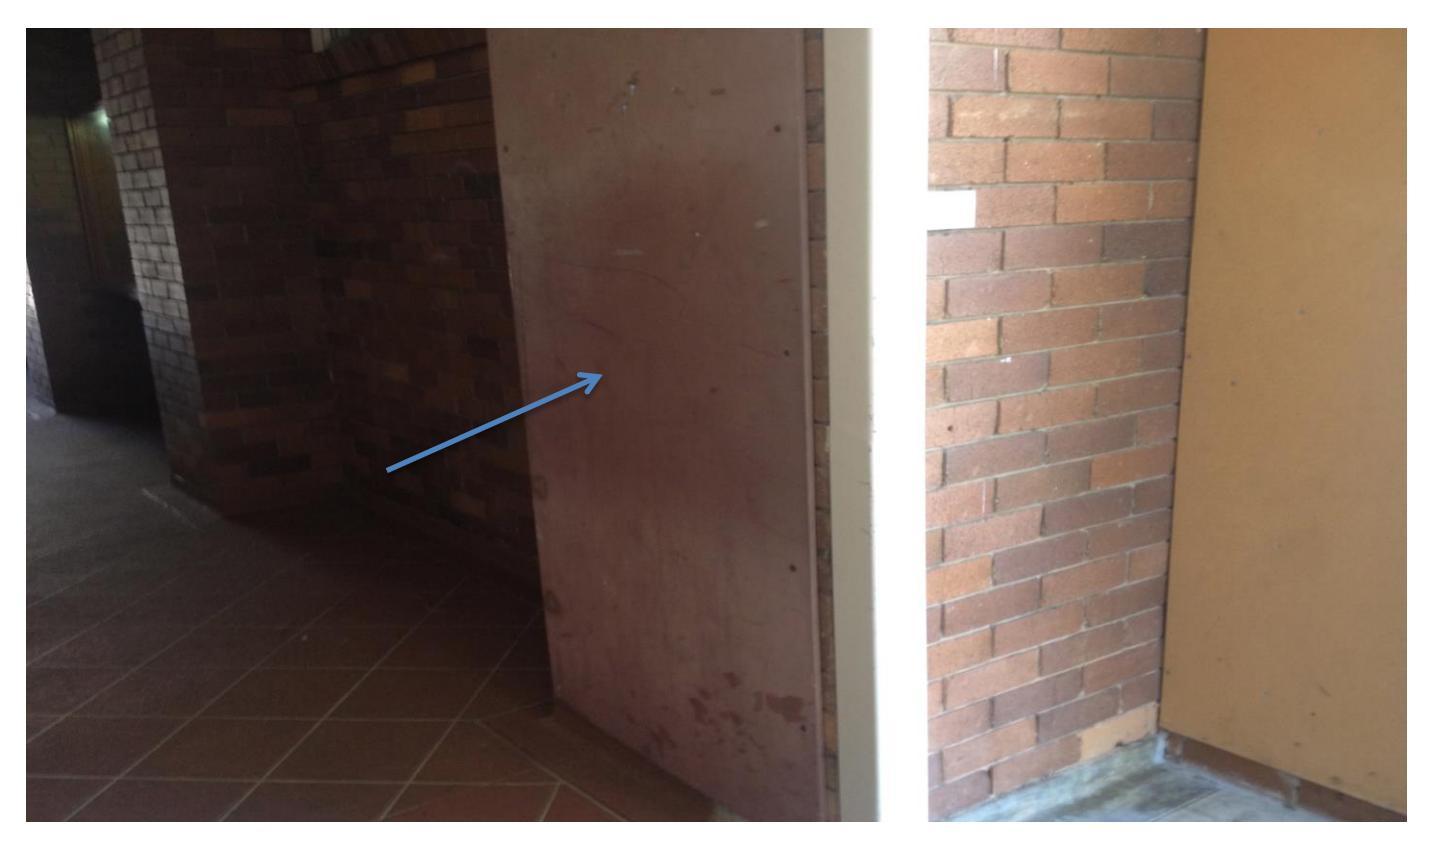
**Photo 5:** Asbestos cement sheet riser cover panels on the western end of the northern perimeter of Level 2 and Level 3 of C Block.

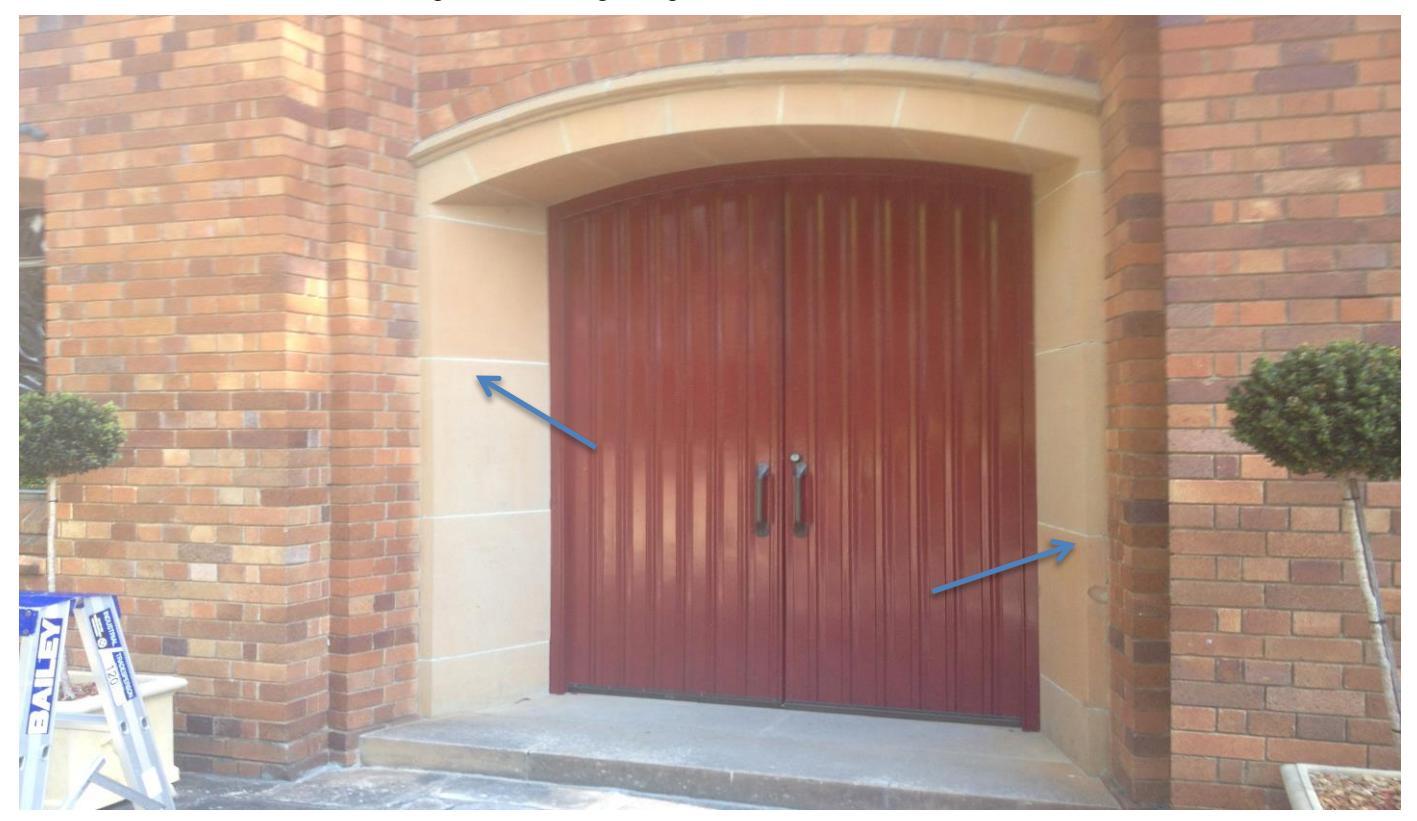
Photo 8: Caulking containing asbestos within the sandstone brickwork of the Main Entrance doorway to the Chapel.

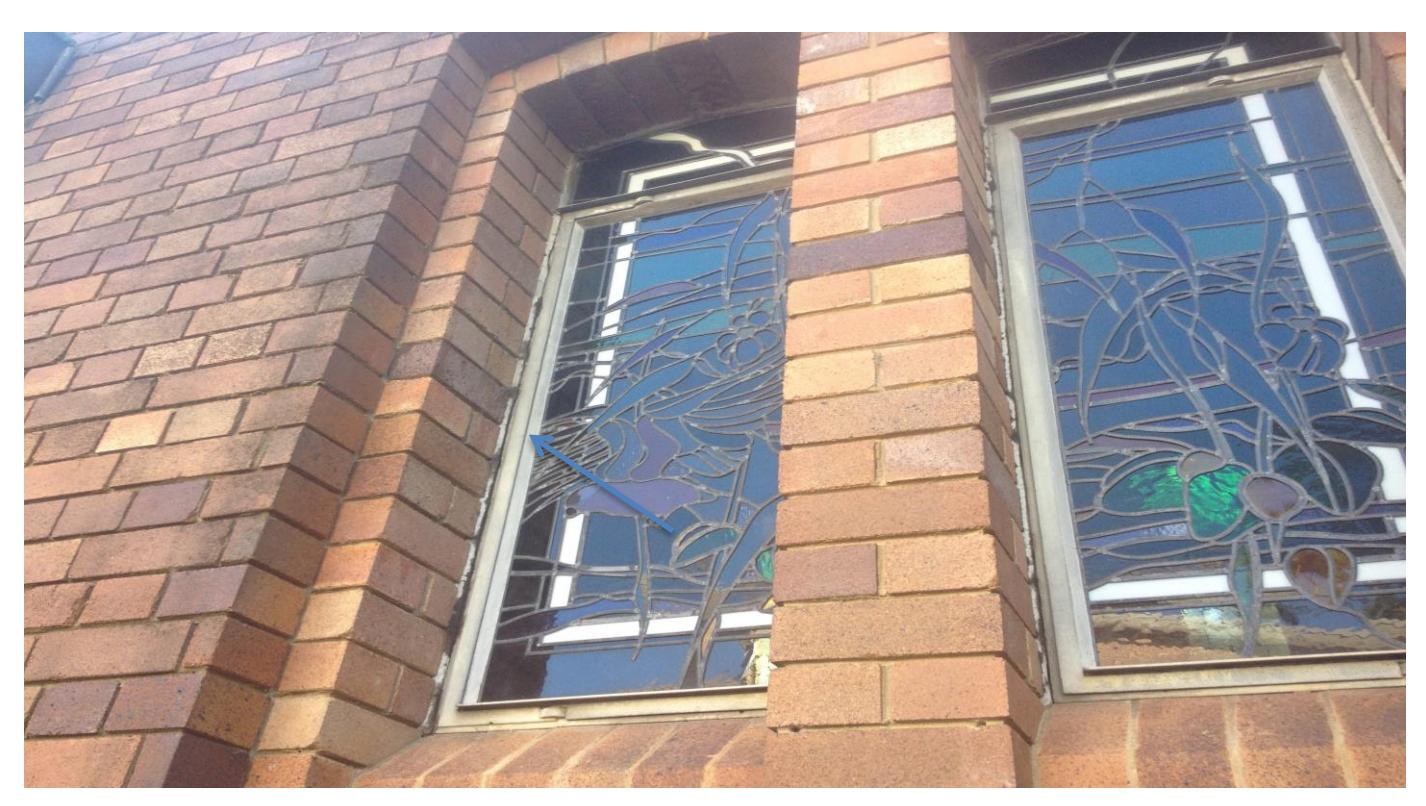
Photo 9: Mastic containing asbestos in-between the window frames and brickwork of the Chapel.

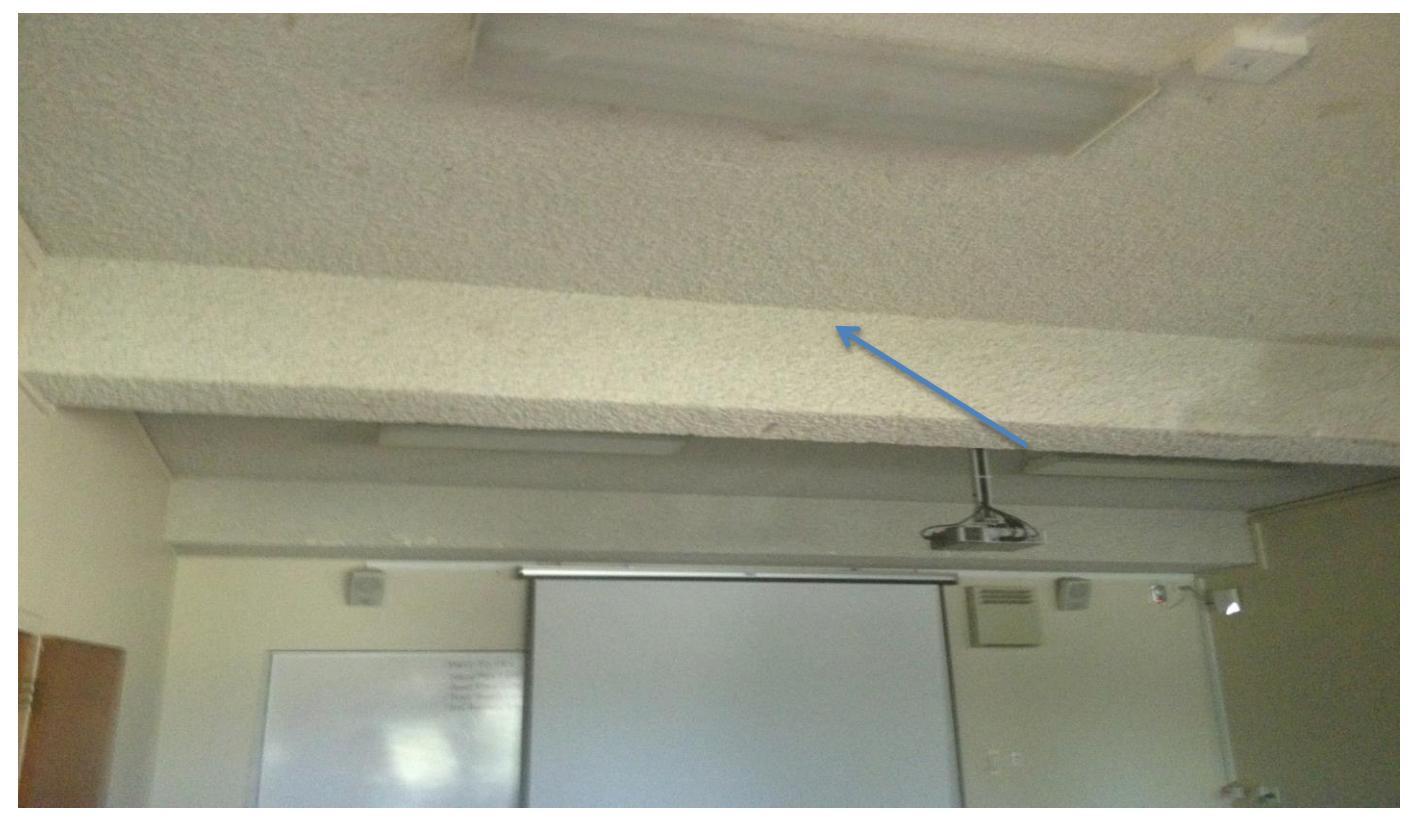
Photo 10: Vermiculite containing on the ceiling lining of the Classroom on the Lower Level of the Chapel.

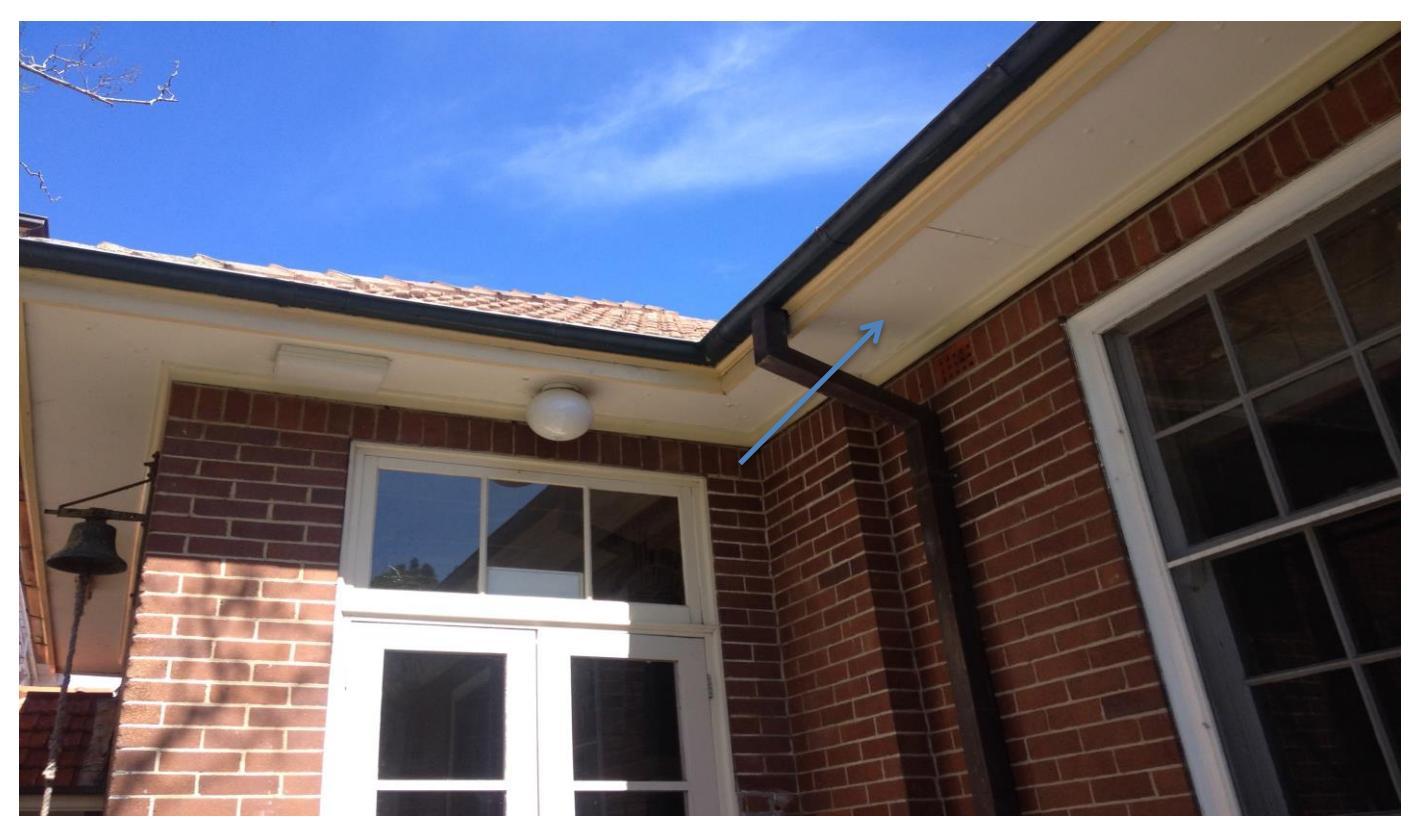
Photo 11.Asbestos cement sheeting on the external eave linings of the Dining Room/Kitchen.

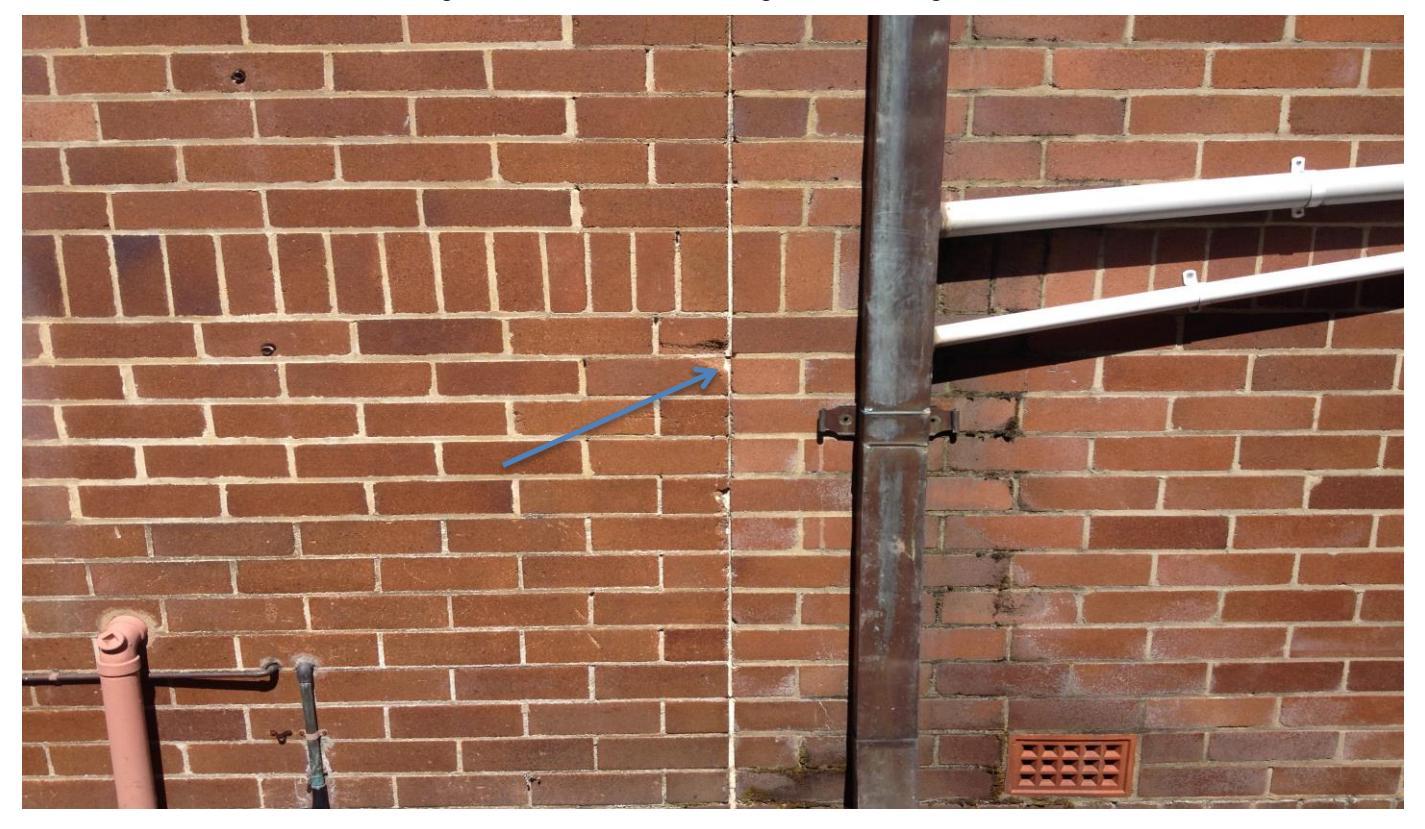
**Photo 12:** Mastic containing asbestos in the expansion joints on the northern external wall of the Dining Room/Kitchen.

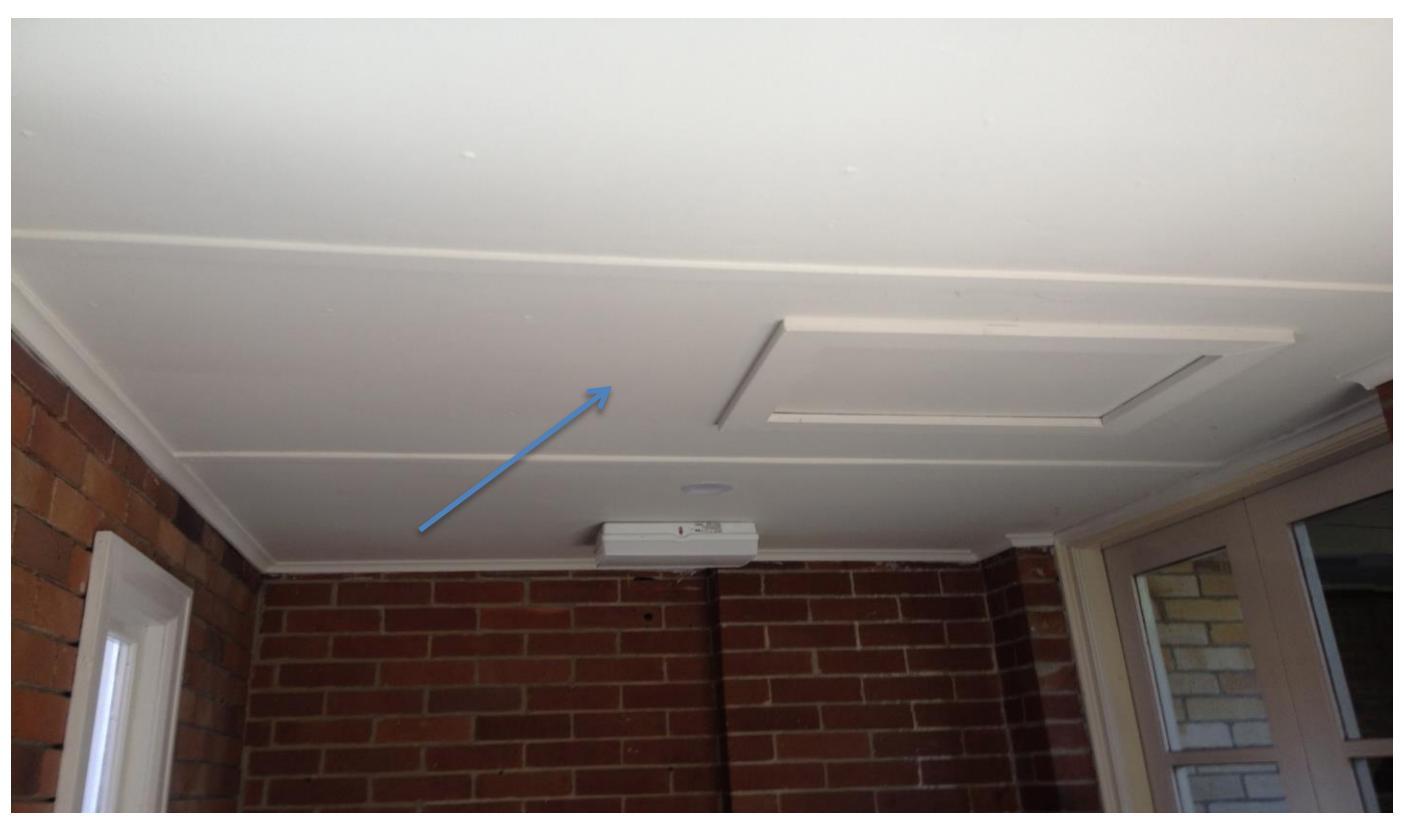
Photo 13: Asbestos cement sheeting on the ceiling lining of the eastern external entrance to Dining Room/Kitchen.

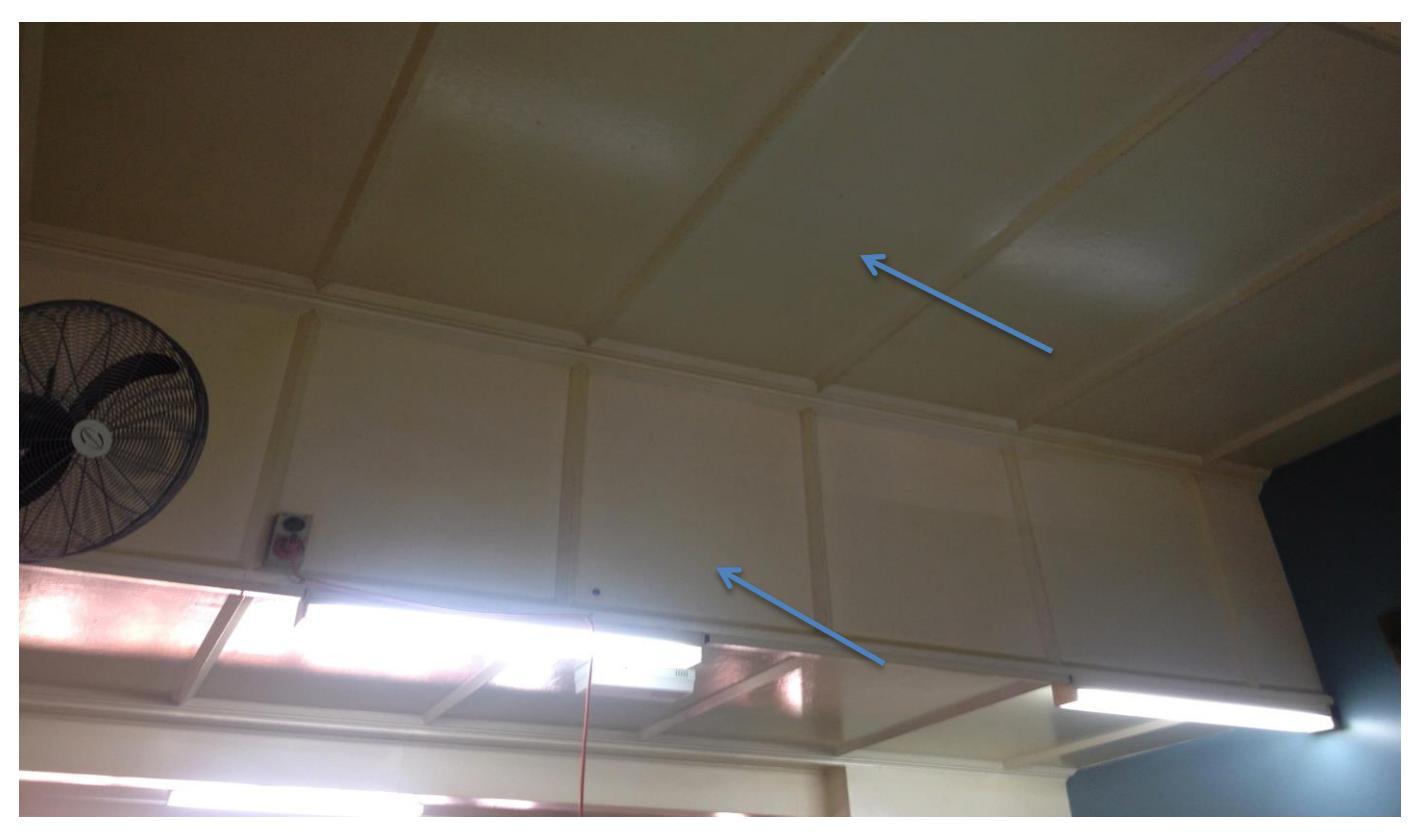
Photo 15: Asbestos cement sheeting on the ceiling lining of the Kitchen within the Dining Room/Kitchen.

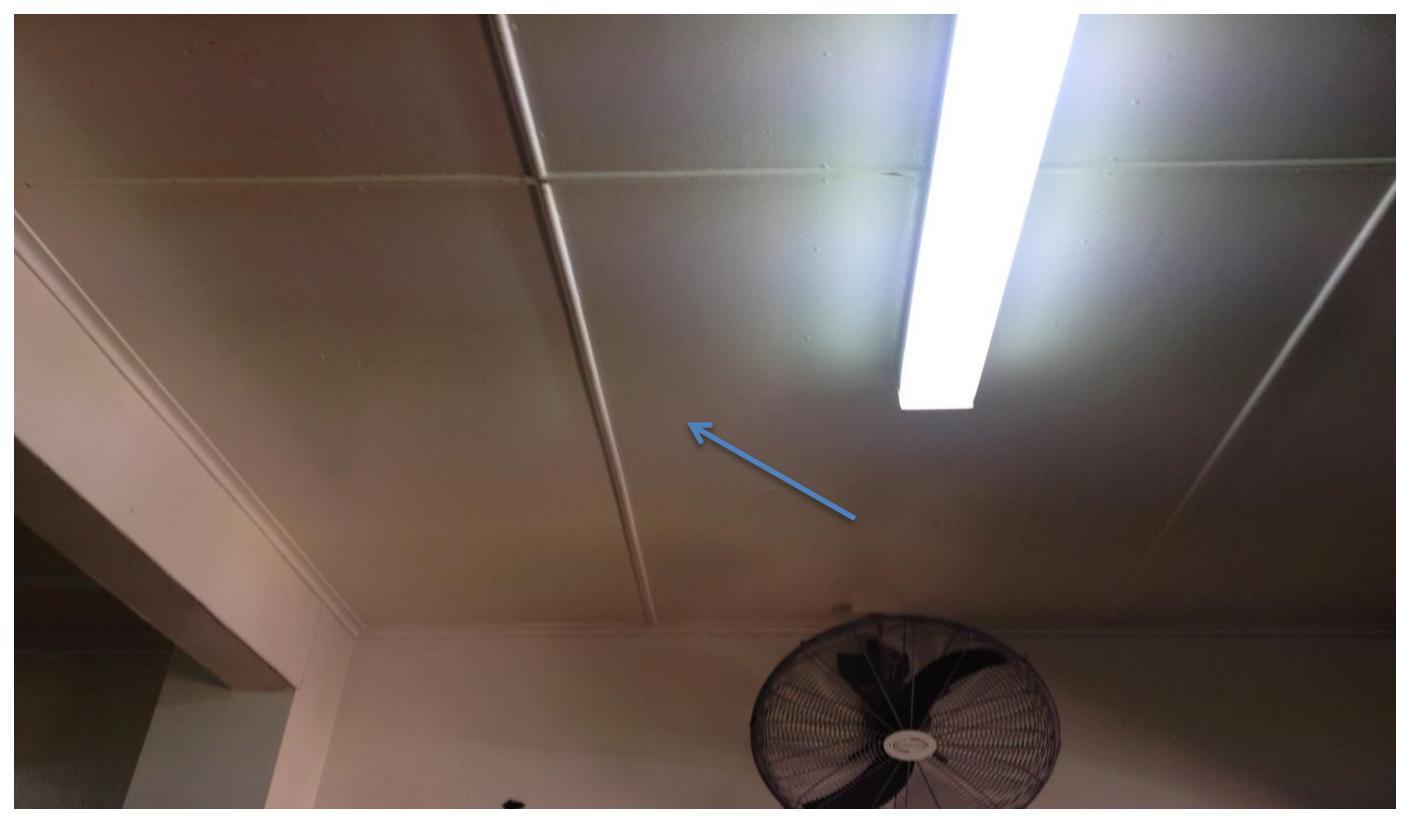
Photo 16: Asbestos cement sheeting on the ceiling lining of the Office within the Dining Room/Kitchen.

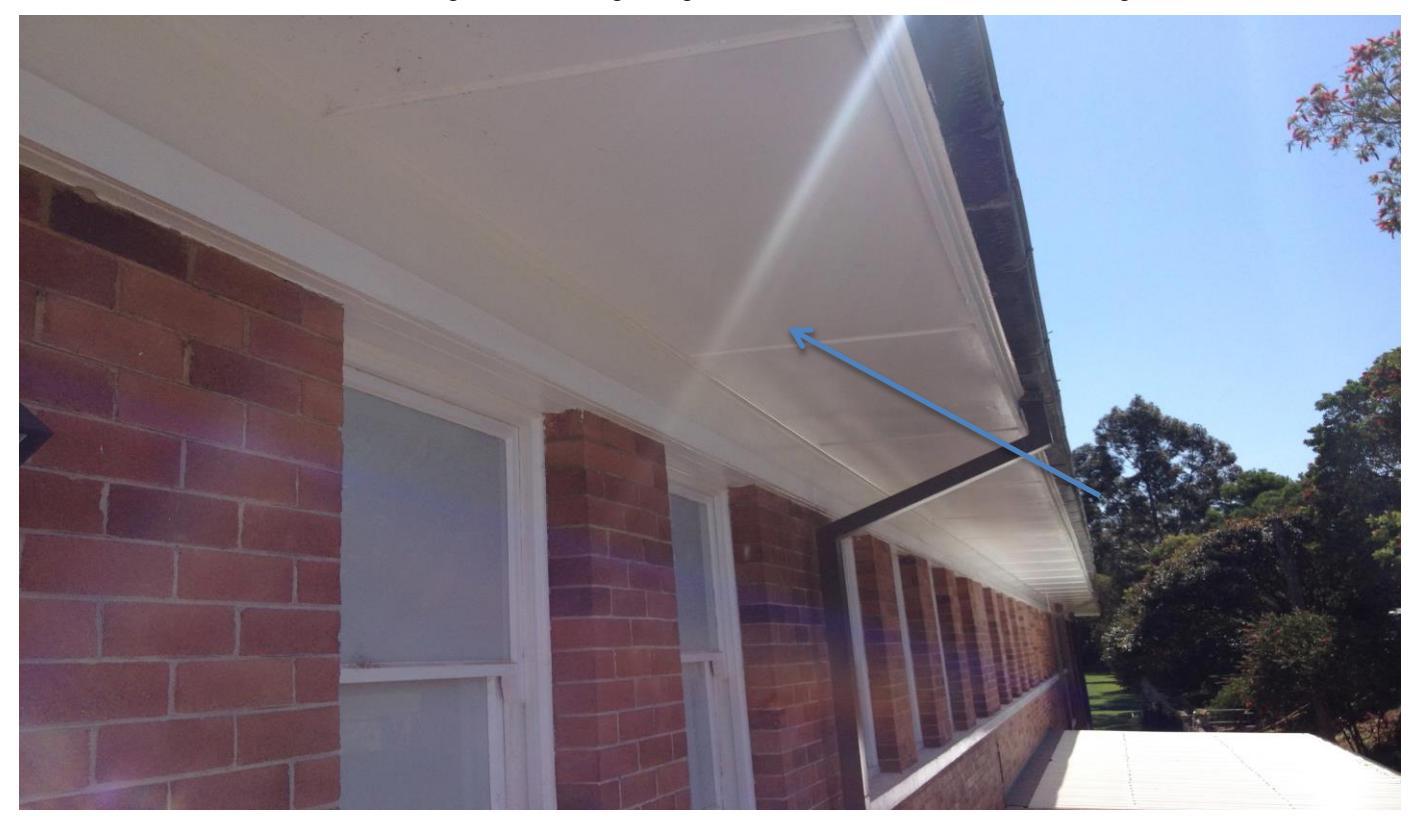
Photo 18: Asbestos cement on the eave linings of Junior School – Original Wing.

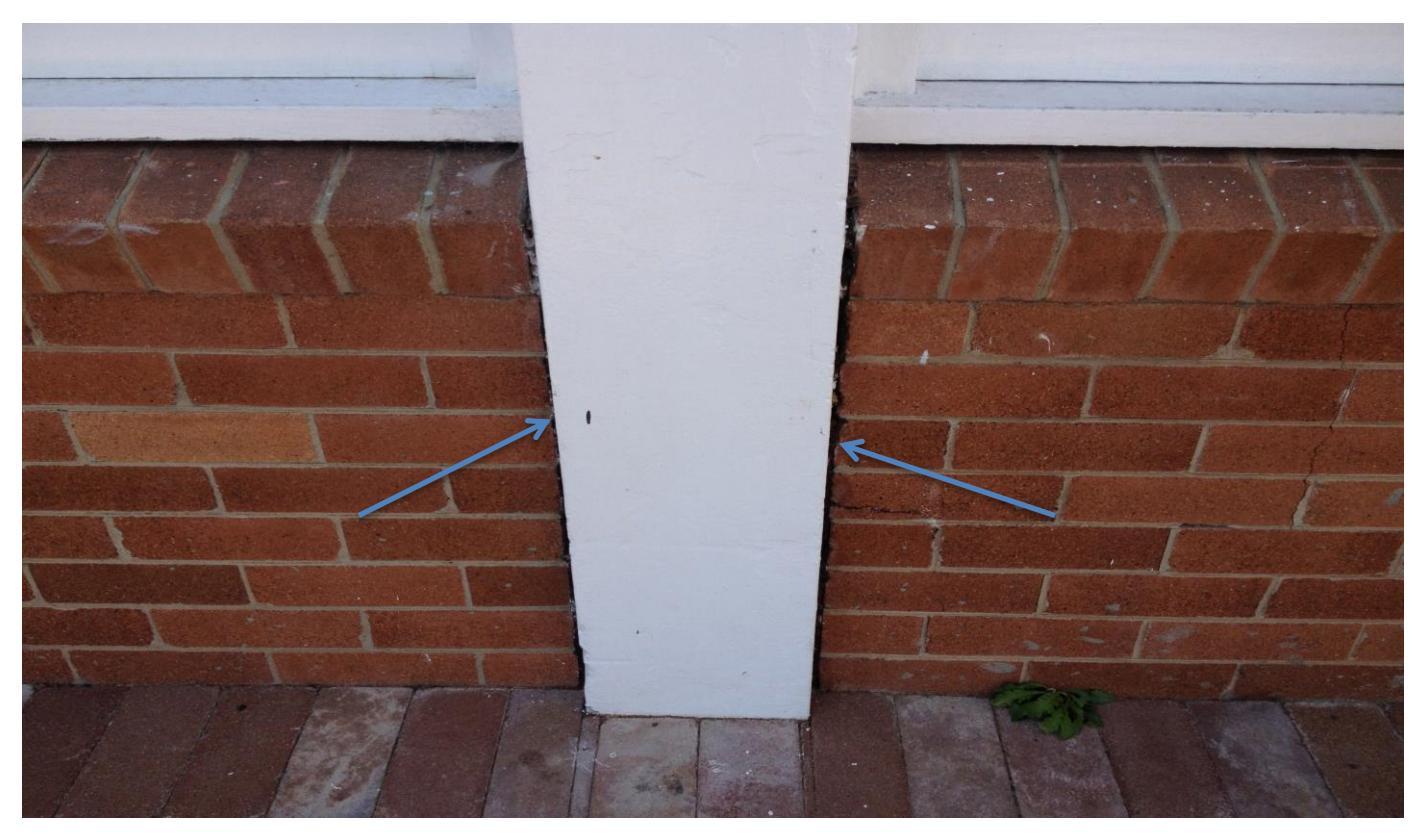
Photo 19: Mastic containing asbestos in the expansion joints on the eastern and western perimeter walls on Level 2 and Level 3 of Junior School – Original Wing

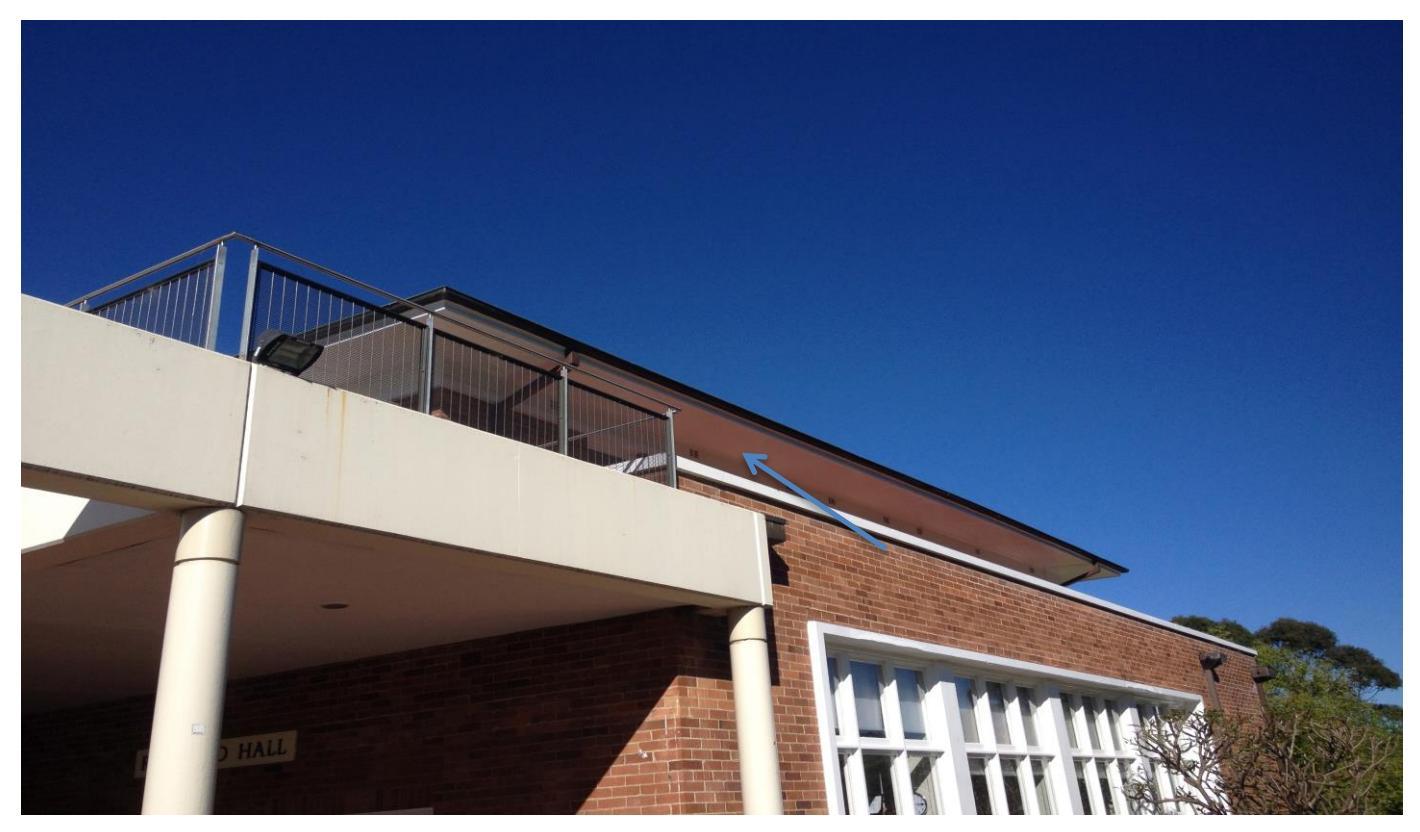
Photo 21: Asbestos cement sheeting on the eave linings of Junior School - RW Hall.

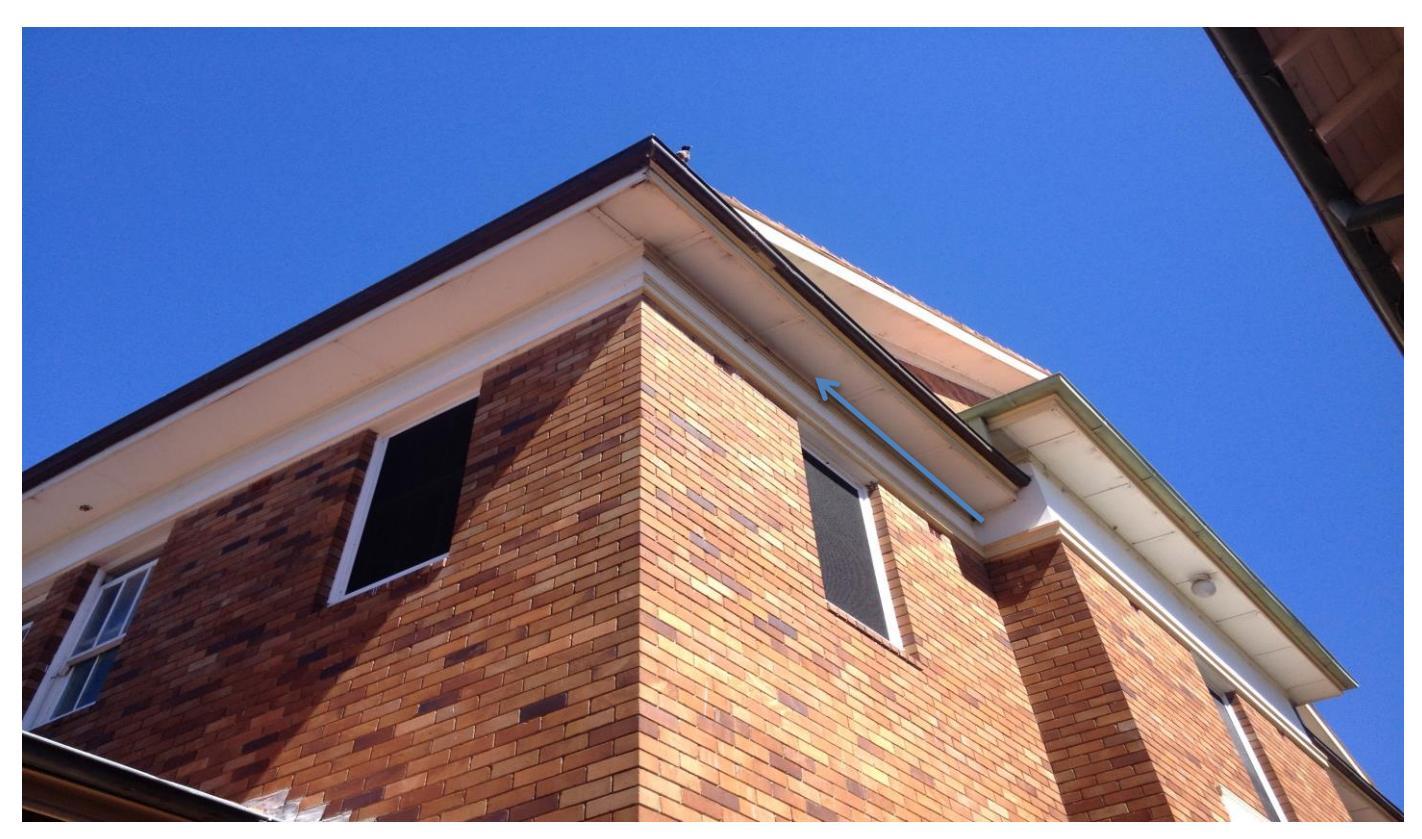
Photo 23: Asbestos cement sheeting on the eave linings of Boys Boarding – West Wing.

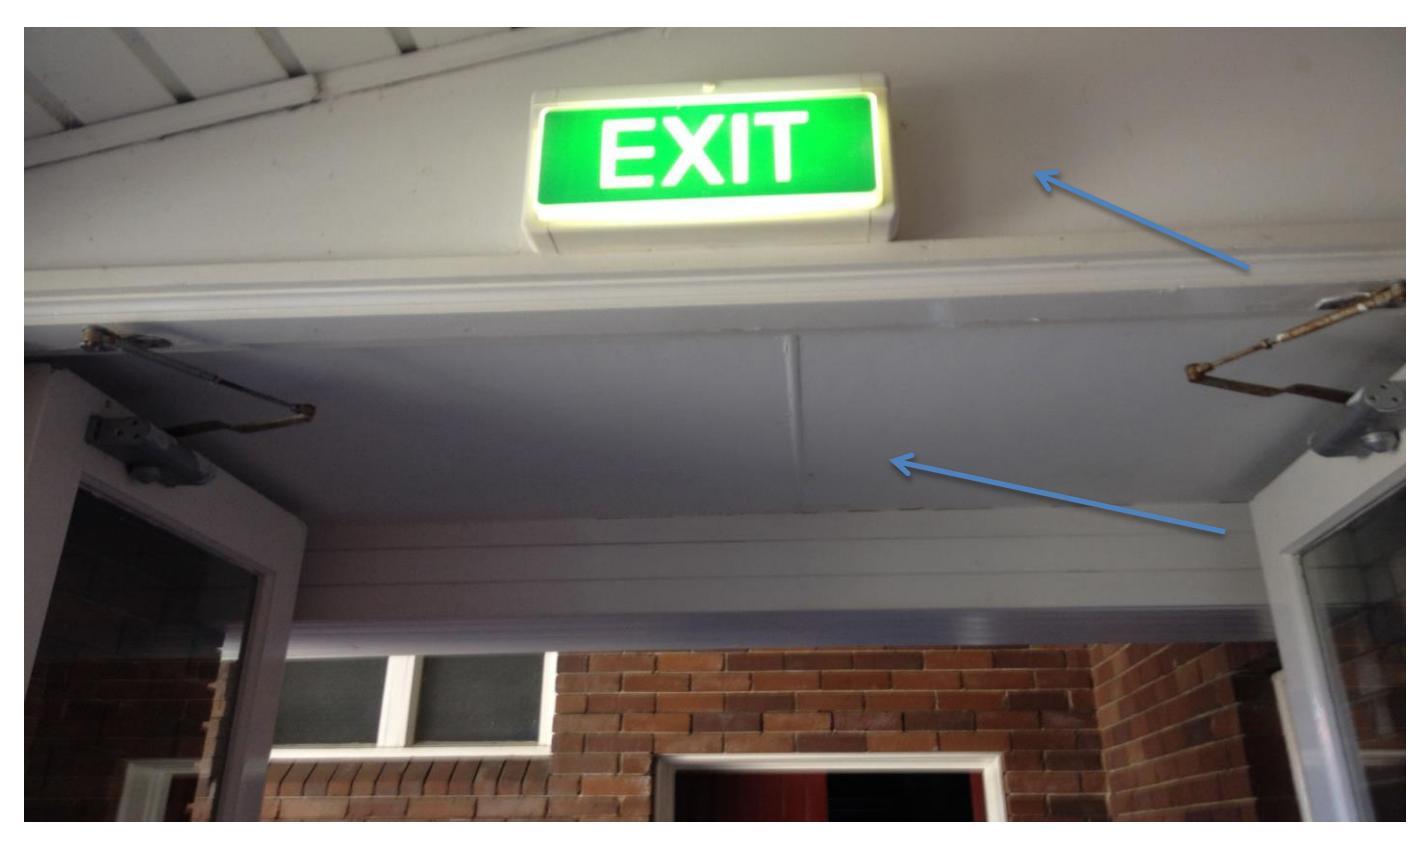
**Photo 24:** Asbestos cement sheeting on the ceiling linings and fascia linings of the exit to the eastern stairwell on the Ground Level of Boys Boarding – West Wing.

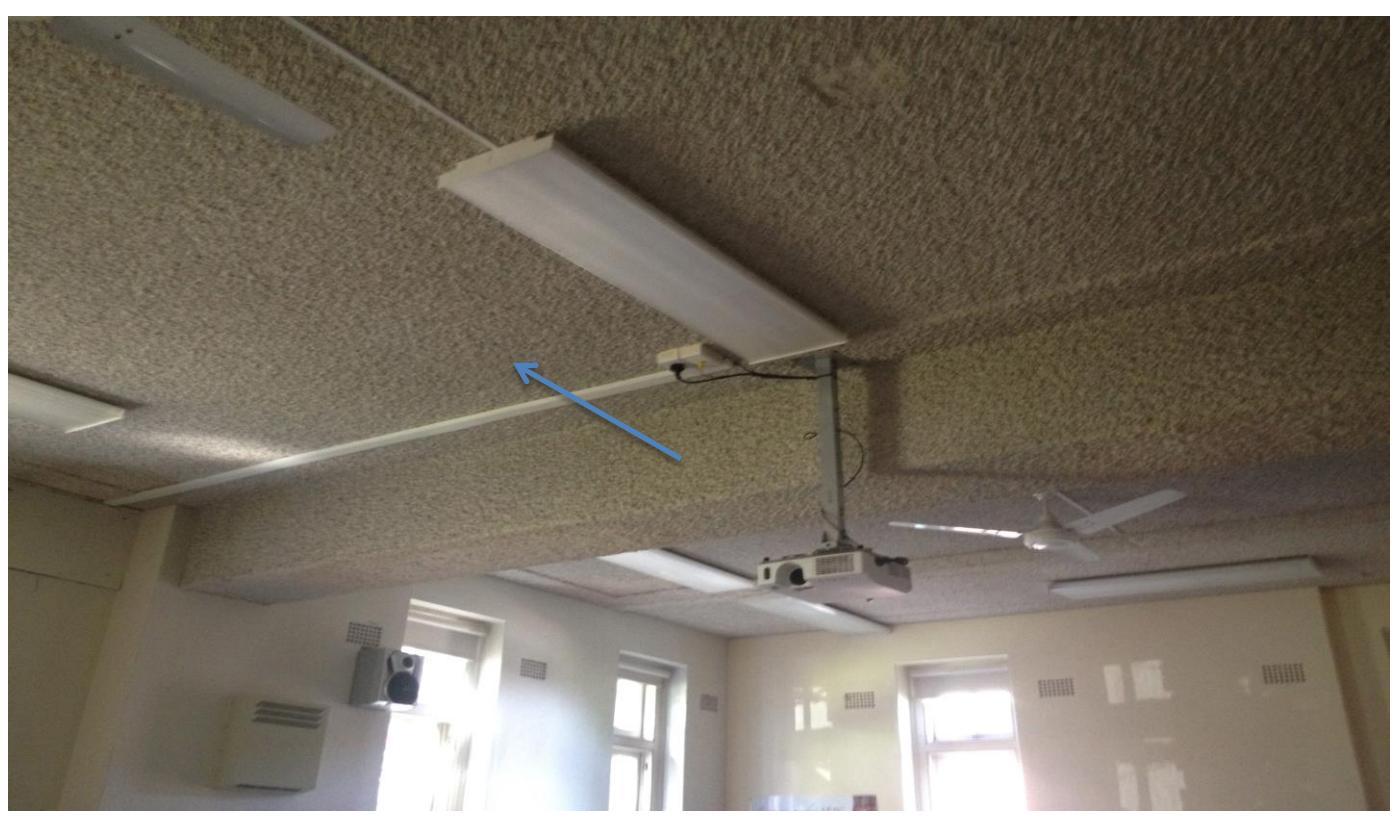
Photo 27: Vermiculite containing asbestos on the ceiling linings of Room L2 of the Language's Building.
