HAZARDOUS MATERIALS REGISTER

Barker College – 91 Pacific Highway

Project No. 21401 [Rev 1.]

Date: 10/09/20

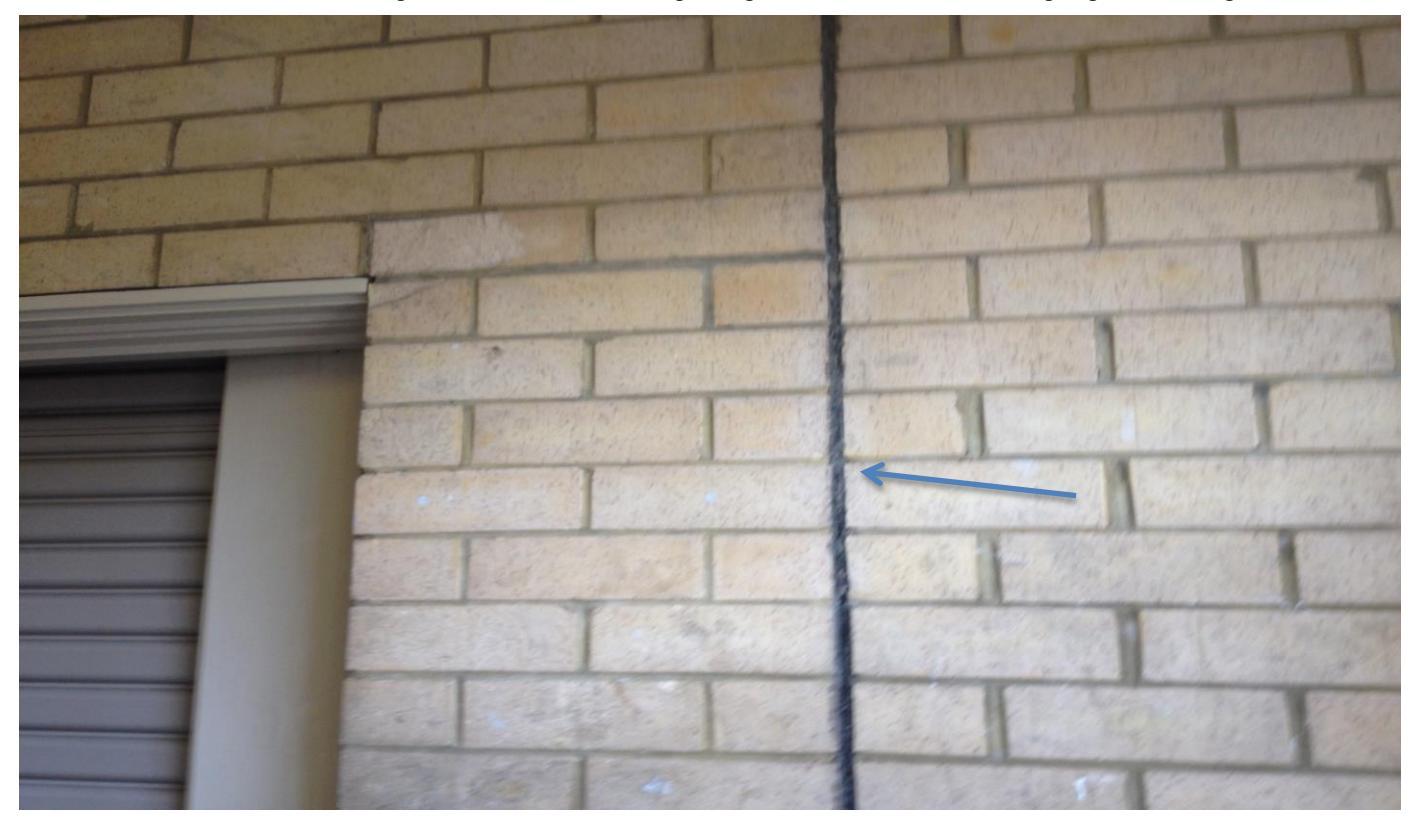
**Photo 28:** Mastic containing asbestos in the expansion joints of the walls in the Foyer Area of the Girls Lockers Rooms on Level 1 of C Block - Math's Department.

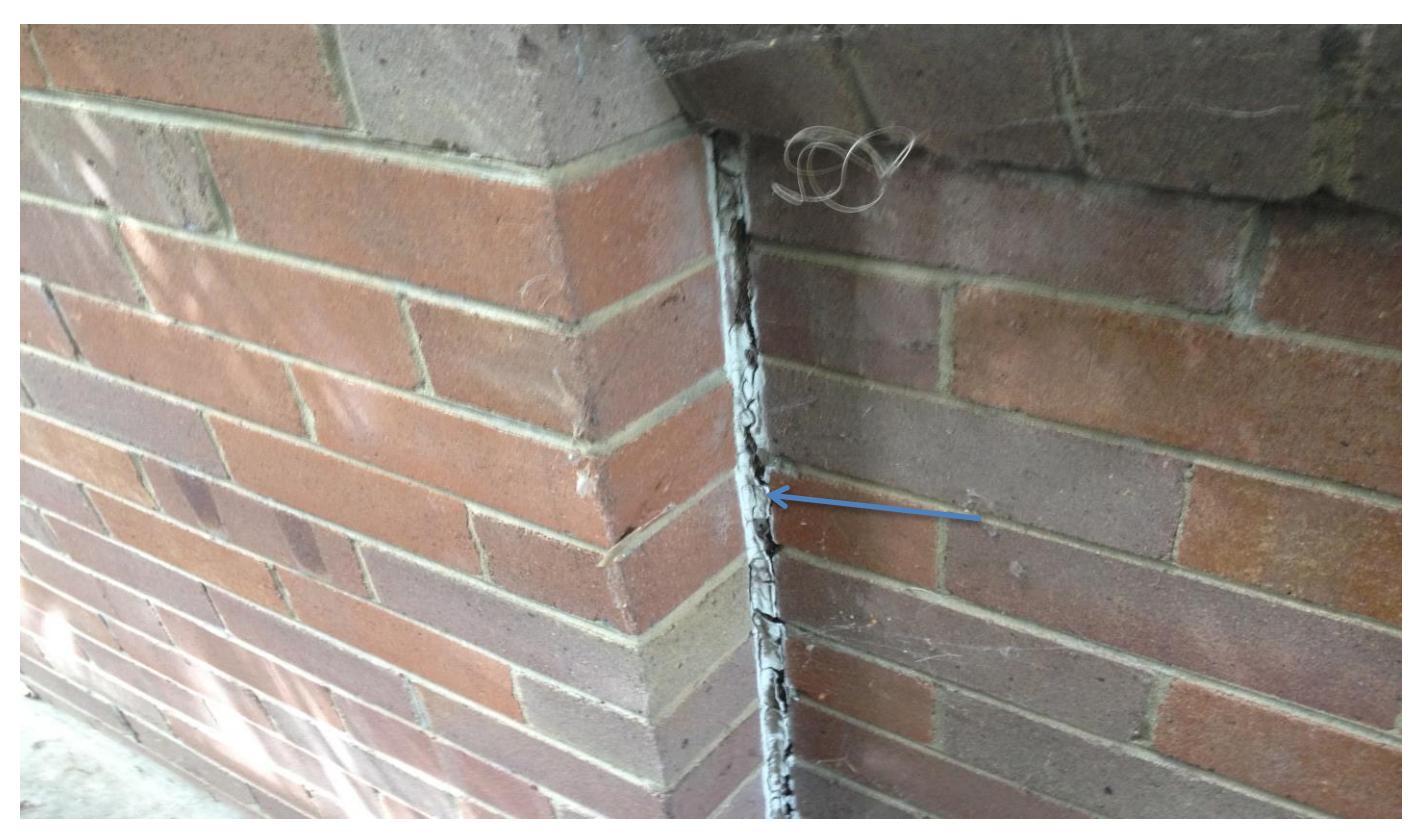
**Photo 29:** Mastic containing asbestos found in the expansion joints in the southern external wall of Level 1, Level 2, Level 3 and Level 4 of C Block - Math's Department.

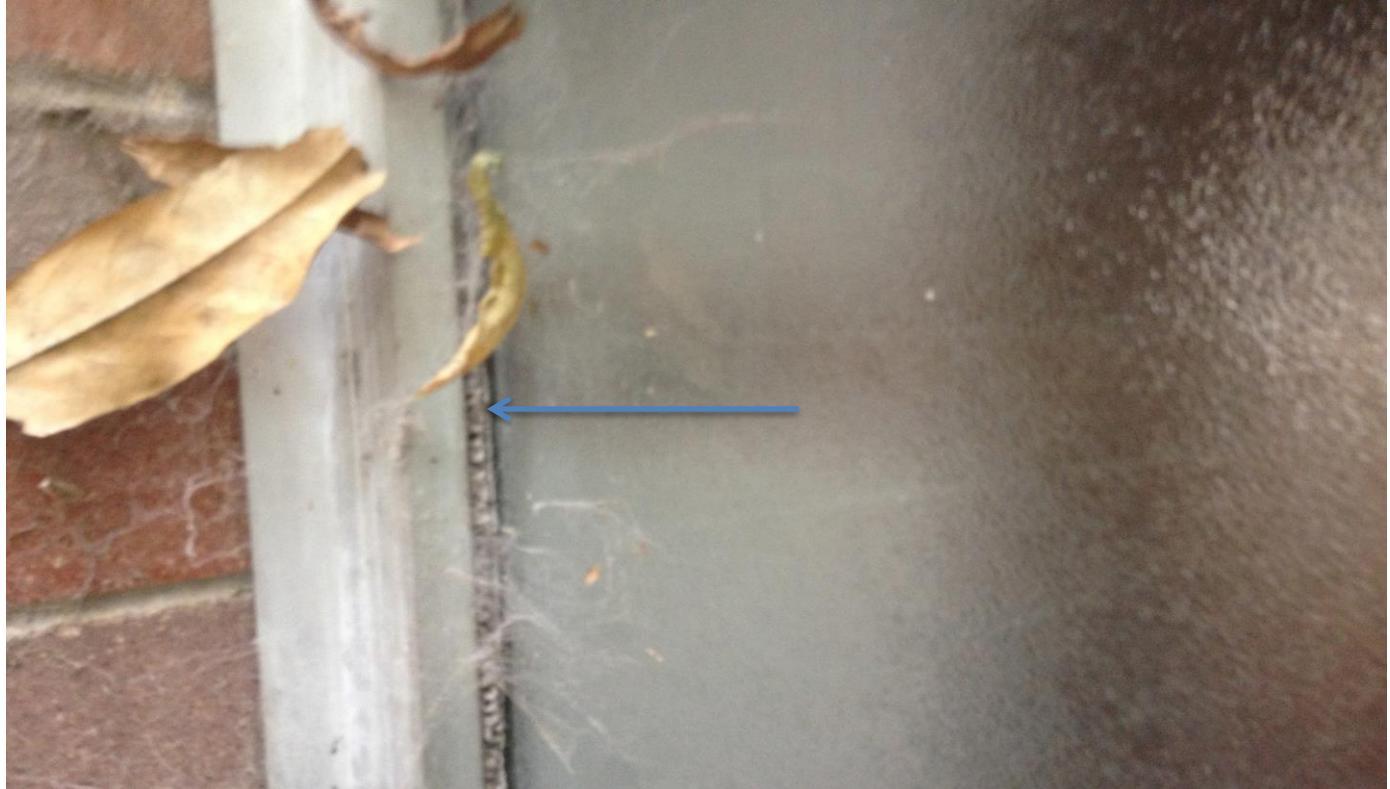
**Photo 30:** Mastic containing asbestos found in the window frames throughout Level 1, Level 2, Level 3 and Level 4 of C Block - Math's Department.

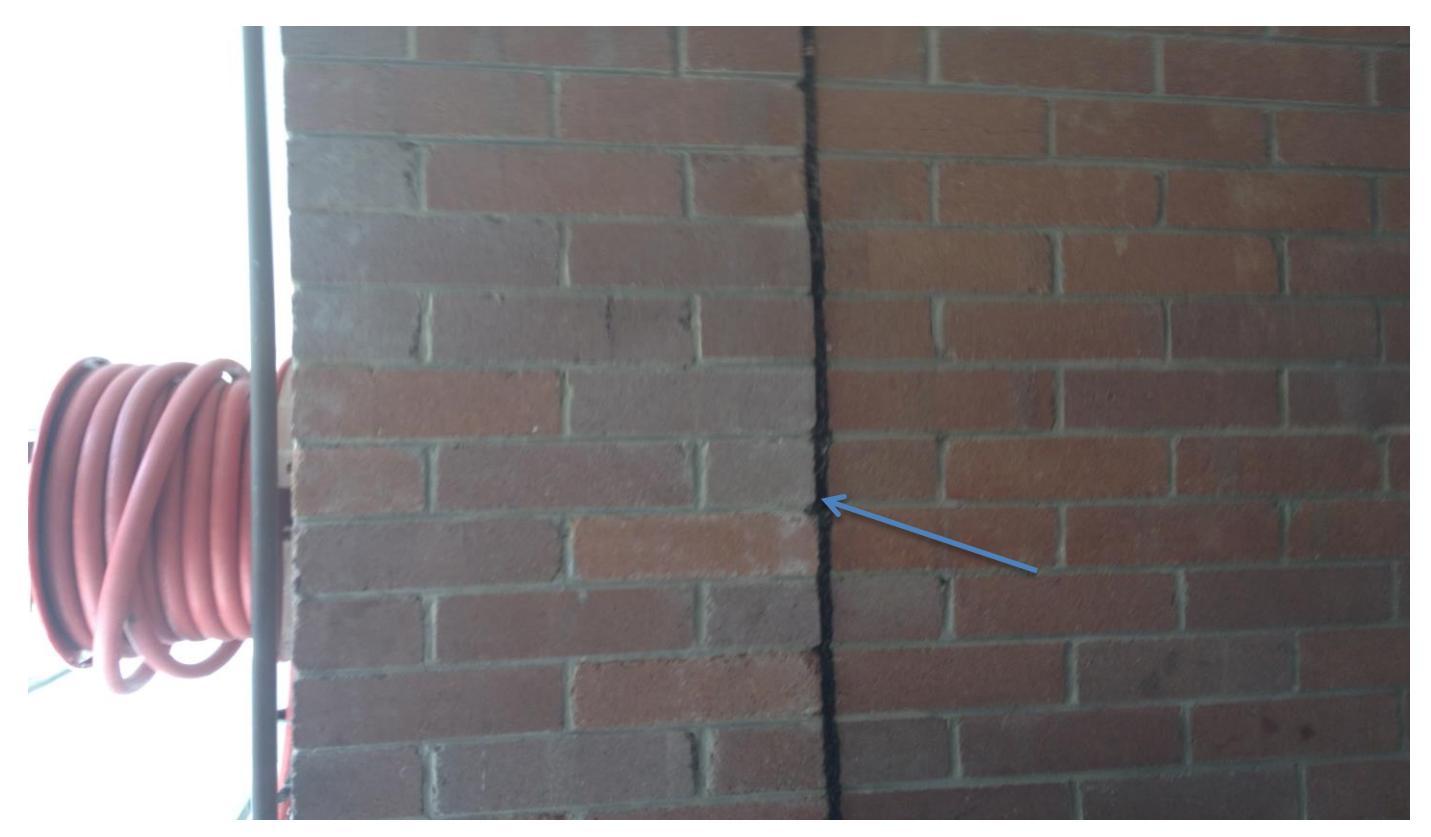
**Photo 31:** Mastic containing asbestos found in the expansion joints of the walls in the southern stairwell on Level 3 of C Block - Math's Department.

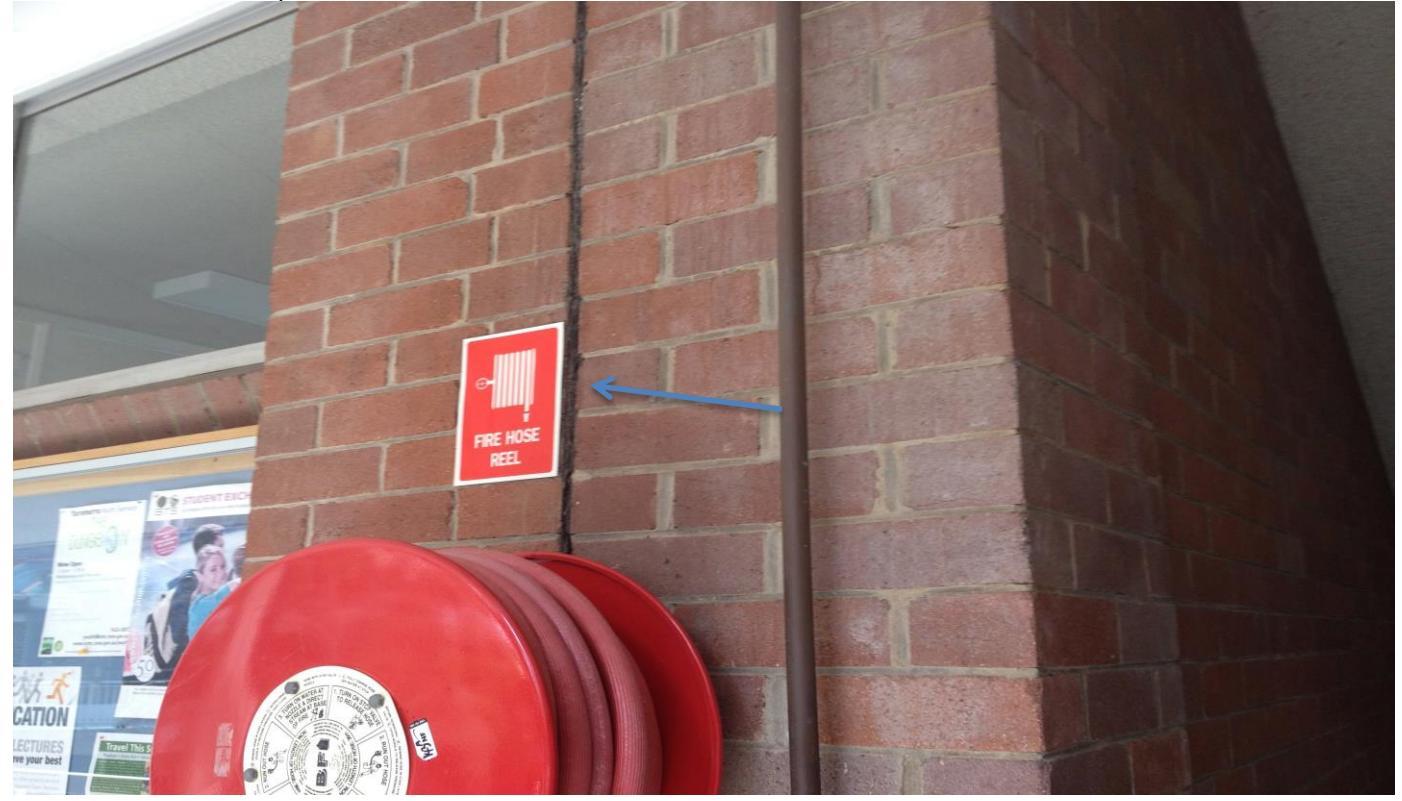
**Photo 32:** Mastic containing asbestos found in the expansion joints of the northern walls of the Math's Staff Rooms on Level 3 of C Block - Math's Department.

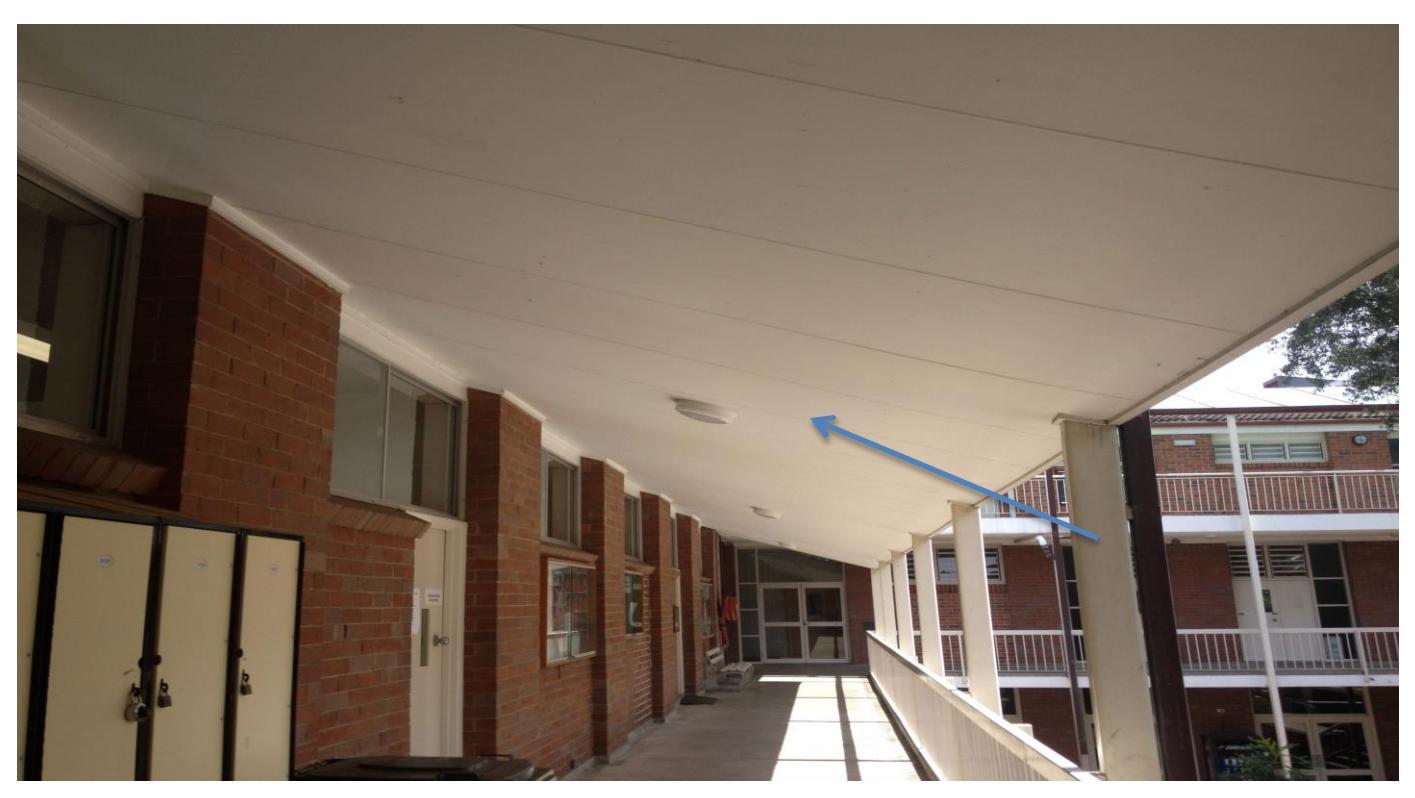
**Photo 33:** Fibreboard containing asbestos on the awning lining outside of the Math's Staff Rooms on Level 3 of C Block - Math's Department.

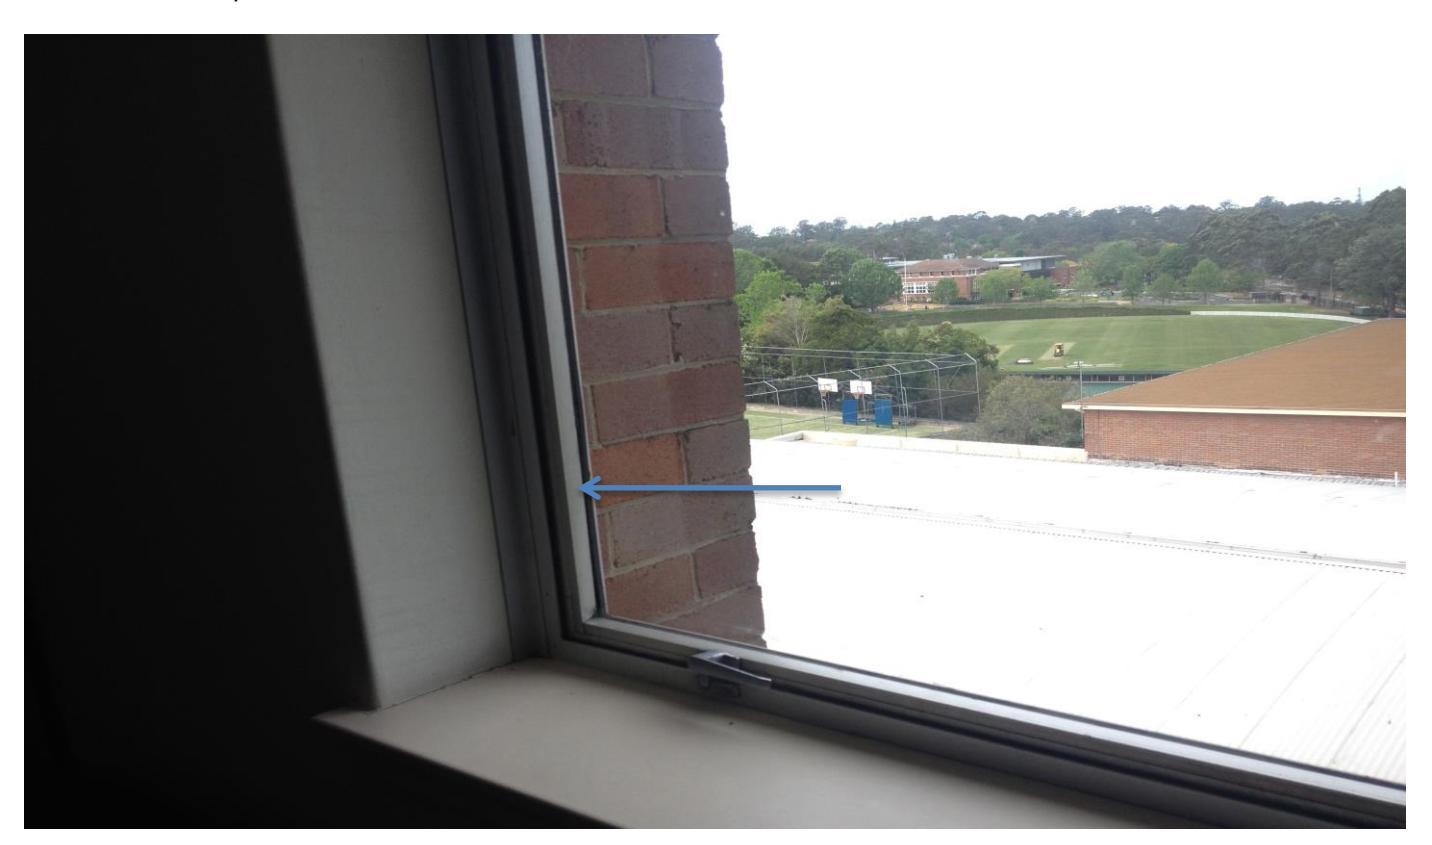
**Photo 34:** Mastic containing asbestos in the window frames of the Staff Common Room on Level 4 of C Block - Math's Department. Similar mastic is present internally in all window frames of the Math's Department.

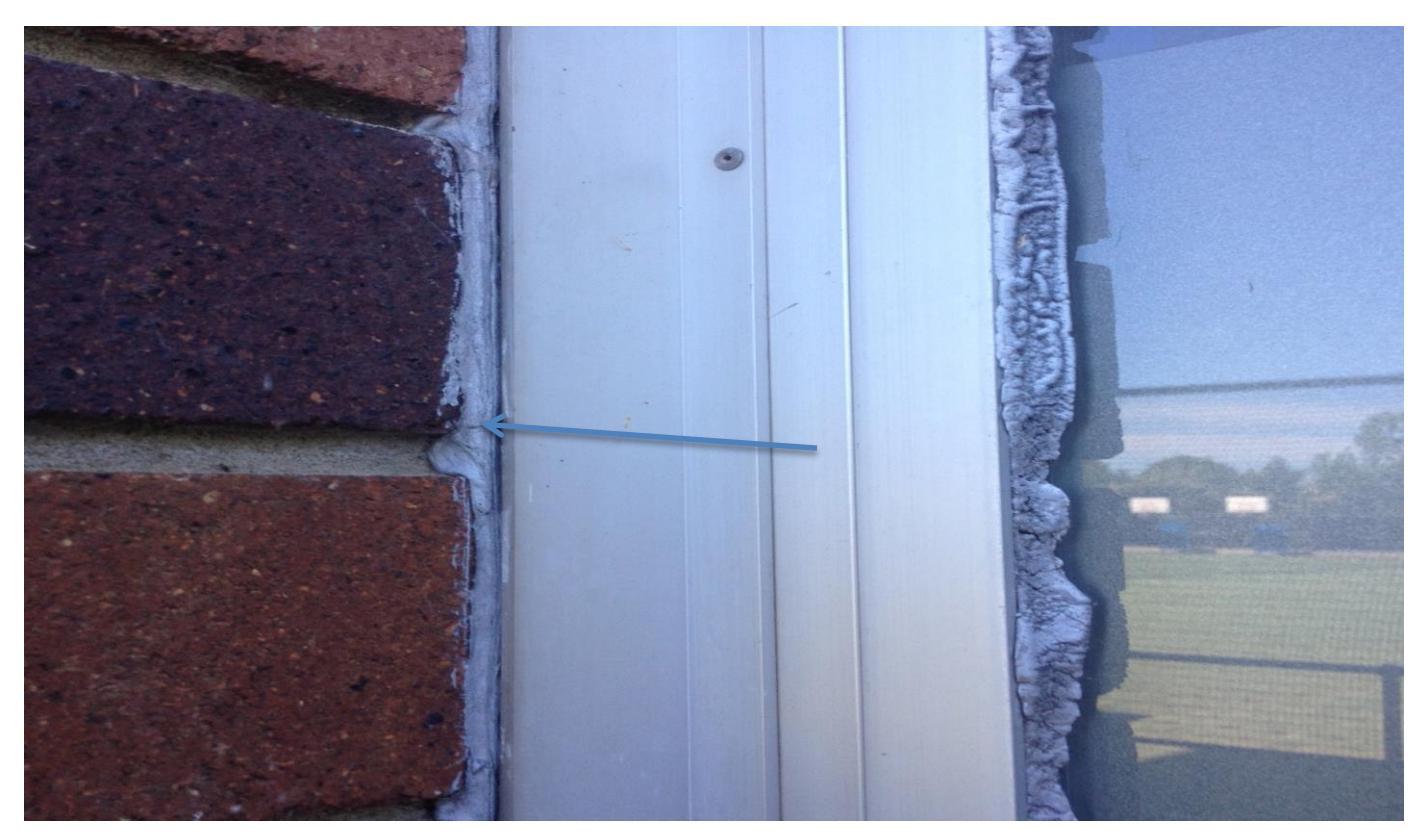
**Photo 35:** Mastic containing asbestos in-between the window frames and brickwork of the Bunker Level of Undercroft Administration. Similar mastic is present on the Perimeter Windows of the Undercroft Administration.

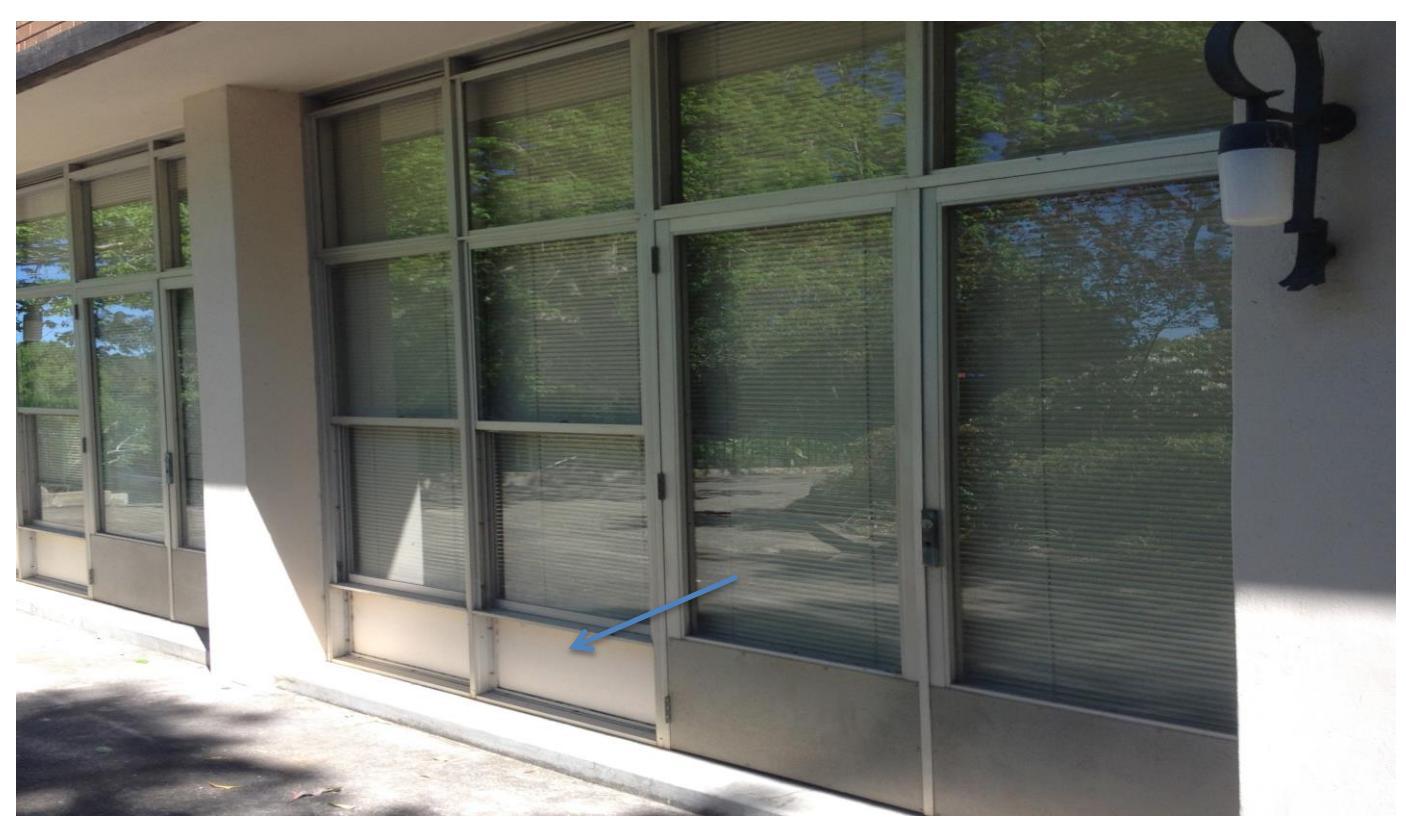
**Photo37:** Asbestos cement sheet infill panels below the window frames on the eastern perimeter of the Middle Undercroft Administration Office's.

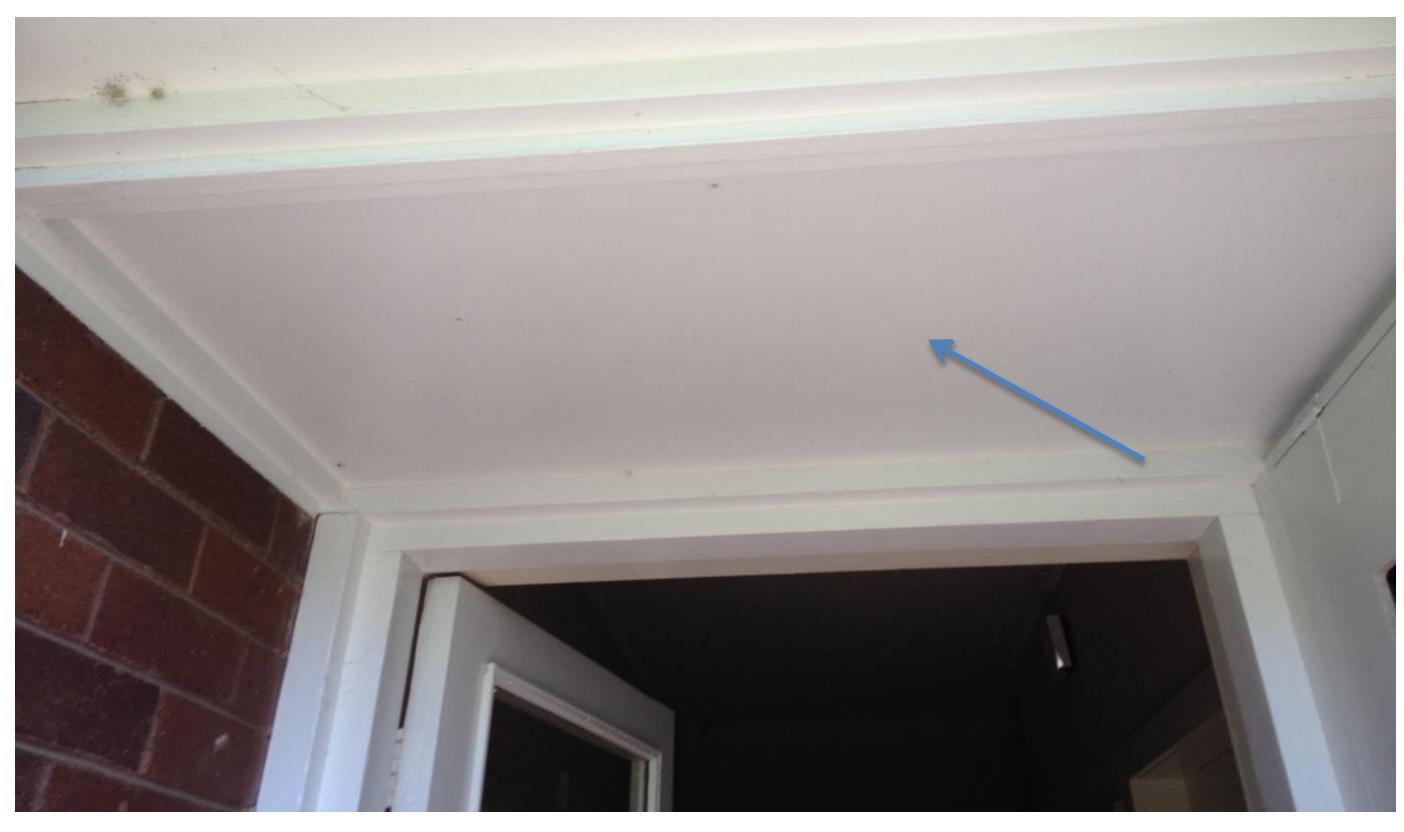
Photo 39: Asbestos cement sheet panel above the eastern entrance of OOSH – 7 Clarke Road.

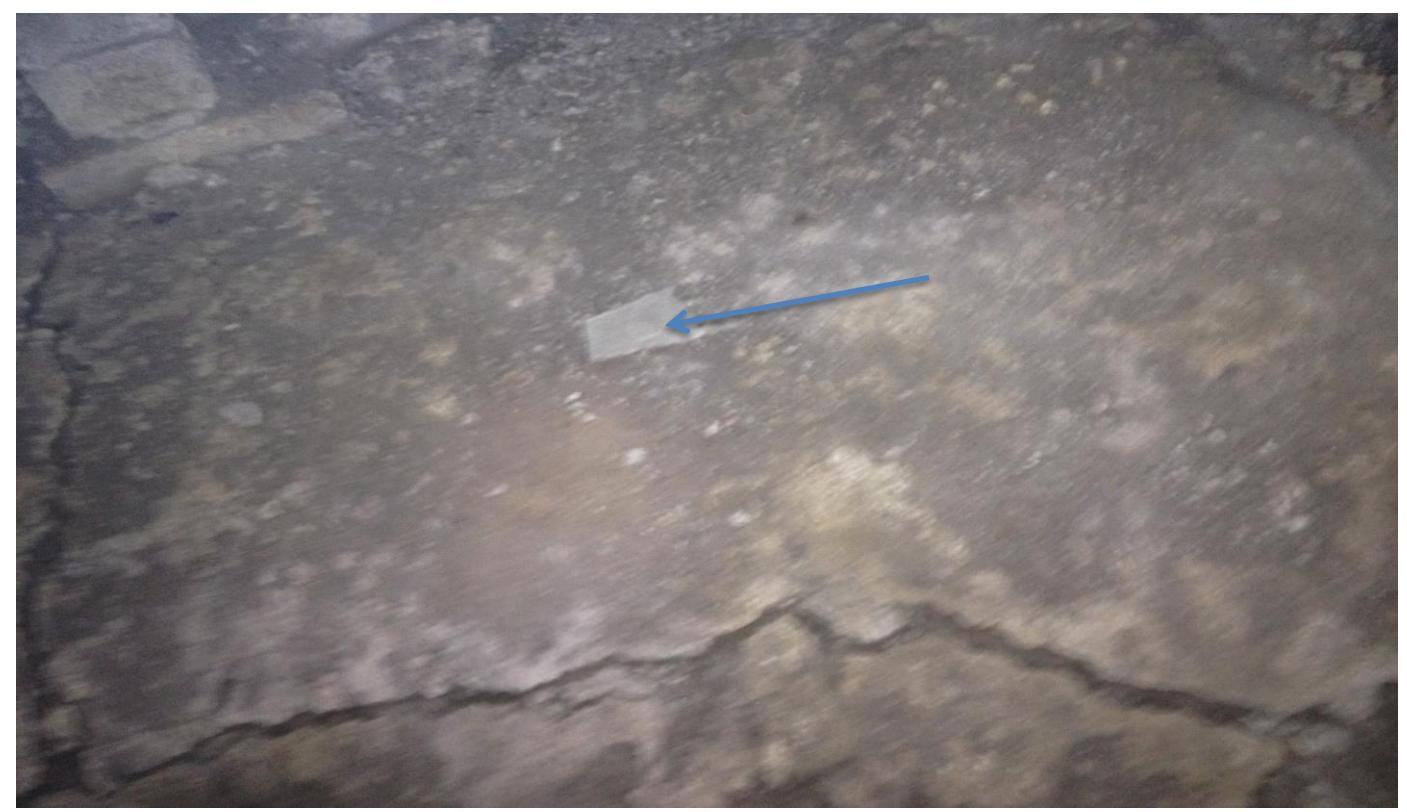
Photo 40: Millboard containing asbestos in the sub-floor throughout OOSH – 7 Clarke Road.

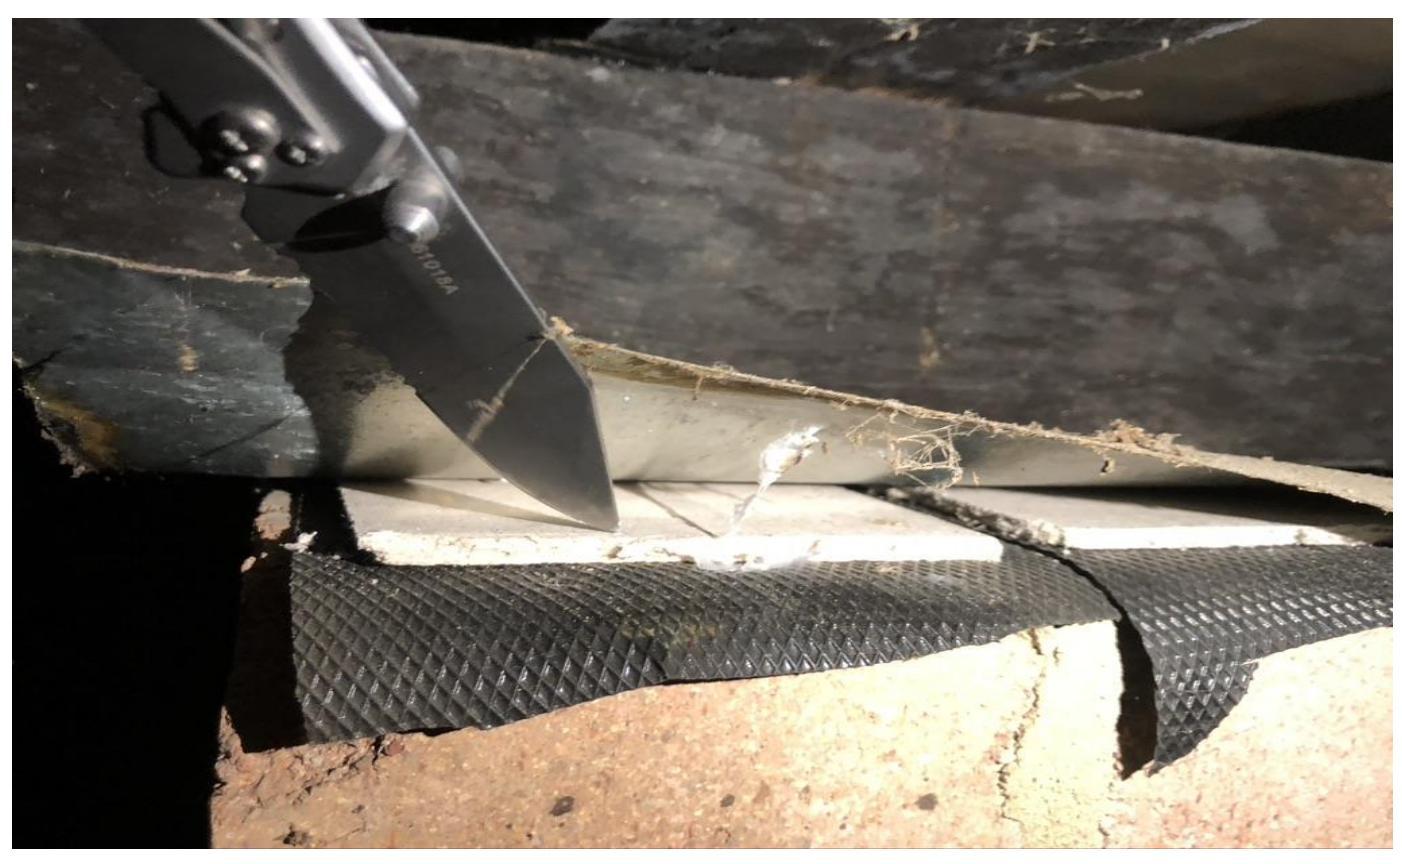
Photo 41: Packers in sub floor of building

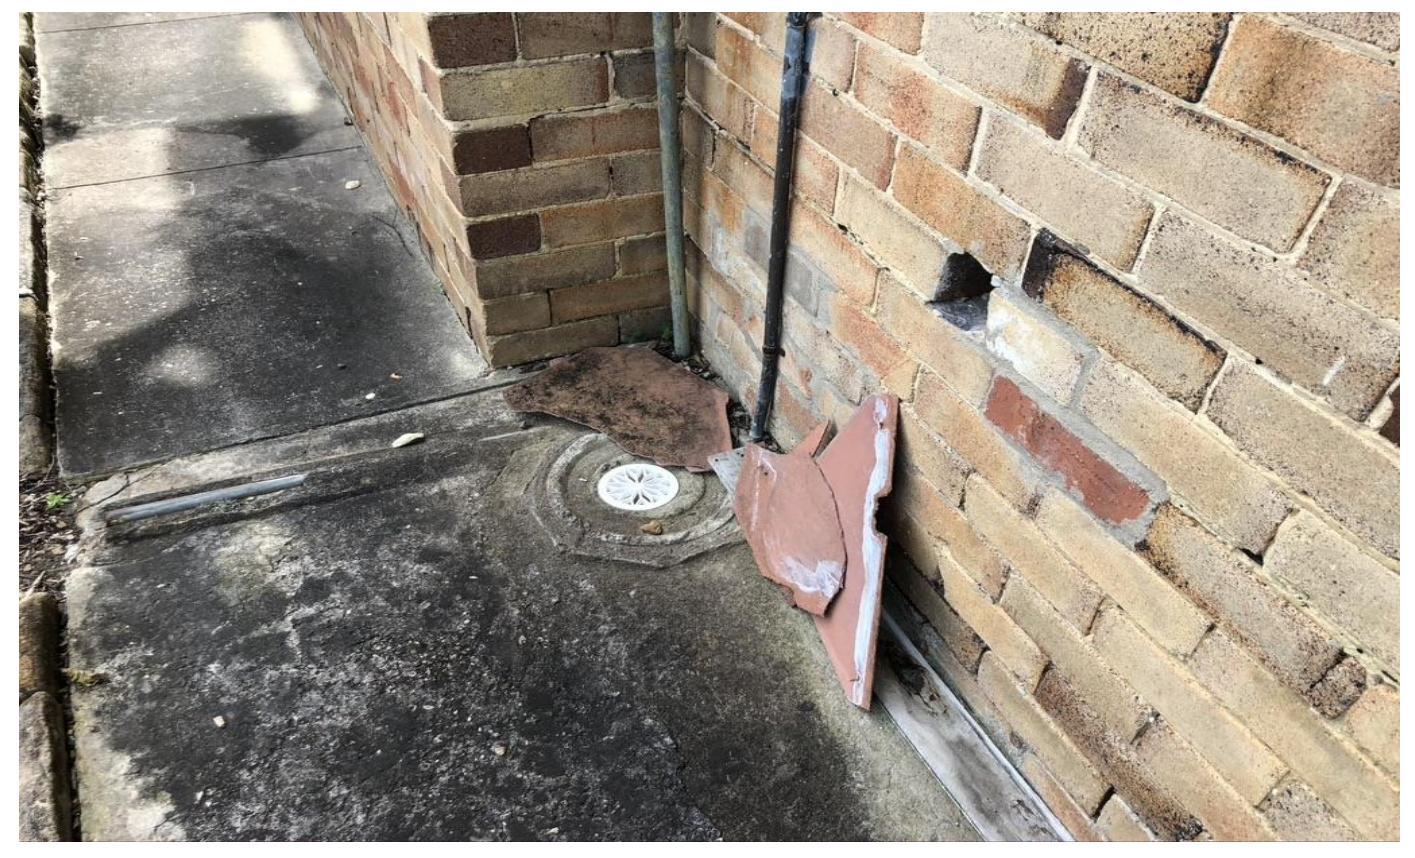
Photo 42: Fibrous cement sheet fragments at the side access of the building

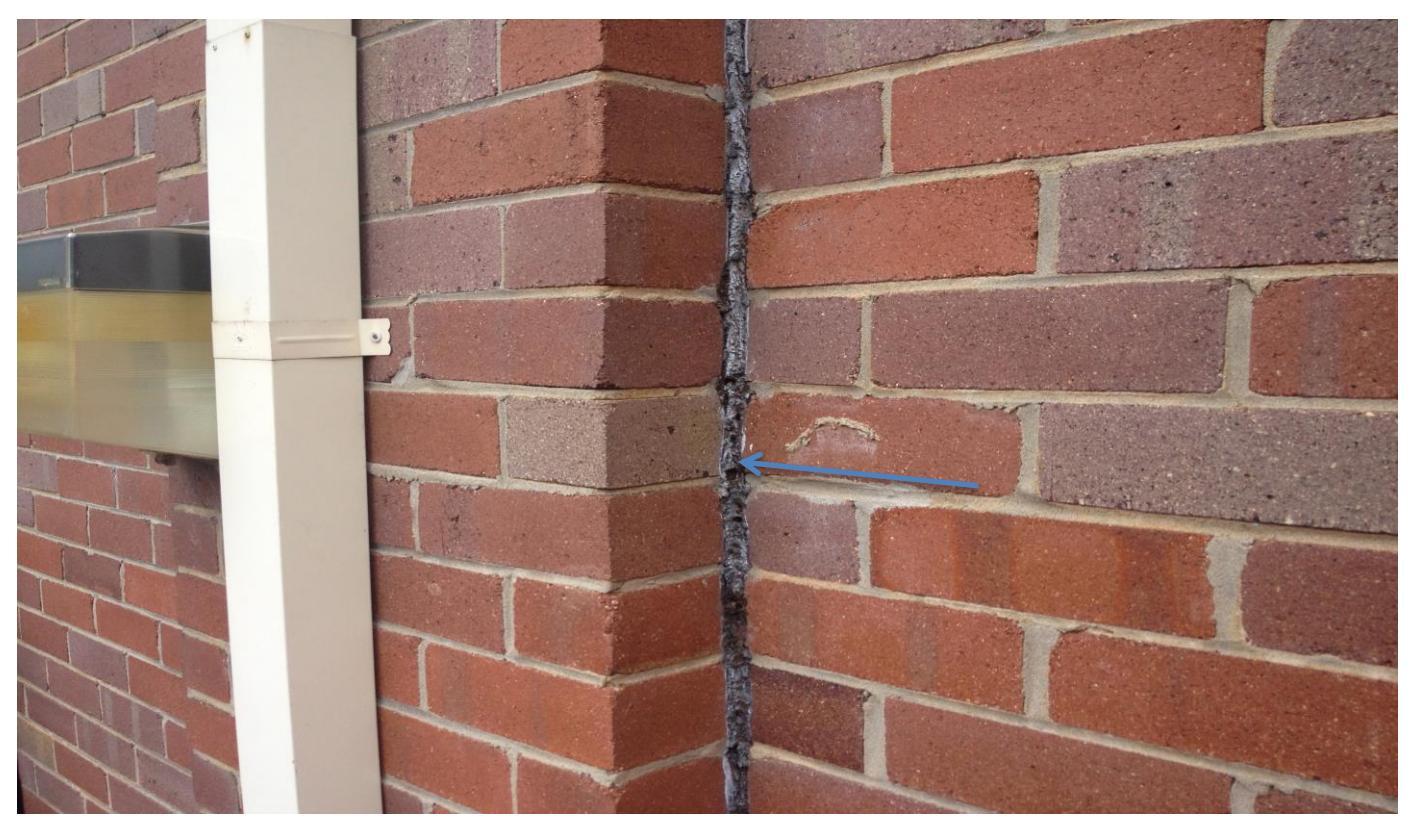
Photo 43: Mastic containing asbestos in the expansion joints of the external perimeter walls of the PDHPE Centre.

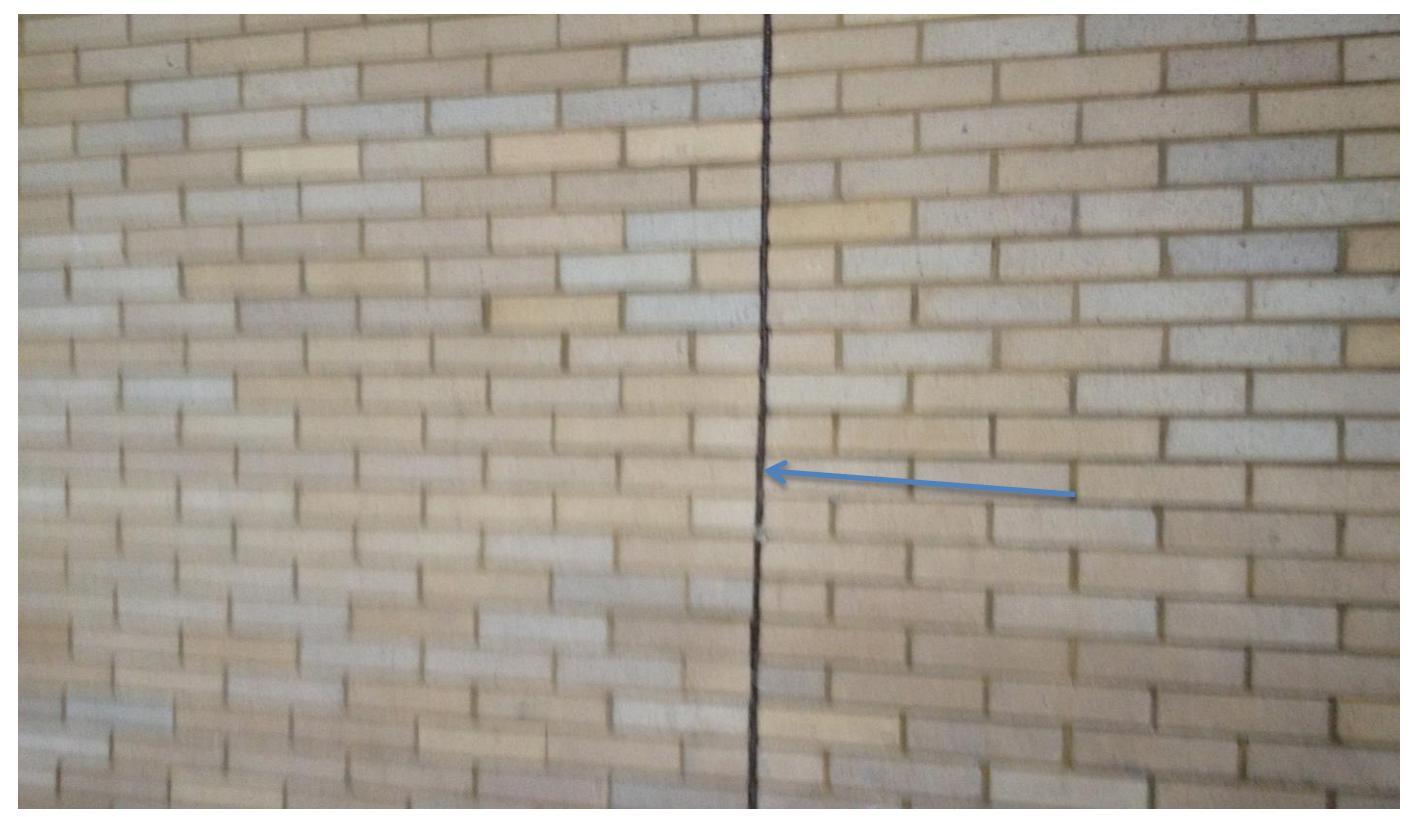
**Photo 44:** Mastic containing asbestos in the expansion joints of the internal perimeter walls of the Basketball Courts within the PDHPE Centre.

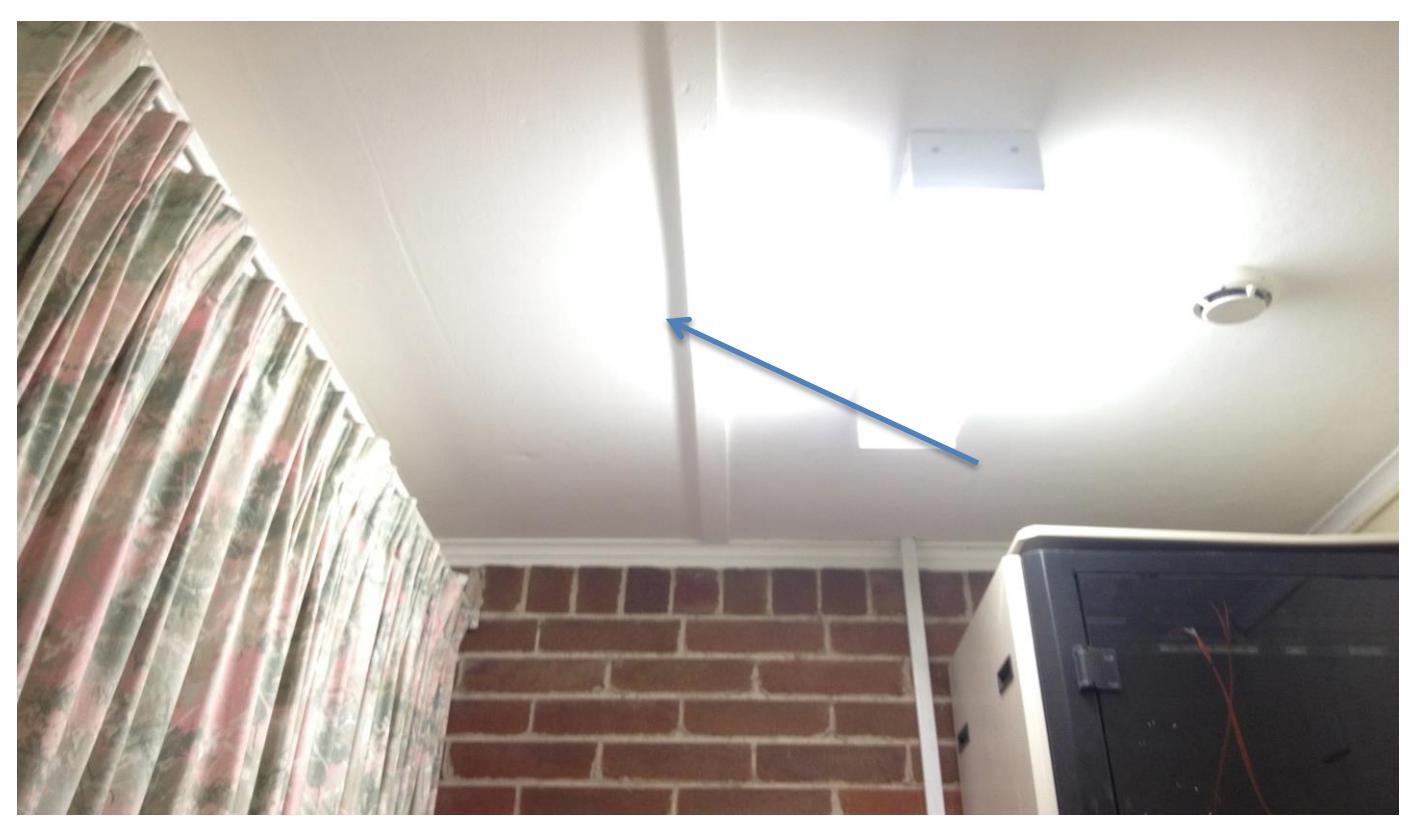
**Photo 45:** Asbestos cement sheeting on the ceiling lining Drinks Machine Room adjacent the southern entrance on Level 2 of Plume Boarding House.

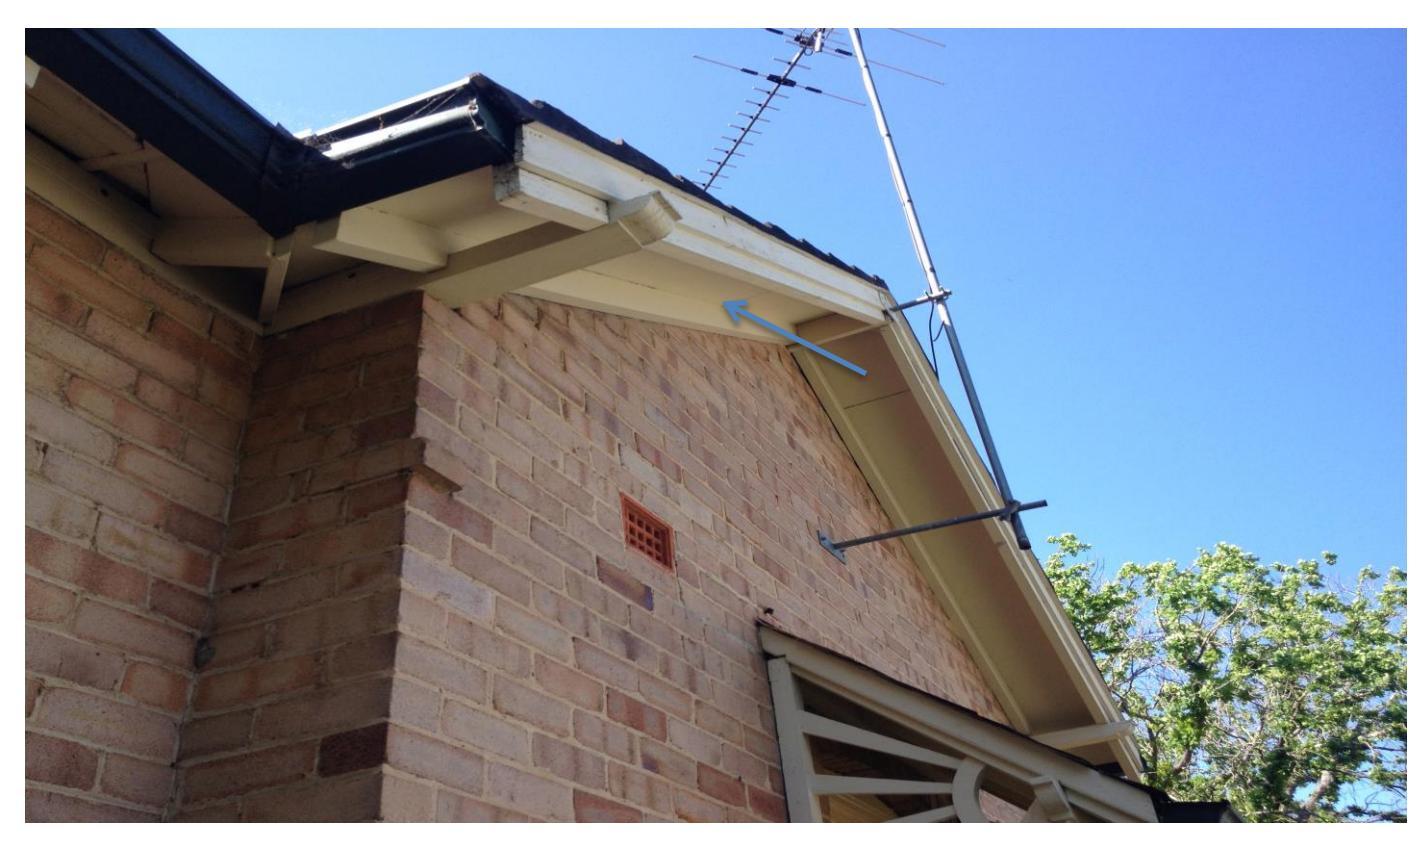
Photo 47: Asbestos cement sheeting eave linings of 9 Clarke Road – Preparatory Administration.

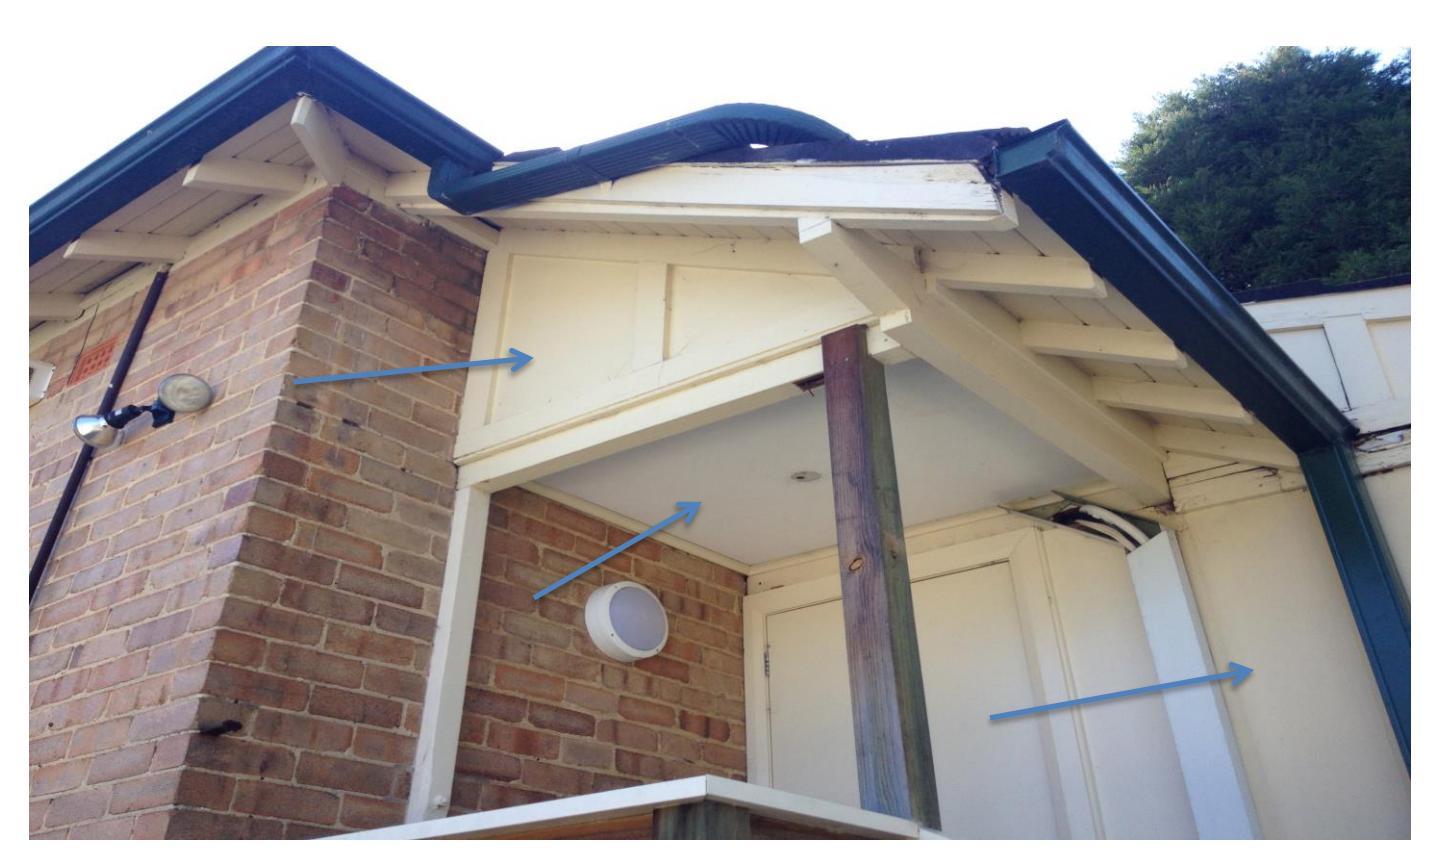
**Photo 48:** Asbestos cement sheeting on the western external wall cladding of the Rear Add On, and the ceiling lining and gable end of the rear entrance to 9 Clarke Road – Preparatory Administration.

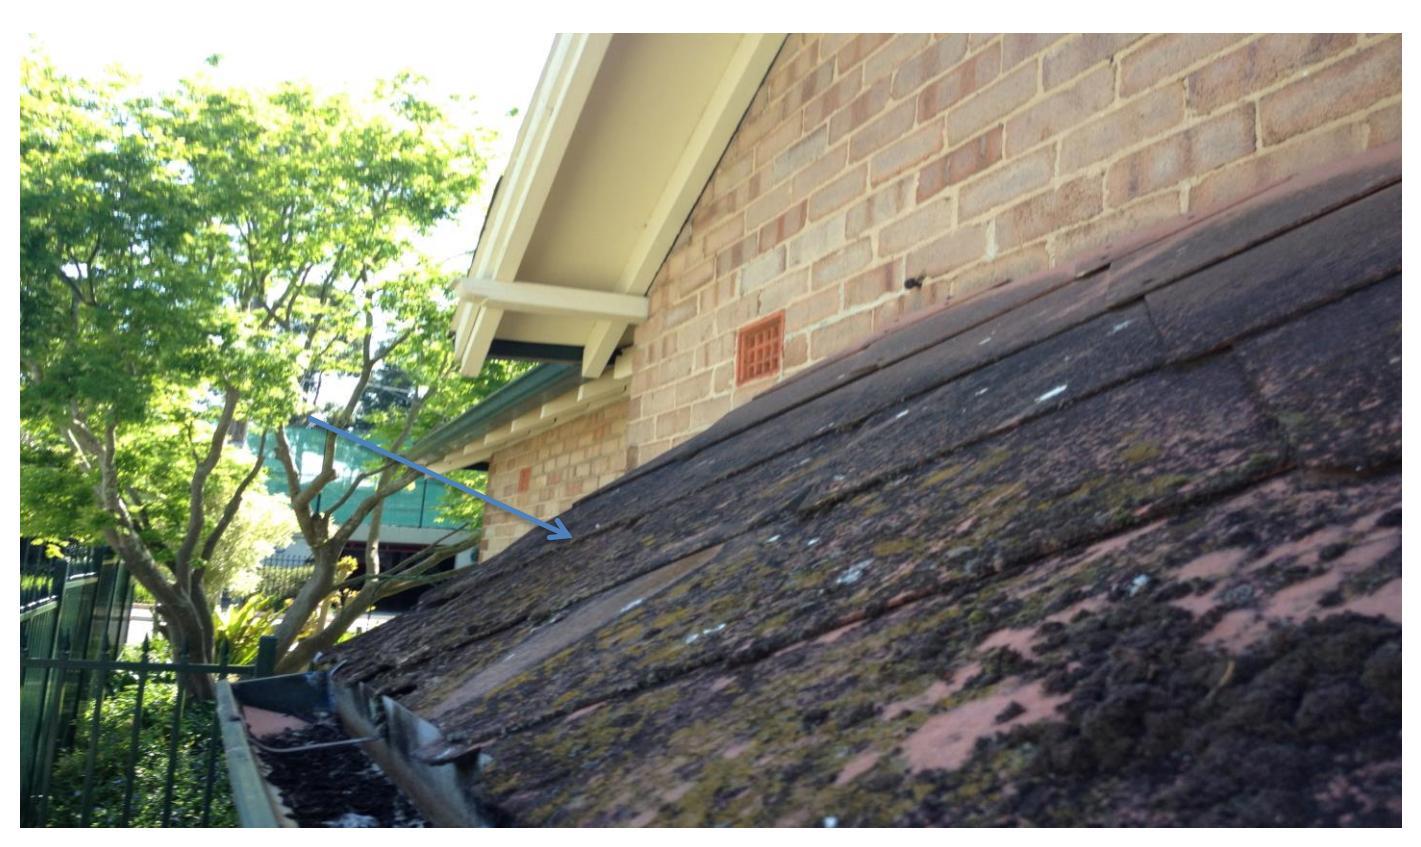
Photo 49: Asbestos cement shingles on the window awnings of 9 Clarke Road – Preparatory Administration.
