HAZARDOUS MATERIALS REGISTER

Barker College – 91 Pacific Highway

Project No. 21401 [Rev 1.]

Date: 10/09/20

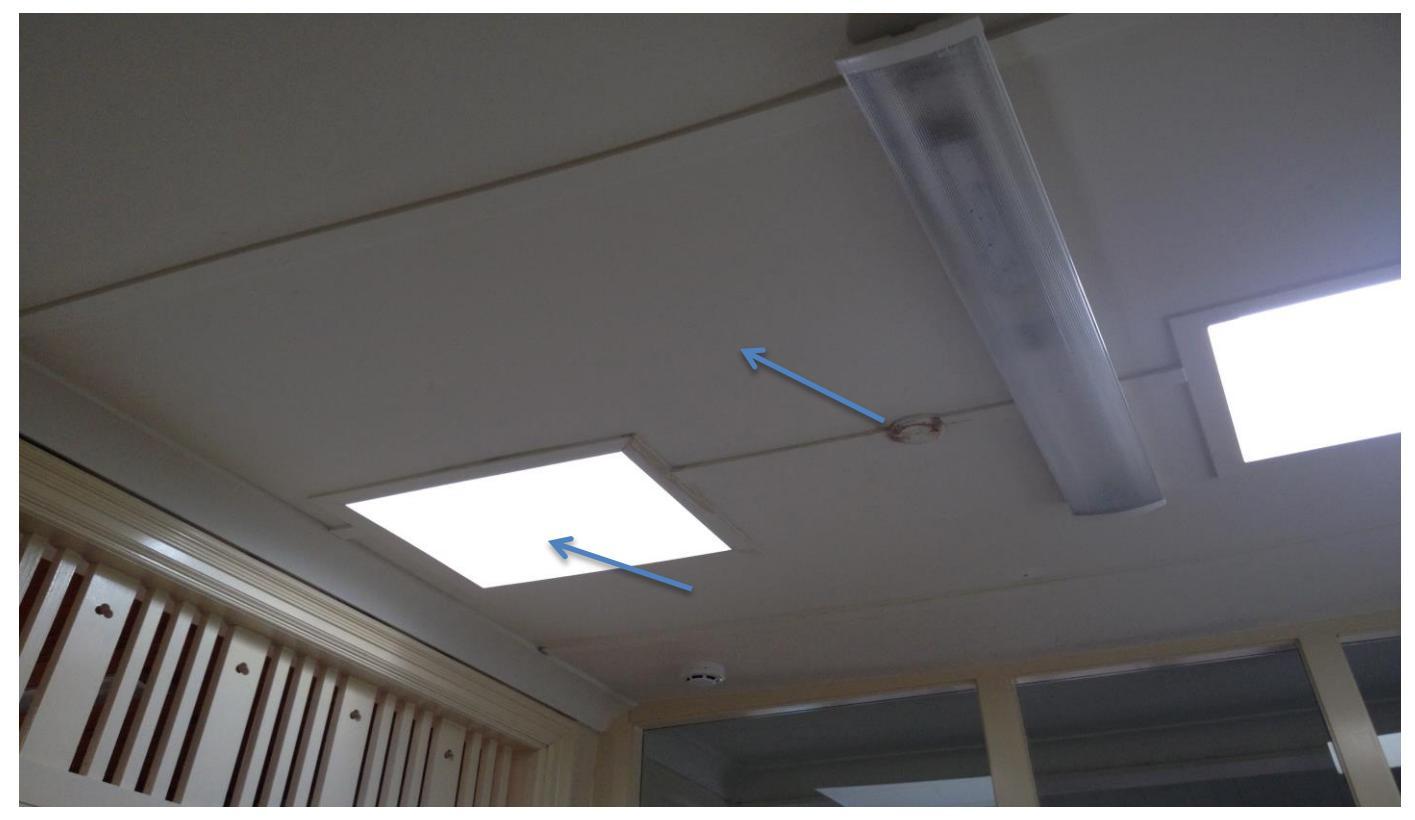
**Photo 50:** Asbestos cement sheeting on the ceiling lining and internal walls of the skylights of the room adjacent the Kitchen in 9 Clarke Road – Preparatory Administration.

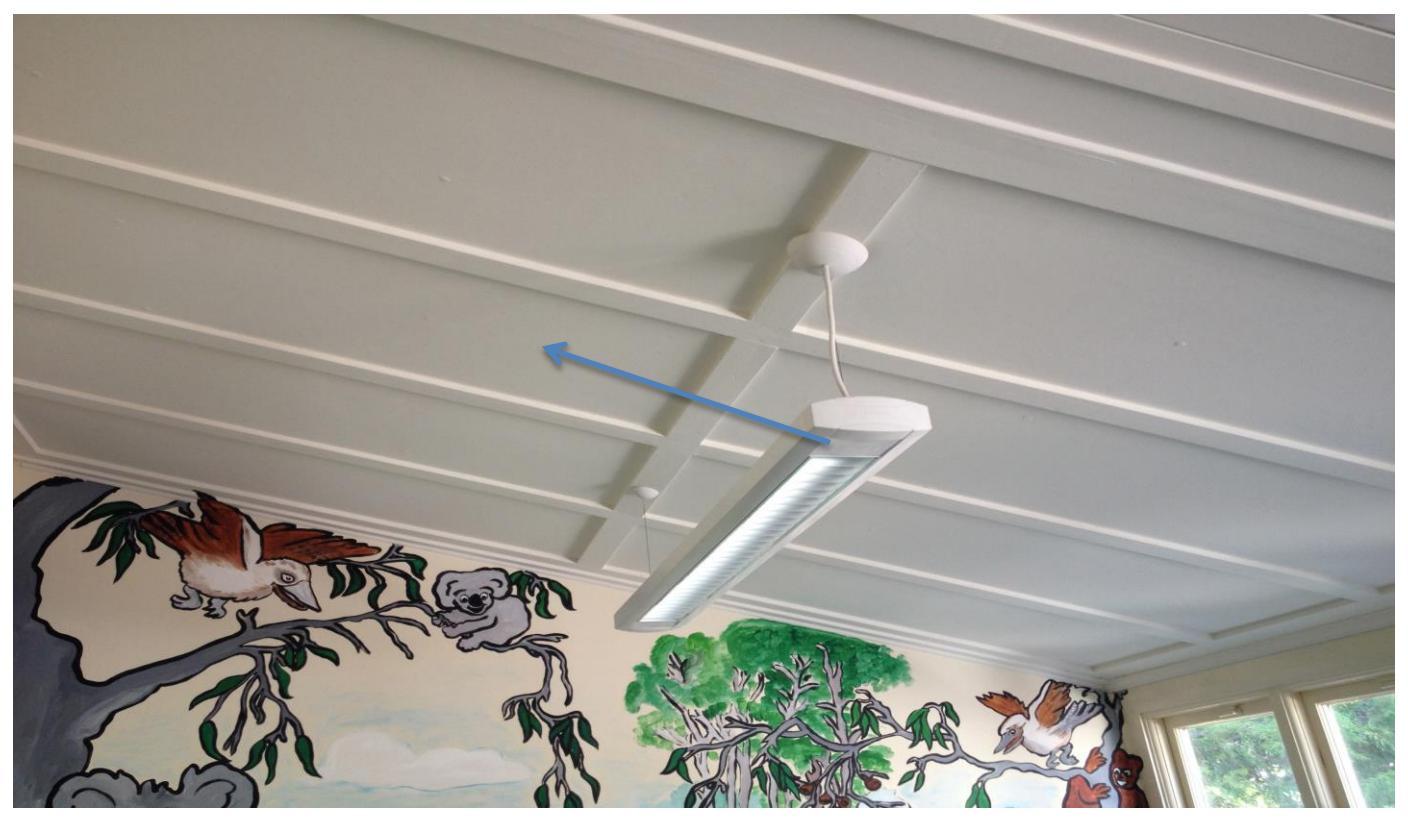
**Photo 51:** Asbestos cement sheeting on the ceiling lining of the Rear Add On (library) in 9 Clarke Road – Preparatory Administration.

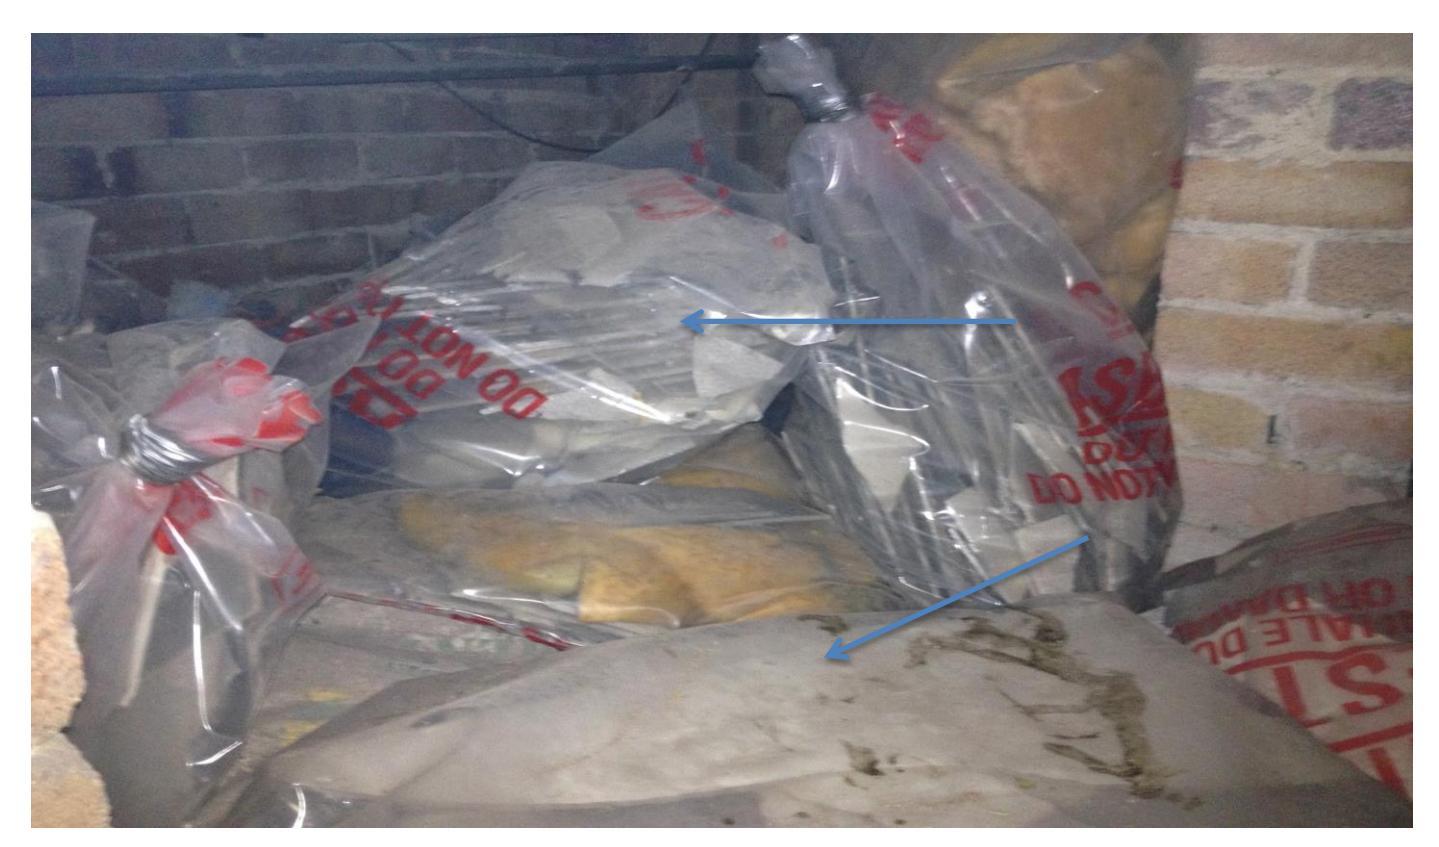
Photo 52: Bagged asbestos cement sheet debris within the sub-floor 9 Clarke Road – Preparatory Administration.

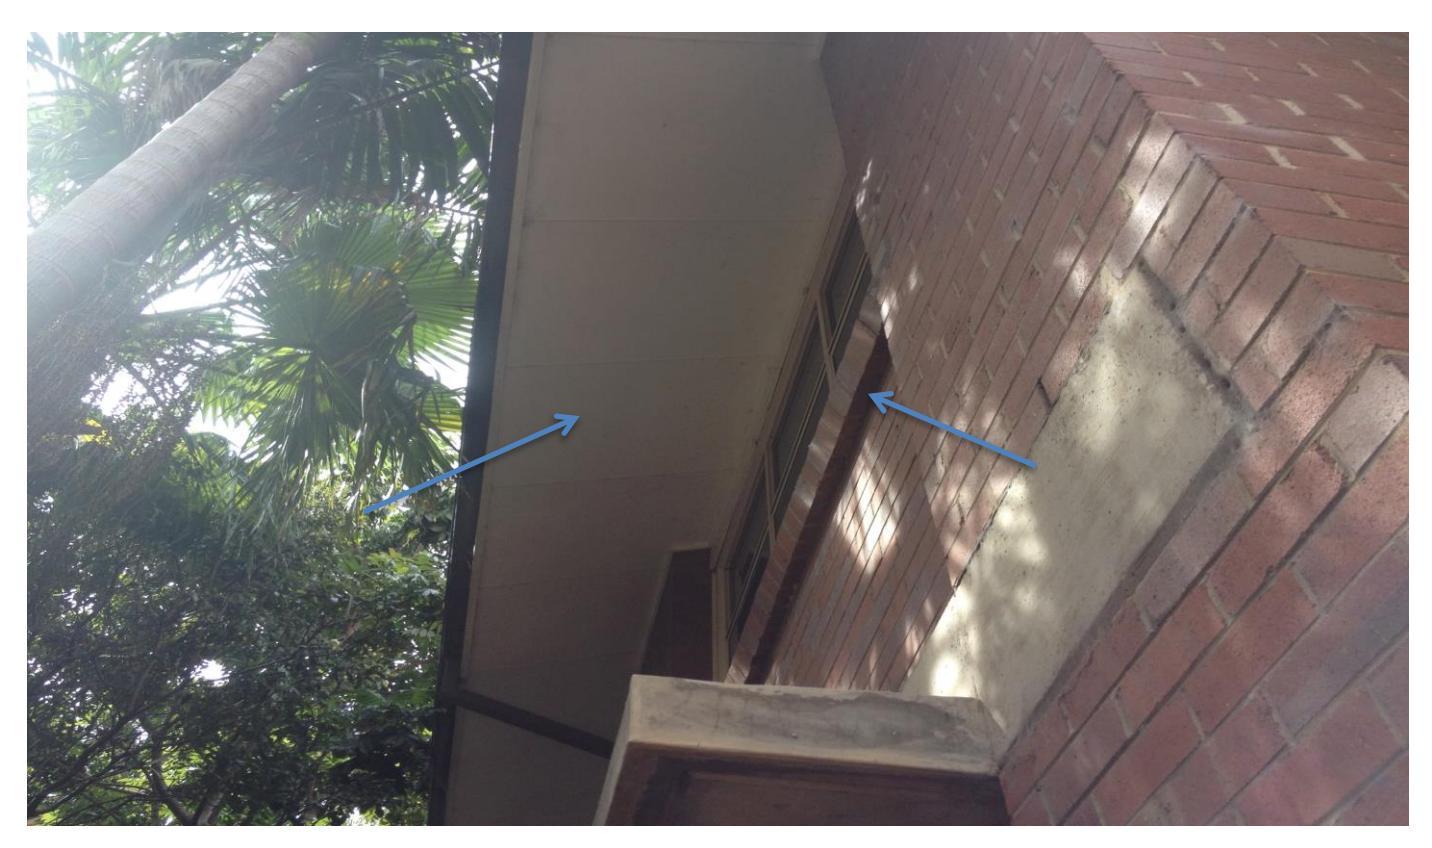
Photo 53: Asbestos cement sheeting on the eave linings of C Block – Science Annex.

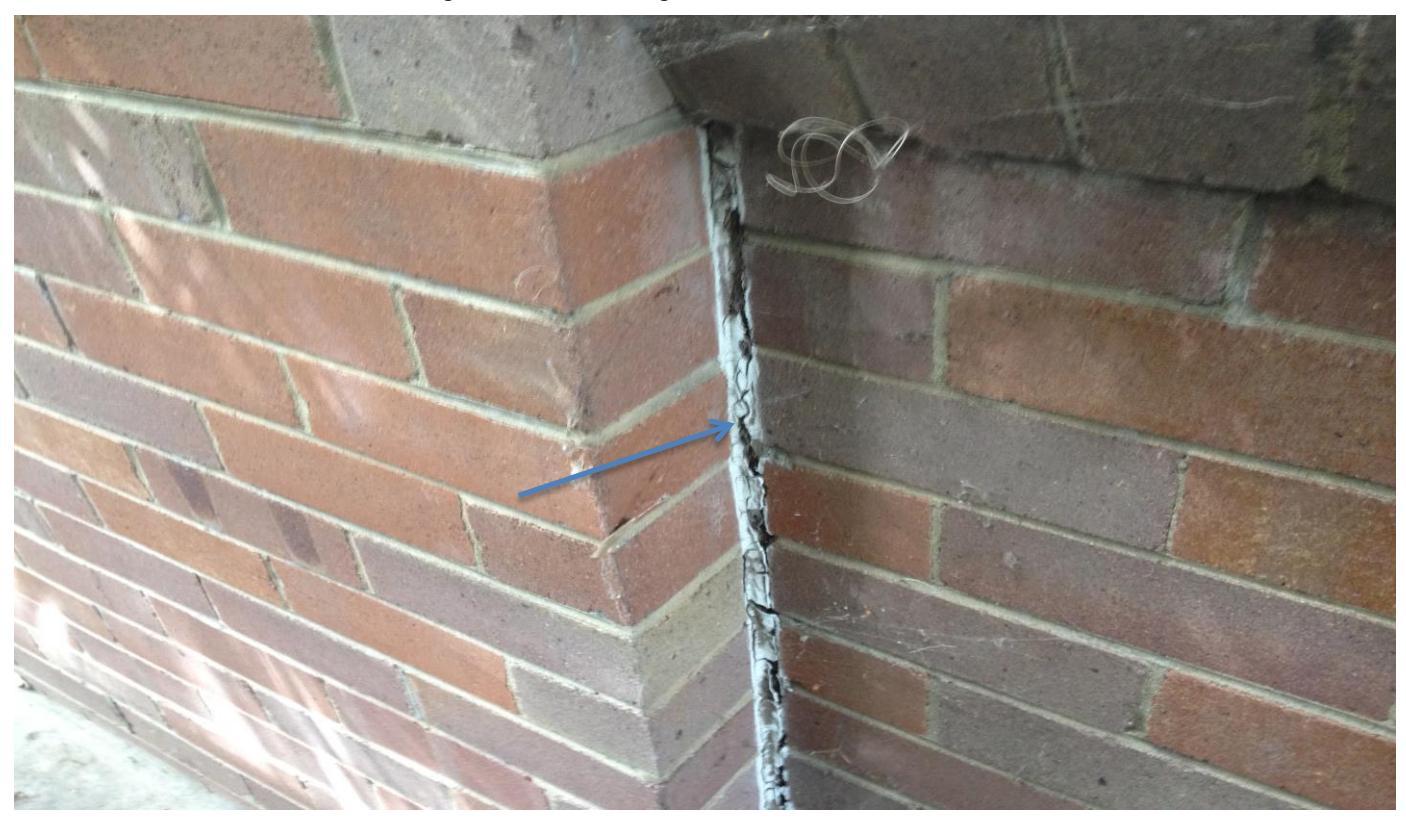
**Photo 54:** Mastic containing asbestos in the expansion joints of the northern perimeter wall of C Block – Science Annex.

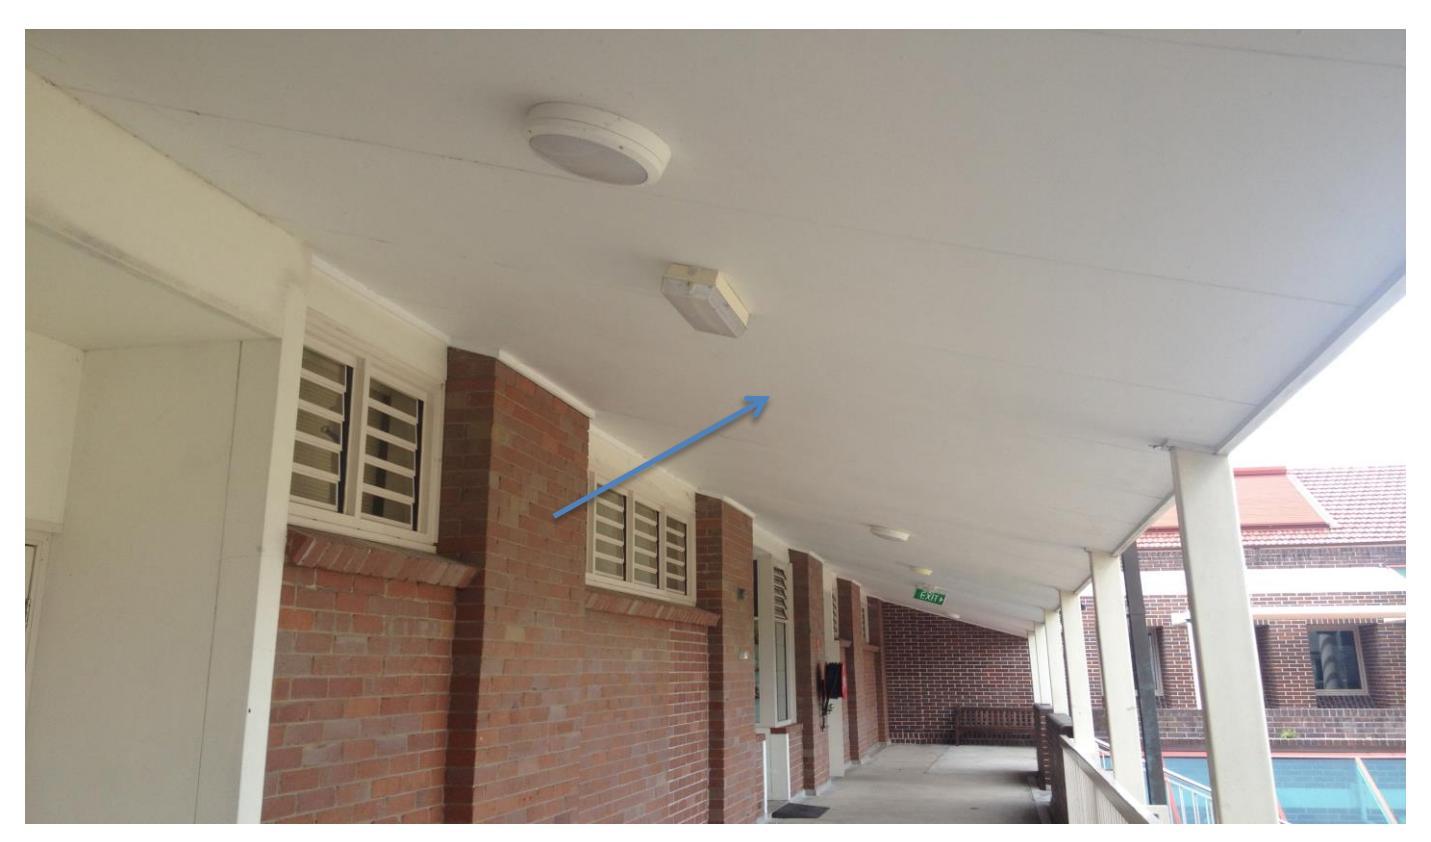
Photo 55: Asbestos cement sheeting on the awning linings of Level 4 of C Block – Science Annex.

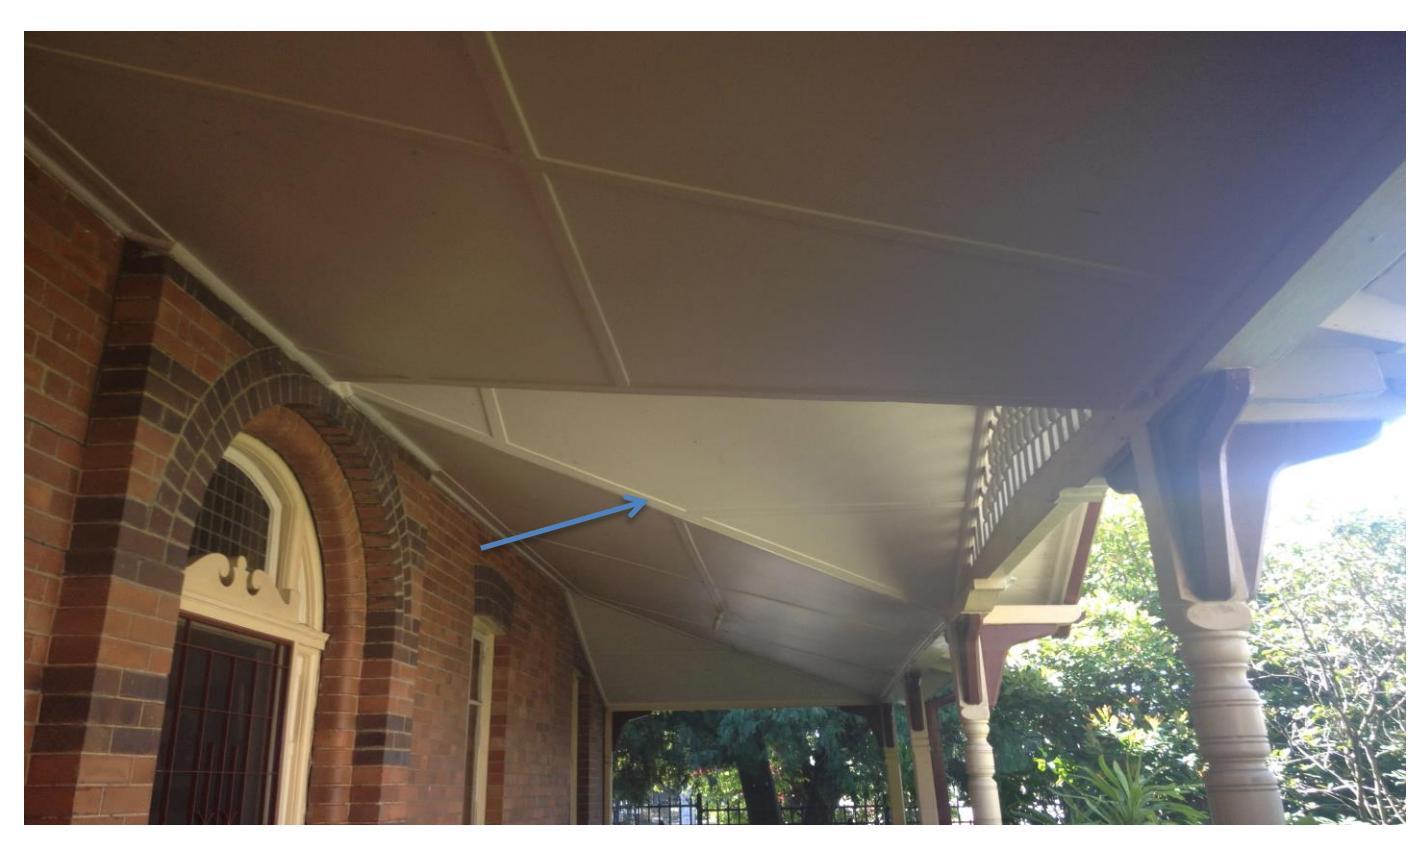
Photo 56: Asbestos cement sheeting on the ceiling lining of the verandah of Stokeleigh House.

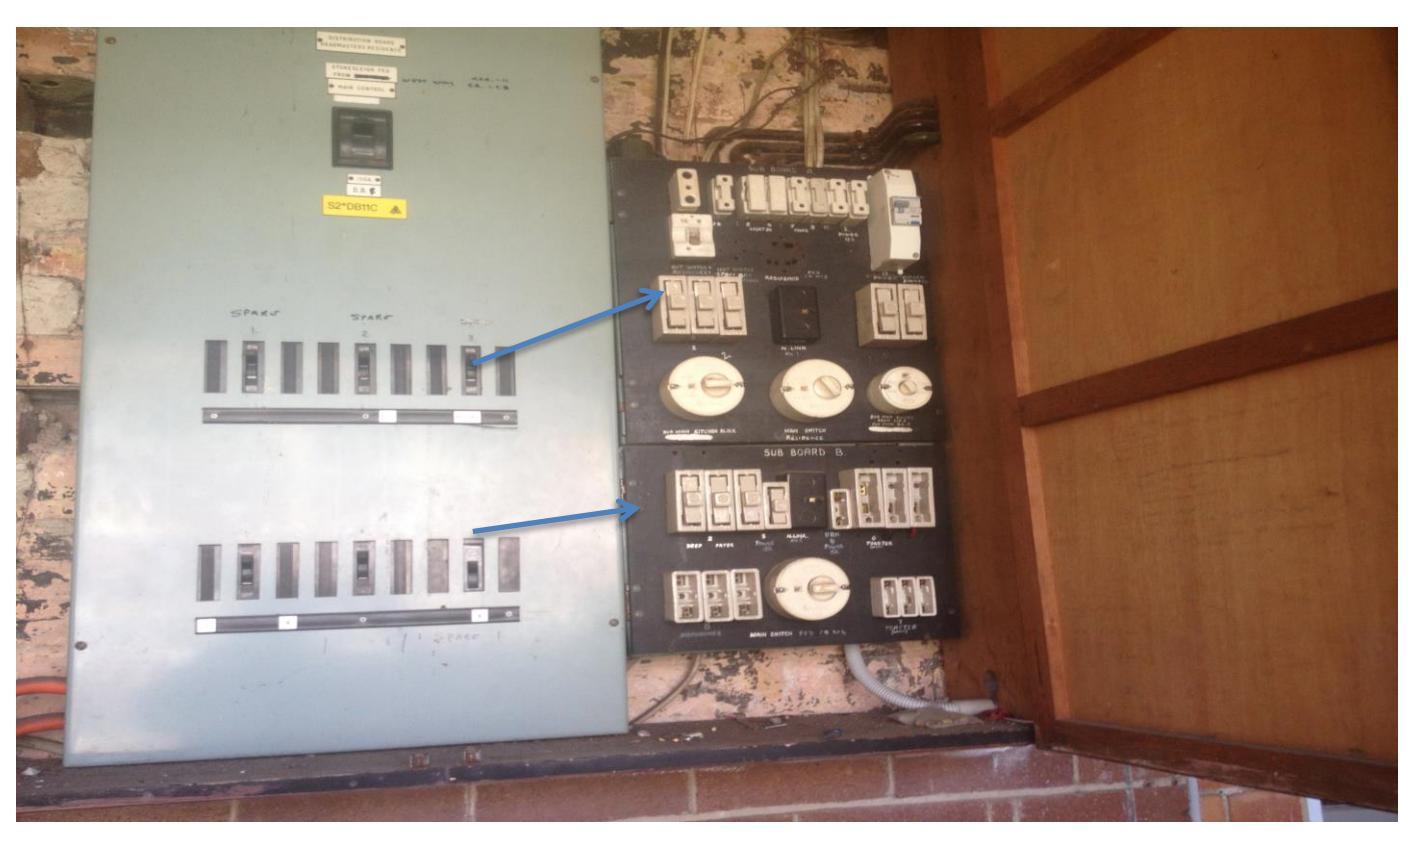
**Photo 57:** Two (2) bituminous electrical backing boards containing asbestos in the electrical box on the verandah of Stokeleigh House.

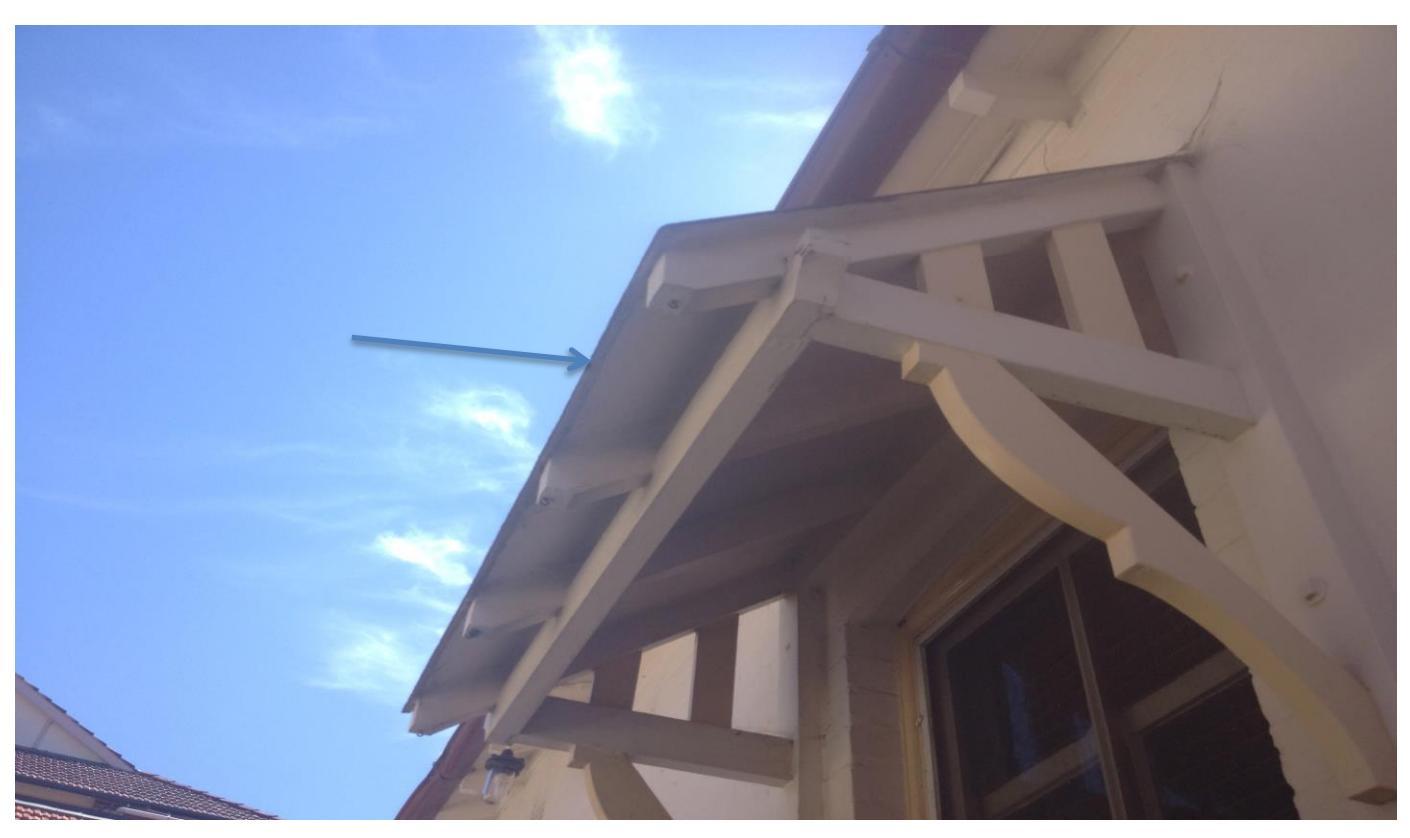
Photo 59: Asbestos cement sheeting above the windows on the southern perimeter of Stokeleigh House.

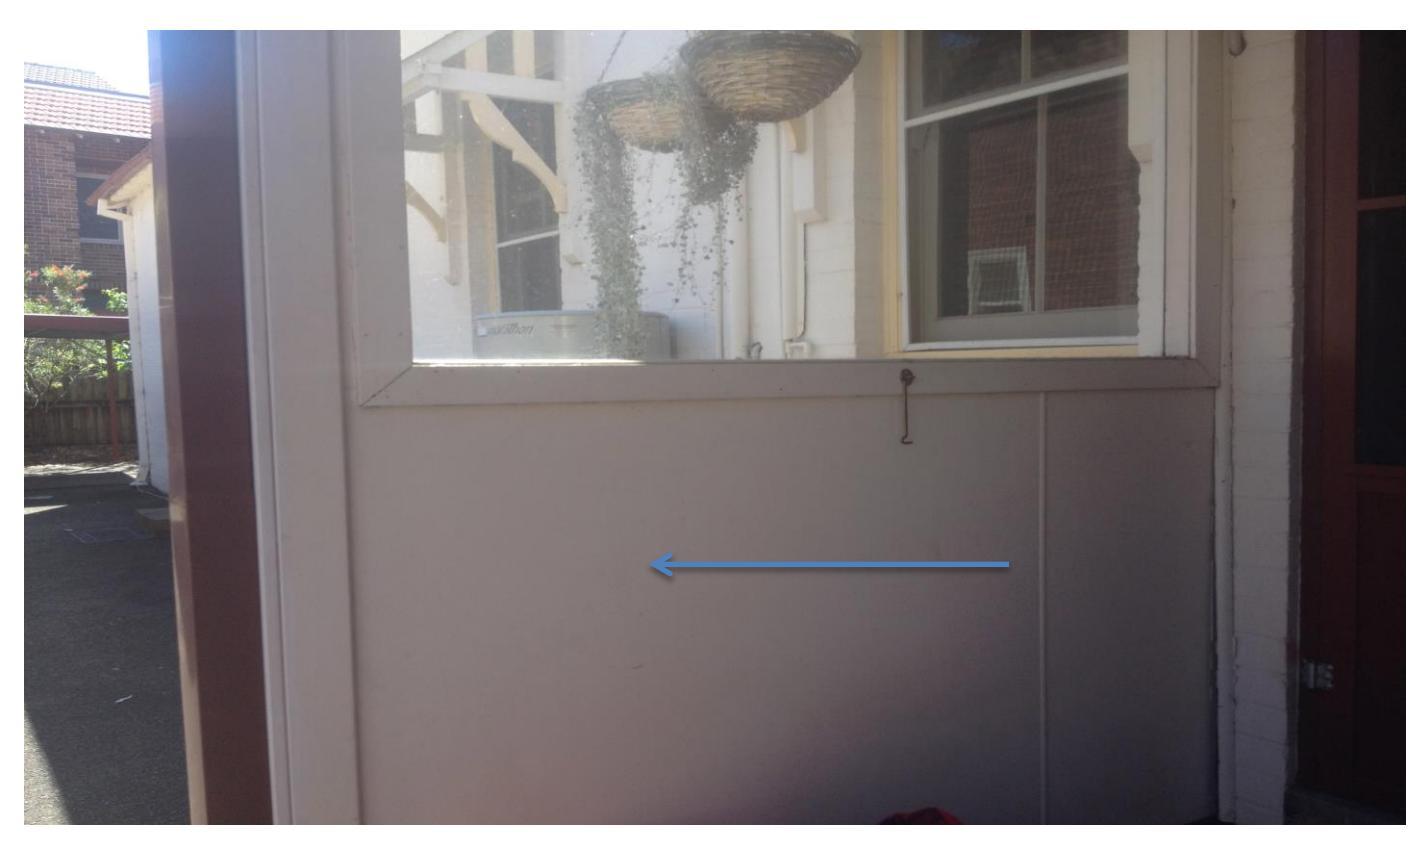
Photo 60: Asbestos cement sheeting partition wall at the southern entrance of Stokeleigh House.

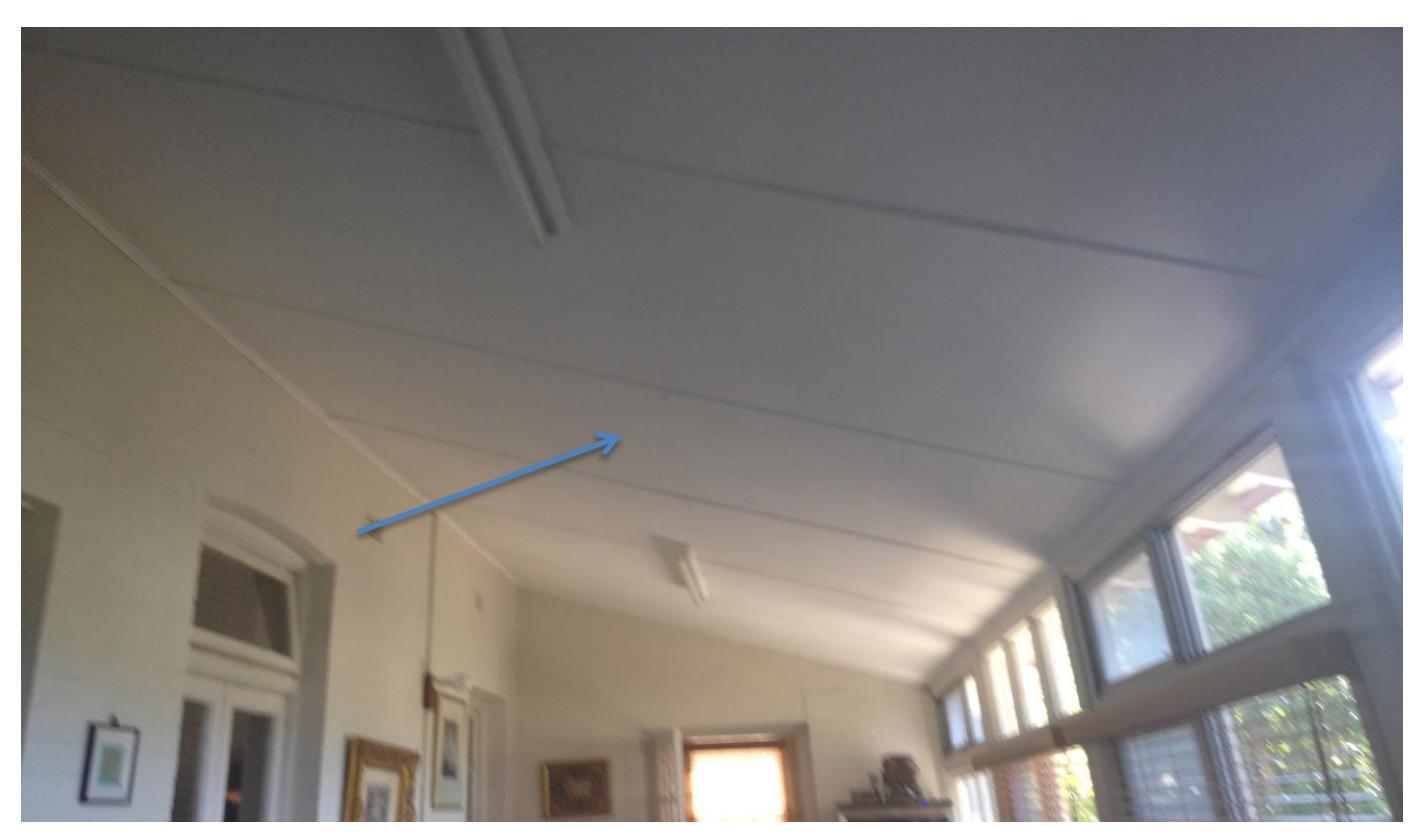
Photo 61: Asbestos cement sheeting on the ceiling lining of the Sunroom of Stokeleigh House.

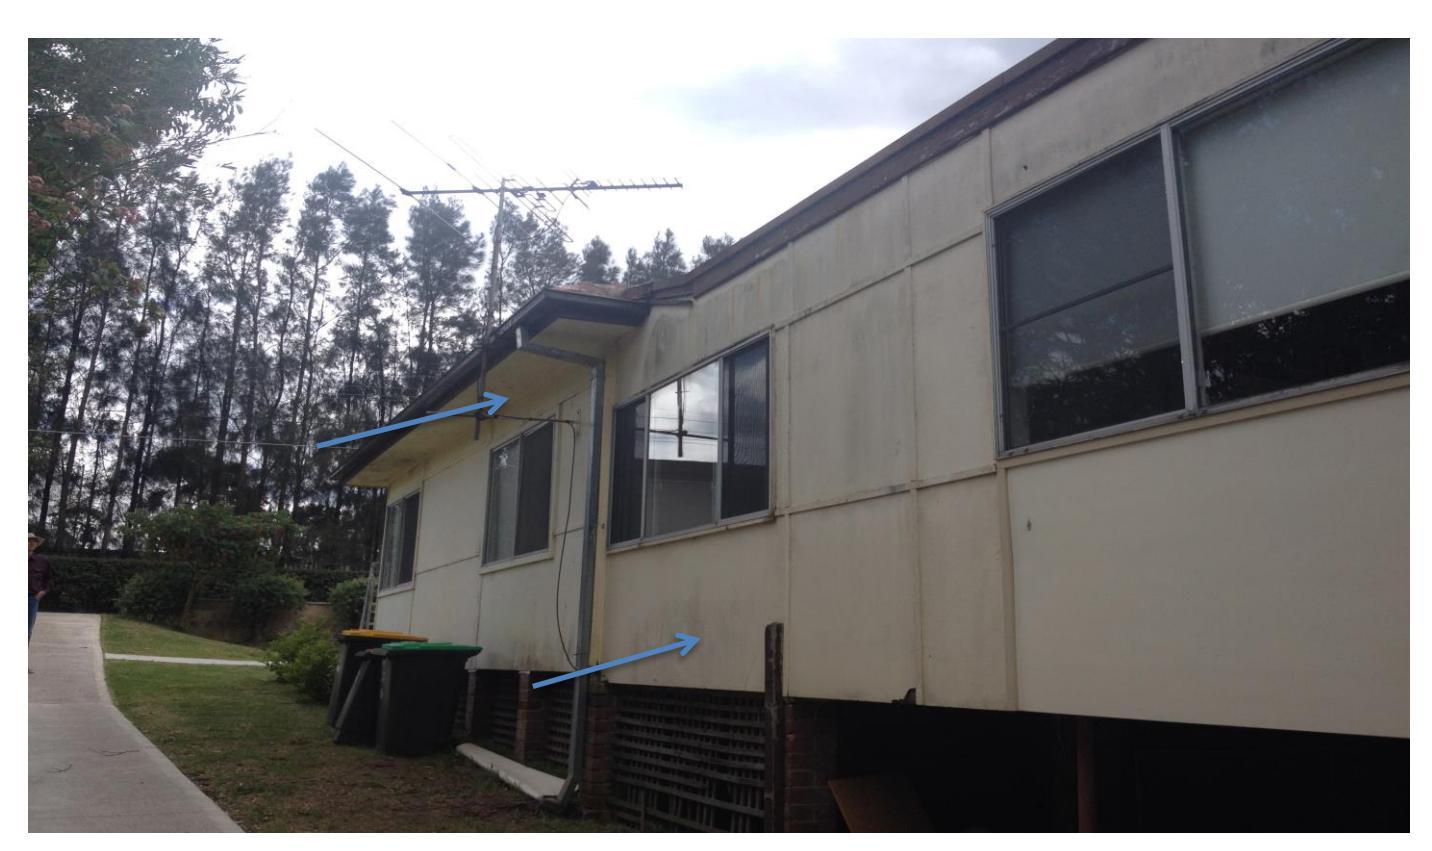
**Photo 62:** Asbestos cement sheeting on the eave lining's and external wall cladding of 21 Clarke Road – Male Boarding Accommodation.

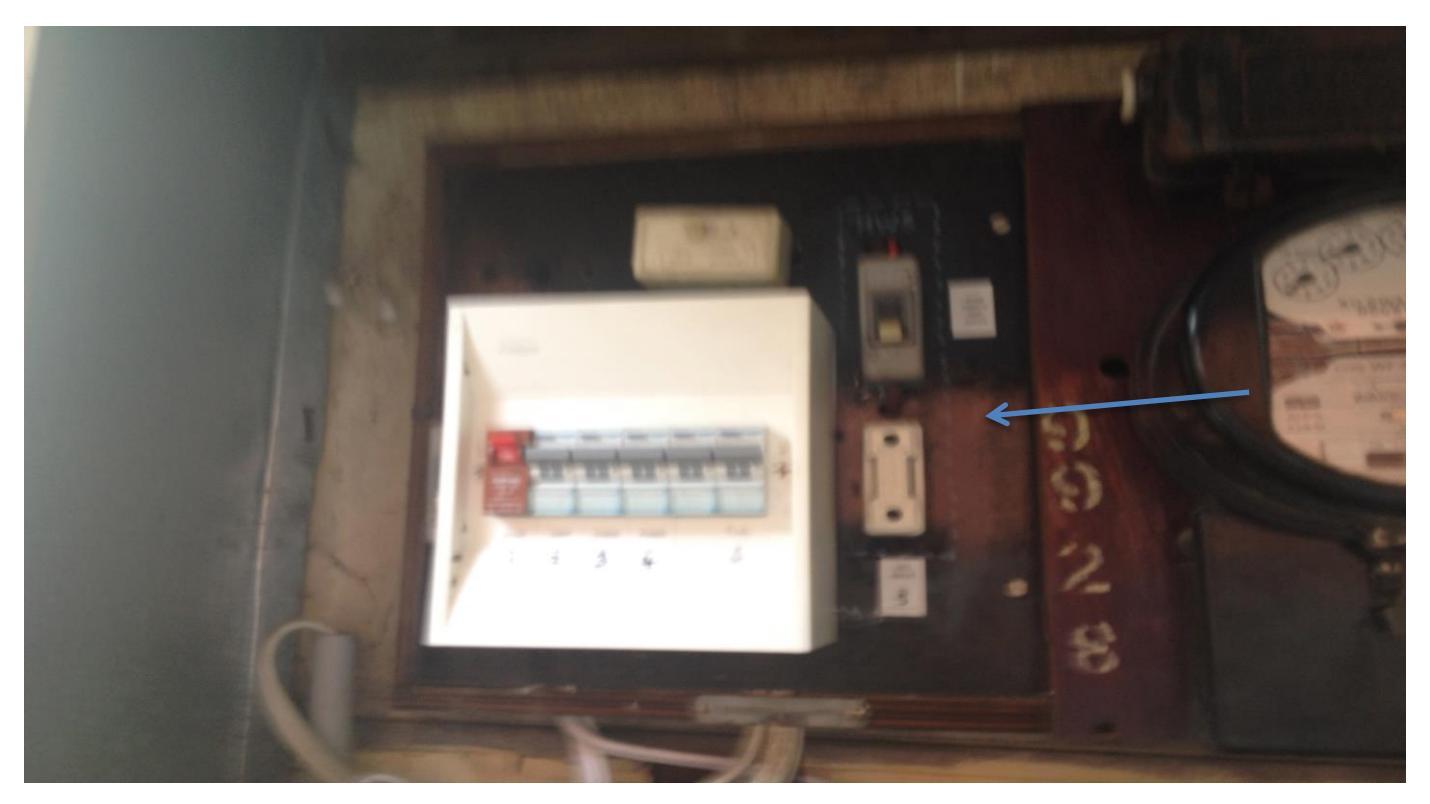
**Photo 63:** Bituminous electrical backing board containing asbestos on the eastern perimeter of 21 Clarke Road – Male Boarding Accommodation.

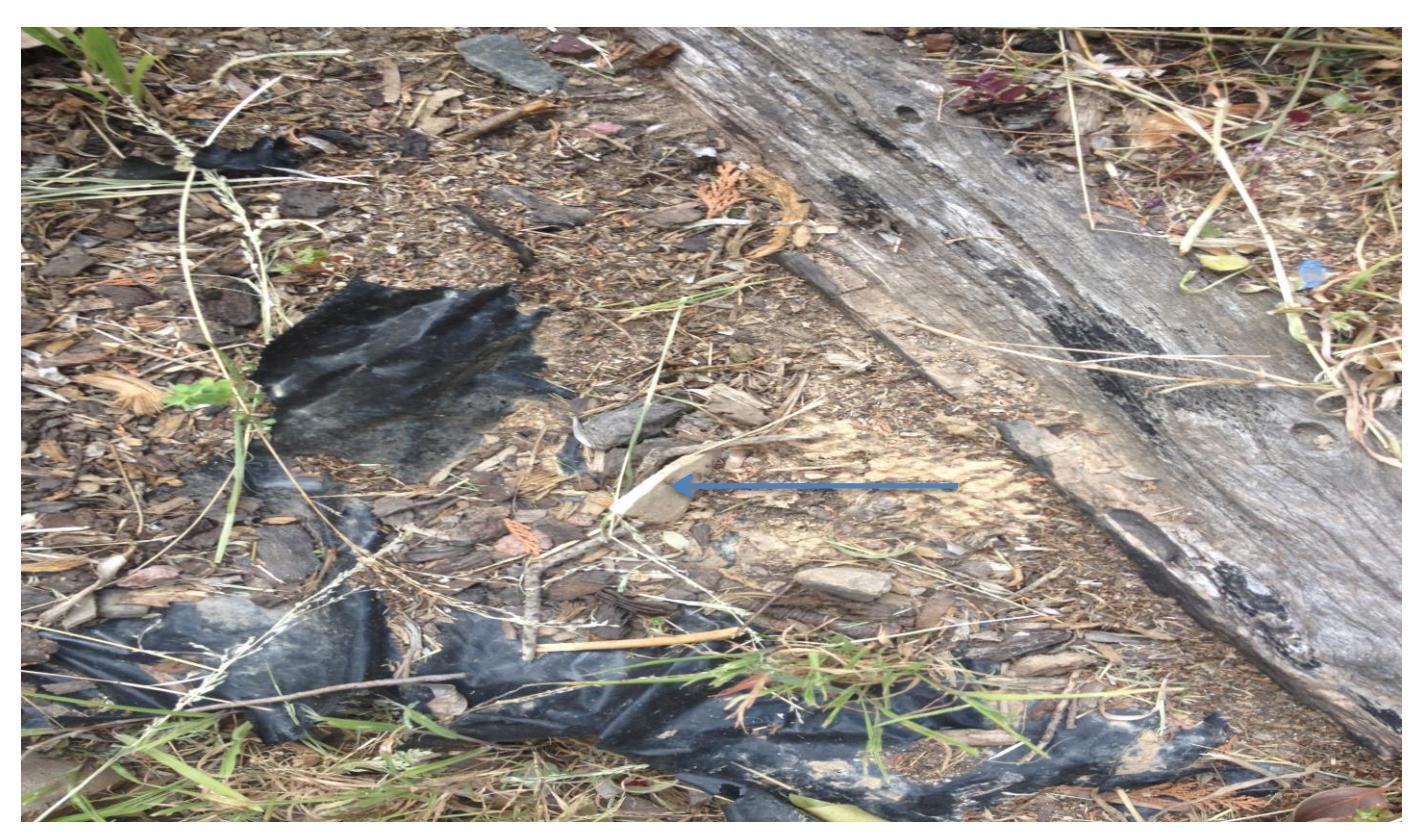
**Photo 64:** Asbestos cement sheet debris on the ground surface of the garden bed on the northern perimeter of 21 Clarke Road – Male Boarding Accommodation.

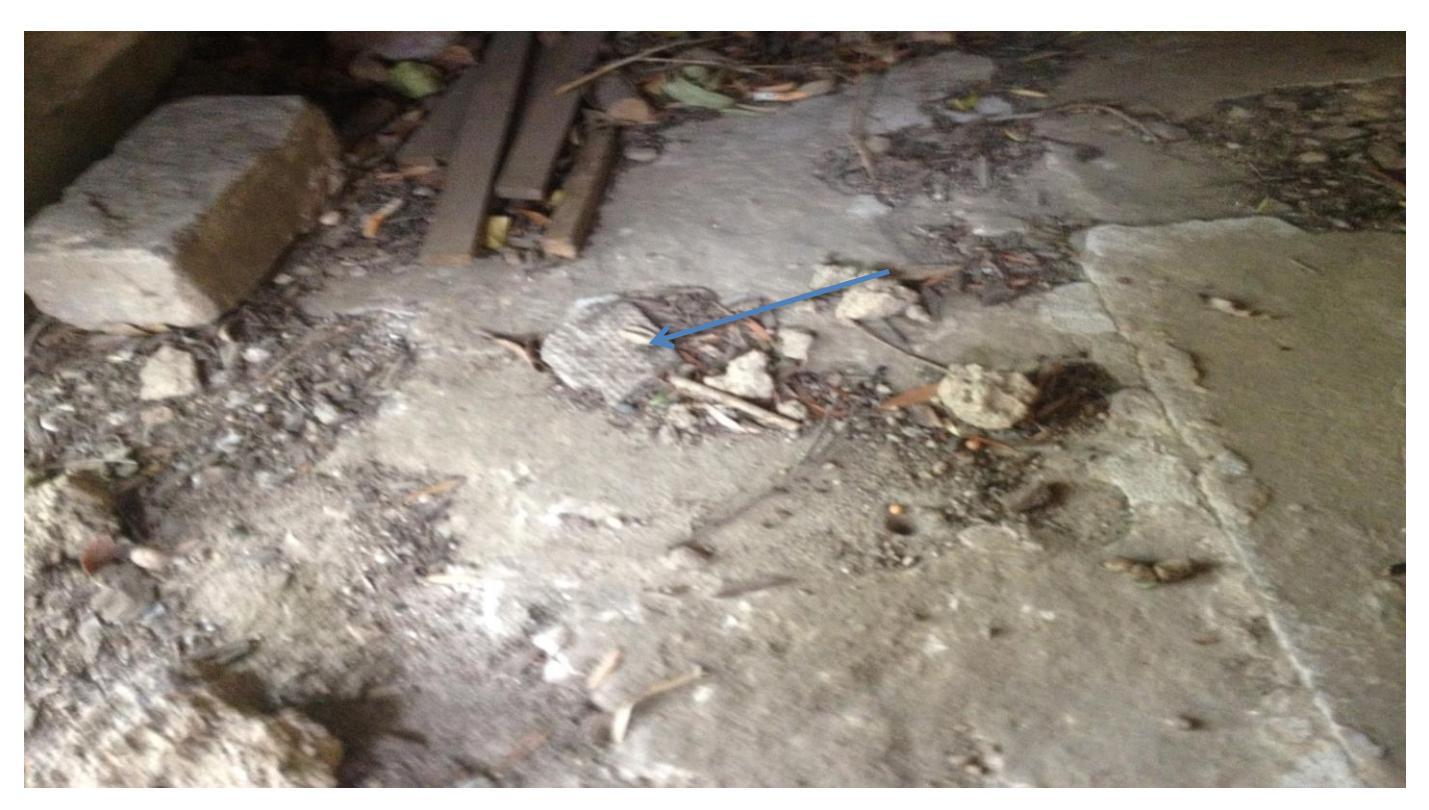
**Photo 65:** Asbestos cement sheet debris on the ground surface of the sub-floor of 21 Clarke Road – Male Boarding Accommodation.

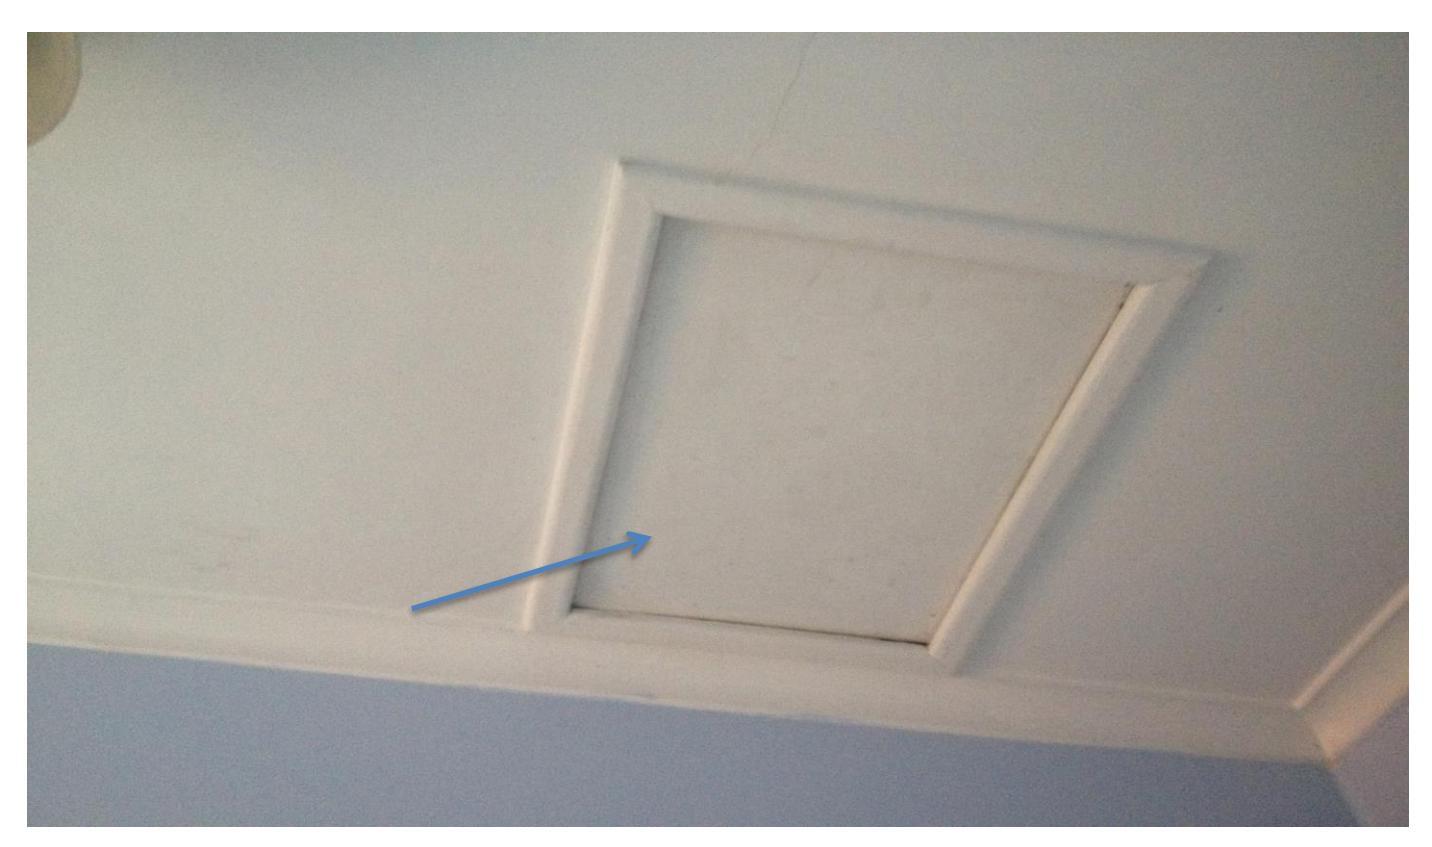
Photo 66: Asbestos cement man-hole cover in the Bathroom of 21 Clarke Road – Male Boarding Accommodation.

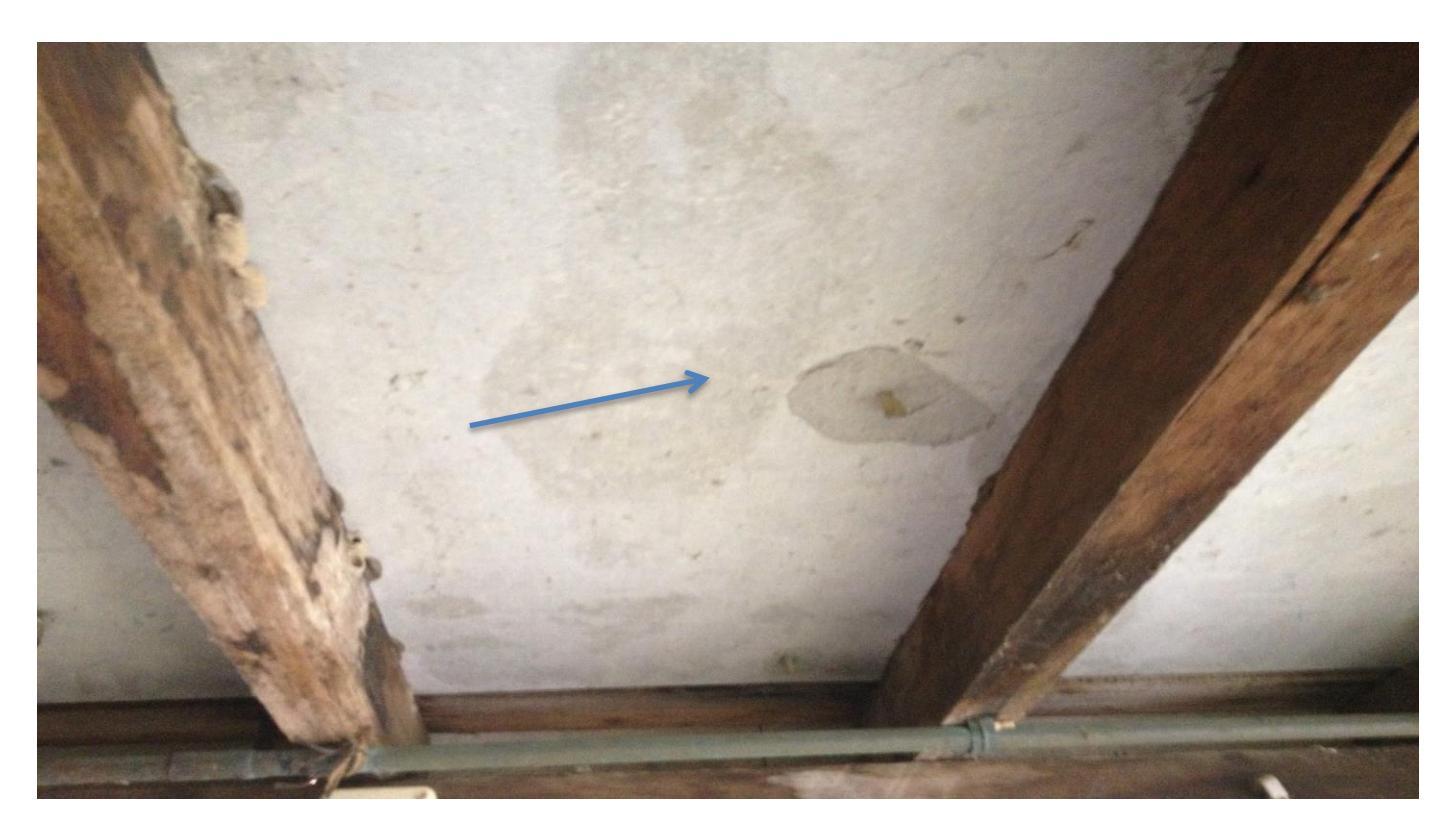
Photo 68: Compressed asbestos cement sheet floor in the Bathroom of 21 Clarke Road – Male Boarding Accommodation.

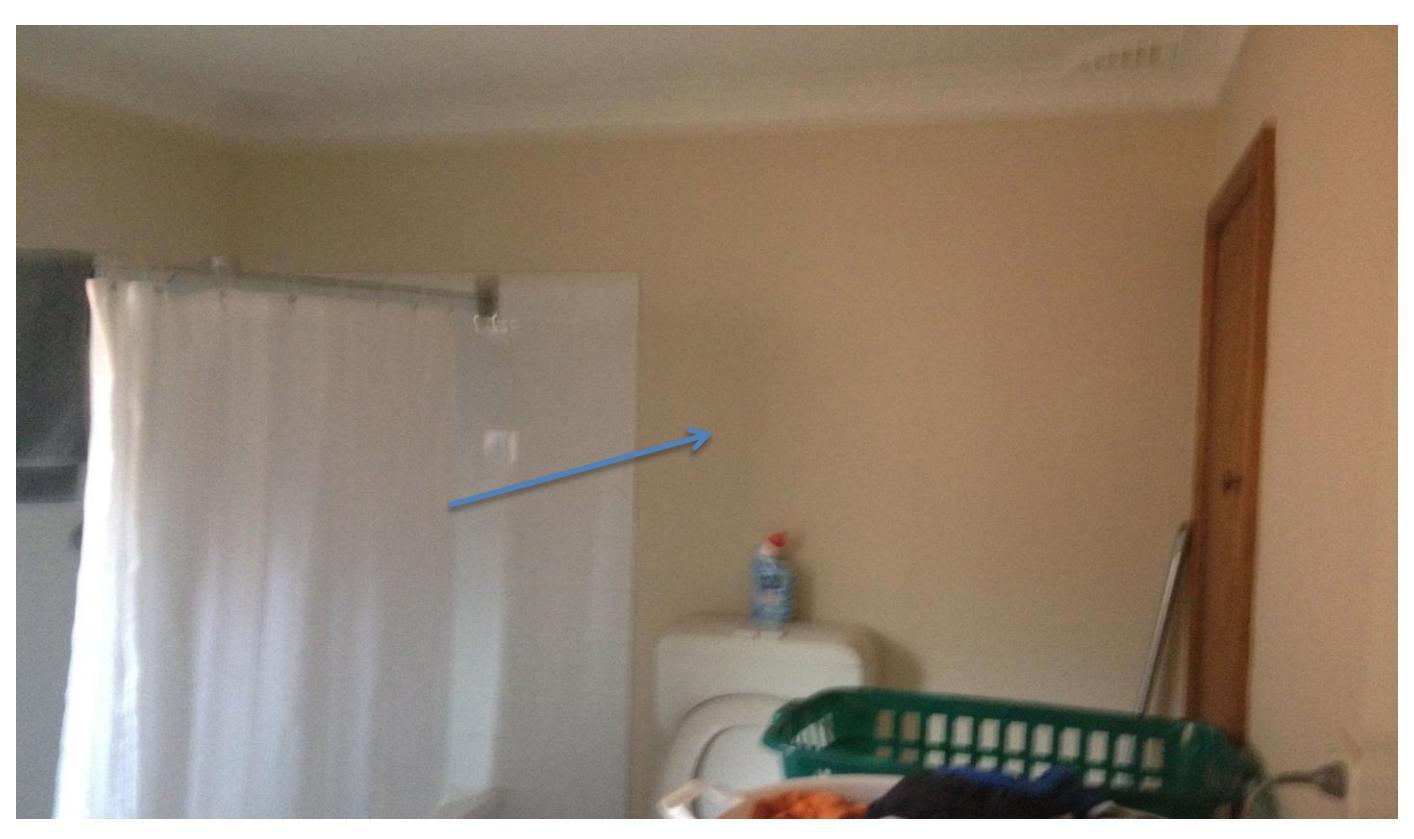
**Photo 69:** Asbestos cement sheeting on the internal wall cladding of the laundry of 21 Clarke Road – Male Boarding Accommodation.

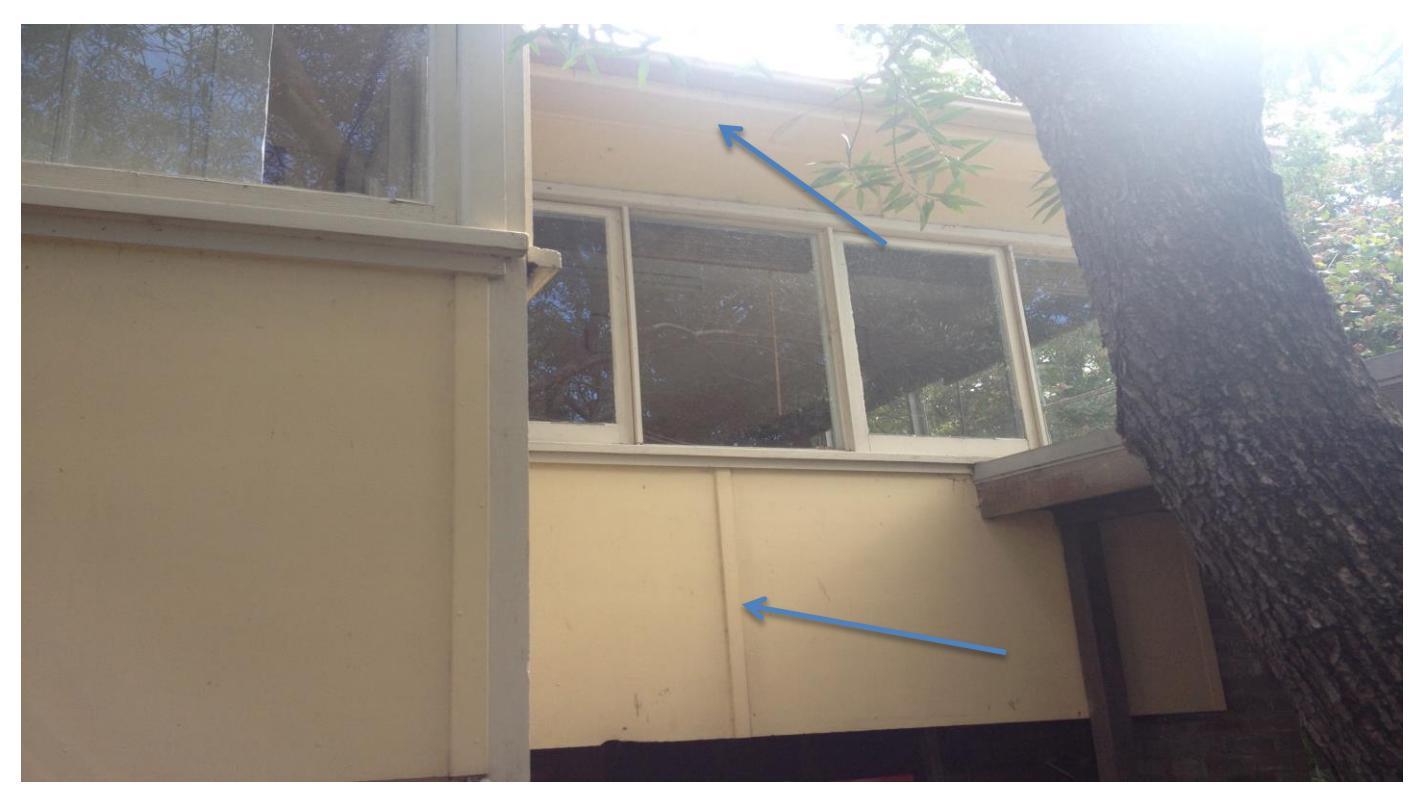
**Photo 100:** Asbestos cement sheeting on eave linings and external wall cladding of the rear addition to 23 Clarke Road – Female Boarding Accommodation.
