HAZARDOUS MATERIALS REGISTER

Barker College – 91 Pacific Highway

Project No. 21401 [Rev 1.]

Date: 10/09/20

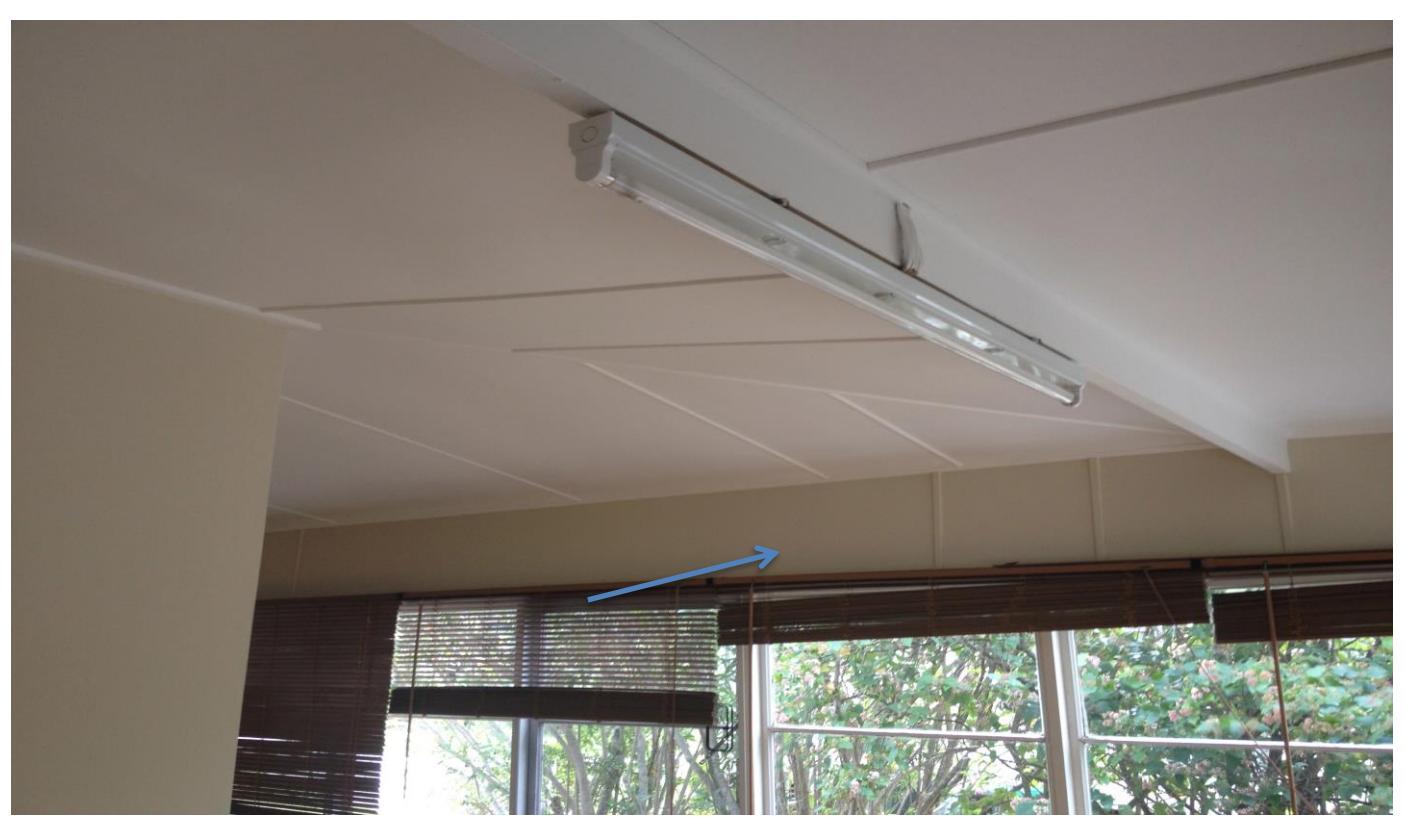
**Photo 73:** Asbestos cement sheeting above the windows of the Sunroom of 23 Clarke Road – Female Boarding Accommodation.

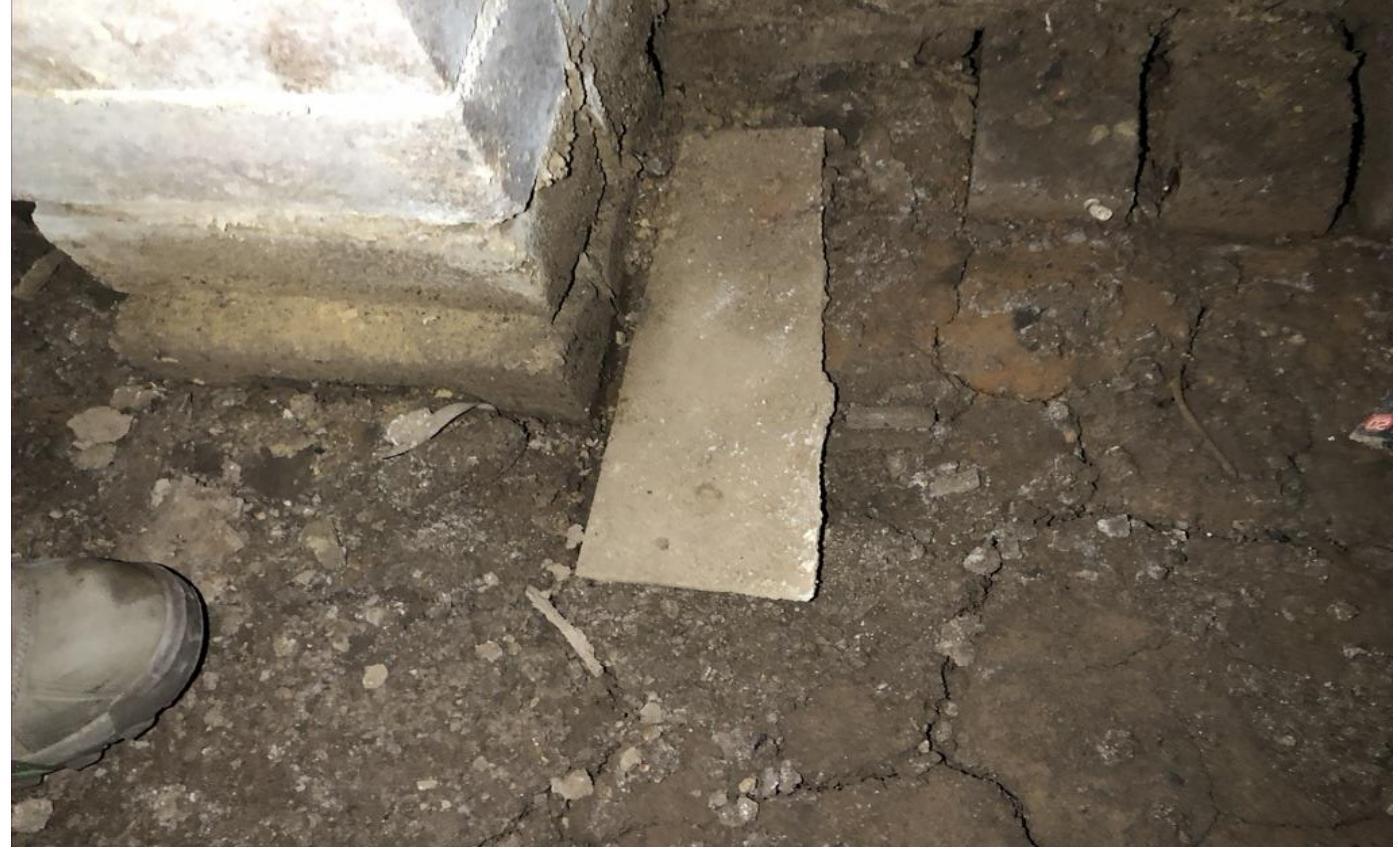
Photo 74: Sub Floor Fragments

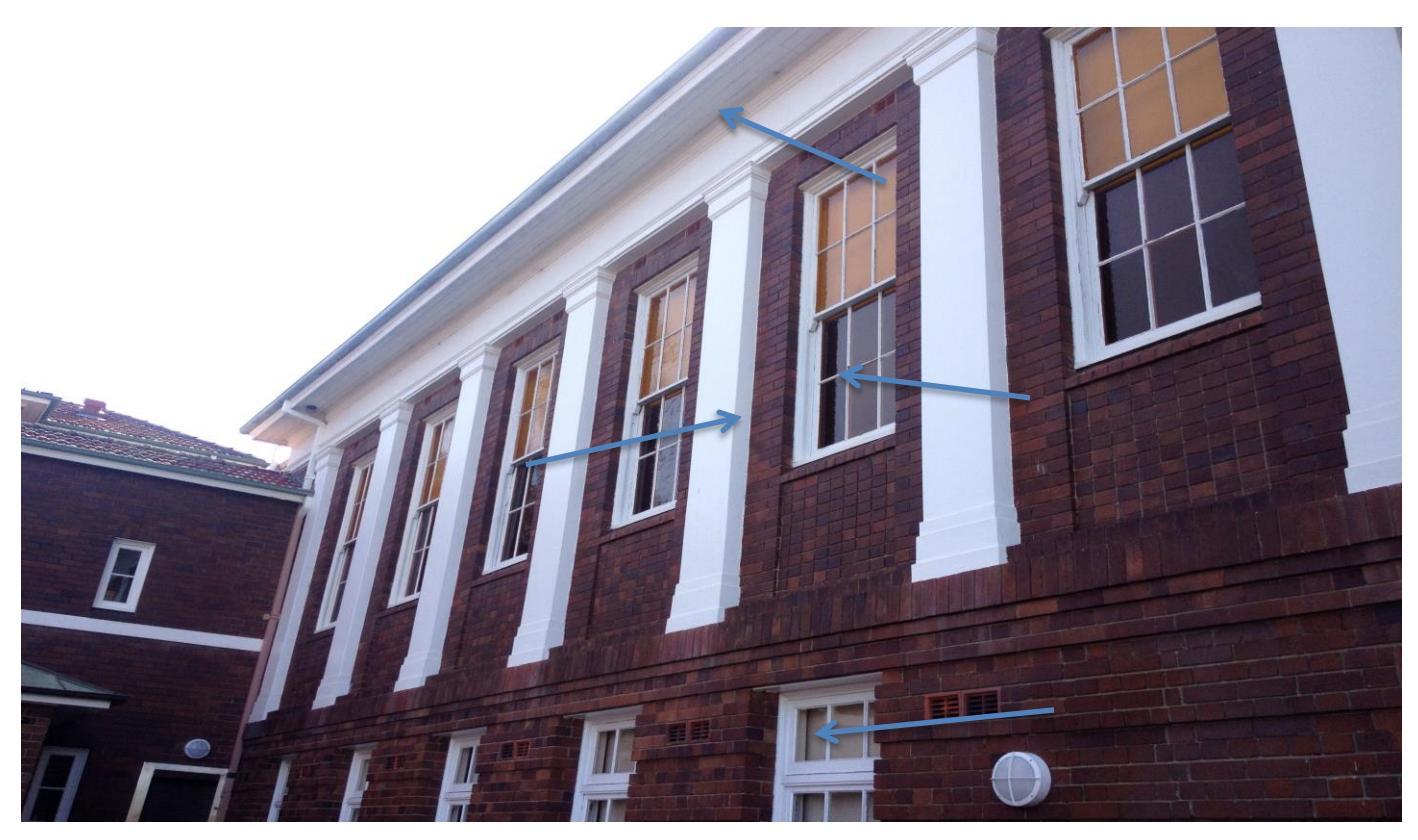
**Photo 75:** White paint containing elevated levels of lead on the window frames and eave linings of Boyce Hall and on the window frames of Language.

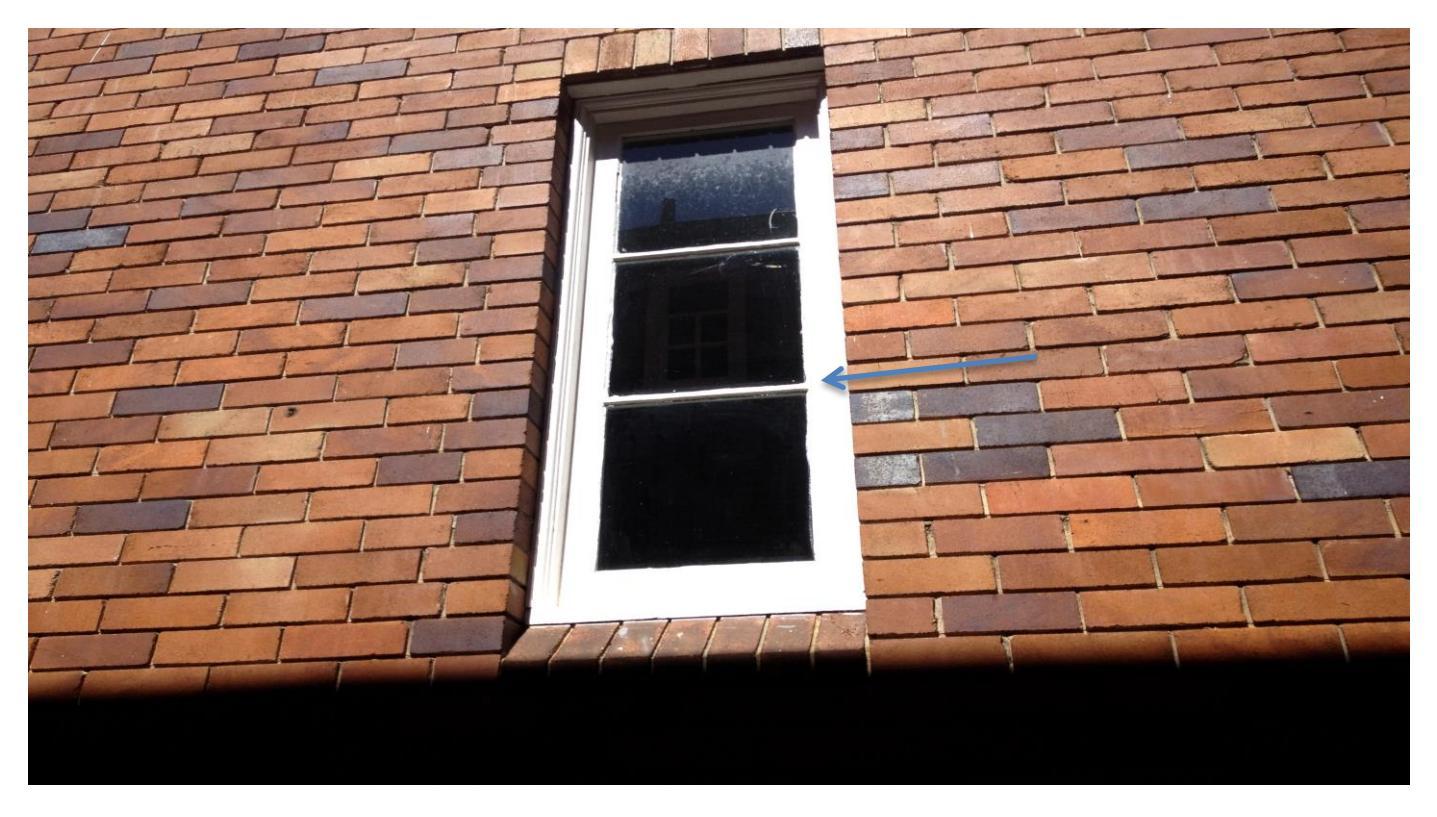
**Photo 77:** White paint containing elevated levels of lead on the window frames on the Ground Level of Boys Boarding.

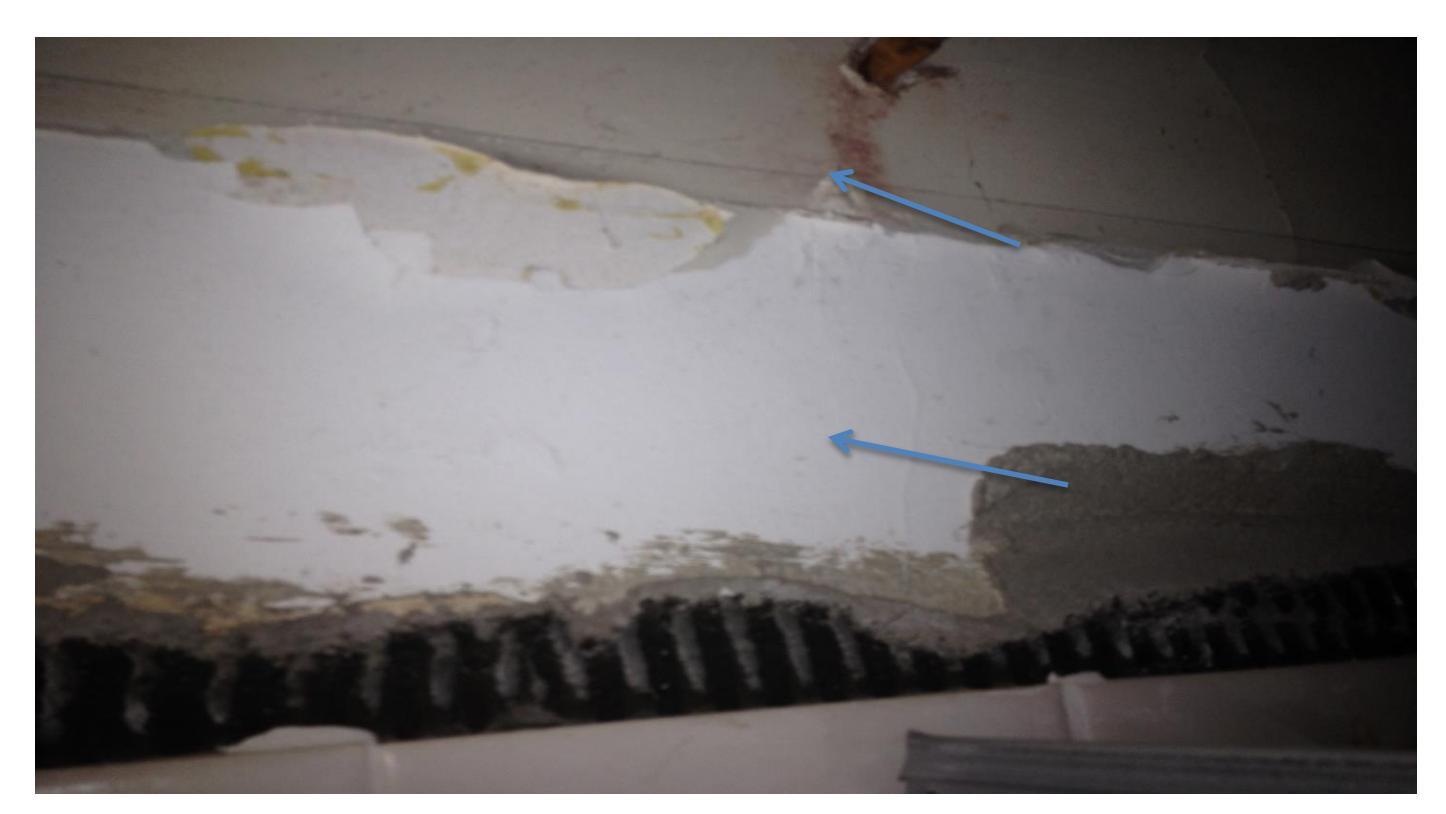
**Photo 78:** Cream/grey paint containing elevated levels of lead on the soffit lining and internal walls in the ceiling space of the showers adjacent the eastern entrance on the Ground Floor of Plume Boarding House.
