9.1 HISTORY OF THE PUMP HOUSE

9.2 PHYSICAL ANALYSIS OF THE PUMP HOUSE

10 THE ENGINE HOUSE

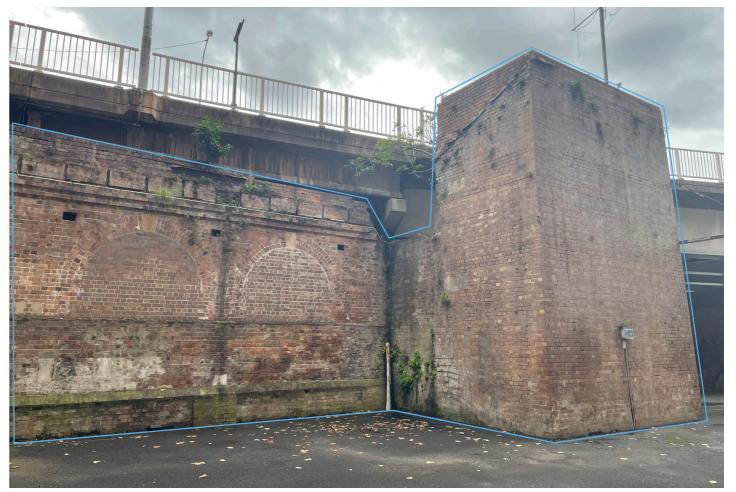
Figure 9.13 Remnant northern wall and chimney base (blue) of the 1899 Pump House (Source: Powerhouse 2022)

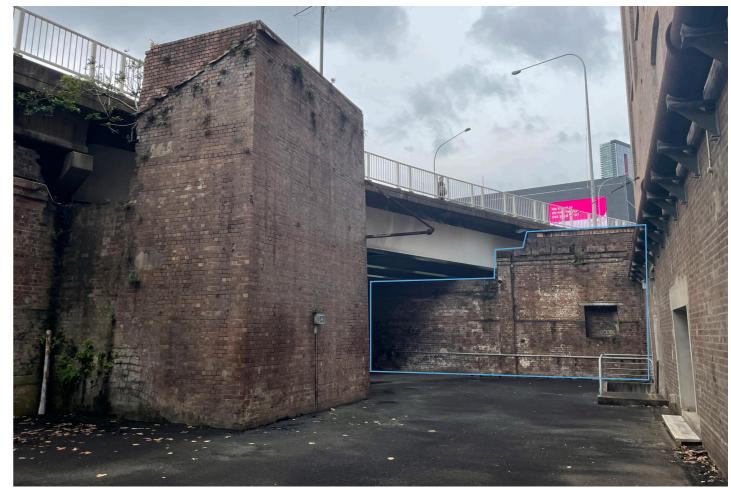
Figure 9.14 Remnant eastern wall (blue) of the 1899 Pump House (Source: Powerhouse 2022)

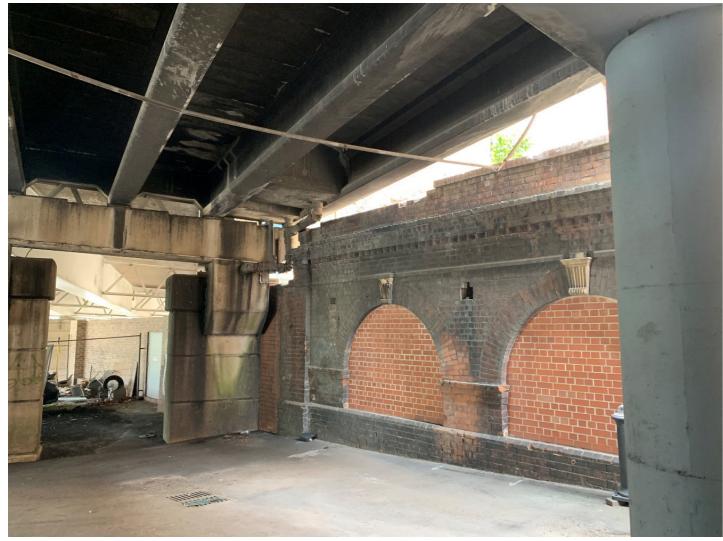
Figure 9.15 Remnant northern façade of the former Pump House is only visible from beneath the William Henry Street bridge (Source: Curio 2020)

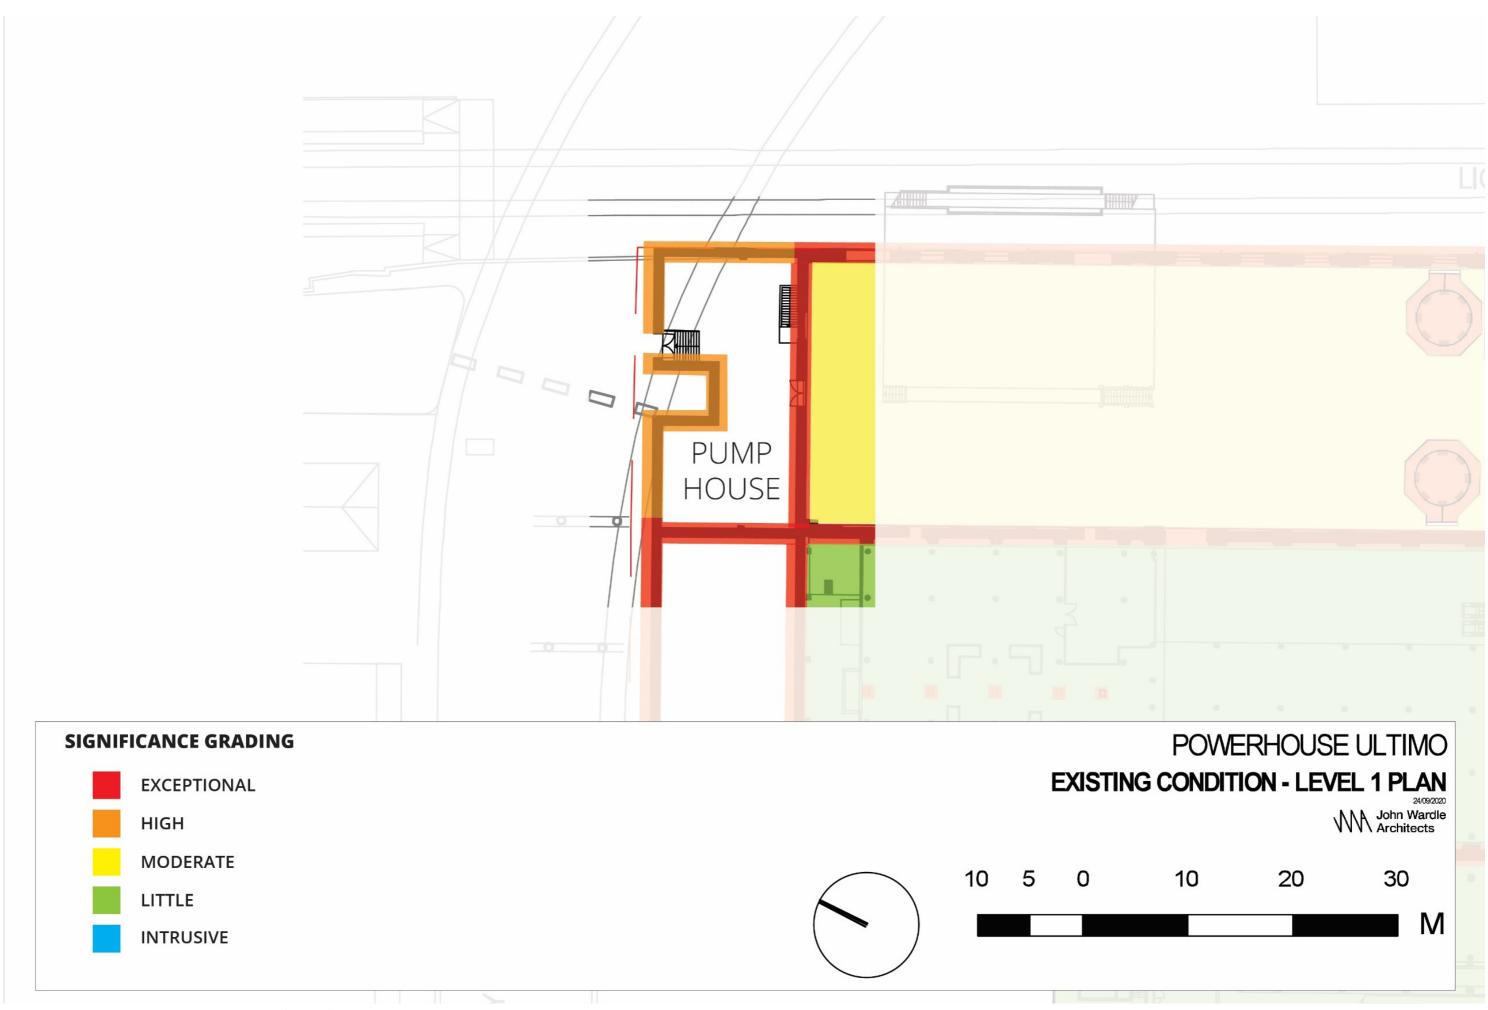
Figure 9.17 Former Pump House Grading of Significant Components (Curio 2021)

ELEMENT GRADING **IMAGE** NOTES MODERATE Roof Structure The majority of the form and structure of the roof of the pump house is no longer present, with only several iron beams remaining attached to the remnant fabric of the chimney stack and to the northern wall of the Boiler House. The outline of the former Pump House roof remains visible on the wall of the boiler house and this visual feature should be retained. External Walls (Original) HIGH As one of the only remaining elements from the original Power House, the original walls are of high significance. Opportunities to interpret the remnant fabric of the Pump House should be investigated. Chimney HIGH As the only extant chimney from the original 1899 Power House, what remains of the pump house chimney is of high significance. Opportunities to interpret the remnant fabric of the Pump House should be investigated. Floor • LITTLE The modern asphalt surface that has been constructed across the footprint of the former Pump House consistent with Level 1 of the Boiler House, including concrete access stairs adjacent to the Boiler House northern façade, and access to William Henry Street, are of little significance.

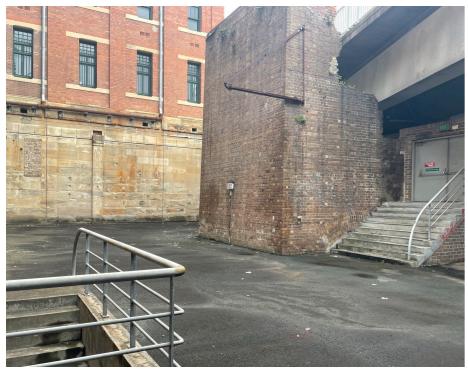
Pump House Viewpoint 1: North Annex in Background. Remnant chimney fabric and roof truss visible. Access to William Henry Street in right. Modern asphalt surface consistent with Boiler House Level 1.

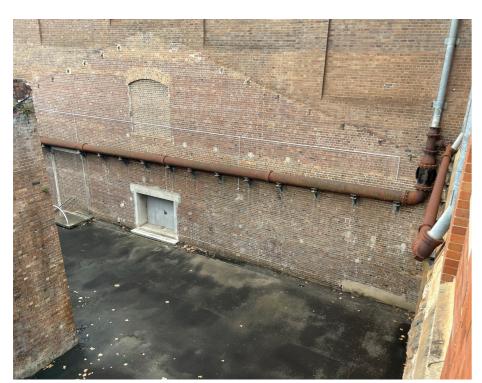
Pump House Viewpoint 4: Boiler House northern façade, outline of former Pump House roof visible in brickwork.

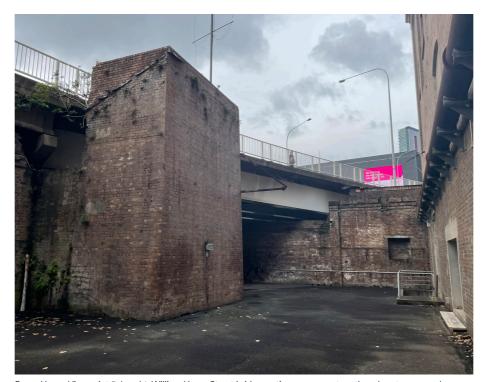
Pump House Viewpoint 5: Level 1, William Henry Street bridge resting on remnant north and eastern pump house walls, remnant chimney section.

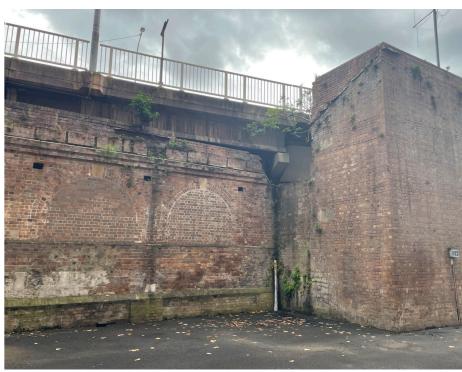
Pump House Viewpoint 6: Level 1, interior of remnant northern wall and chimney, William Henry Street bridge above.

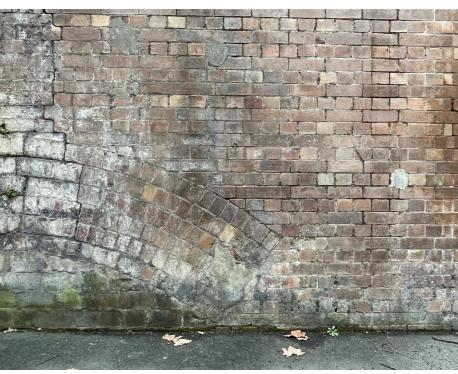
Pump House Viewpoint 8: Original brick archway obscured by construction of modern Level 1 surface

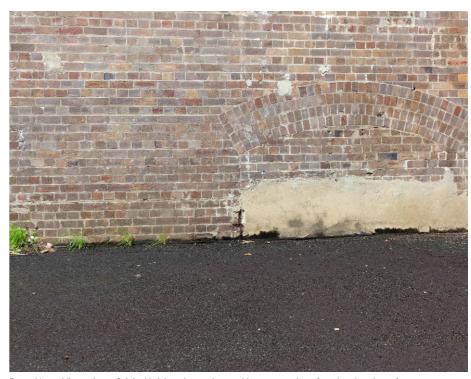
Pump House Viewpoint 9: Original brick archway obscured by construction of modern Level 1 surface

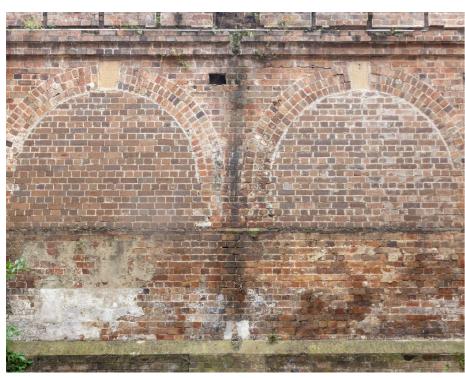
Pump House Viewpoint 10: Northern wall interior, bricked over archways

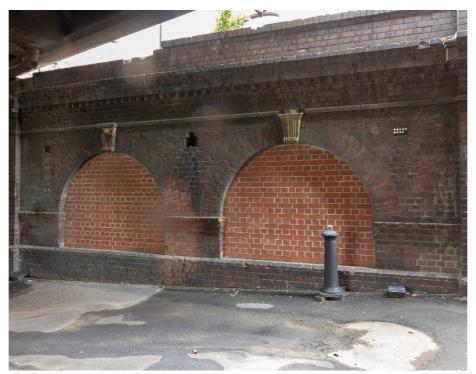
Pump House Viewpoint 11: Northern wall exterior from William Henry St, archways infilled with modern brick
