# ARBORICULTURAL DEVELOPMENT IMPACT AND TREE PROTECTION REPORT

Shoalhaven Hospital –  
**Acute Services Building Project**  
North Street and Scenic Drive  
NOWRA NSW 2541  
Lot 1 DP 1043088, Lot 1 DP 1128  
777, Lot 2 DP 1128777, Part 7300 DP 1132679  
JULY 2022  
FINAL (Updated 30<sup>th</sup> August 2022)

Prepared for: Health Infrastructure  
c/o Johnstaff

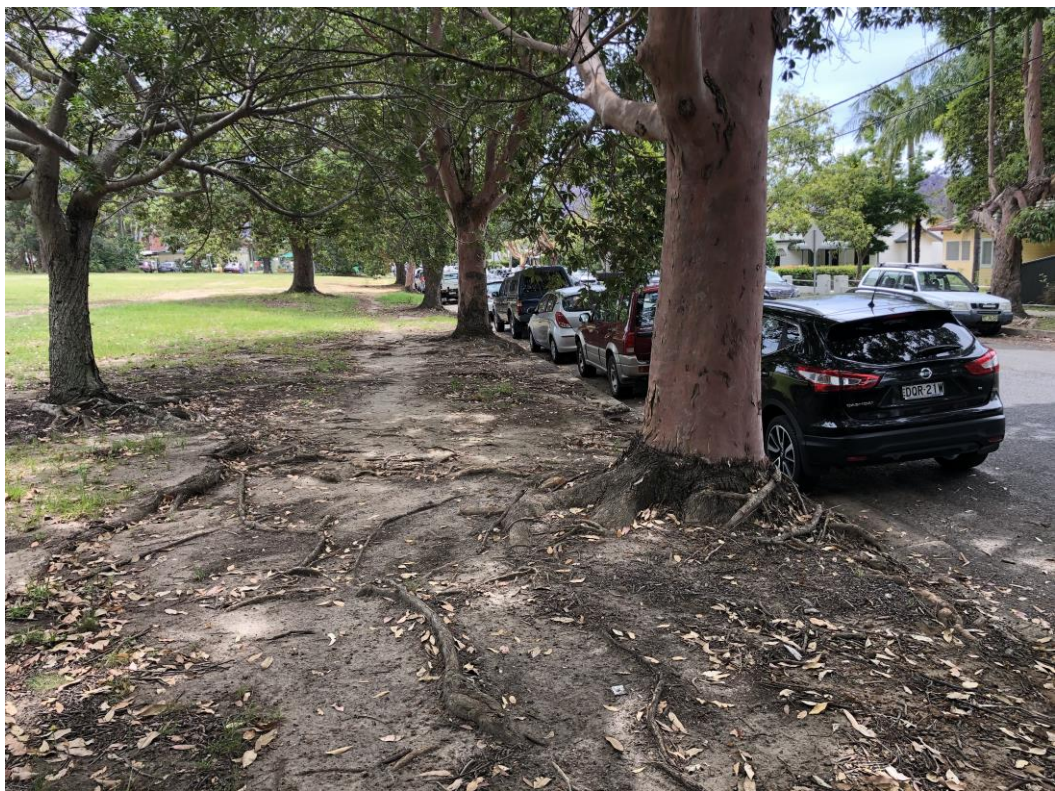
- 3.6** Shoalhaven Street has Brushbox specimens planted as street trees along the road verge (Trees 57-62). These trees provide good visual amenity to the streetscape, however they have grown with raised exposed woody roots that are some distance higher than the kerb and gutter that they are near (Plate 1). Any large scale development works will require this damaged kerb and gutter to be repaired and this will be difficult to do if trying to retain these trees along Shoalhaven Street.

**Plate 1:** Image showing Trees 57-62 along Shoalhaven Street and the woody surface roots clearly evident. P. Vezgoff

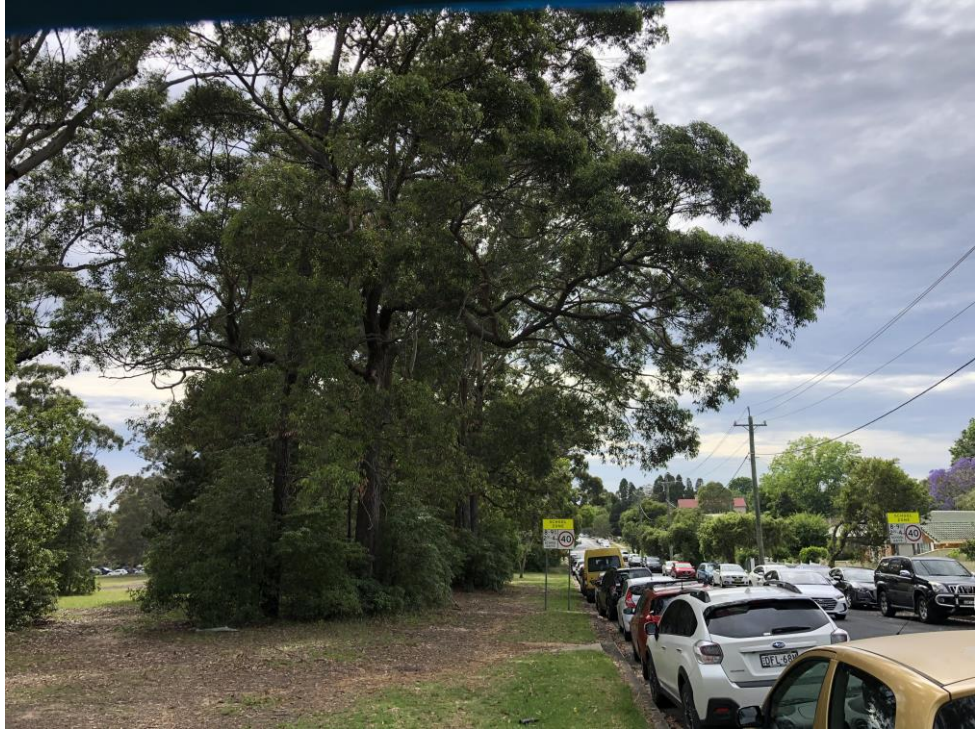
- 3.7** The large mature specimens along North Street are probably the more significant trees within the site (Plate 2). These trees are generally in good health and condition and provide a good visual screen between the site and nearby residential dwellings. If any of these trees are retained the area should be retained as garden area, and not a high use pedestrian area, due to the potential for limb failure from these trees.

**Plate 2:** Image showing the large mature specimens along North Street . P. Vezgoff

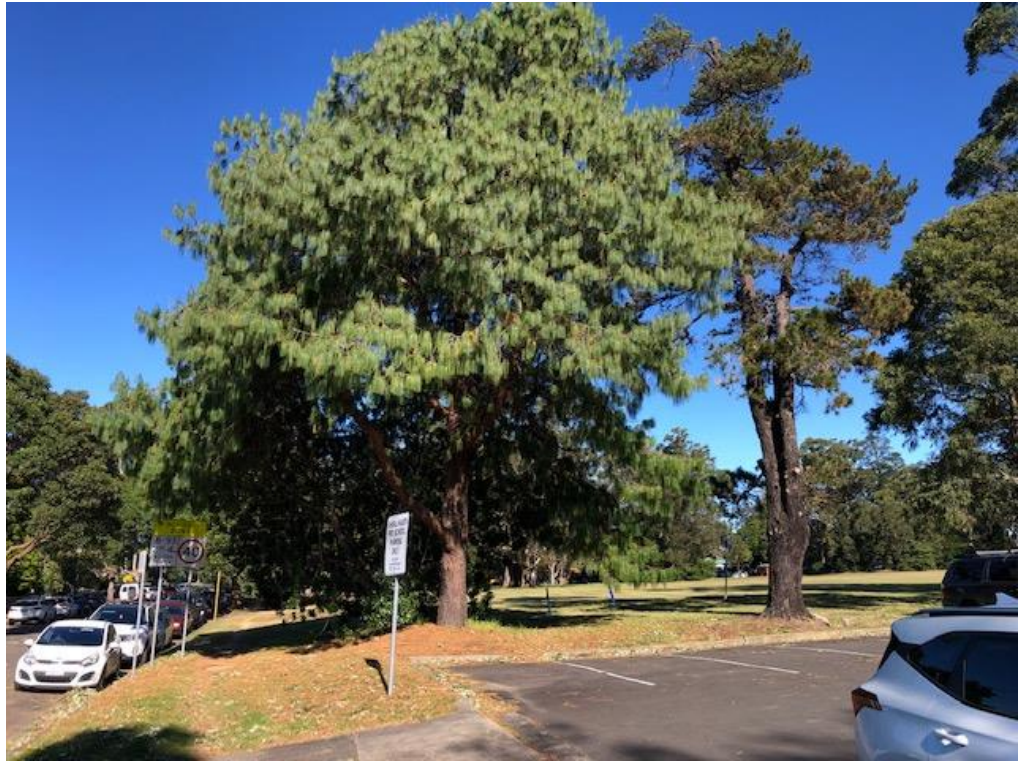
- 3.8** The trees in and around the childcare centre are mostly natives but are smaller specimens that could be replaced if necessary (Plates 3 and 4). Trees 72 and 73 are two (2) large Radiata Pines that look impressive in their open location however they are in decline and do not have a very long life expectancy (Plate 5).

**Plate 3:** Image showing exotic specimens 64 and 65. P.Vezgoff.

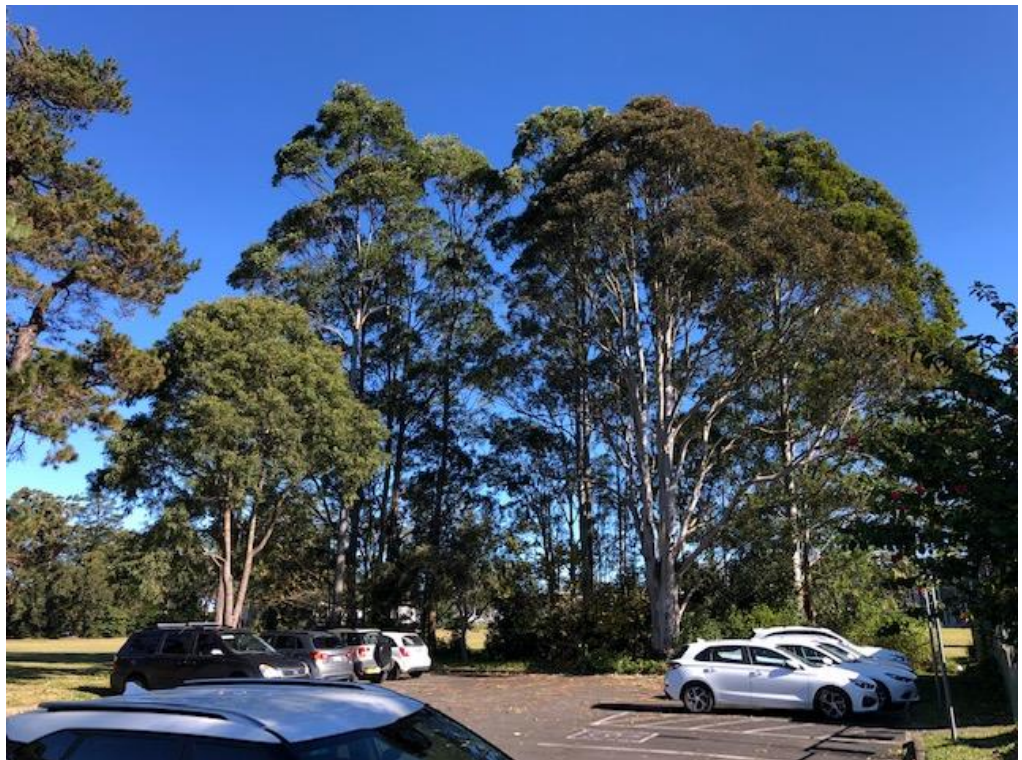
**Plate 4:** Image showing Trees 66-71. P.Vezgoff.

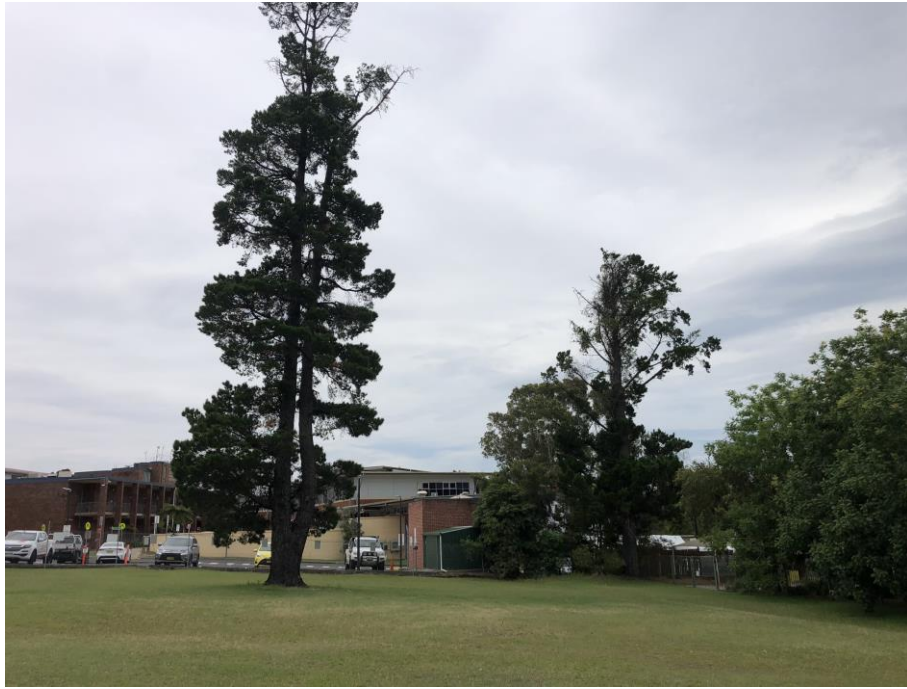
**Plate 5:** Image showing Trees 72 and 73 . P. Vezgoff

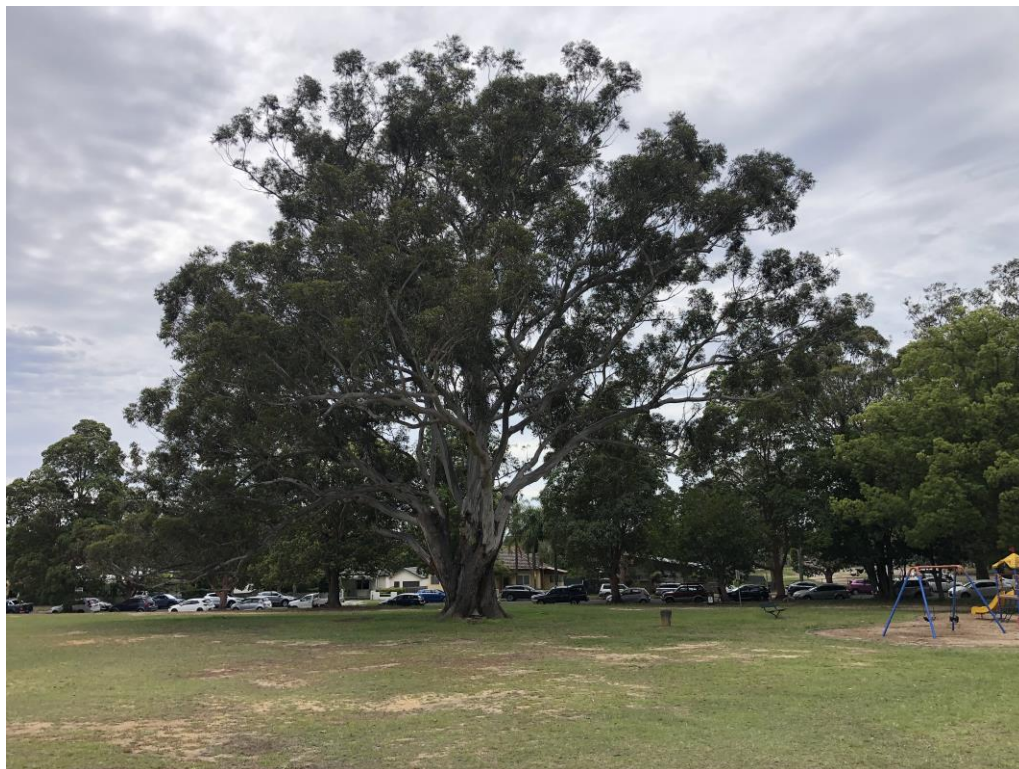
- 3.9** Tree 50 is a large mature Blackbutt (*Eucalyptus pilularis*). This tree has a very large broad canopy that is almost twenty (20) metres radius (Plate 6). This tree would be considered to be the most significant individual tree on site. This tree would appear to be one of the larger site constraints due to the size and age of the tree. Examination of the lower stem shows that there are wounds on this tree that may indicate it is an Aboriginal scar tree (Plate 7). Specialist advice should be sought to confirm this. This tree, based on its size and branching development, could be as old as 300 years.

**Plate 6:** Image showing Tree 50 possibly the oldest tree on site. P. Vezgoff

- 4.5** For the purpose of this report, I have categorised Tree 50 as having a high significance rating for its current status. In terms of long term planning this tree may live for another forty (40) years however all trees do not live forever and at some stage this tree will enter senescence where dieback and the shedding of limbs will be part of this senescing process. Level changes and altering the surface hydrology around this tree is likely to speed up this senescing process. It will be important that the existing levels are retained and that the pedestrian path is designed so that water does not pool within the TPZ area (See Note 1, Tree Protection Plan). Potentially this tree could be retained however the entire area under the drip line should be planted out as garden area (Plate 12) in order to

reduce the element of risk from limbs that may fail from a tree of this age. The current plans show the area being turf (See Note 2, Tree Protection Plan).

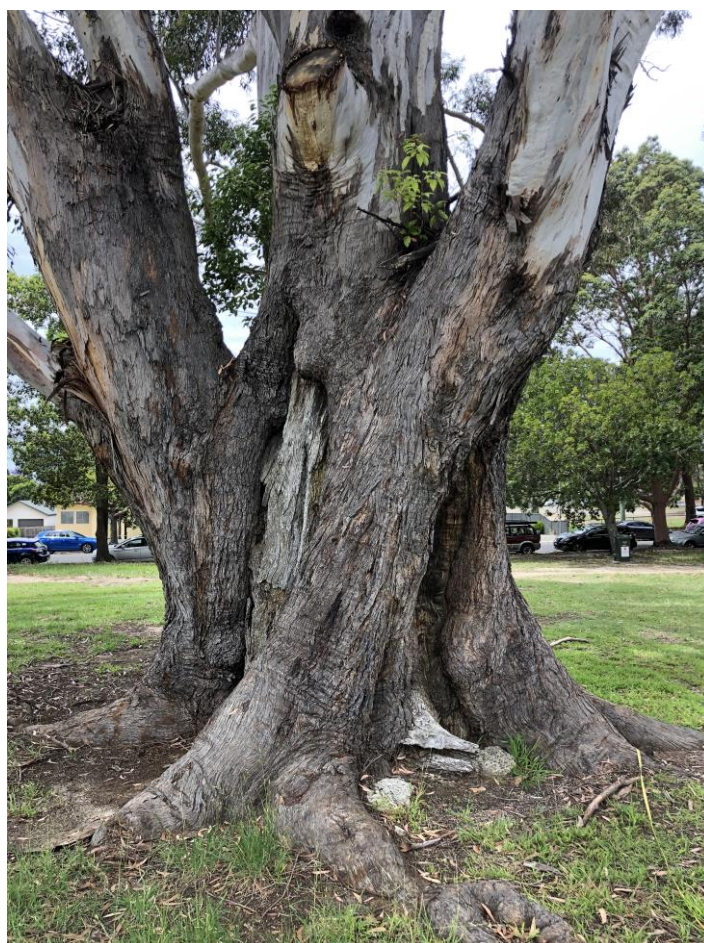
**Plate 7:** Image showing the old scars on Tree 50. P. Vezgoff

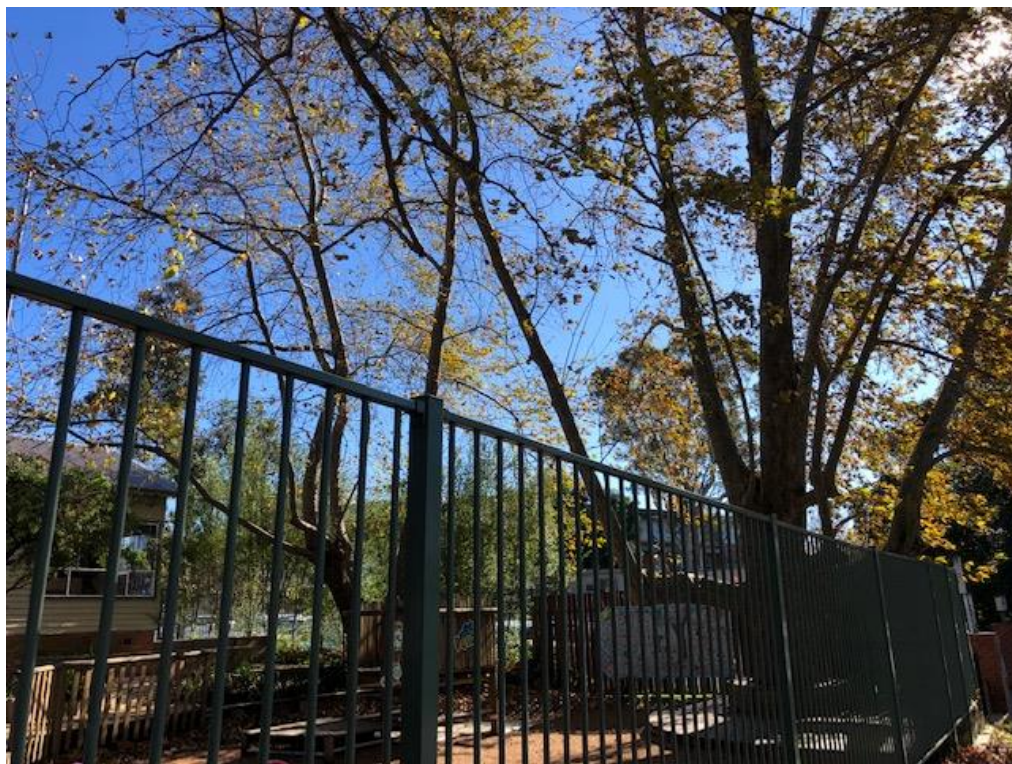
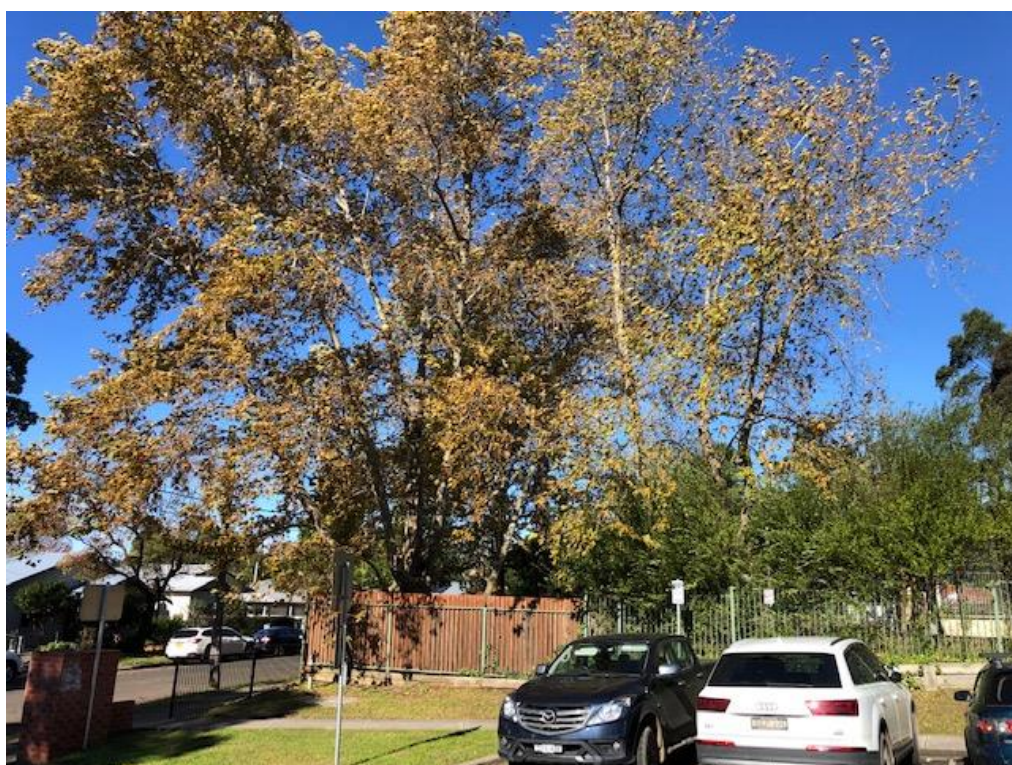
- 3.10** Trees 98, 99 and 100 are London Plane Trees (*Platanus × acerifolia*). These trees are exotic species, in good health and condition (Plates 8, 9 and 10). The main trunks, first and second order branches are free of any cracks, splits or fruiting bodies. Old pruning wounds are showing good occlusion, a sign that the trees are photosynthesizing effectively. New extension growth was noted with leaf colour showing good vitality. Trees 98 and 99 show a history of lopping and as such have developed a poor branching structure.

**Plate 8:** Image showing Trees 98 and 100. P.Vezgoff.

**Plate 9:** Image showing Trees 98 and 100. P.Vezgoff.

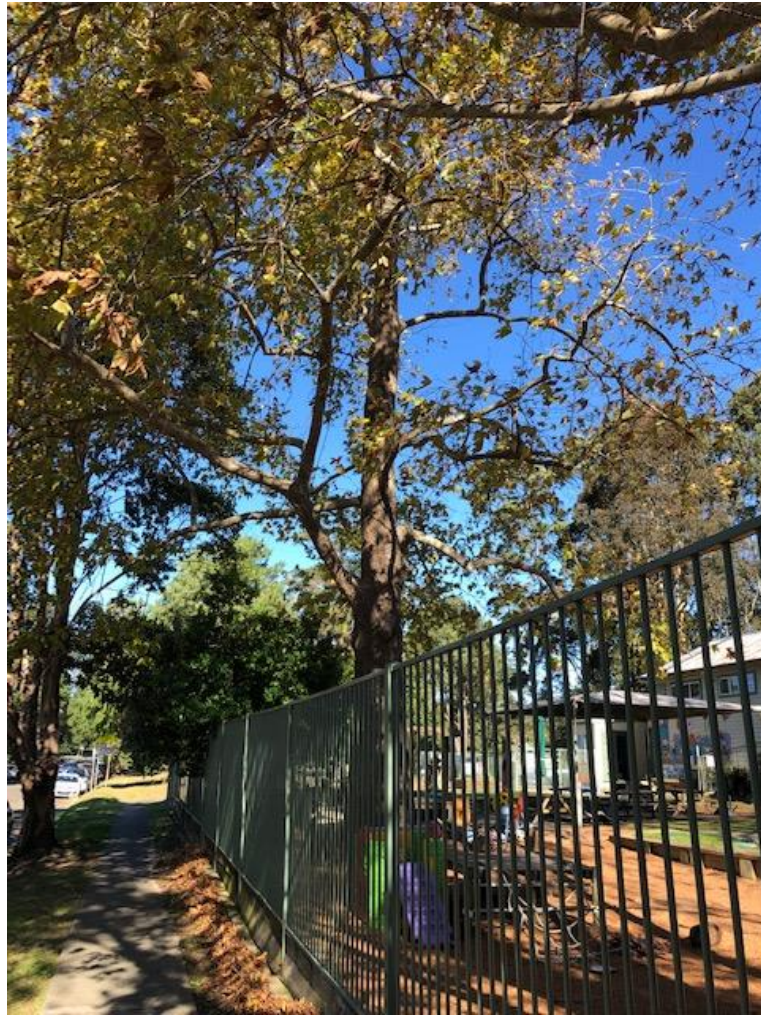
**Plate 10:** Image showing Tree 99, Tree 101 to the left of image. P.Vezgoff.

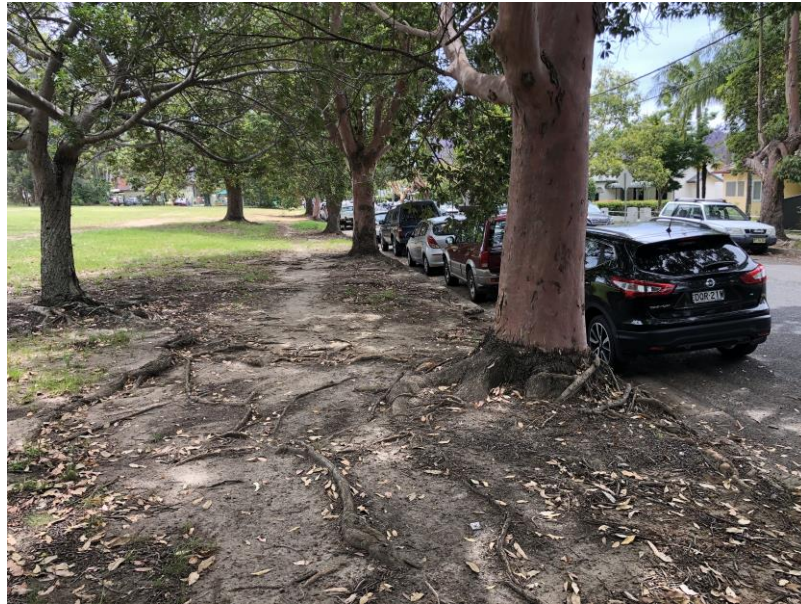
- 3.21** The new footpath proposed along North Street will have minimal impact, however Trees 57 – 60 along Shoalhaven Street will be impacted unless levels can be raised so as not to sever roots on these trees. As shown in Plate 11 there are extensive surface roots from Trees 57-60 that, unless the existing levels can be retained, these trees may have to be considered for removal.

**Plate 11:** Image showing Trees 57-60 along Shoalhaven Street and the woody surface roots clearly evident. P. Vezgoff

- 5.3 Individual trunk protection:** Street trees numbered as 57-60, 62, 74-77 and 101 will require trunk protection to be installed prior to any demolition works occurring. This is achieved by attaching lengths of timber (75mm x 50mm x 2000mm) fastened around the trunk. Geotextile fabric or carpet underlay shall be wrapped around the trunk prior to the timbers being attached. These timbers are to be fastened with hoop iron strapping and not attached directly into the bark of the tree. These timbers are only to be removed when all construction is complete. See Plate 12 for an example of trunk protection. This trunk protection is based on The Australian Standard *Protection of trees on development sites*, AS 4970, 2009.
