Our ref: SYDGE308795AB M1 Rev 1

4-6 Bligh Street, Sydney – Response to SEARs for Issues 13 and 17 for SSD-48674209

Detailed Environmental Site Investigation
4-6 Bligh Street, Sydney

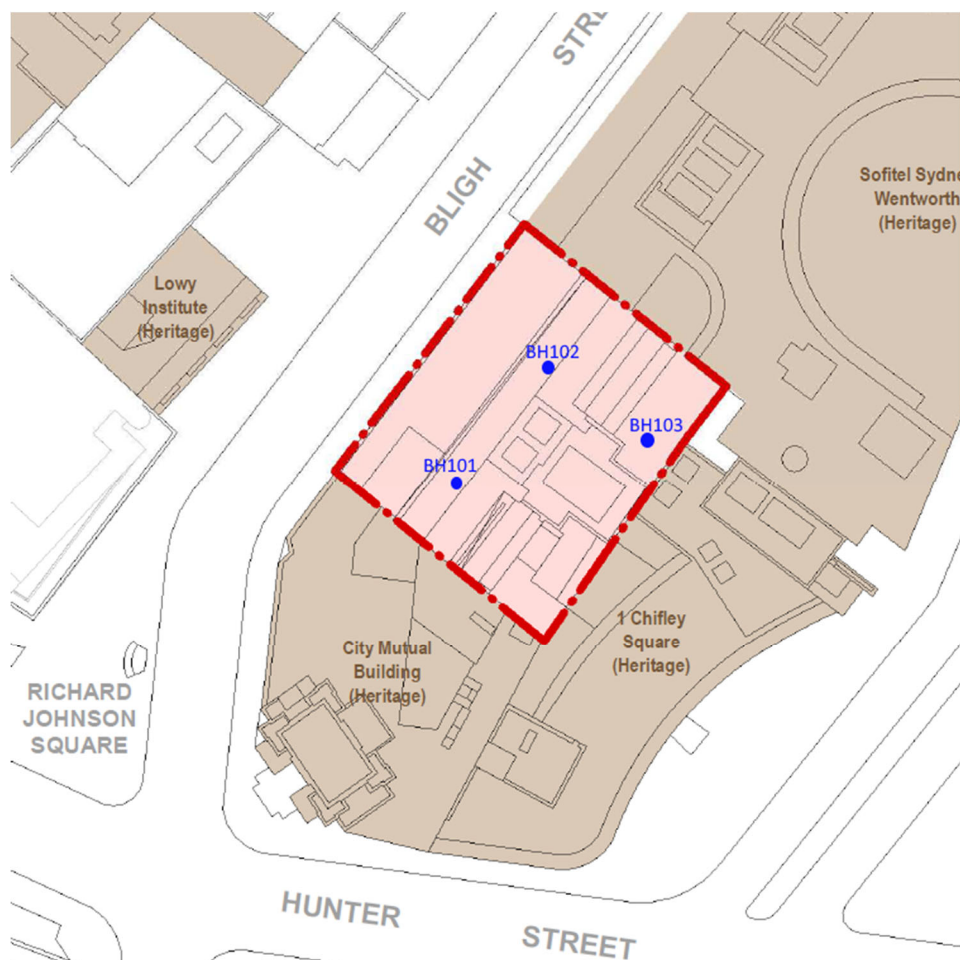
Figure 1: Piezometer locations

Piezometer location	Surface elevation (m AHD)	Casing stickup (m above ground)	Depth to water (m below top of casing)	Date and time	Groundwater level (m AHD)
BH101	17.9	-0.11	11.45	13 Oct 22 9:55am	6.3
BH102	17.9	-0.08	10.69	13 Oct 22 9:45am	7.1
BH103	12.8	-0.08	5.47	13 Oct 22 10:00am	7.3

The current two-level basement does not penetrate the groundwater table. An extension of the basement at the site to provide four levels is expected to intersect approximately the top metre of the groundwater table.

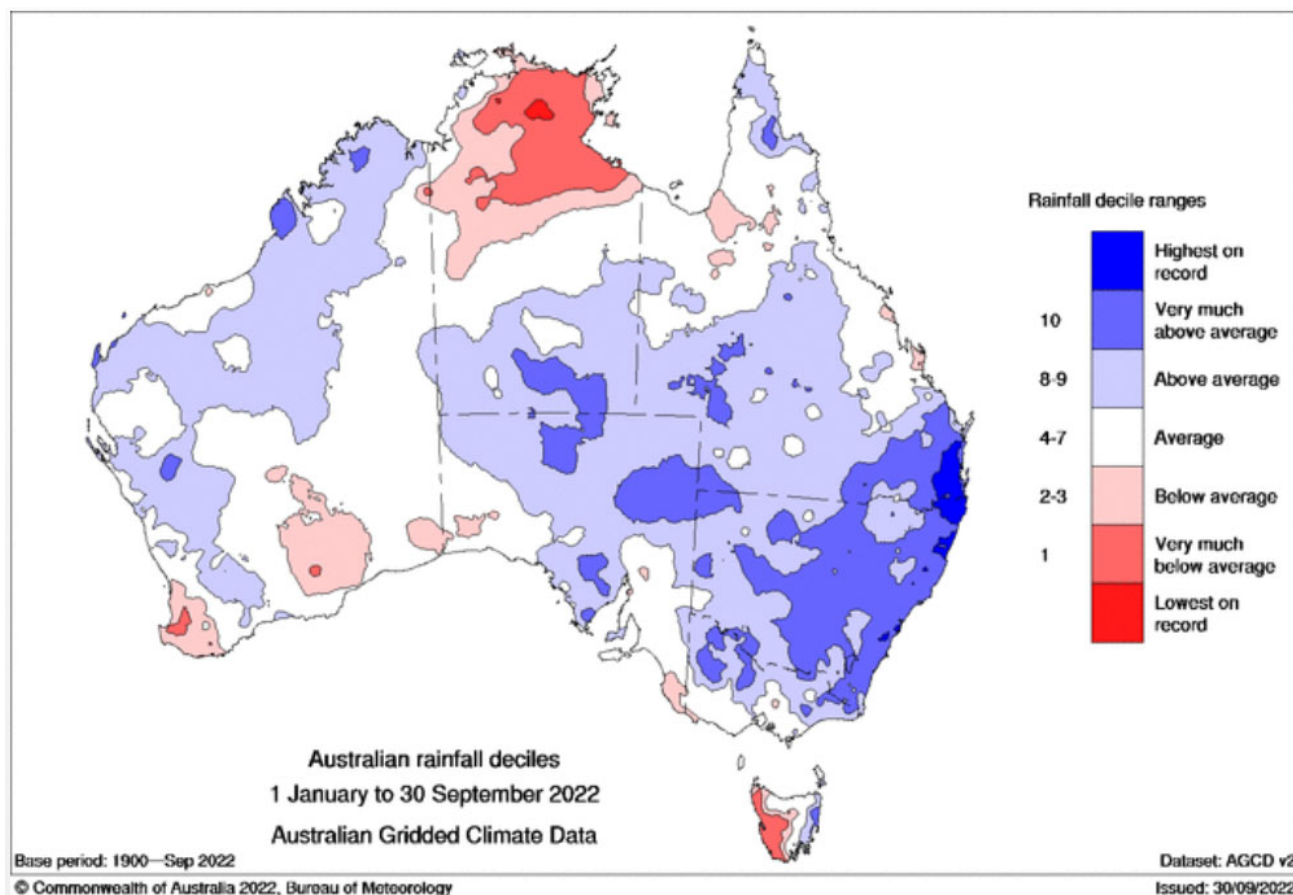
Figure 2: Australian rainfall deciles for 1 Jan 2022 to 30 September 2022

It is noteworthy that these levels were observed following nine months of “very much above average” rainfall in the Sydney region (source: Bureau of Meteorology), refer to Figure 2, and can therefore be assumed to represent groundwater levels higher than the long term average.

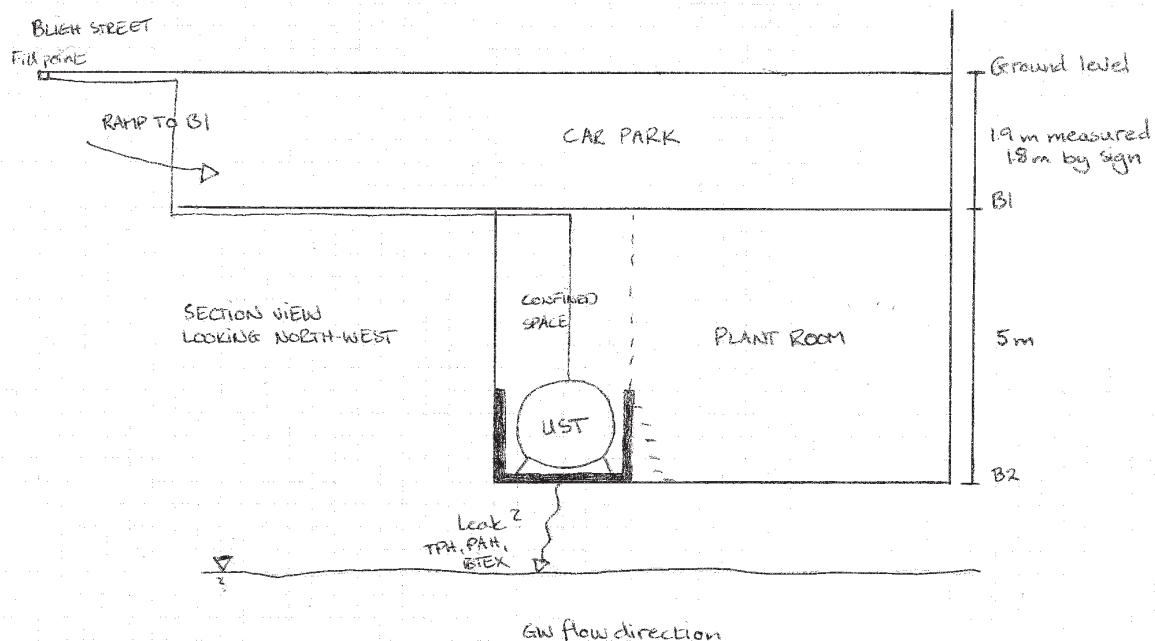
Figure 1: Preliminary CSM (schematic only, not to scale)

A generalised preliminary CSM was developed as part of the DQO process, defining the potential sources of contamination, potentially affected media, Contaminants of Potential Concern (CoPC), potential receptors and exposure scenarios for redevelopment of the site for the proposed hotel and commercial high-rise development.
